REPAIR AND RESTORATION OF THE MOTHER CHURCH

BLC PRESENTATION
28 FEBRUARY 2017

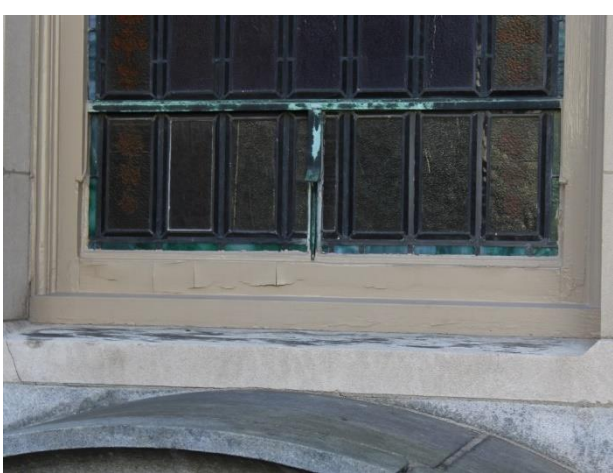
Peeling Paint

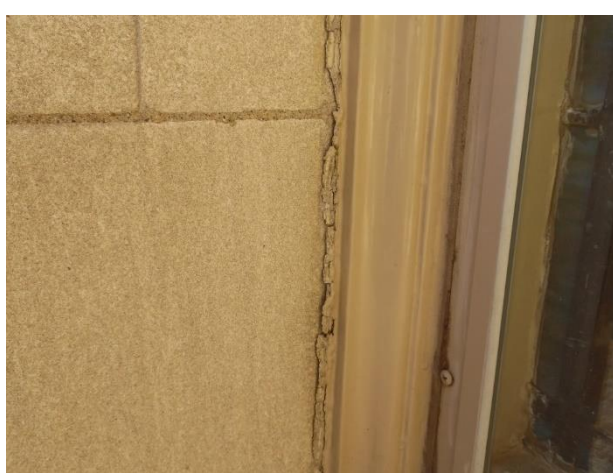
Deteriorated Wood Frame

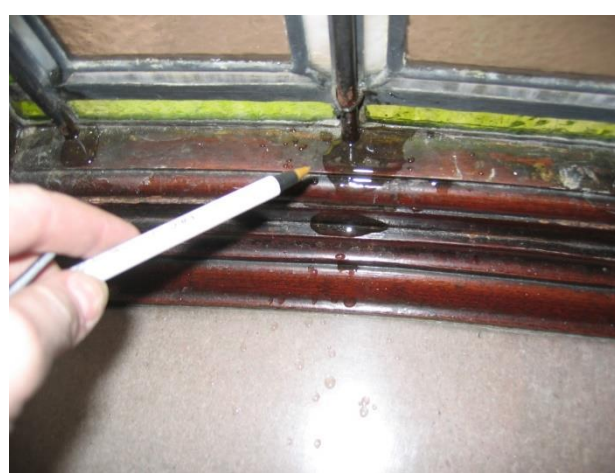
Failed Perimeter Sealant

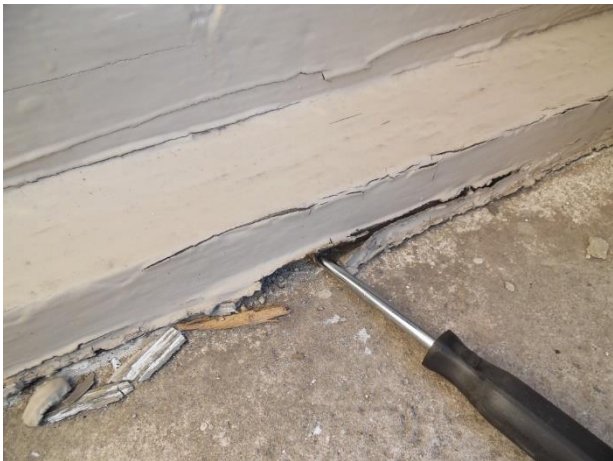
Cracked and Missing Glazing Putty

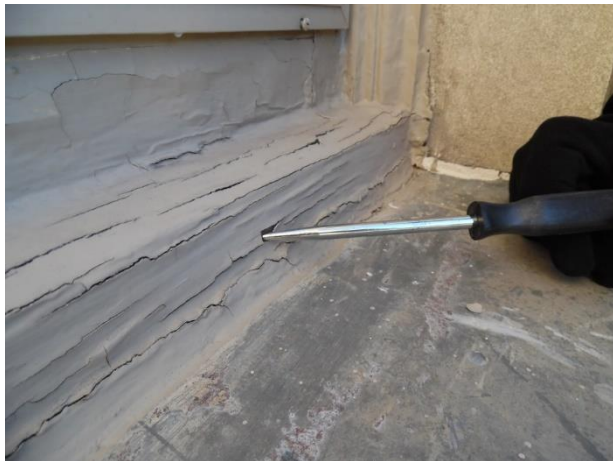
Cracked Glazing

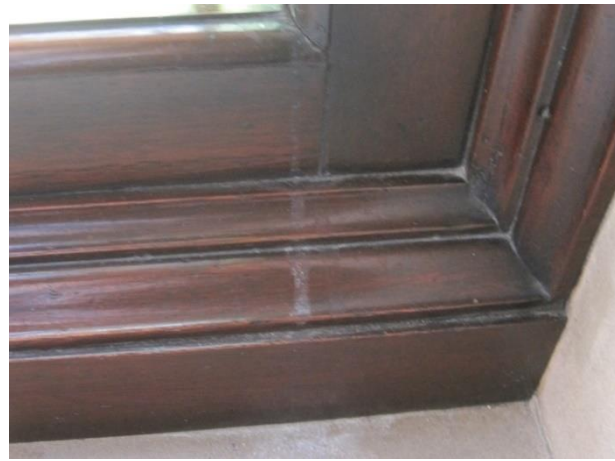
Remedial Sealant

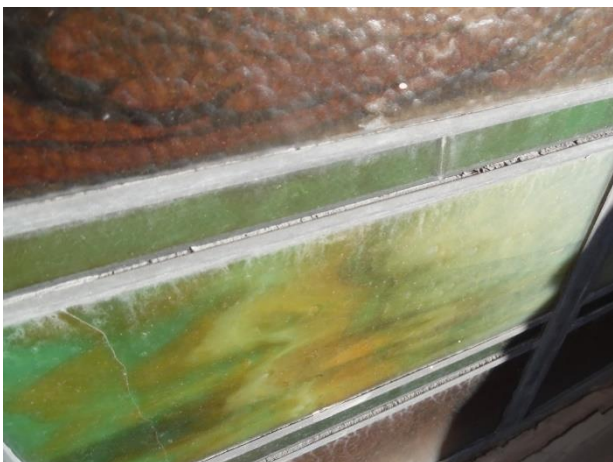
Split Caming

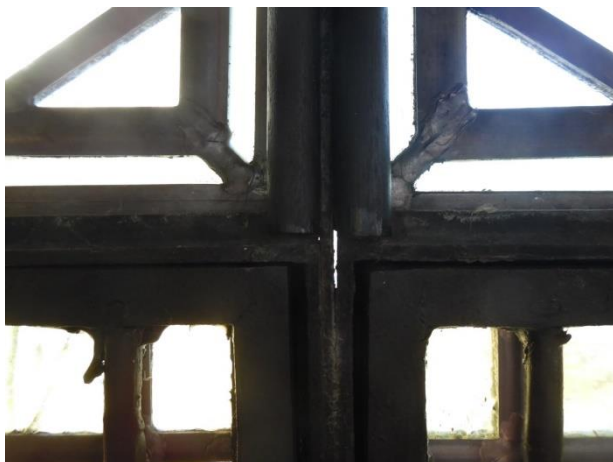
Evidence of Leaks

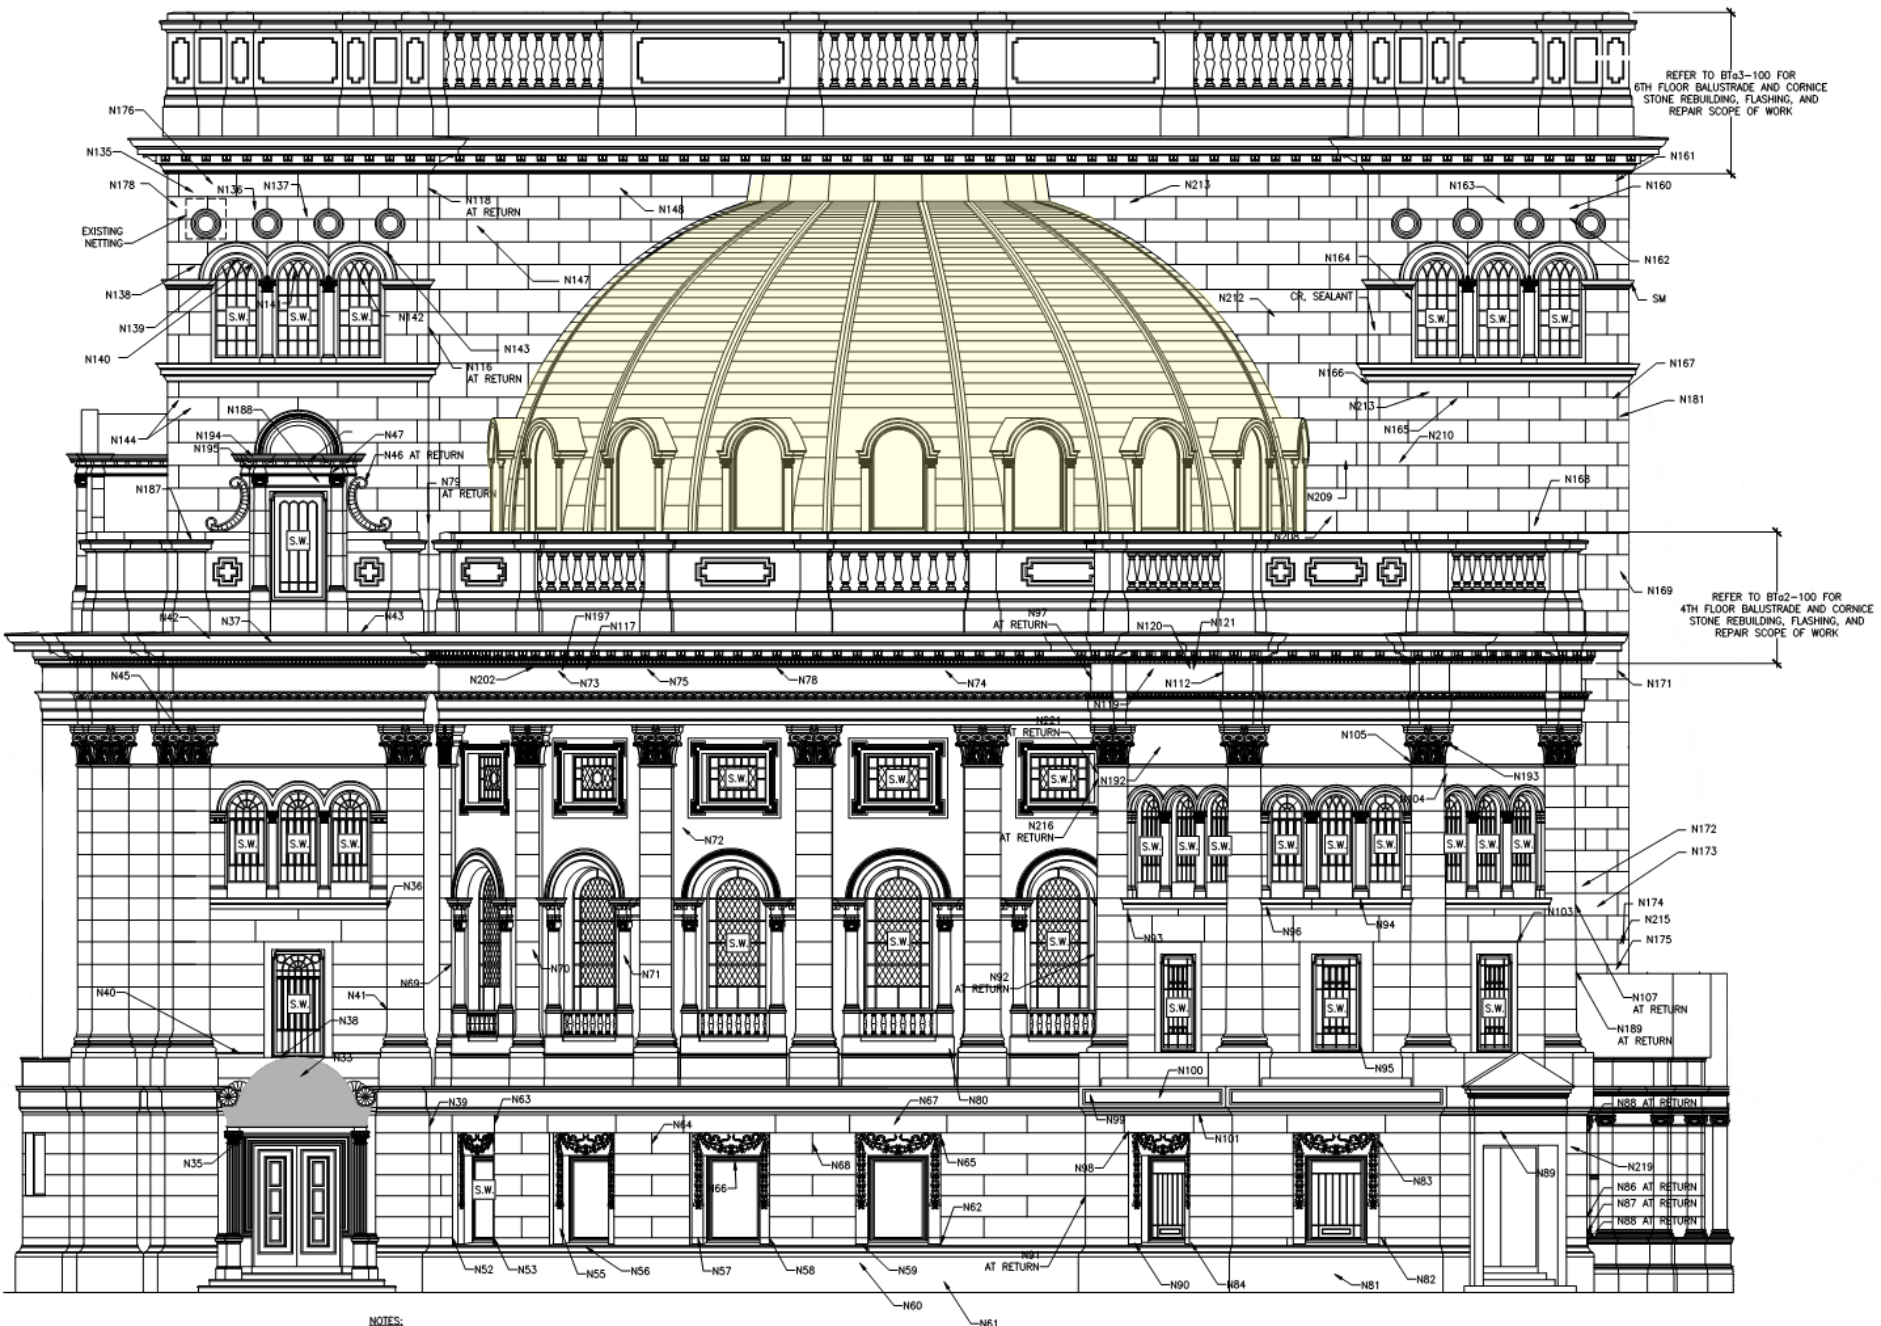
NORTH ELEVATION (SOUTH SIMILAR)

SEMI DOMES

REBUILD DOWN TO GUSTAVINO TILE SUB-STRUCTURE TO PROVIDE NEW WATERPROOFING AND FLASHING

REPLACE TERRA COTTA – IN-KIND OR WITH STONE (ALTERNATE)

REMOVE AND REINSTALL WINDOWS

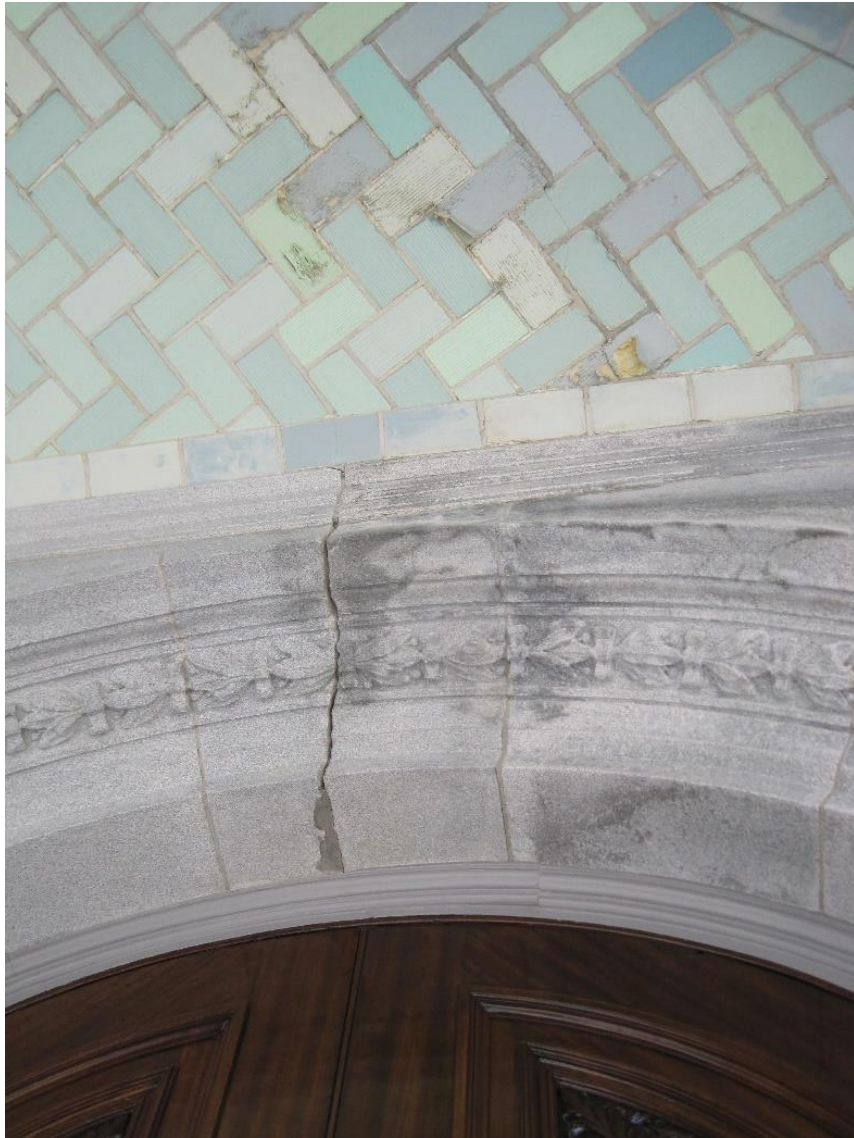
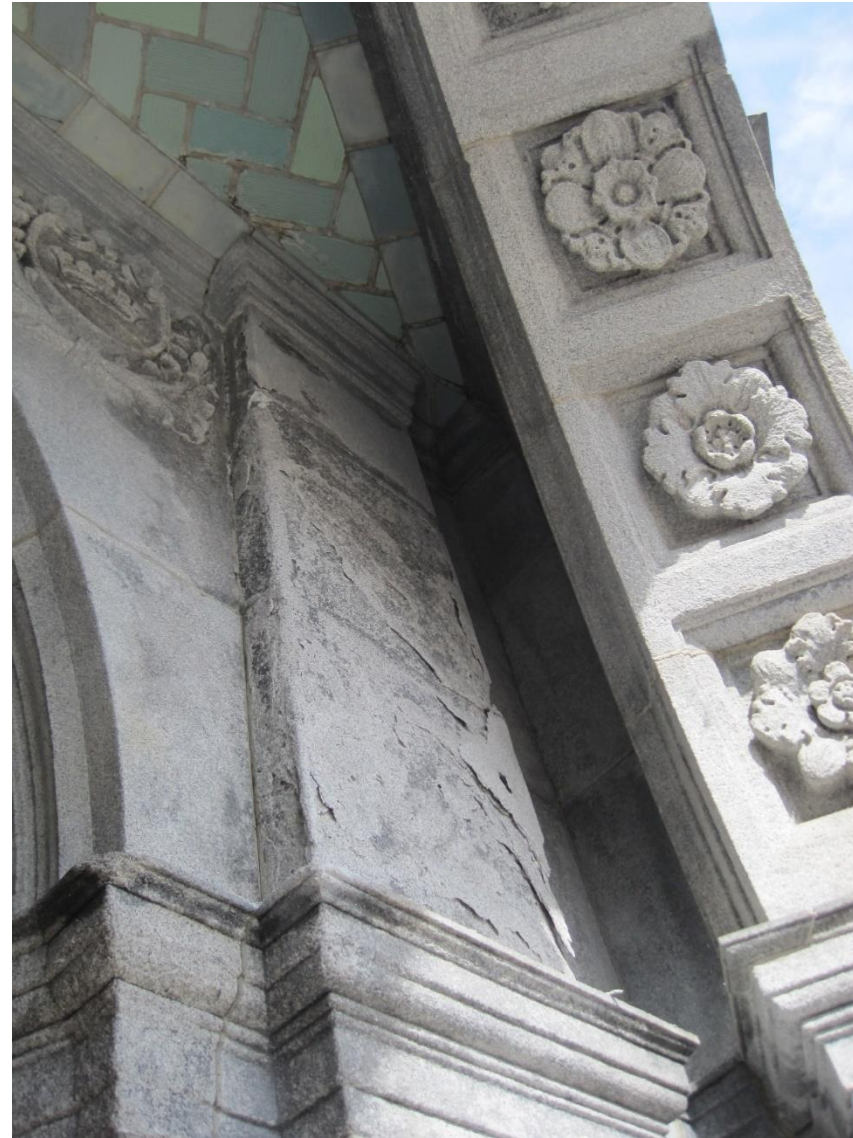
PORTICO DAMAGE
