### Scope of Work

4- 18 Clarendon Street, East Facing Elevation

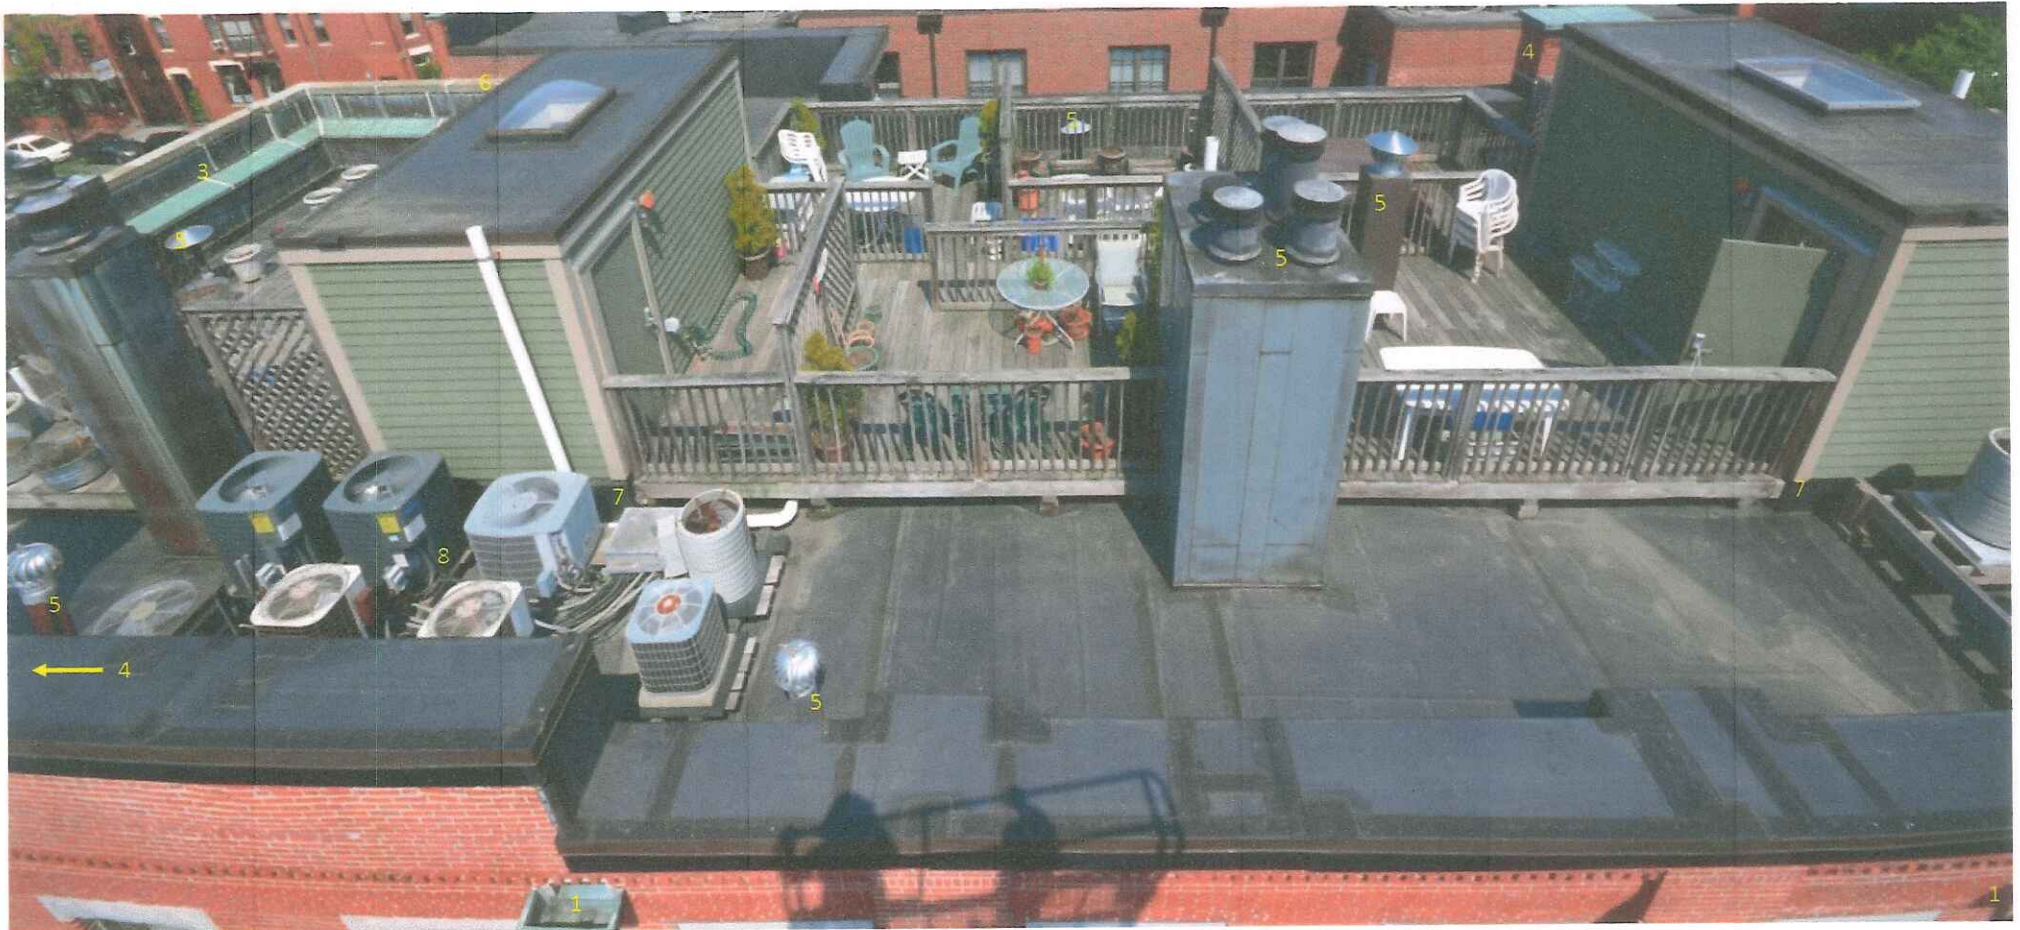
70-80 Warren Avenue Roof

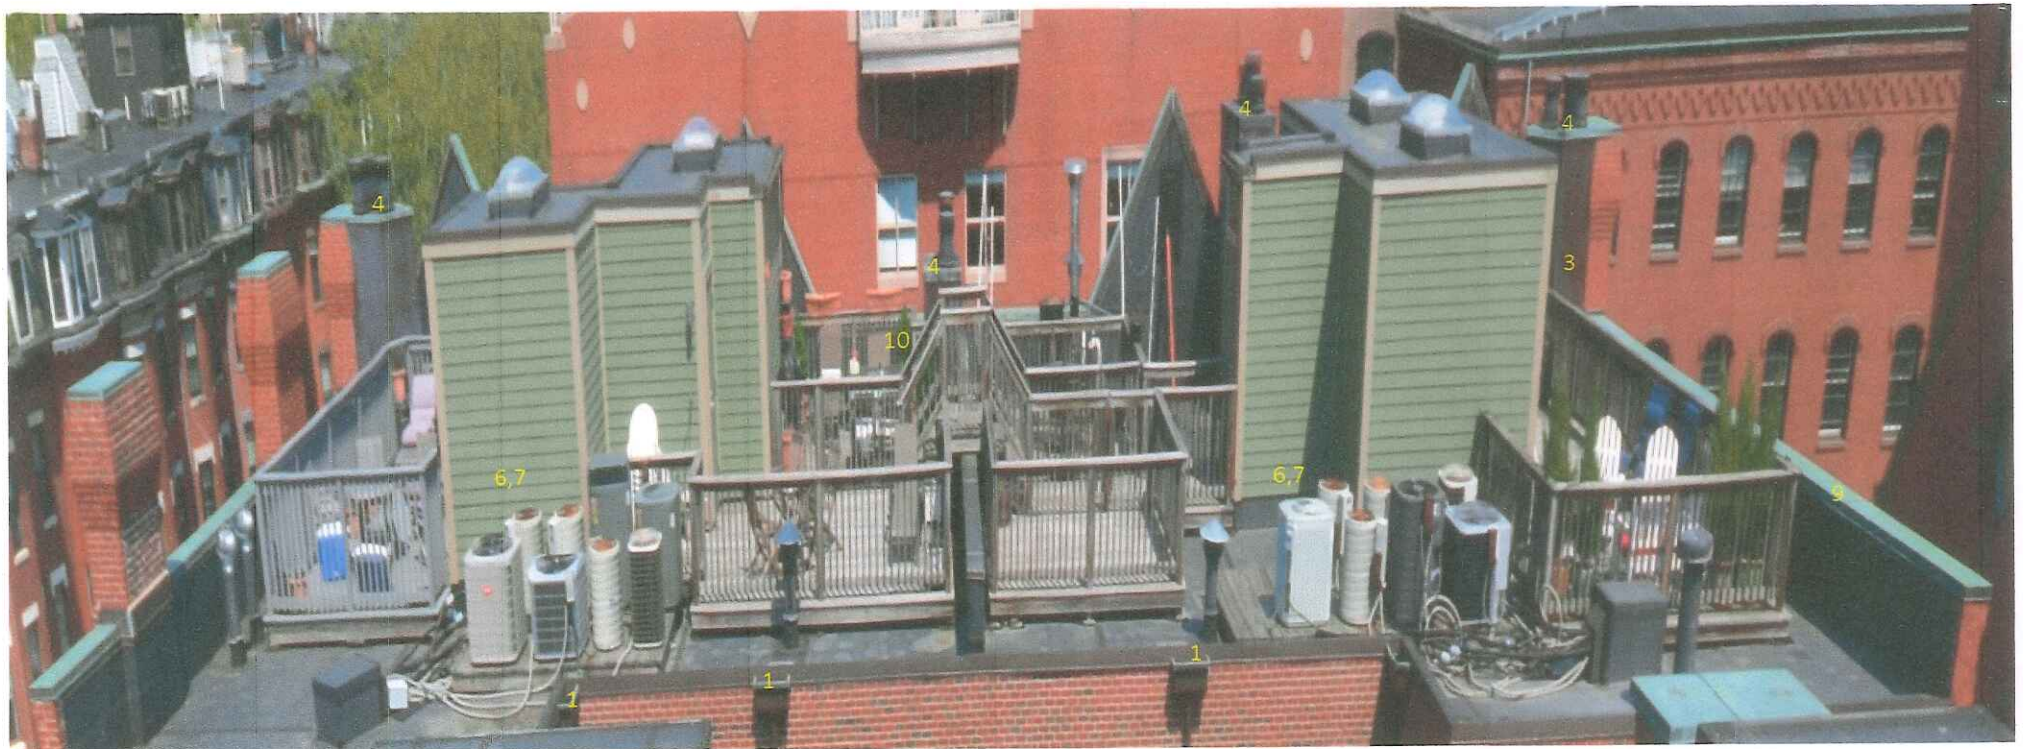
4- 18 Clarendon Street Roof

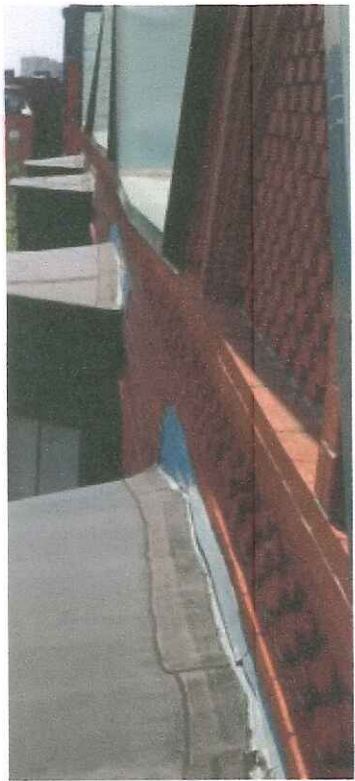
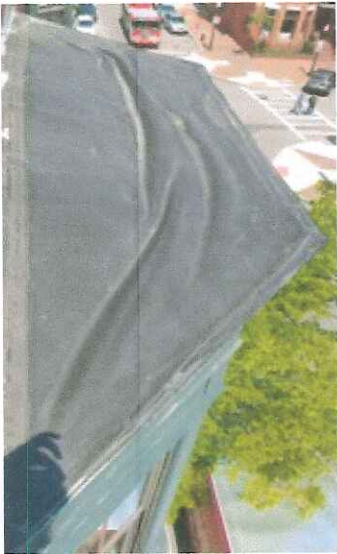
Failed EPDM roof over bay window. Roof has 2 EPDM roofs over copper.

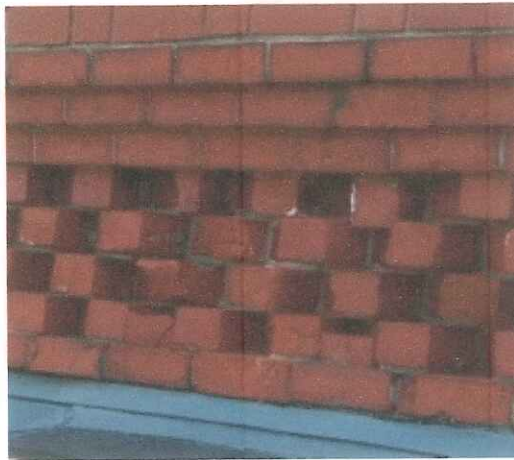
Damaged bricks at Parapet wall.

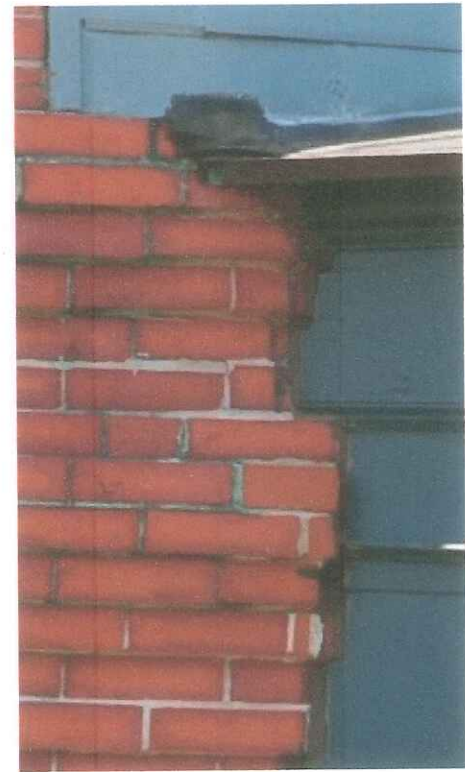
Step crack in bricks at side of bay window.

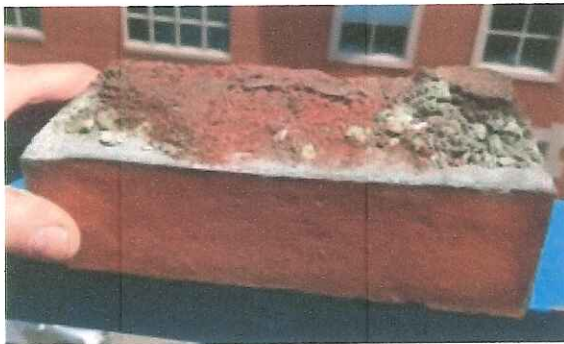
Brick had been removed by hand and the mortar has turned back to sand due to the excessive water infiltration.

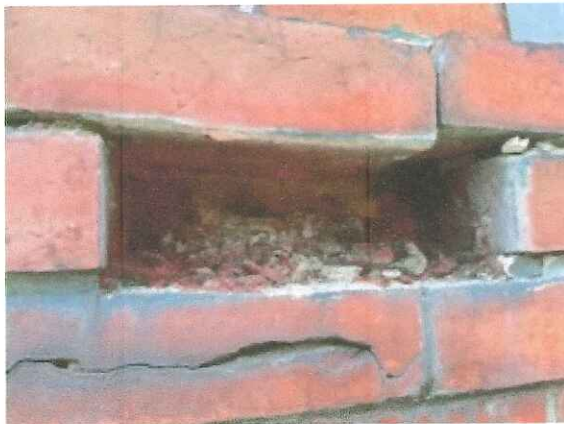
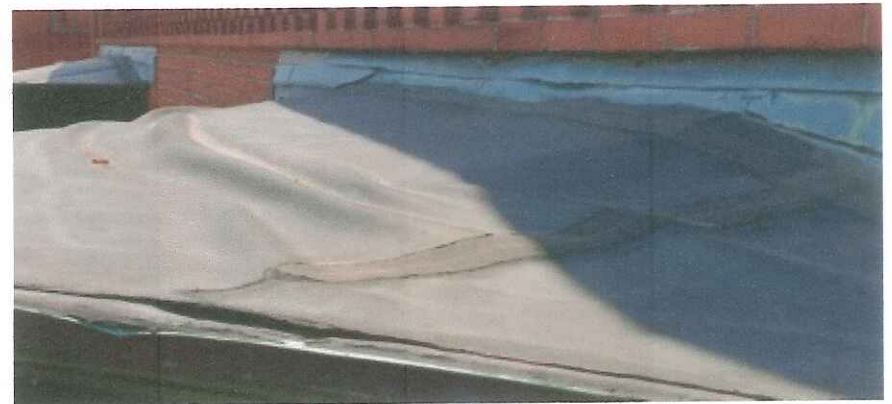
Failed EPDM roof over bay window. Roof has 2 EPDM roofs over copper.

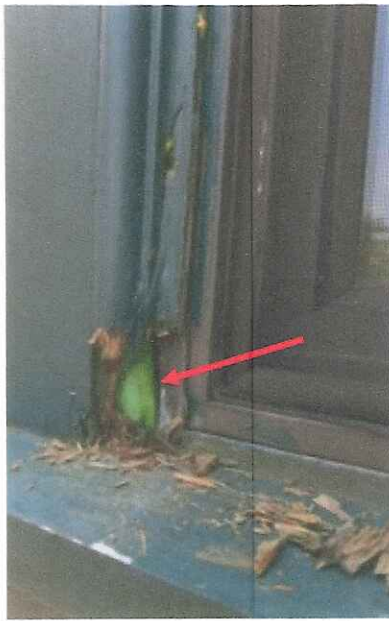
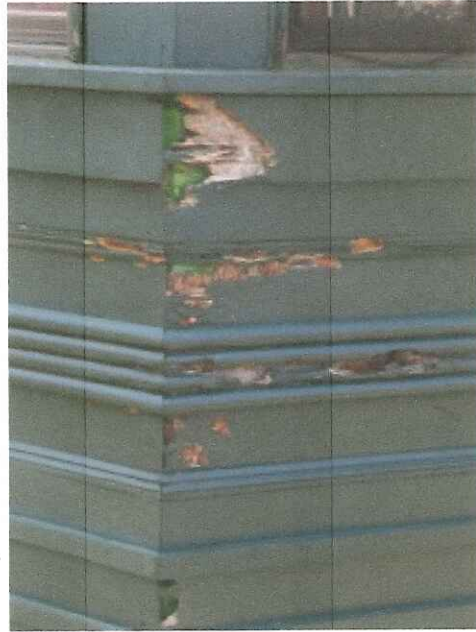
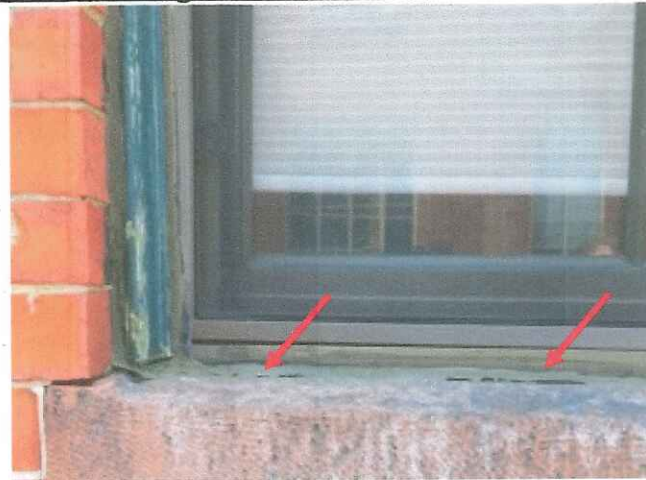
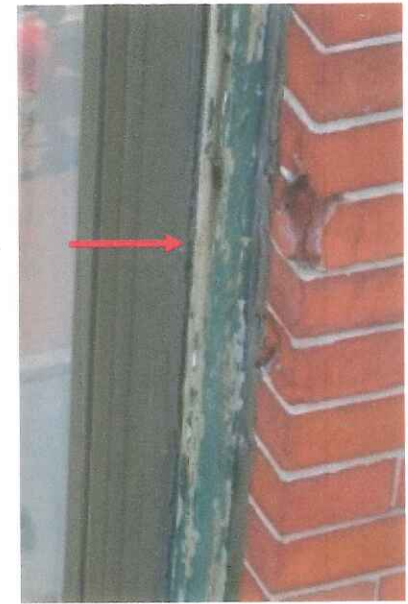
Deteriorated trim work and open caulk joints at windows.

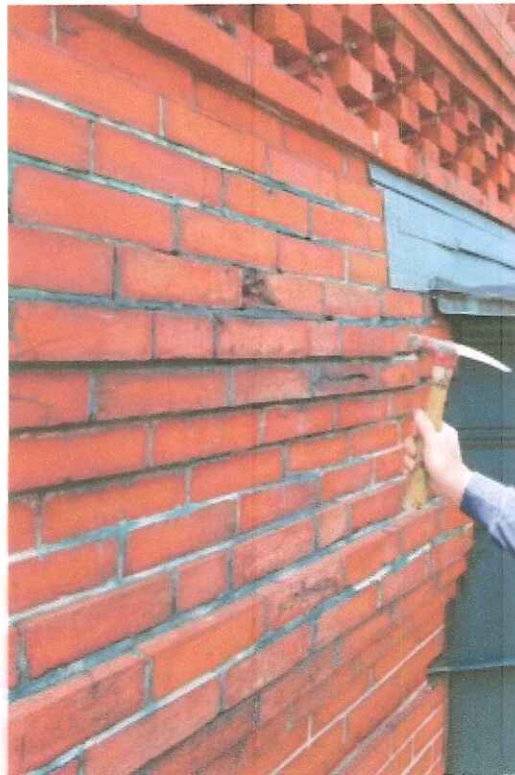
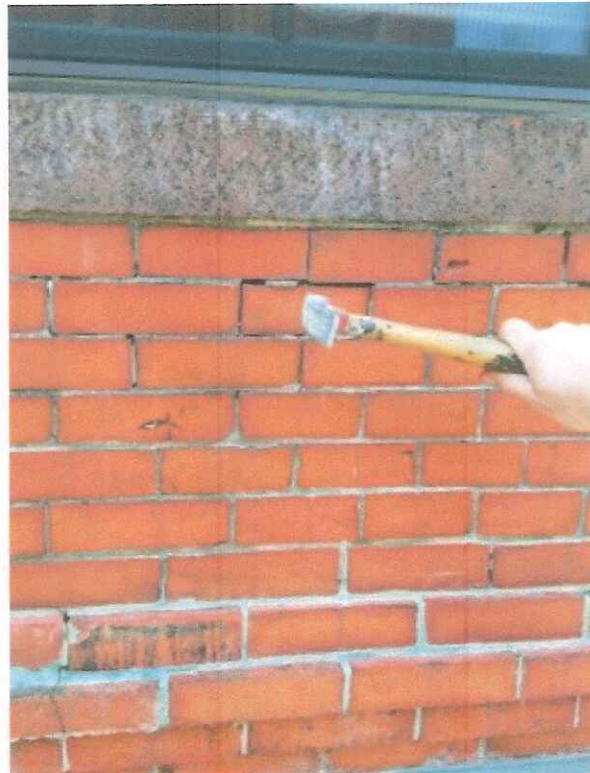
Mortar joints are very deteriorated and bricks can be moved by hand. Masonry will need to be rebuilt. Also note the condition of the bricks.

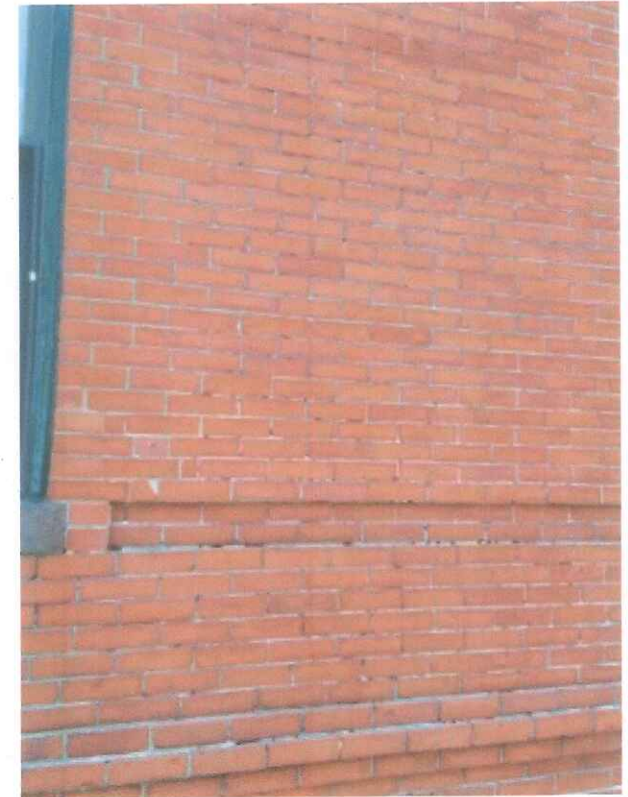
Clarendon Street Building, North Elevation

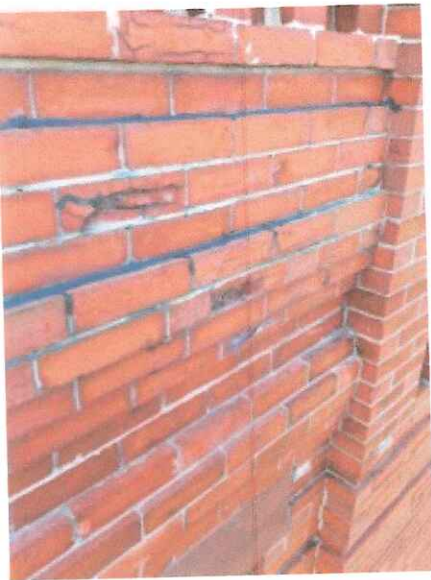
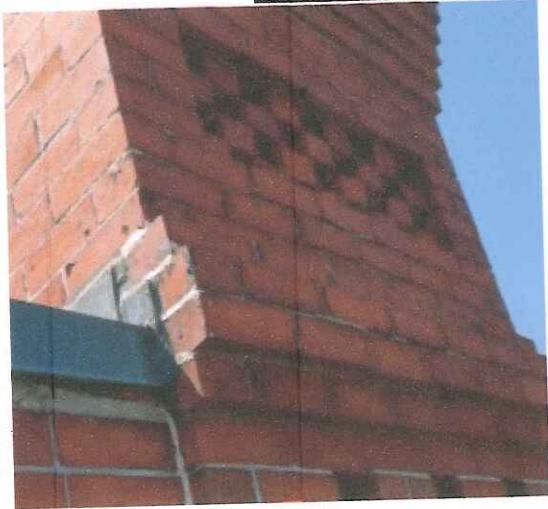
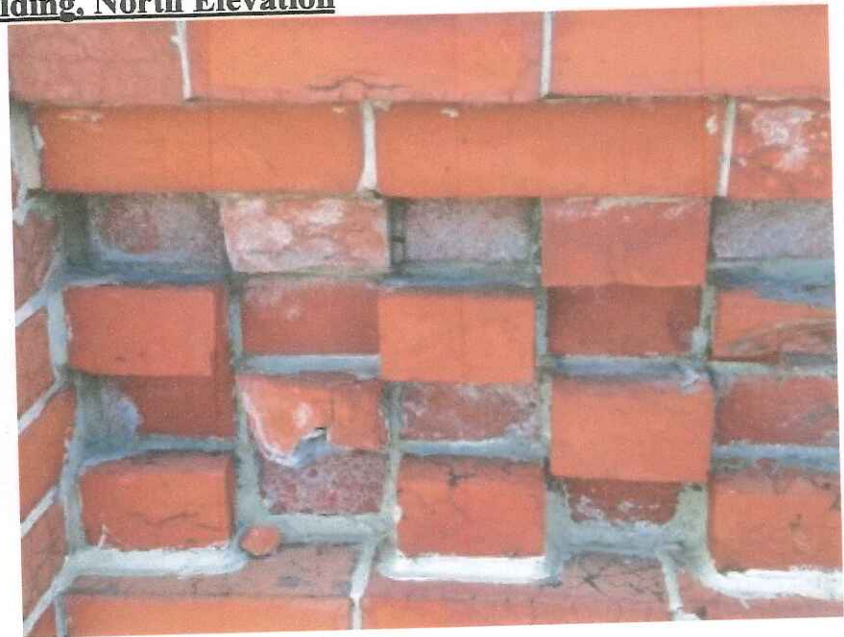
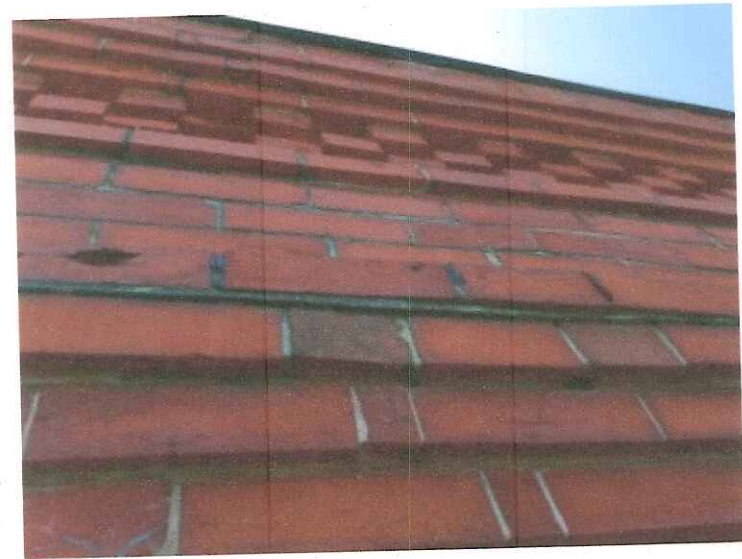
Brickwork is in very poor condition due to water infiltration. Masonry will need to be rebuilt with new bricks due to the extent of the damage.

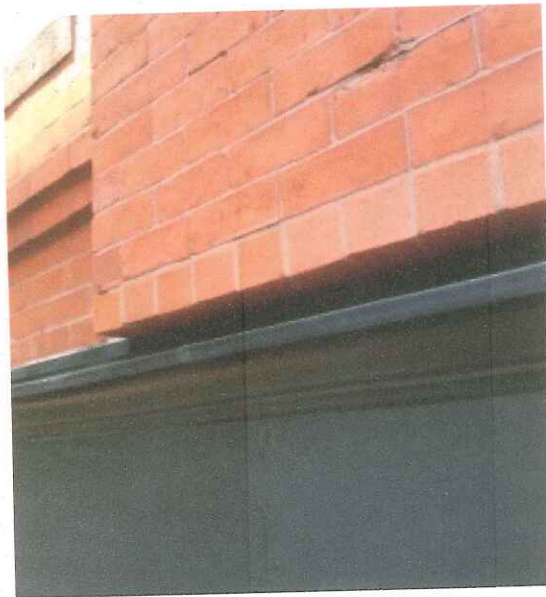
Brickwork had been removed for the storefront and should have a steel lintel to support the brickwork above.

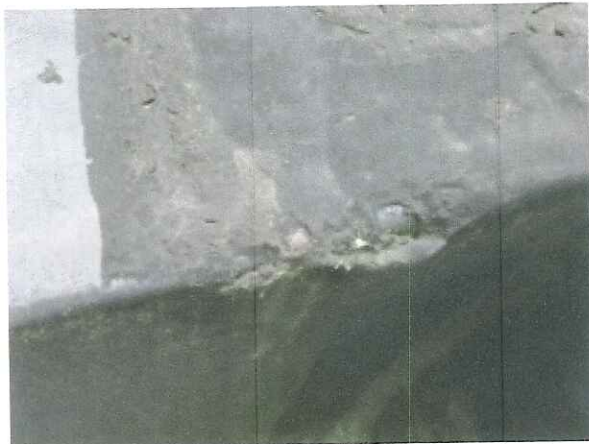
Damage at the EPDM flashing will need to be patched.

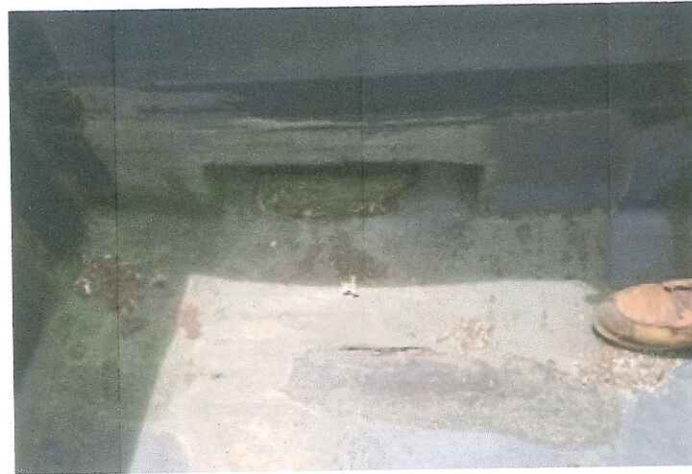
Flashing at the scupper perimeter has been patched with asphalt the is not compatible with the EPDM and will cause the EPDM to deteriorate.

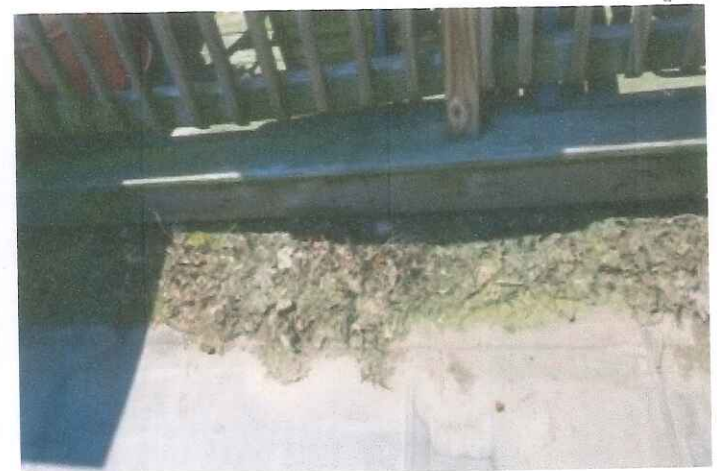
Lots of debris on the roof can cause accelerated roof failure. Roof should be cleaned every few months given the decks.

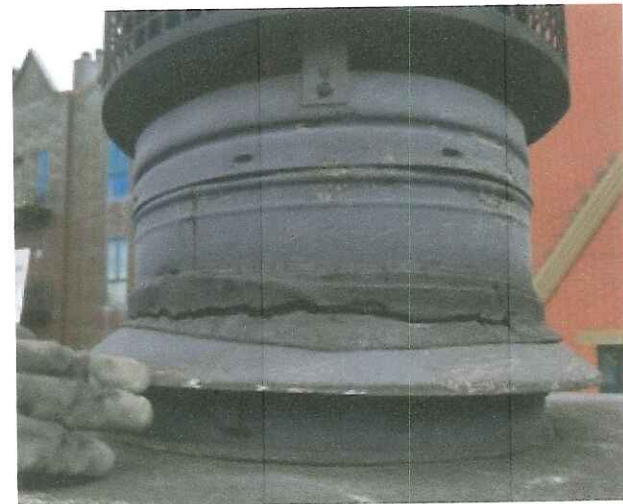
Open flange at vent needs to be re-sealed.

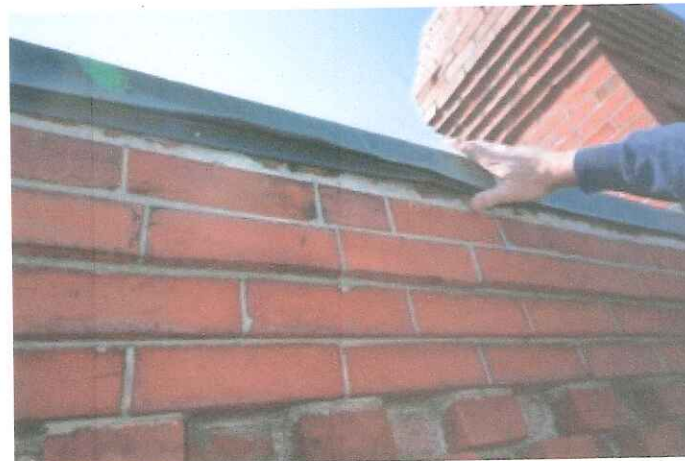
Flashing at the parapet was not installed properly an dis open to water infiltration into the wall.

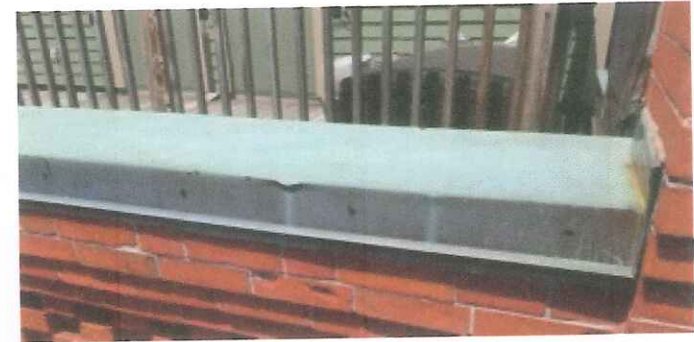
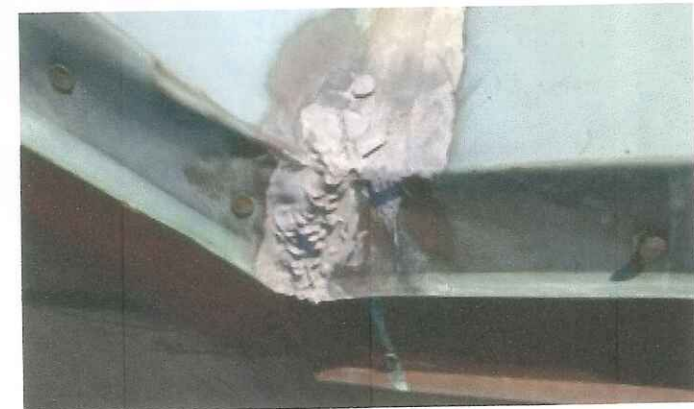
Damaged flashings with face fastening can lead to water infiltration into the roof.

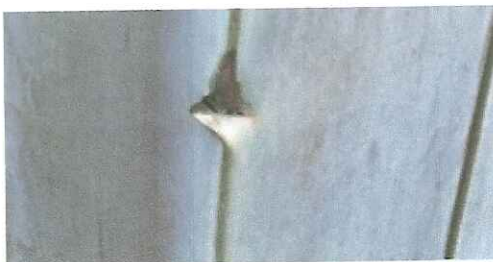
Damage at copper at vent stack needs to be repaired.

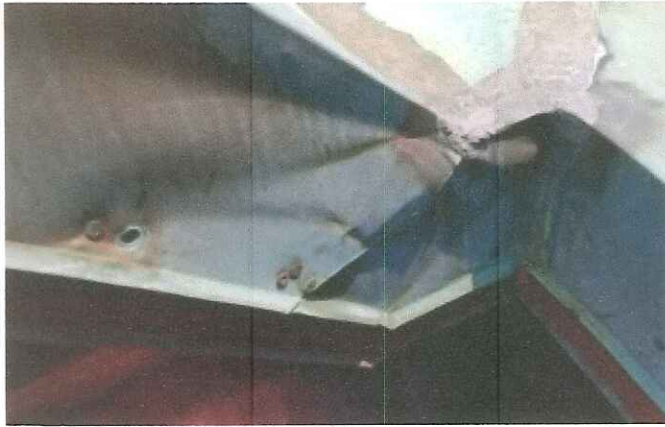
Damaged flashings with face fastening can lead to water infiltration into the roof.

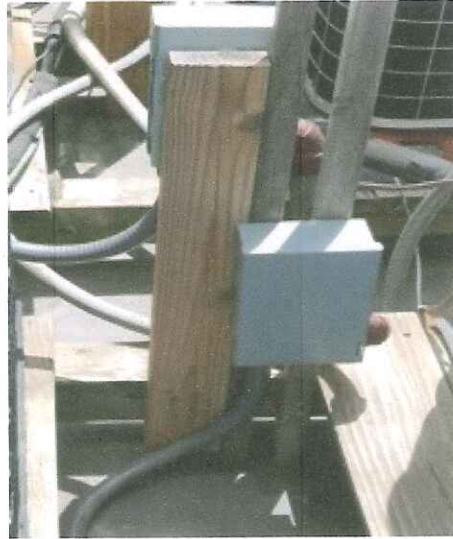
Wood is sitting directly on roof and needs to be set on sleepers and walkway pads.

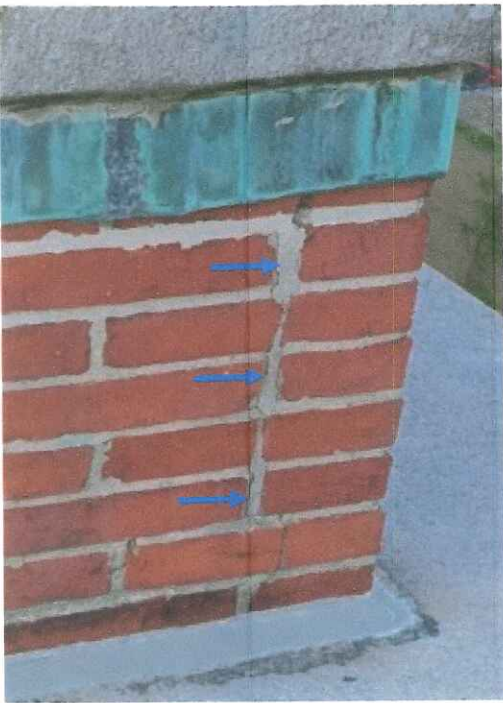
Vertical cracks in brick parapet.

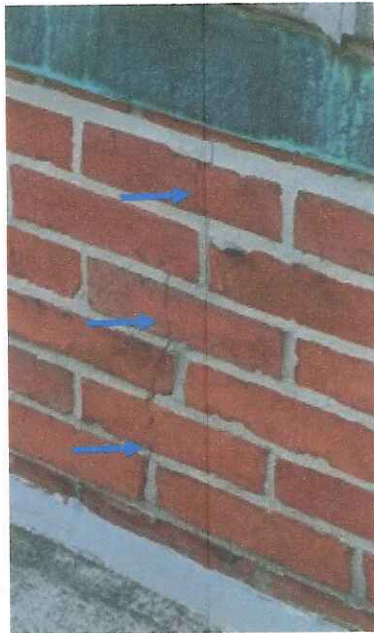
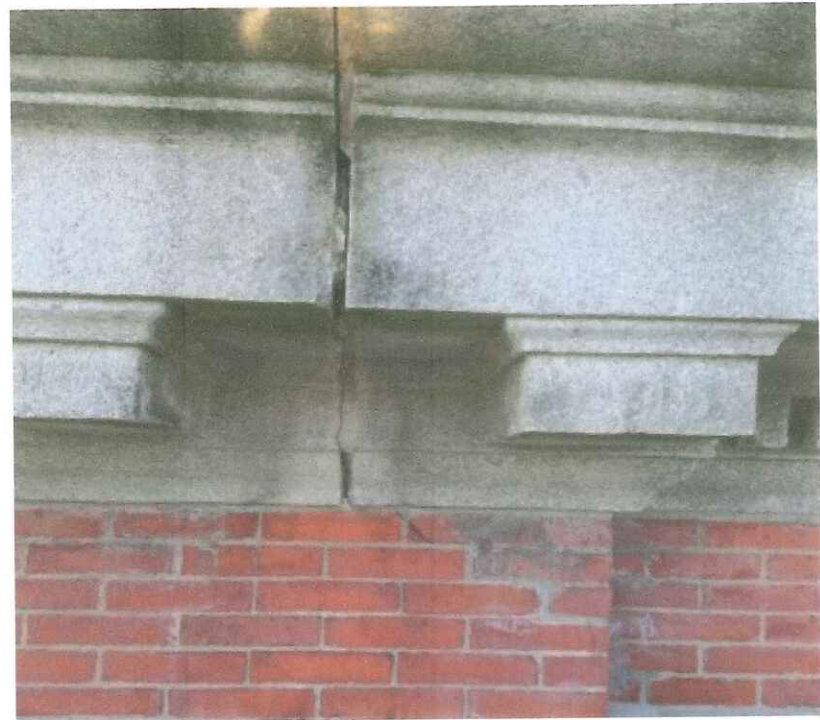
Open crack at granite cornice.

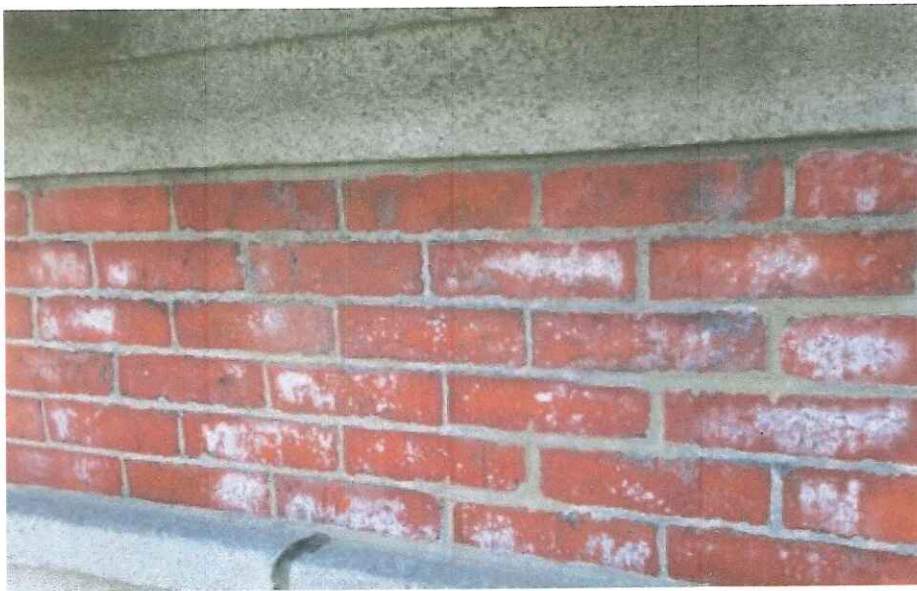
Efflorescence shows that water is getting in through the stone cornice.

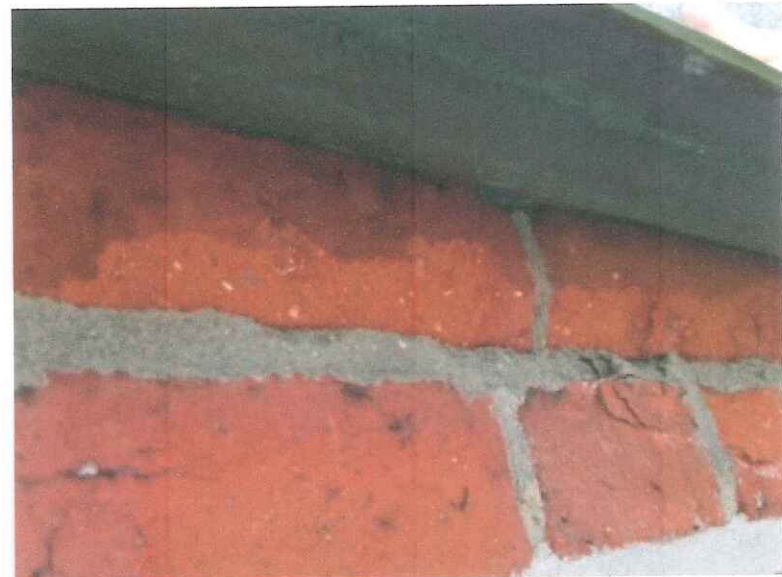
Deteriorated brick behind the parapet flashing that needs to be replaced.

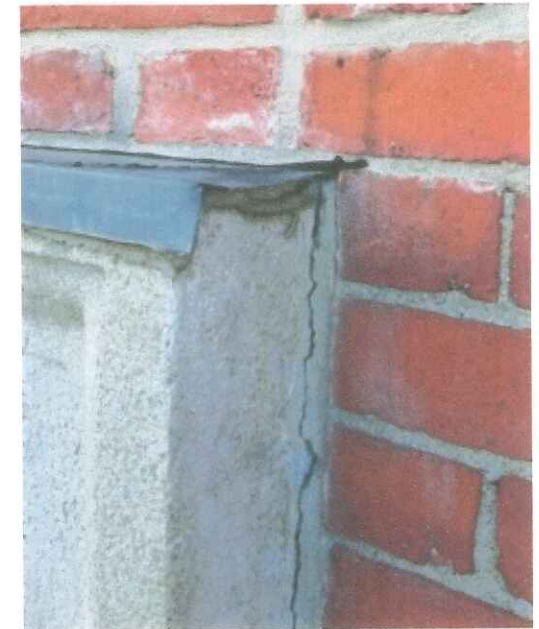
Joint between the brick and granite is cracked and should be replaced with a caulk joint.

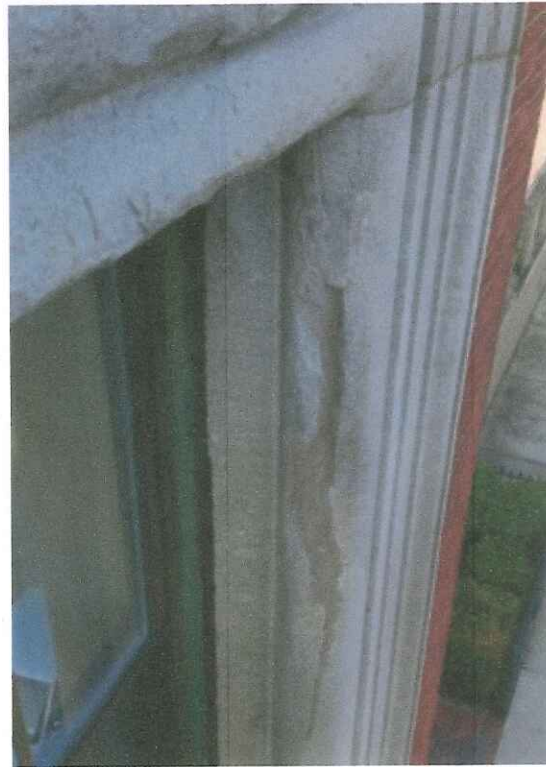
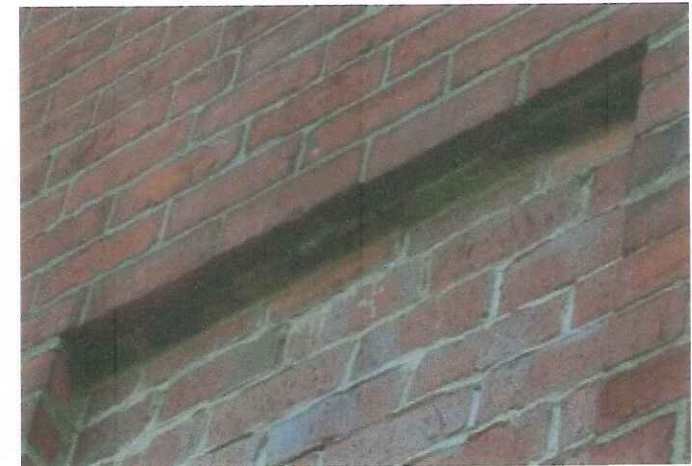
Rusted steel lintel should be removed and inset bricked in. The rust will begin to damage the wall.

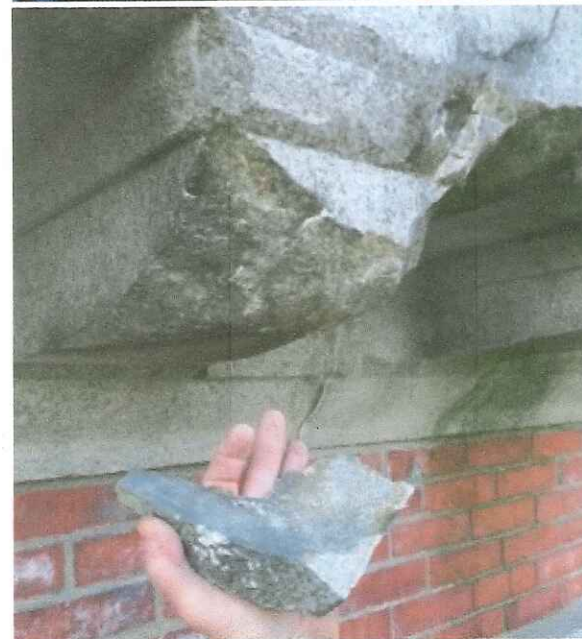
Typical examples of granite that needs to be replaced and or repaired.

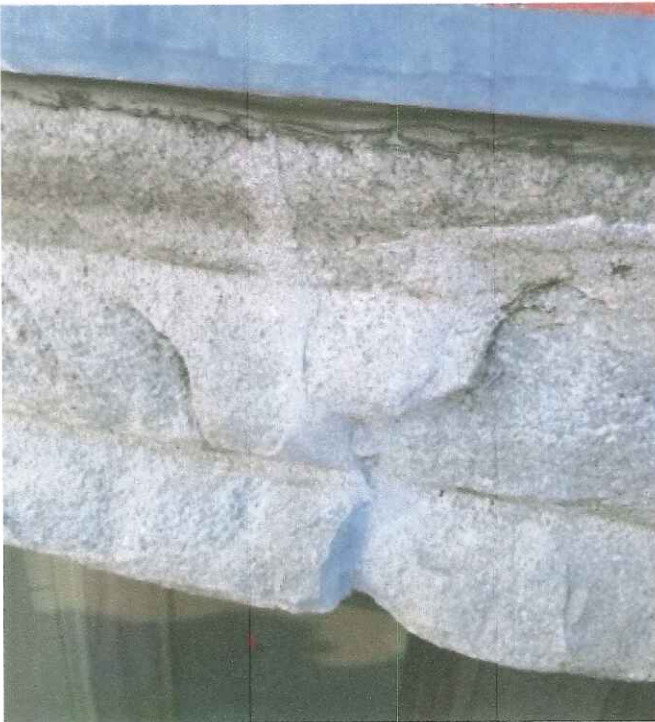
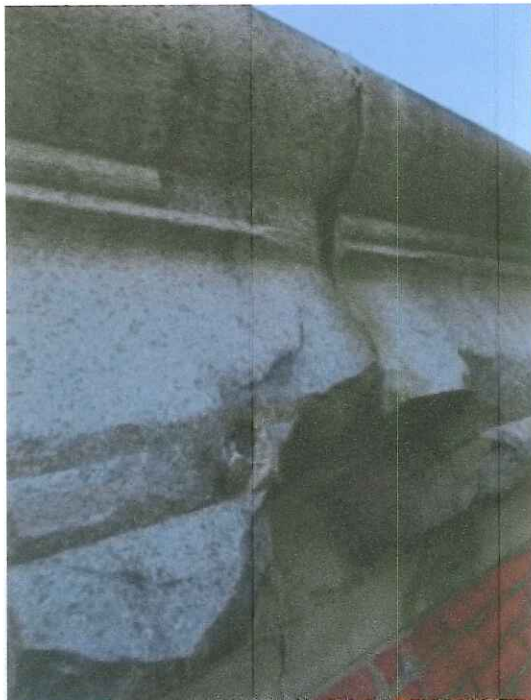
Warren Avenue Building, West Elevation

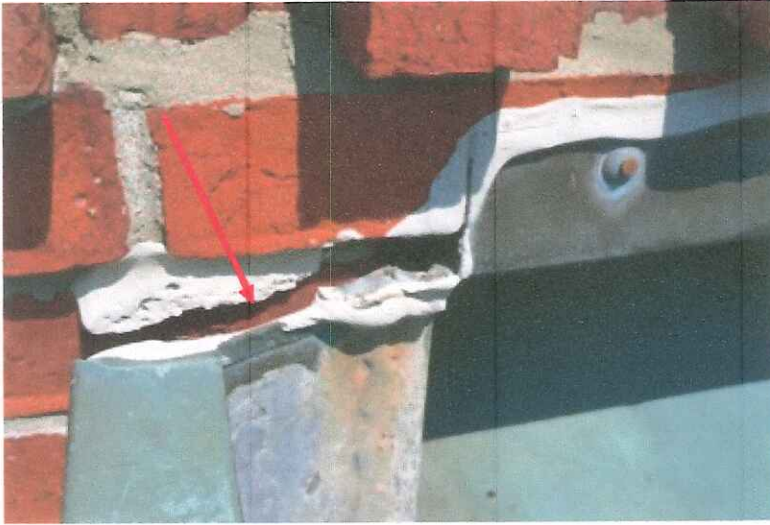
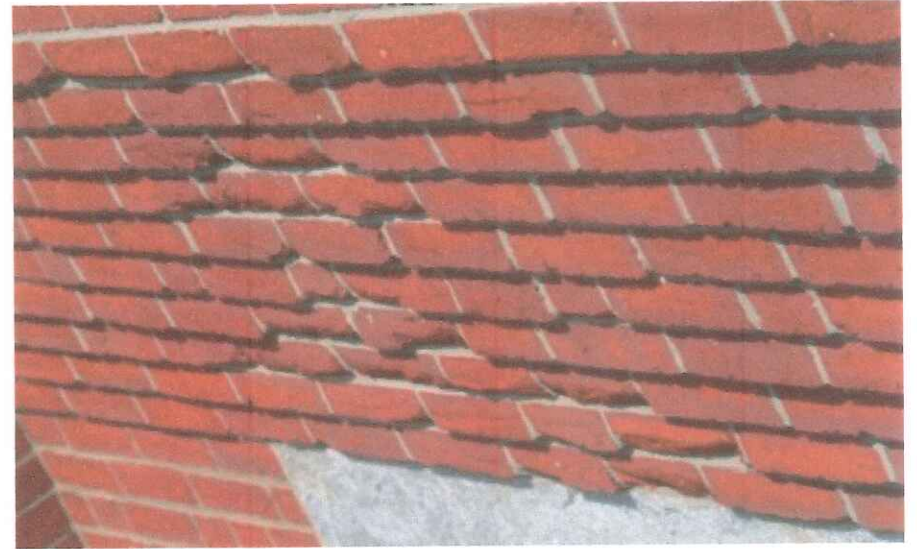
Damaged brick from fire needs to be replaced to prevent future damage.

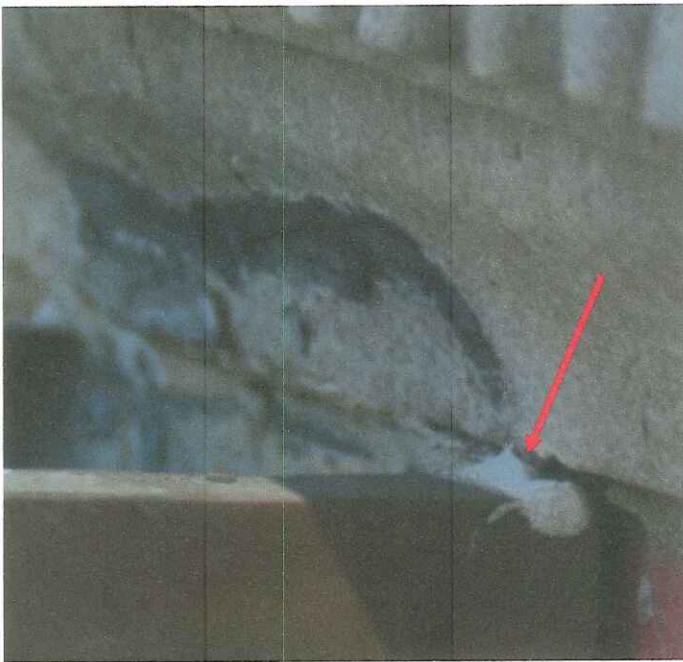
Open caulk joints at the outer face of the scuppers.

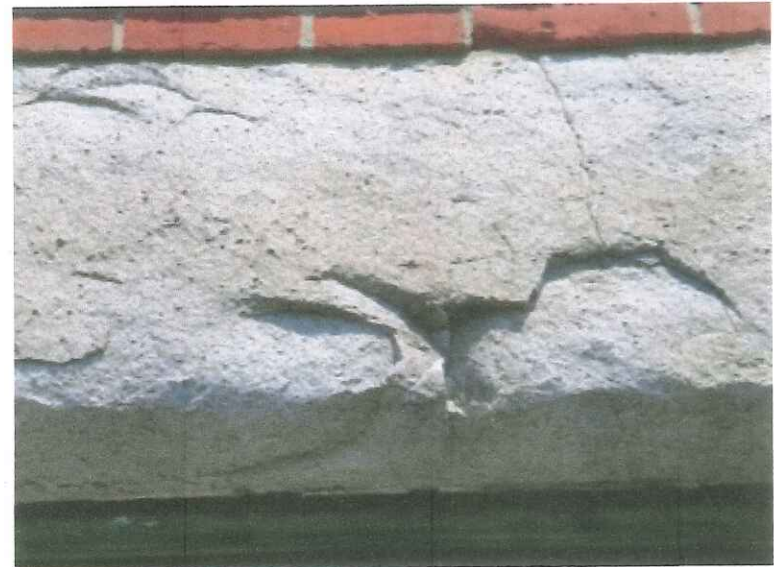
Damaged granite window header needs to be replaced.

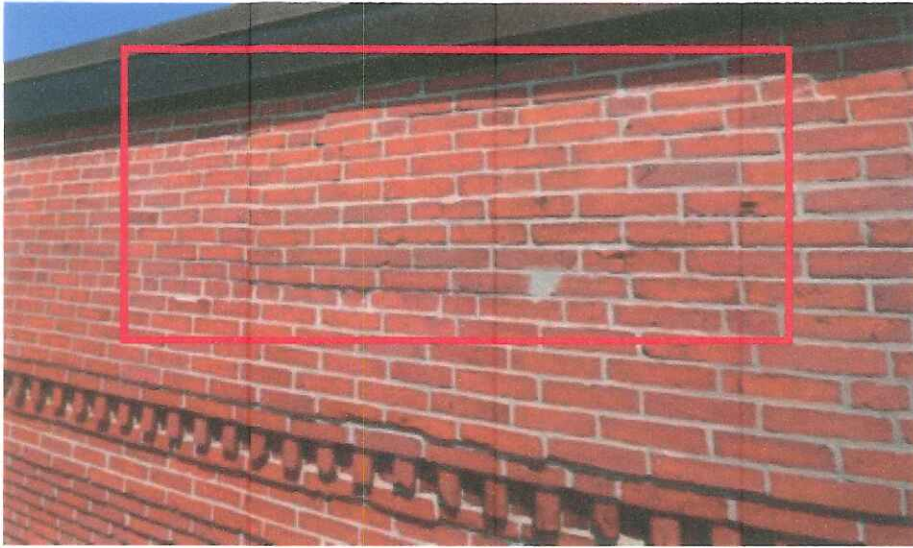
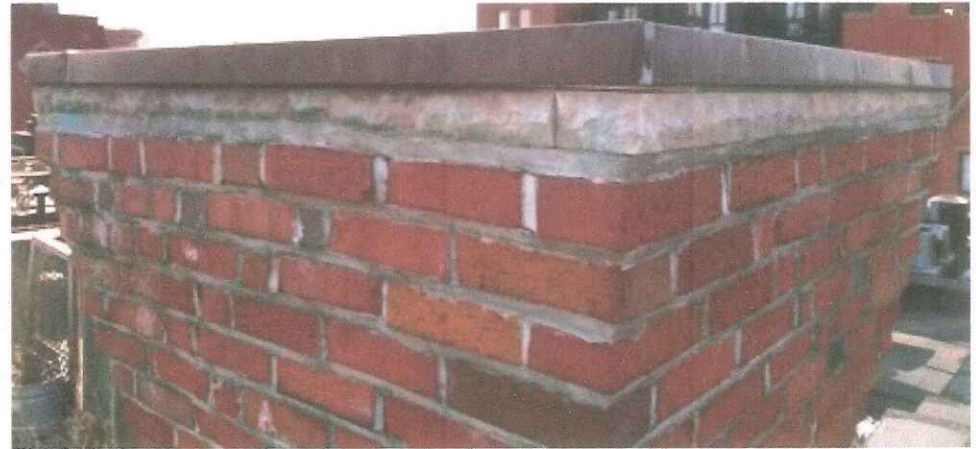
Mortar at the chimney is very hard and is cracked in many areas. The workmanship of the brickwork is poor and the upper section of the chimney should be rebuilt.

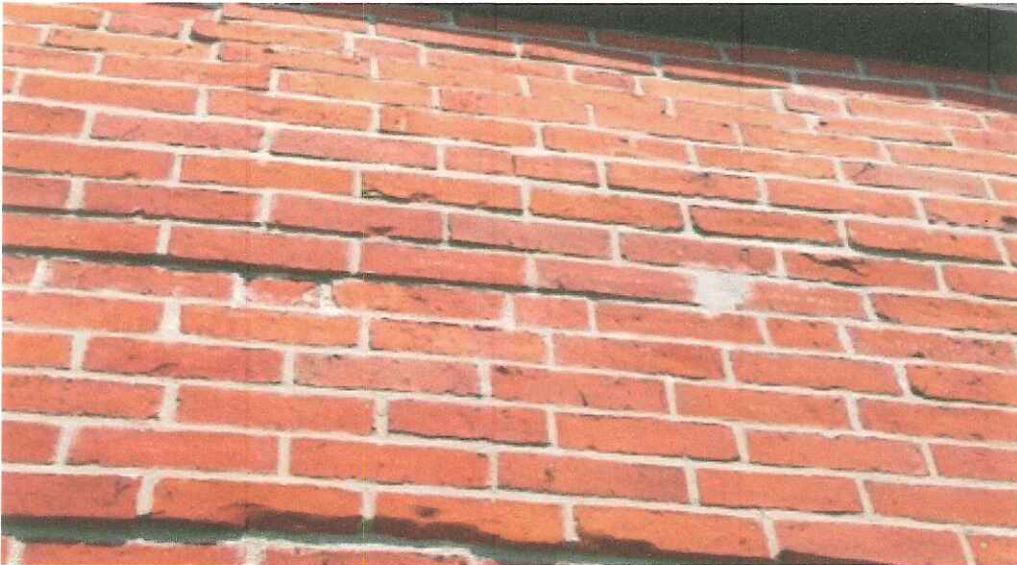
Bulge in masonry parapet needs to be rebuilt.

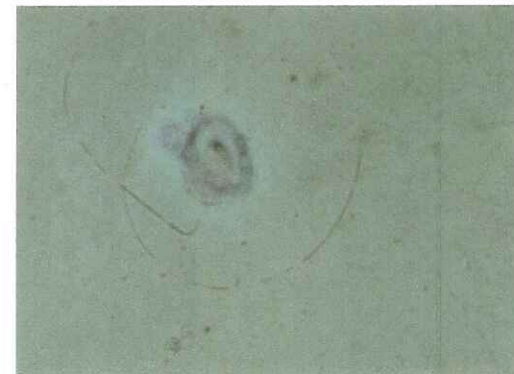
Hole in copper roof overhang needs to be repaired.

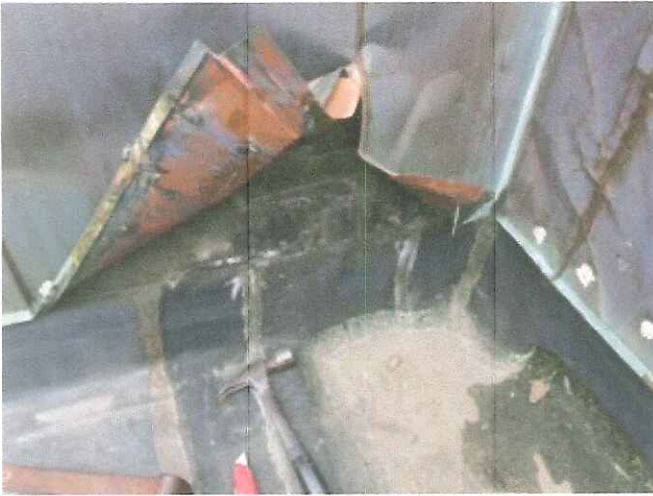
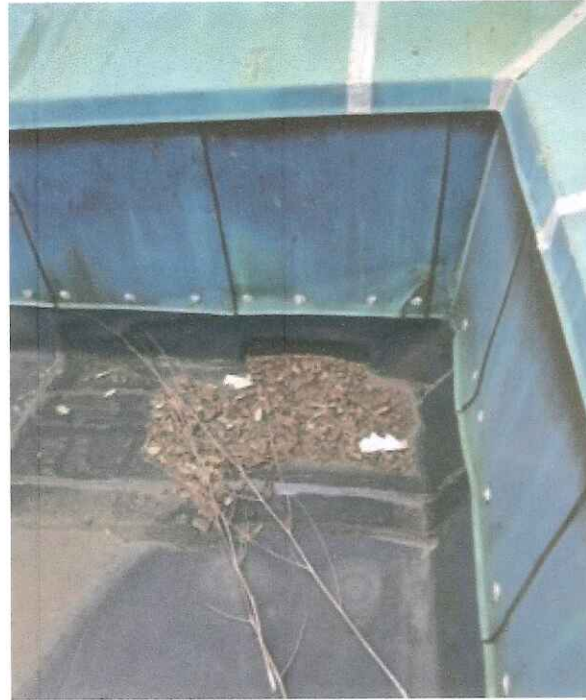
Lots of debris at the roof drain. This can lead to leaking into the flashings. Roof should be cleaned every few months given the decks.

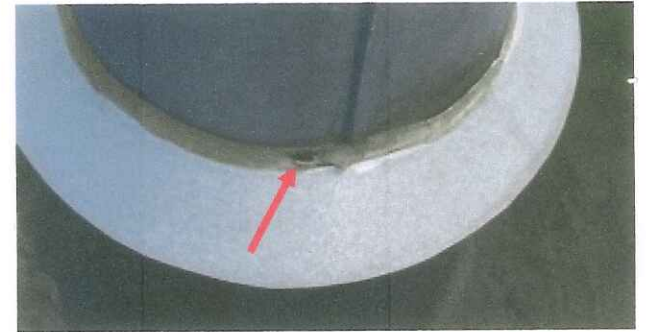
Sealant at flange is open and needs to be re-sealed.

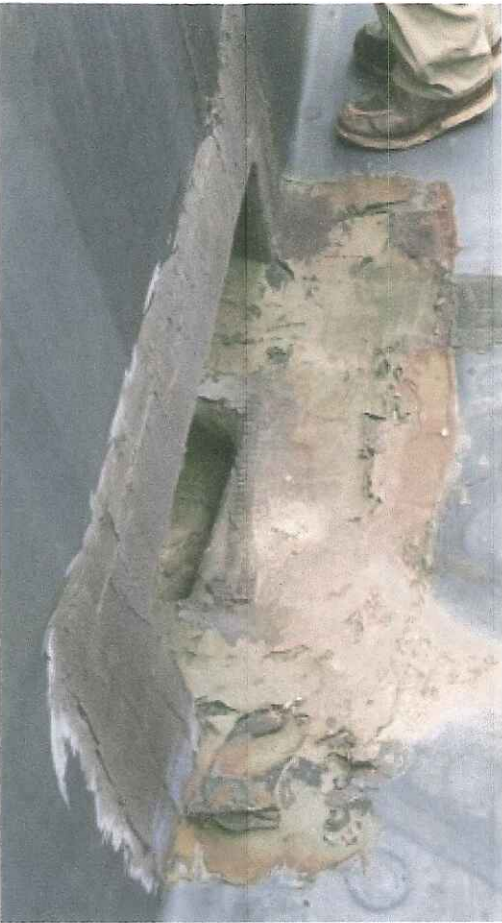
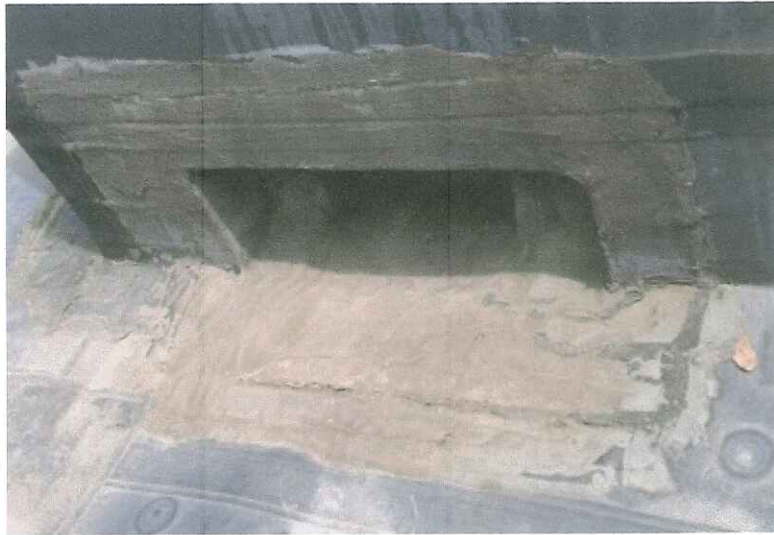
Flashing at the scupper perimeter and flashing has been patched with asphalt the is not compatible with the EPDM and will cause the EPDM to deteriorate.
