### Scope of Work

4- 18 Clarendon Street, East Facing Elevation

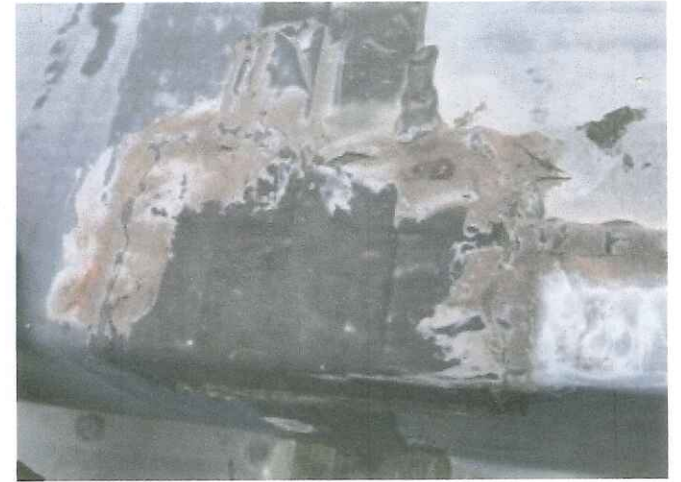
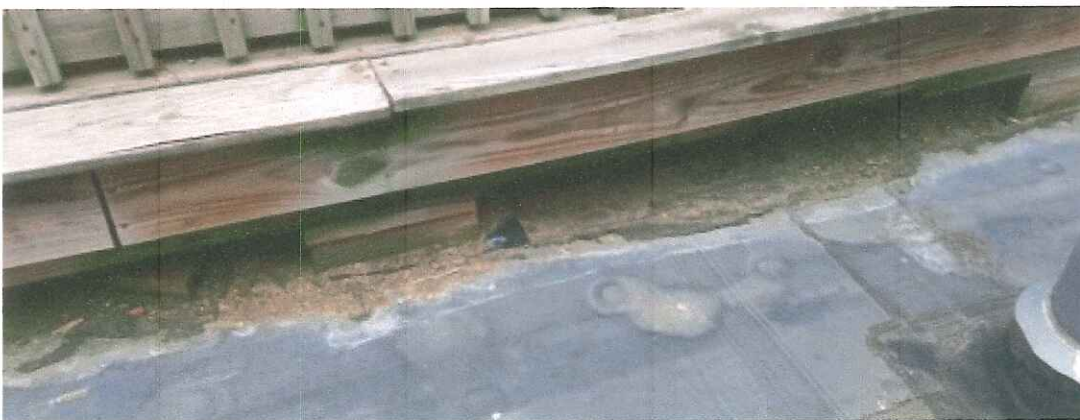
Lots of debris on the roof can cause accelerated roof failure. Roof should be cleaned every few months given the decks.

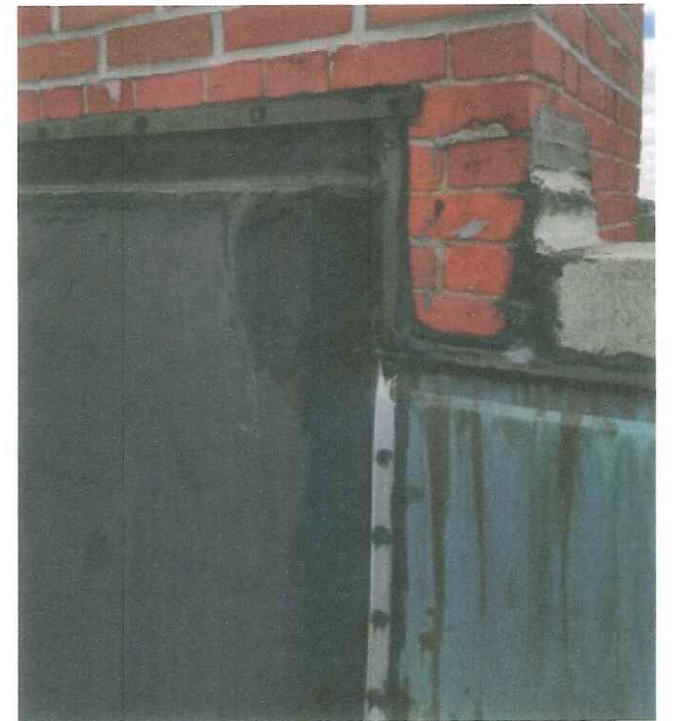
New cap flashing needs to be added at termination bar.
