CERTIFICATE OF APPROPRIATENESS APPLICATION

Re: Fire Escape Repairs at 2 Park Street
Park Street Church

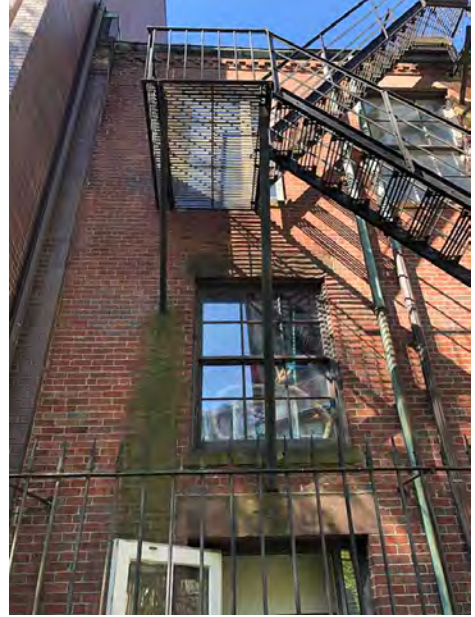
200513-IMG_6916.JPG

Landing at Third Floor Supported by Pair of Brackets

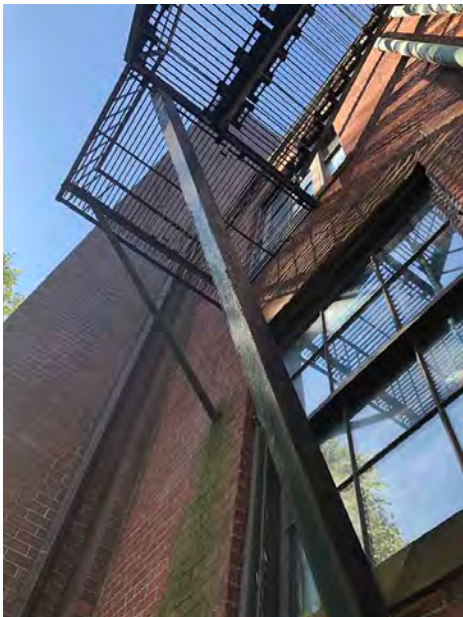
200513-IMG_6876.JPG

*Large Angled Bracket to be Removed;
Replacement Support to be Vertical*

- Supply fabricate and install angle line 4 inch by 4 inches by quarter inch support from the foundation to the first platform (about 19 feet)
- Remove 5 steps, straight out the 5 steps and install it back
- Replace few rusted bolts and nuts
- Primer and paint only repairs
- Include 2 certificates of inspection for the fire escape at 2 park street, and 3 park street

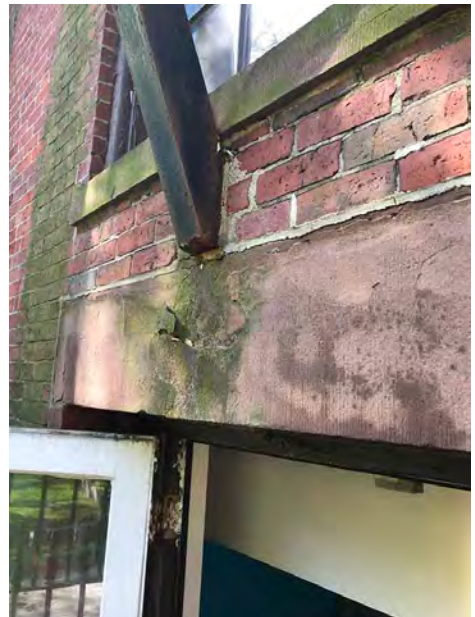
200513-IMG_6875.JPG

*Base of Bracket Embedded in Narrow Masonry Band;
Removal Will Protect Brownstone and Brickwork*

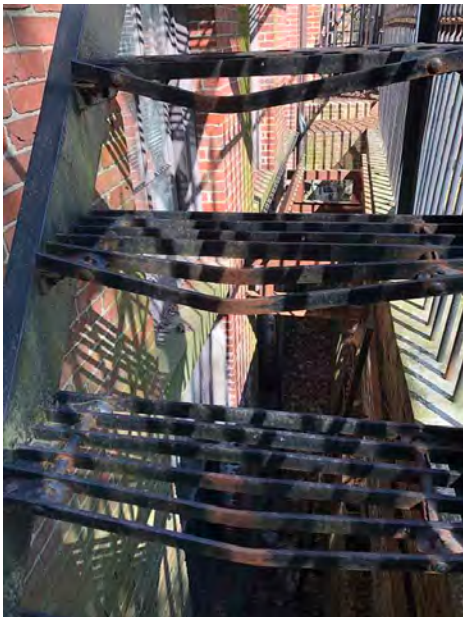
200513-IMG_6878.JPG

Bent Stair Tread Gratings to be Repaired

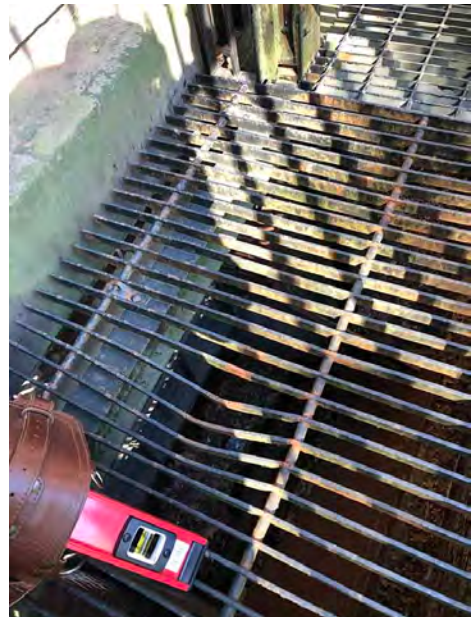
200513-IMG_6872.JPG

Bent First Floor Landing Grating to be Repaired

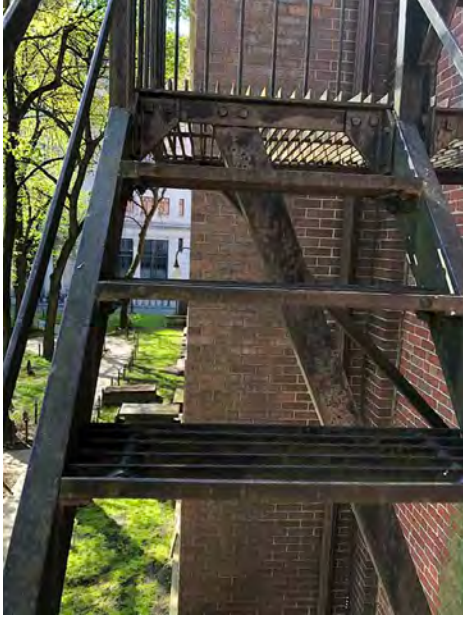
200513-IMG_6887.JPG

*Upper Portion of Angled Bracket at Third Floor Landing;
Smaller Bracket Beyond to Remain in Place;
Larger Bracket in Foreground to be Replaced*

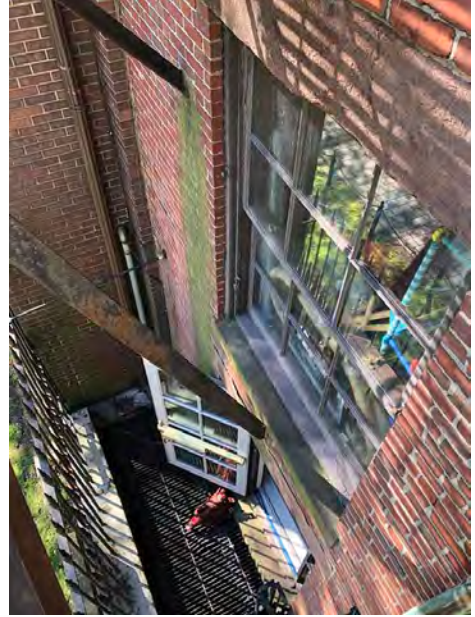
200513-IMG_6889.JPG

*Angled Brackets Supporting Third Floor Landing;
Smaller Bracket to Remain; Larger Bracket to be
Replaced with Vertical Support to Match*

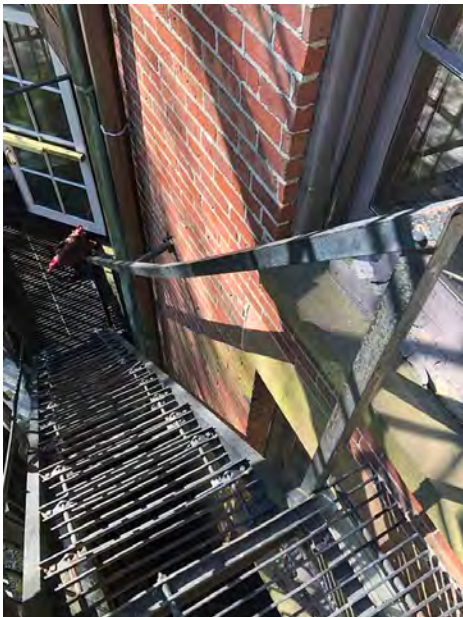
200513-IMG_6885.JPG

Bent Handrail to be Repaired

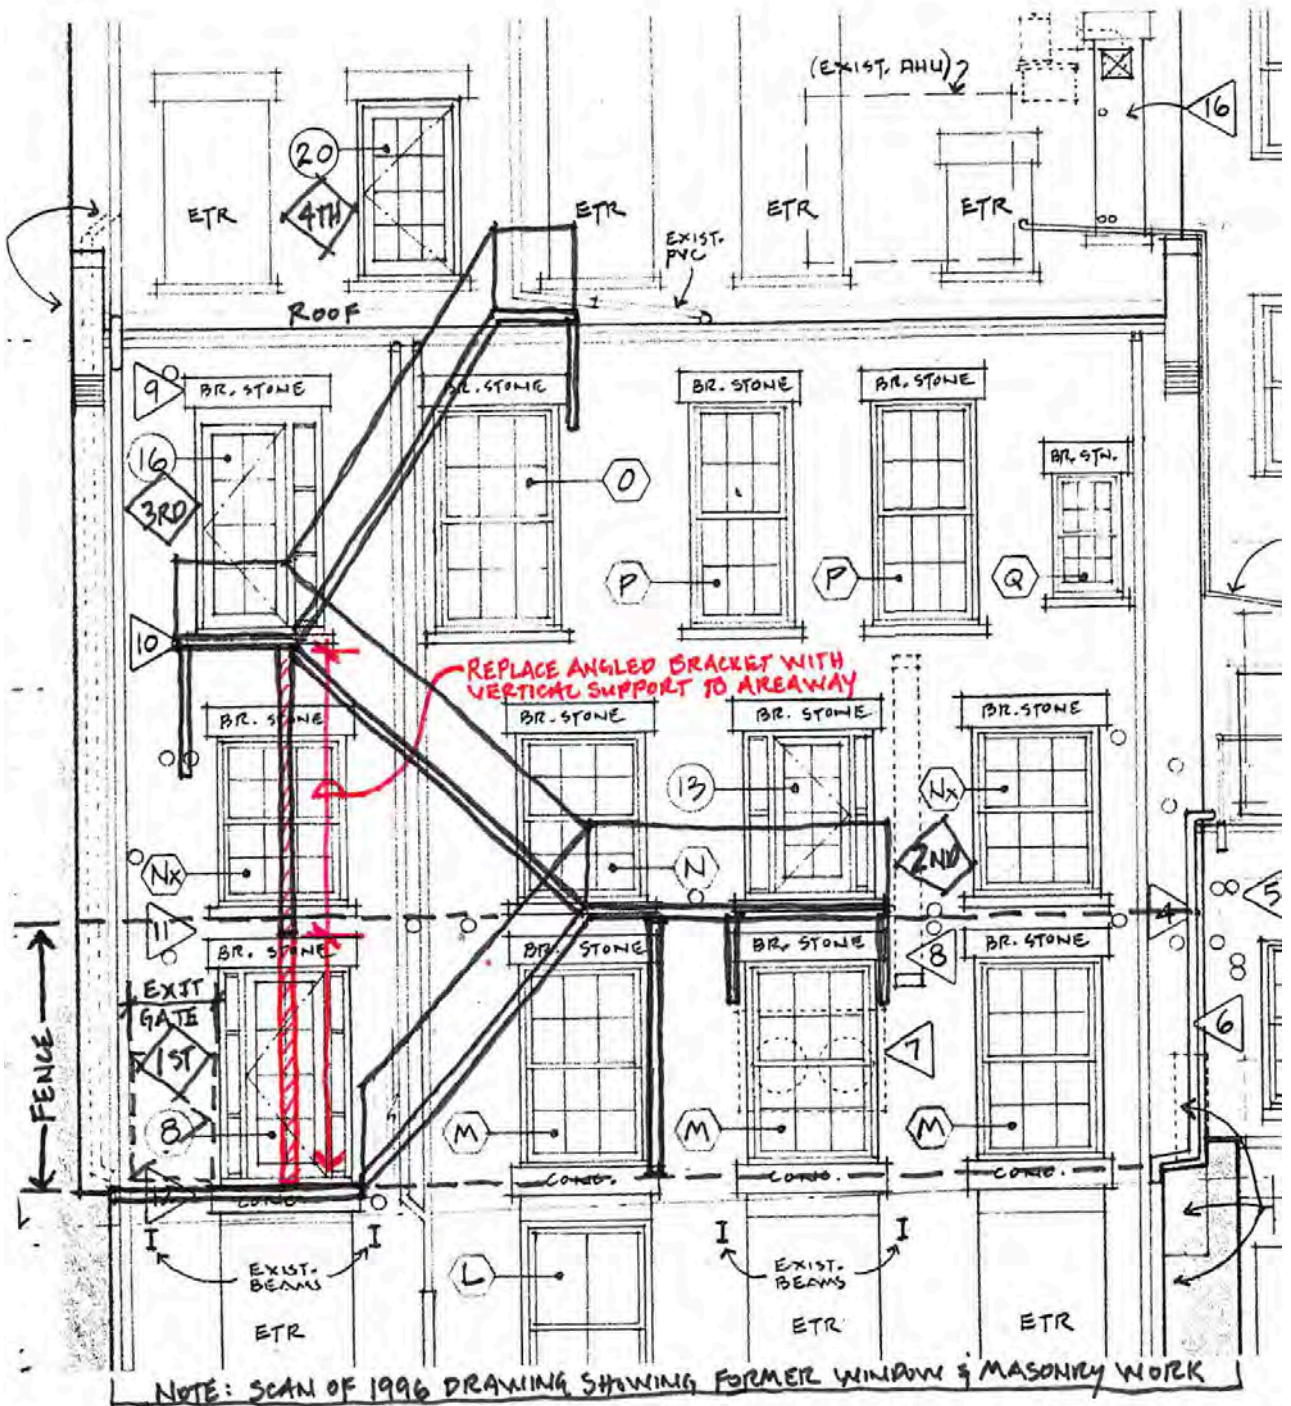
DIAGRAM OF FIRE ESCAPE SHOWING ANGLED BRACKET THAT WILL BE REPLACED WITH VERTICAL SUPPORT; NOTES FOR OTHER WORK ARE FROM 1996 EXTERIOR PROJECT (NOT RELEVANT FOR CURRENT APPLICATION)
