23 UPTON STREET RESTORATION

12-10-20

PREPARED FOR SOUTH END LANDMARK DISTRICT COMMISSION

WINDOW REPLACEMENT

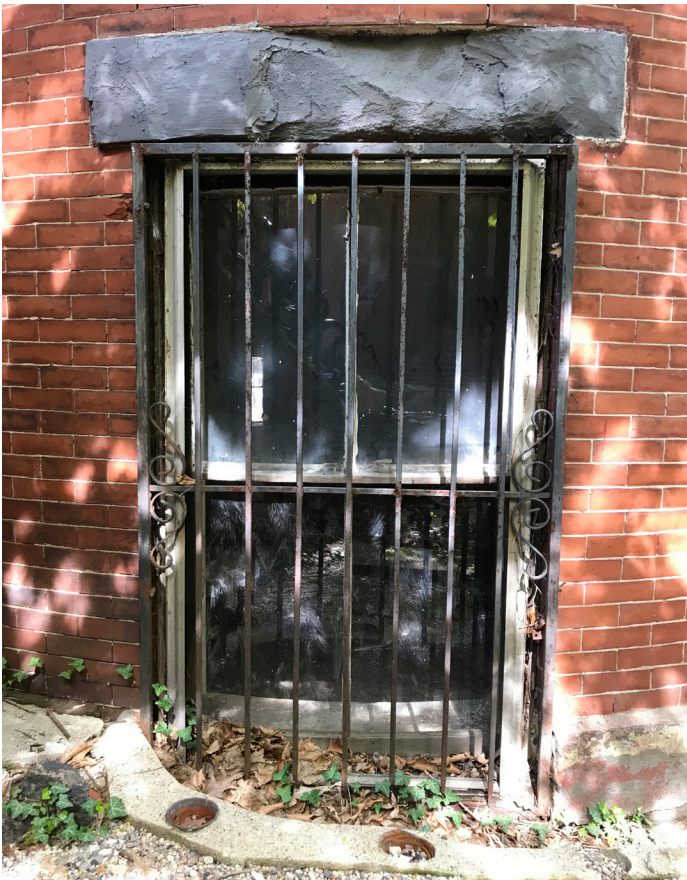
EXTERIOR OF WINDOW

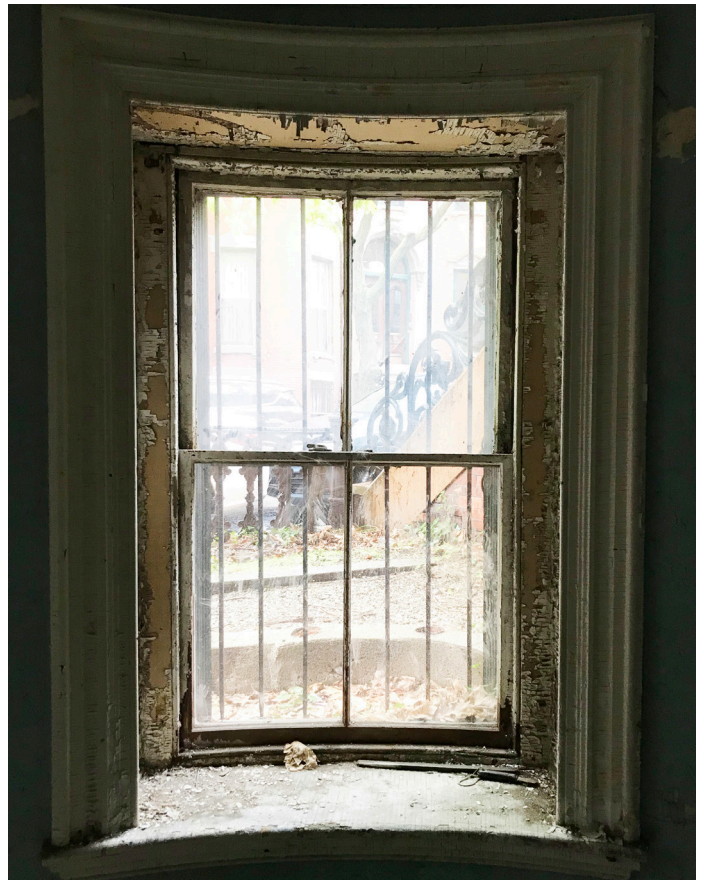
INTERIOR OF WINDOW

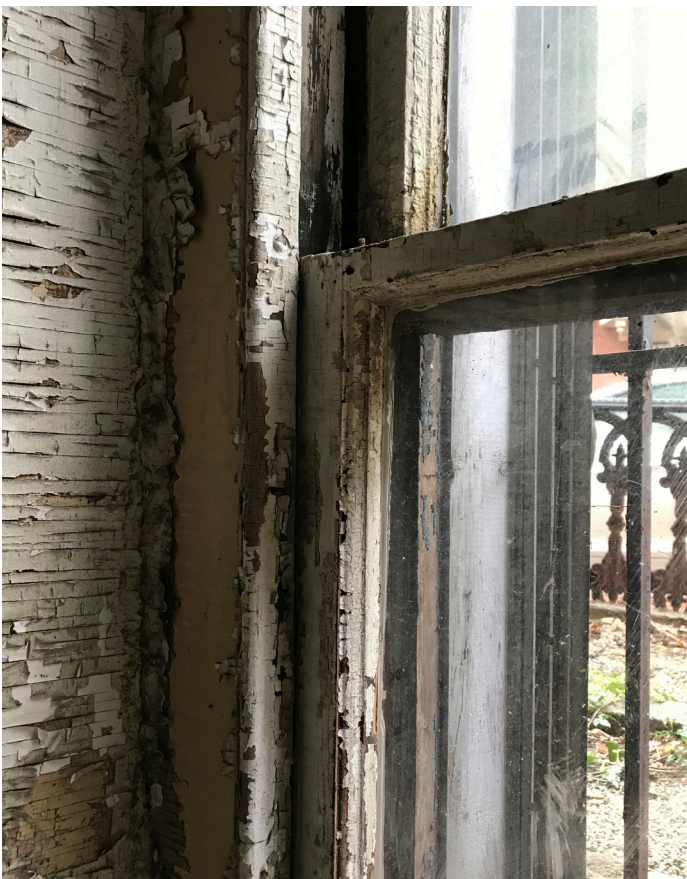
INTERIOR JAMB

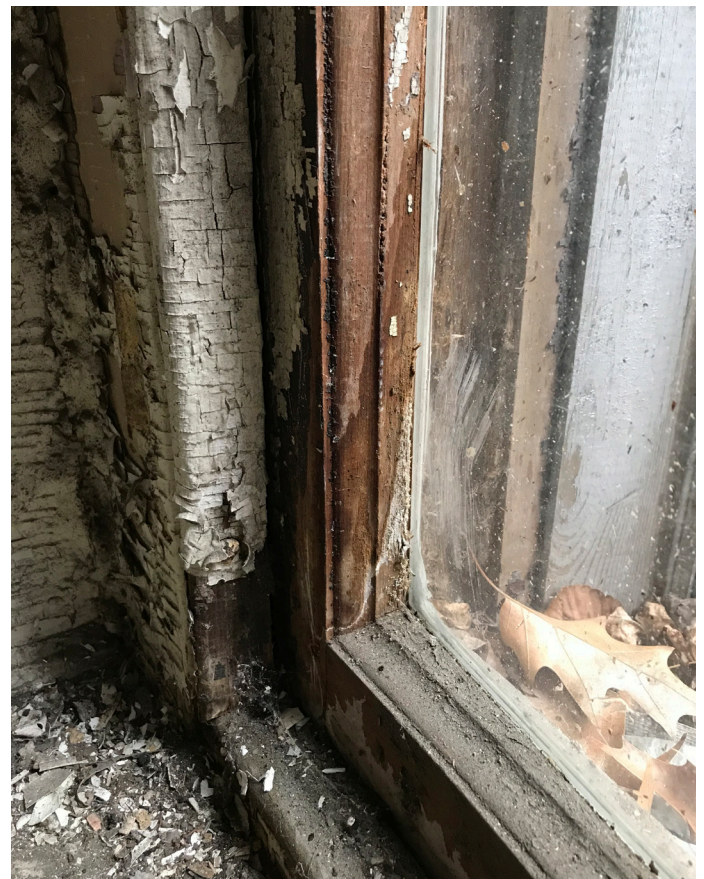
LOWER SASH/SILL

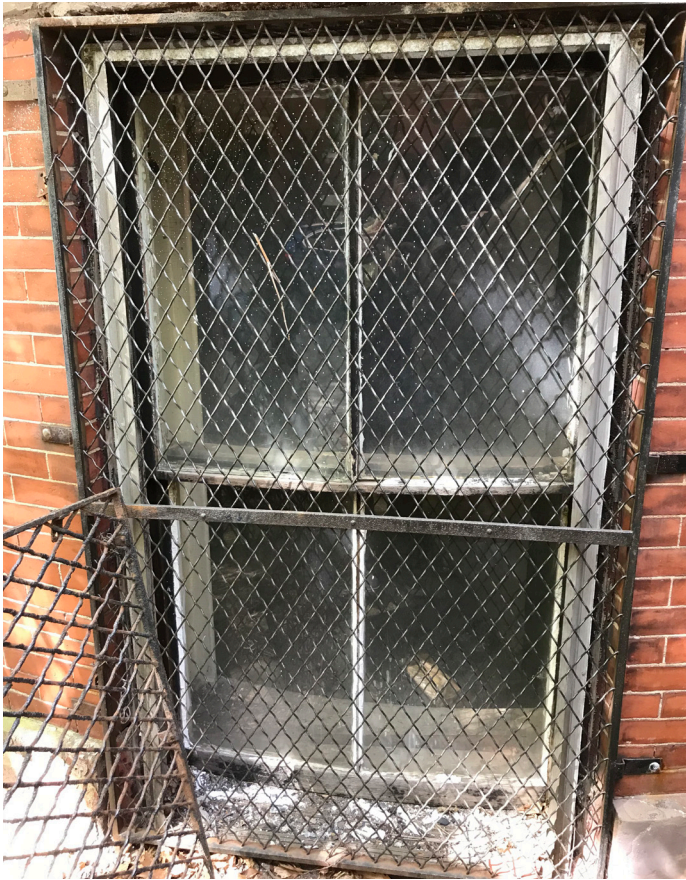
EXTERIOR OF WINDOW

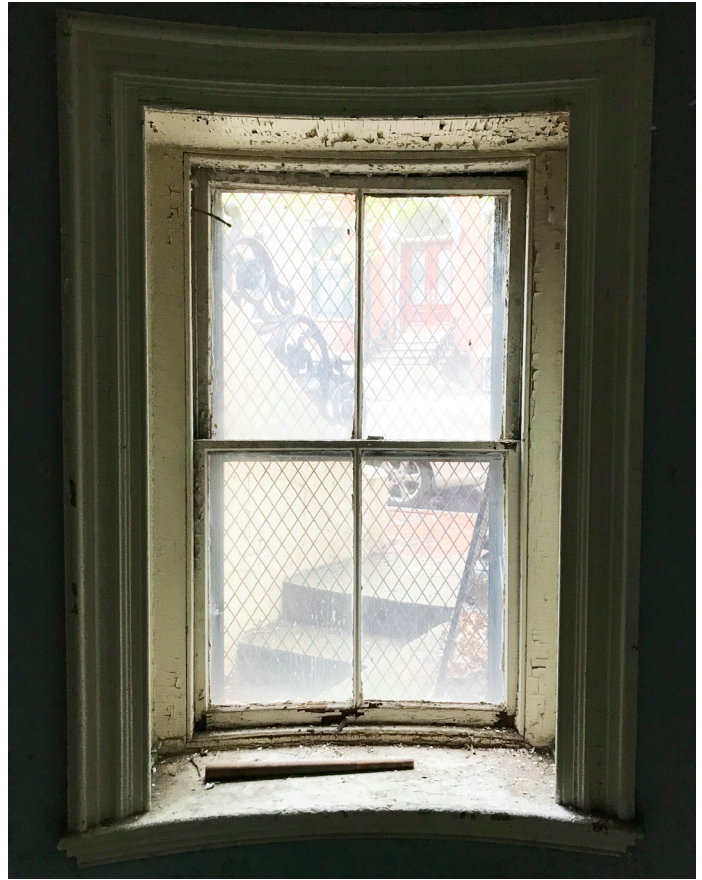
INTERIOR OF WINDOW

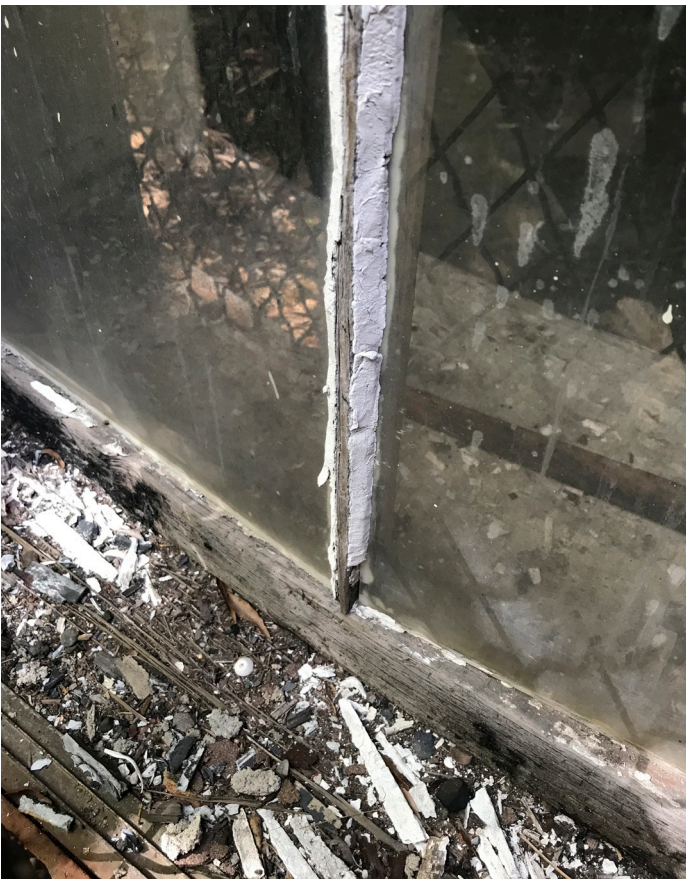
EXTERIOR MUNTIN/SASH

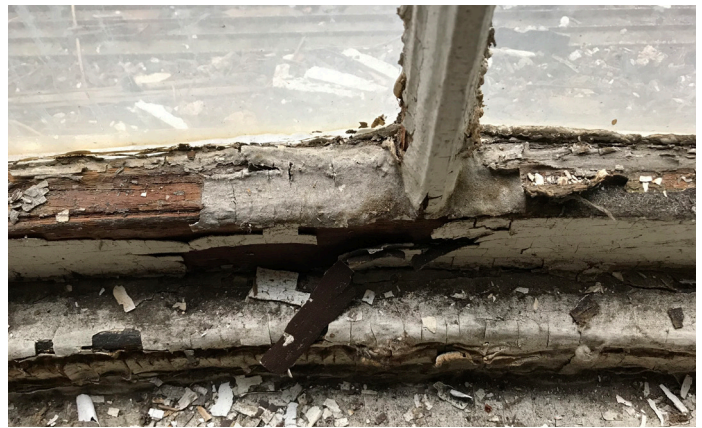
LOWER SASH/SILL

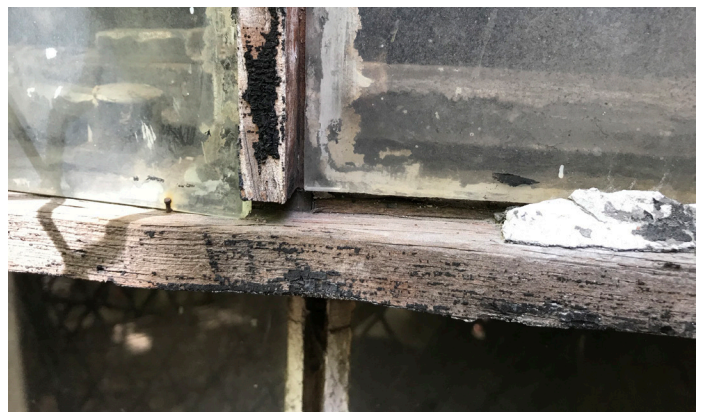
MEETING RAIL

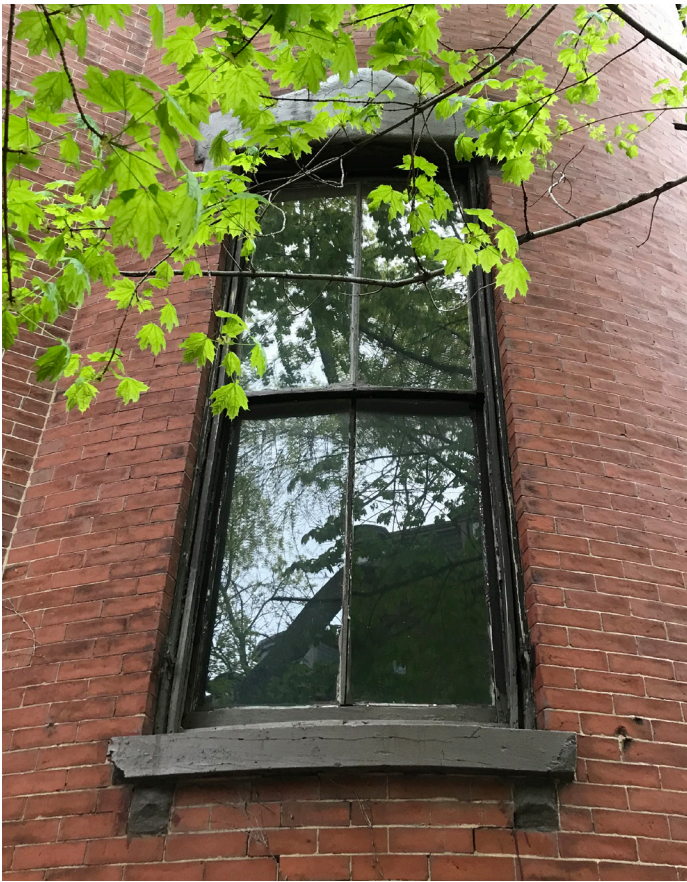
EXTERIOR OF WINDOW

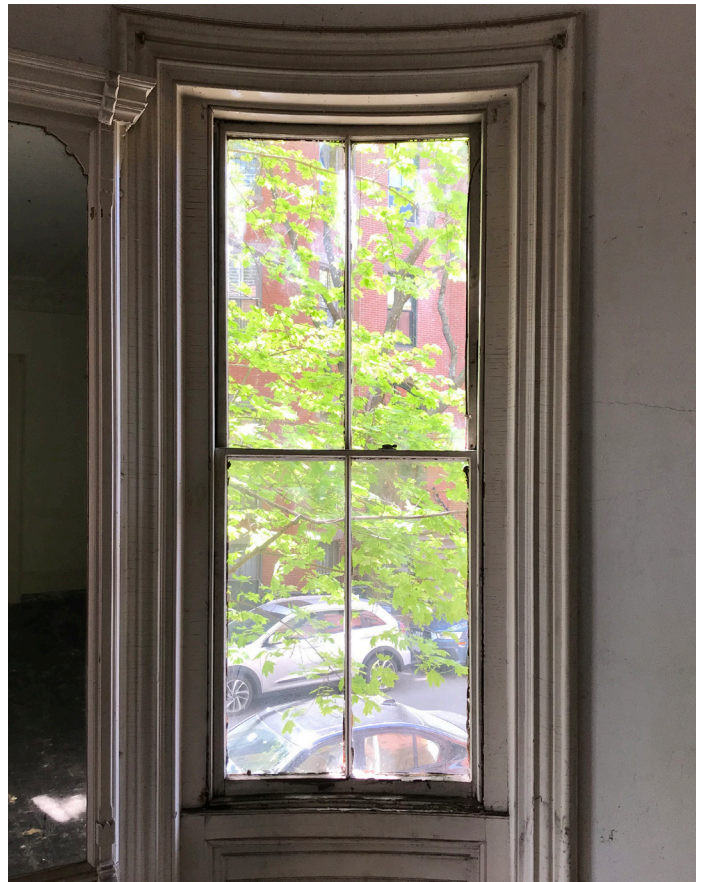
INTERIOR OF WINDOW

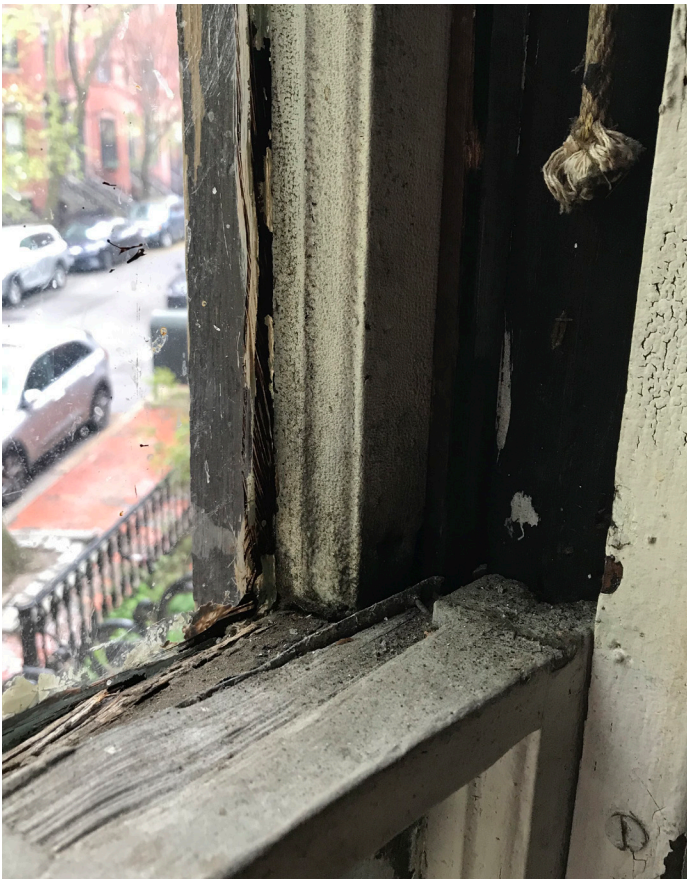
JAMB/MEETING RAIL

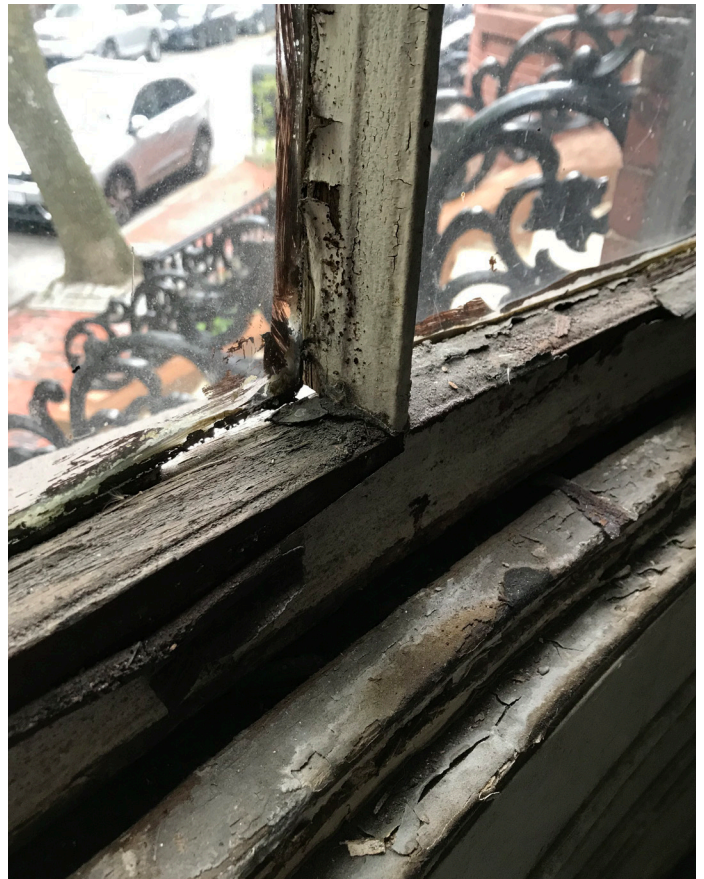
SASH/SILL

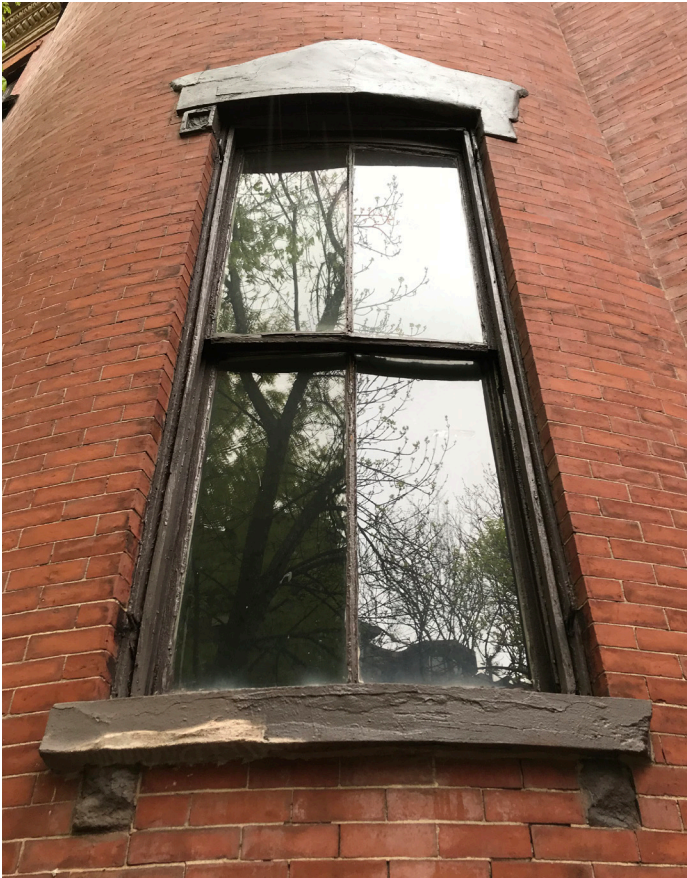
EXTERIOR OF WINDOW

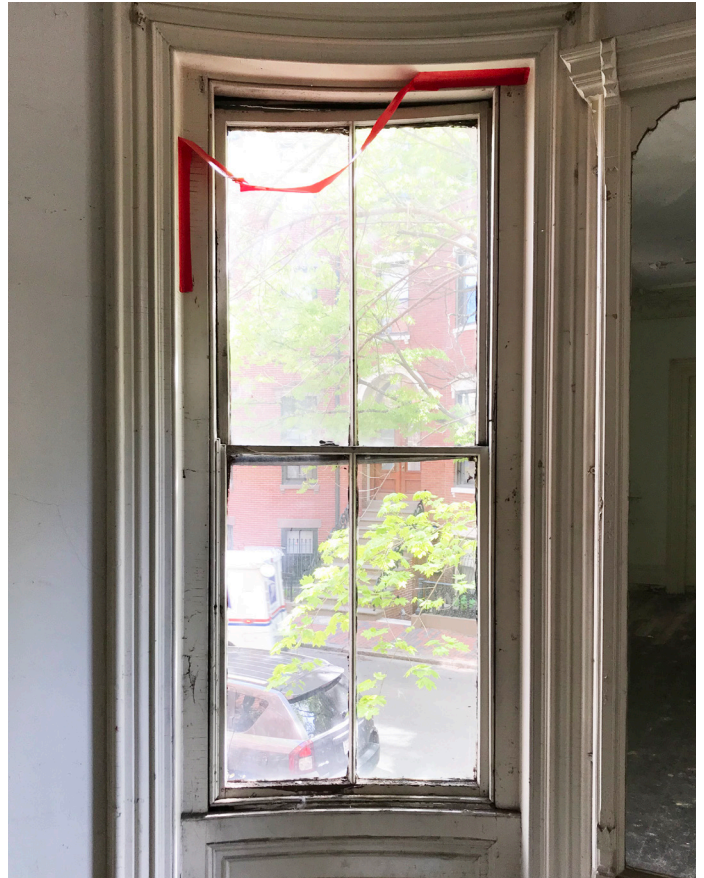
INTERIOR OF WINDOW

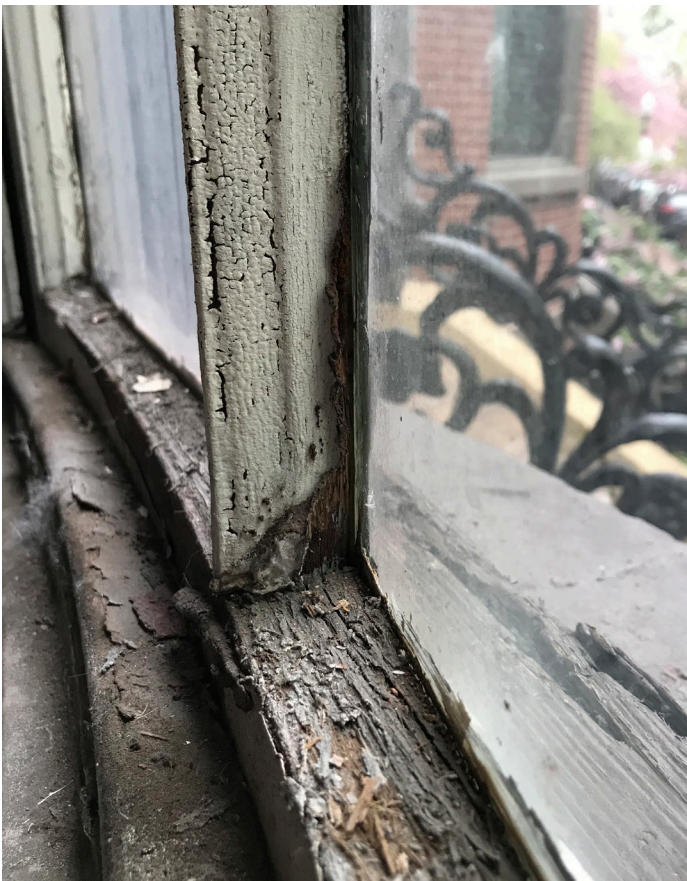
MUNTIN/SILL

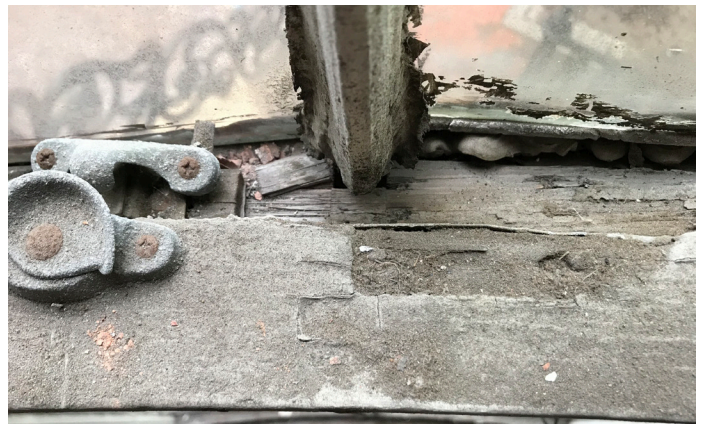
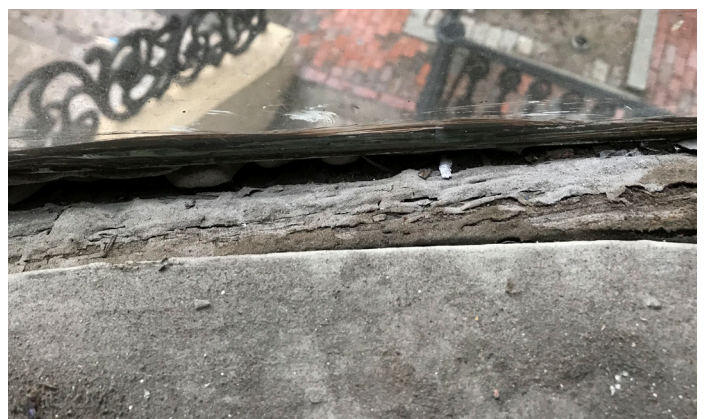
MEETING RAILS

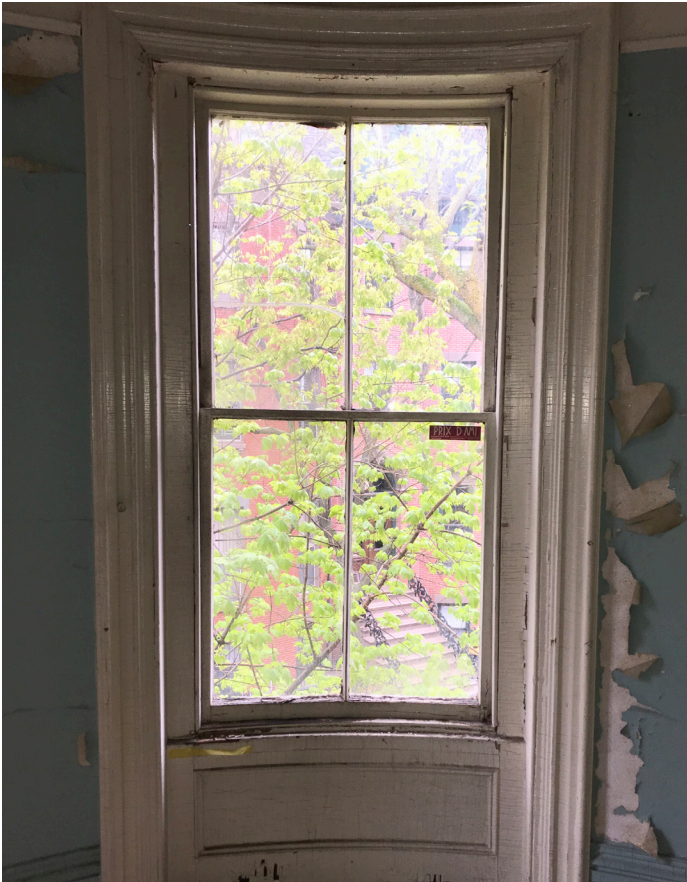
INTERIOR OF WINDOW

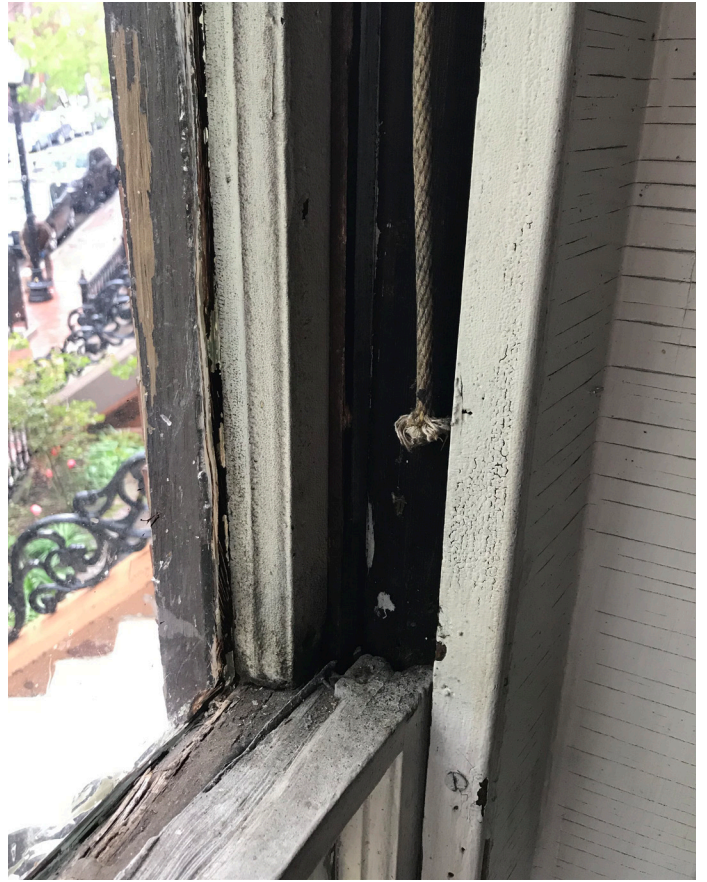
JAMB/MEETING RAILS

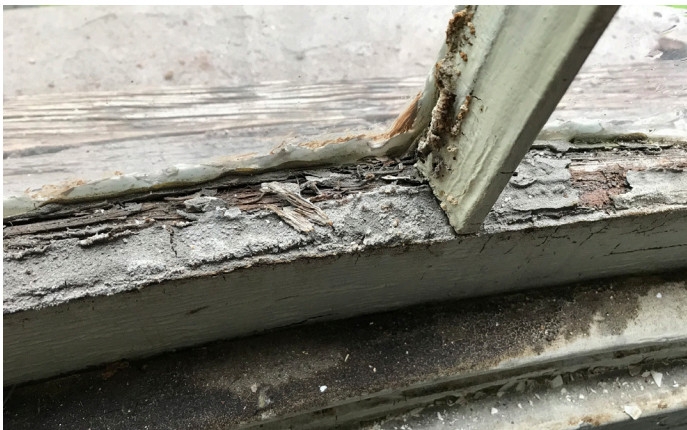
JAMB/LOWER RAIL

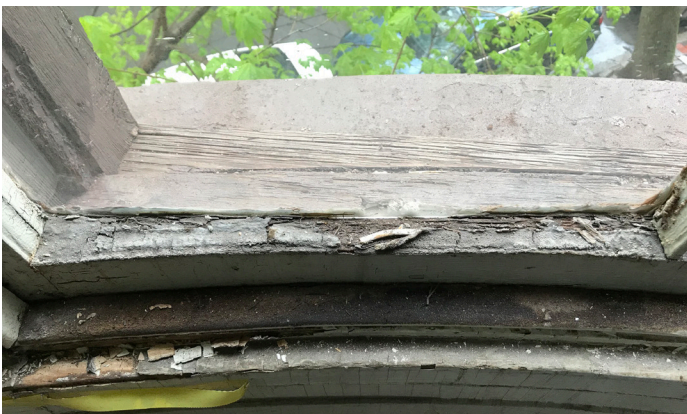
INTERIOR SILL

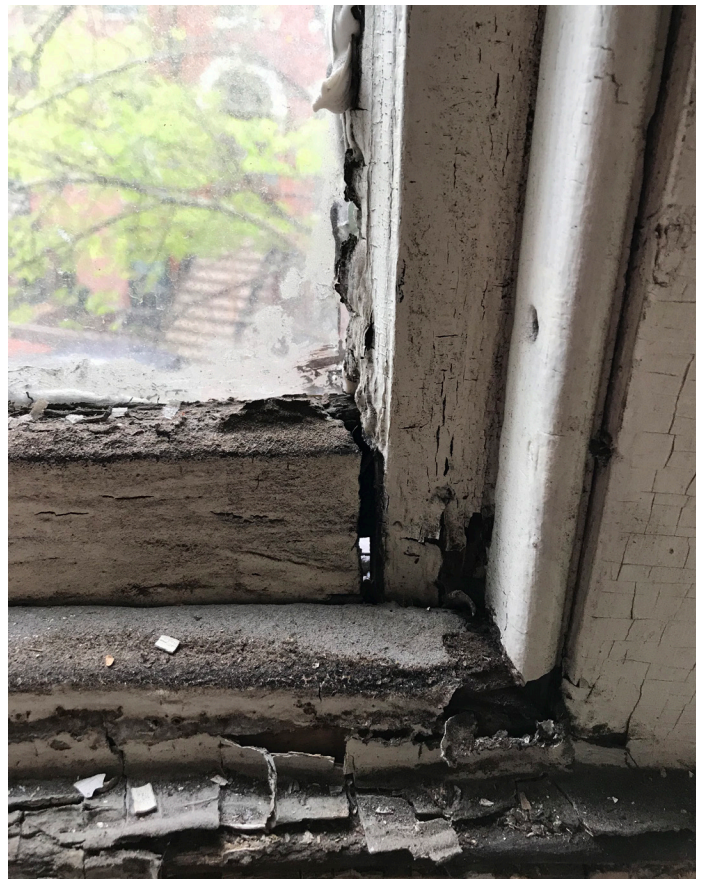
LOWER SASH-BOTTOM CORNER

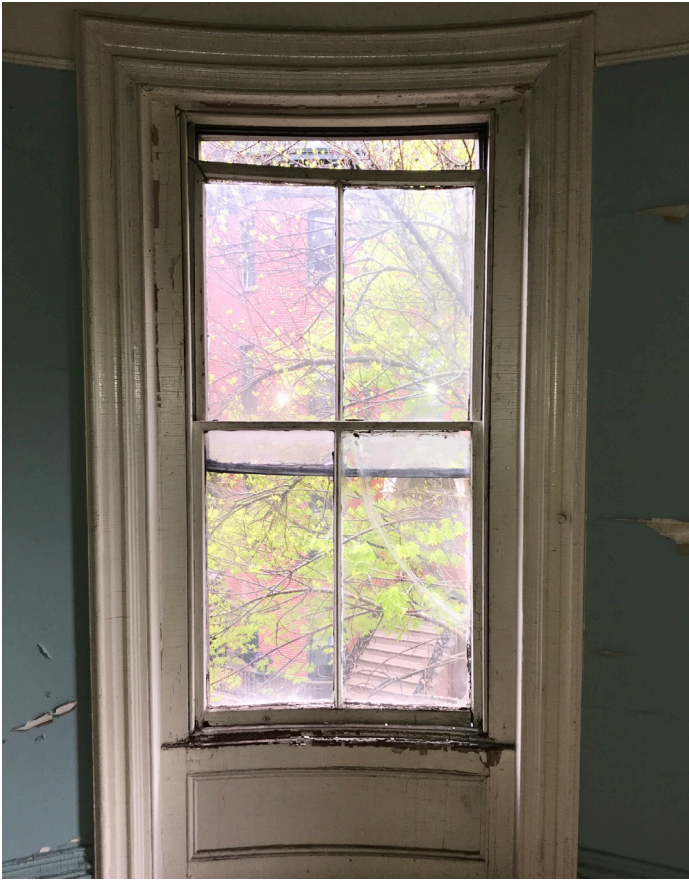
INTERIOR OF WINDOW

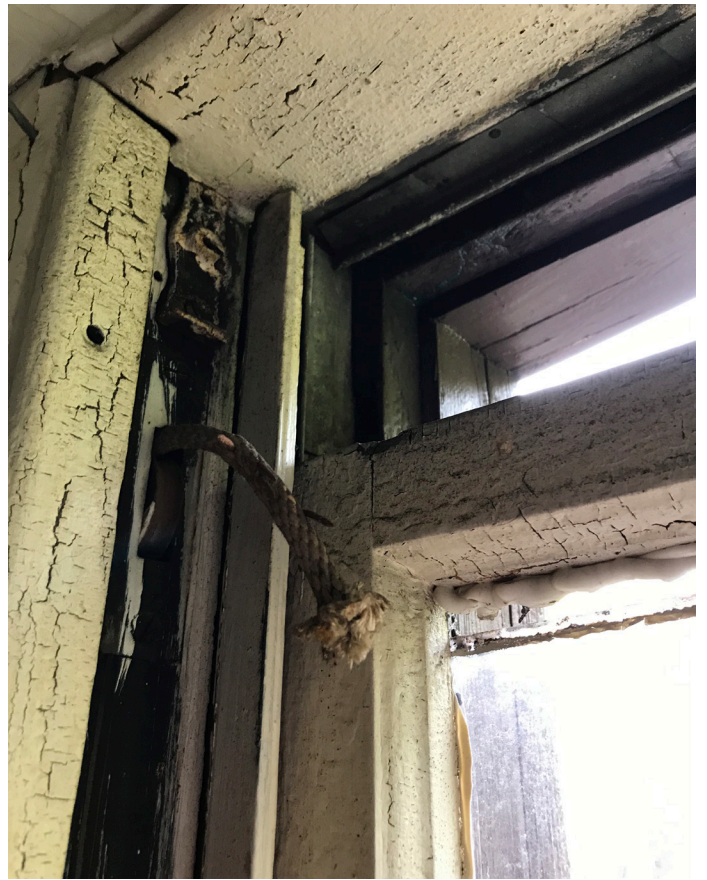
JAMB/CORD

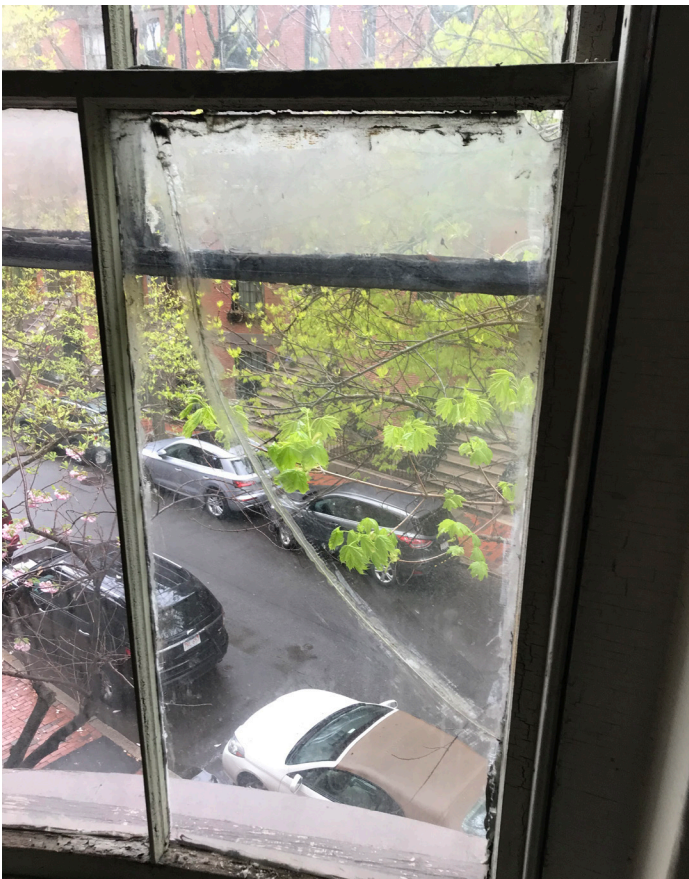
PANE-LOWER SASH

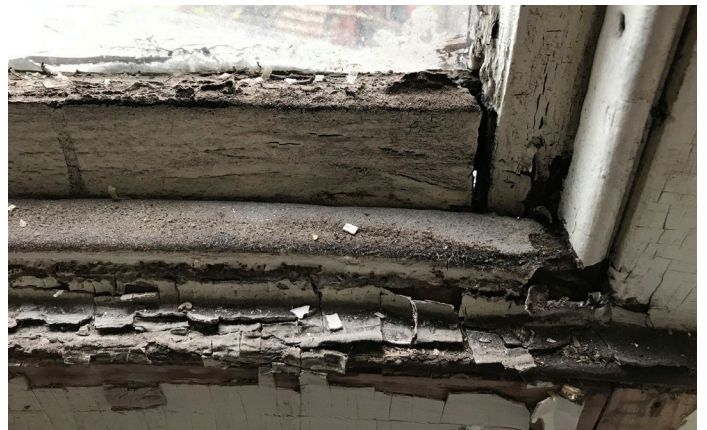
BOTTOM RAIL/SILL

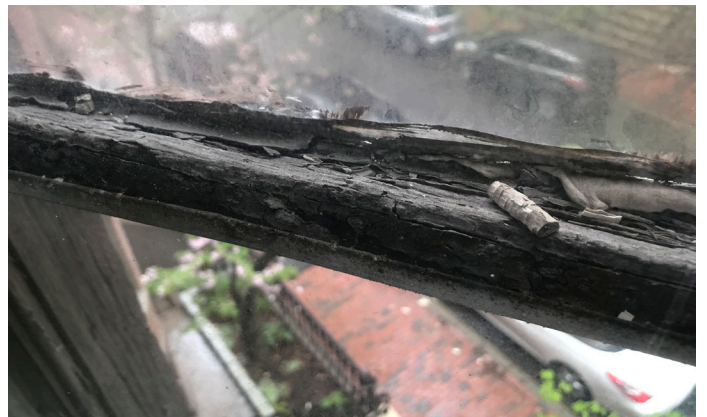
BOTTOM RAIL-TOP SASH

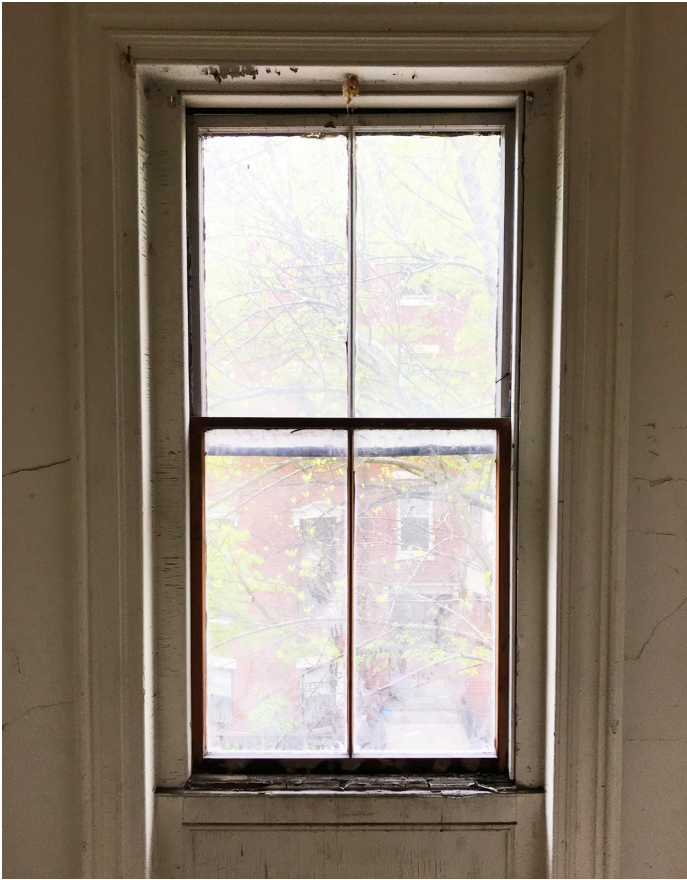
INTERIOR OF WINDOW

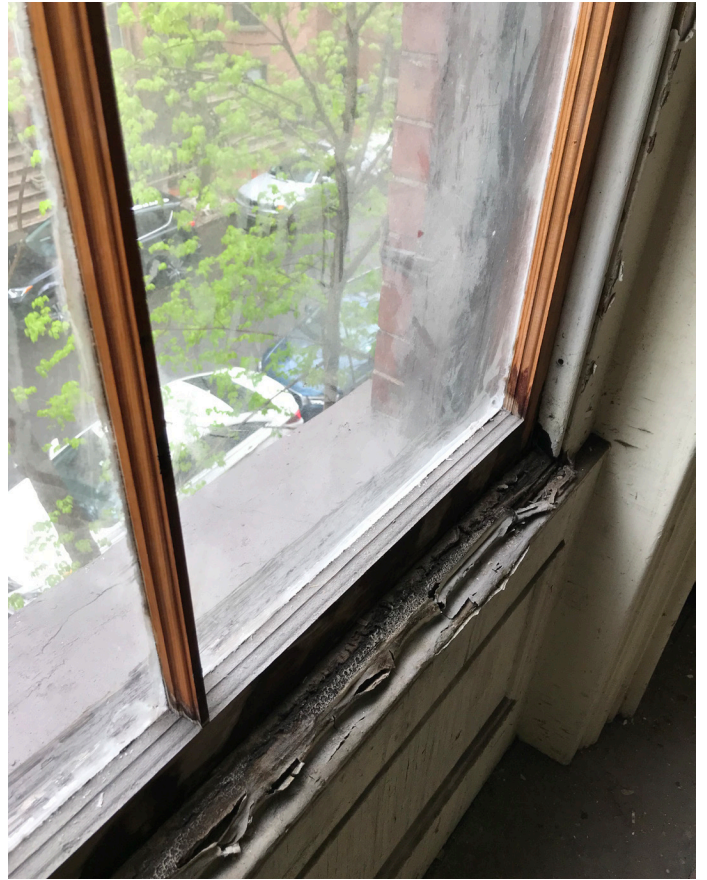
LOWER SASH-REPLACEMENT

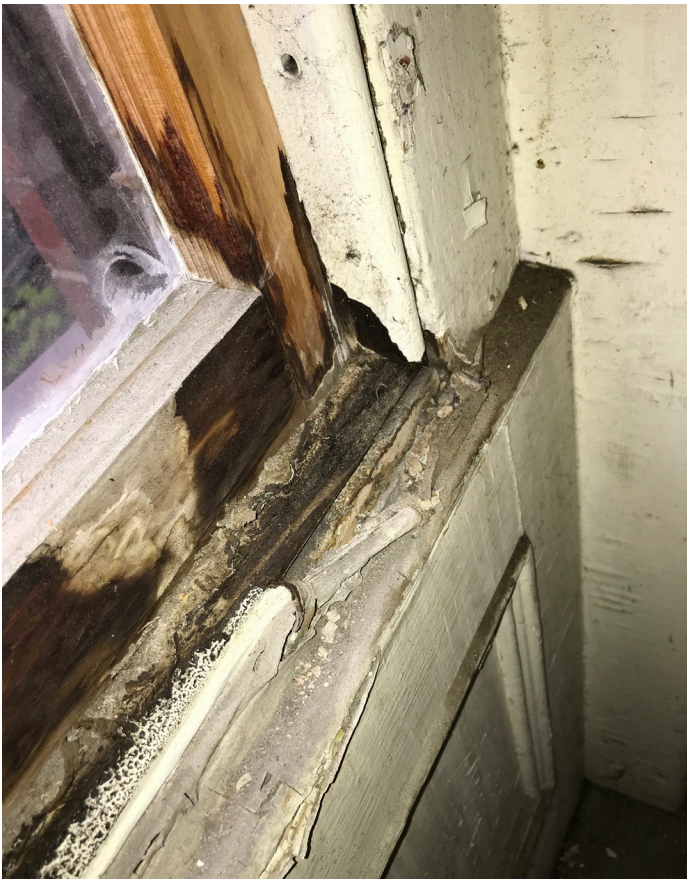
INTERIOR SILL

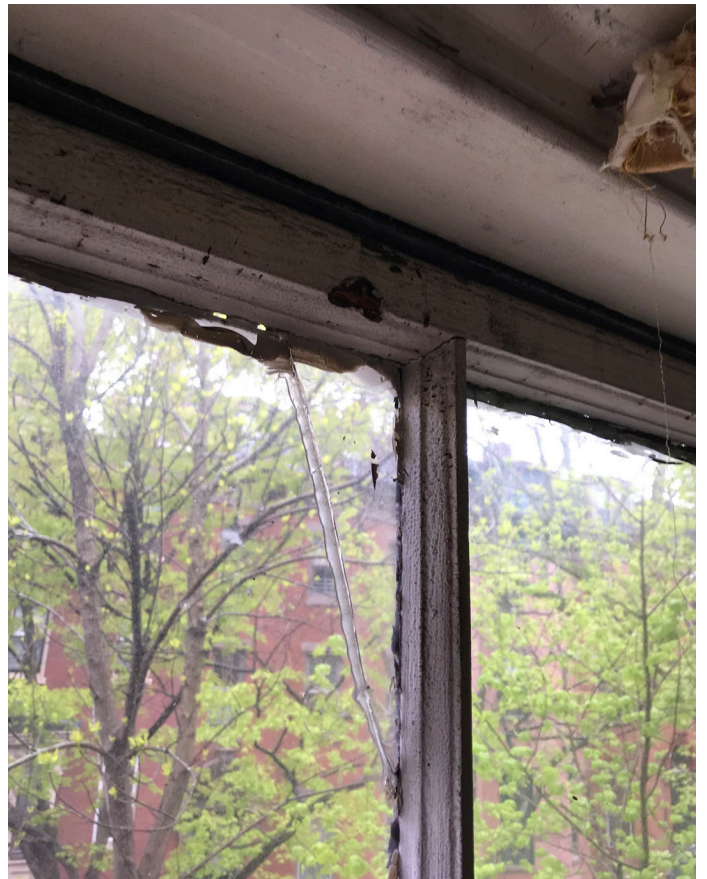
UPPER SASH/MUNTIN
