February 22, 2021

Re: Smokestack Observations
Residence Inn
370 Congress Street
Boston, MA

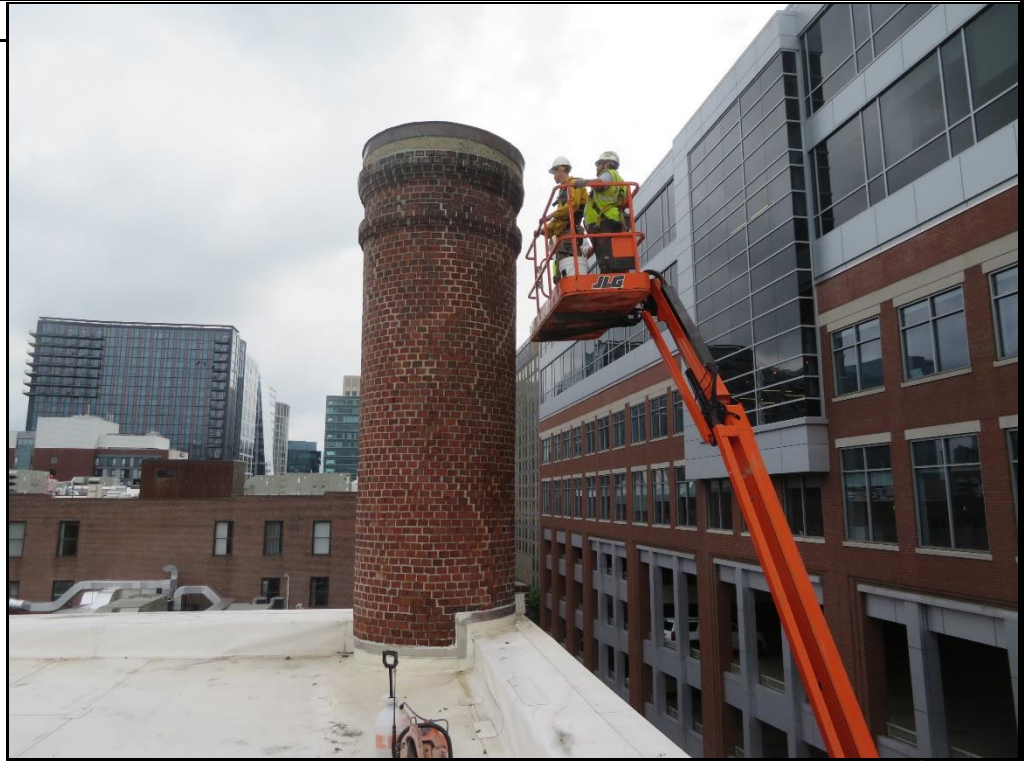
Figure 1

Northeast Rear Corner Stack

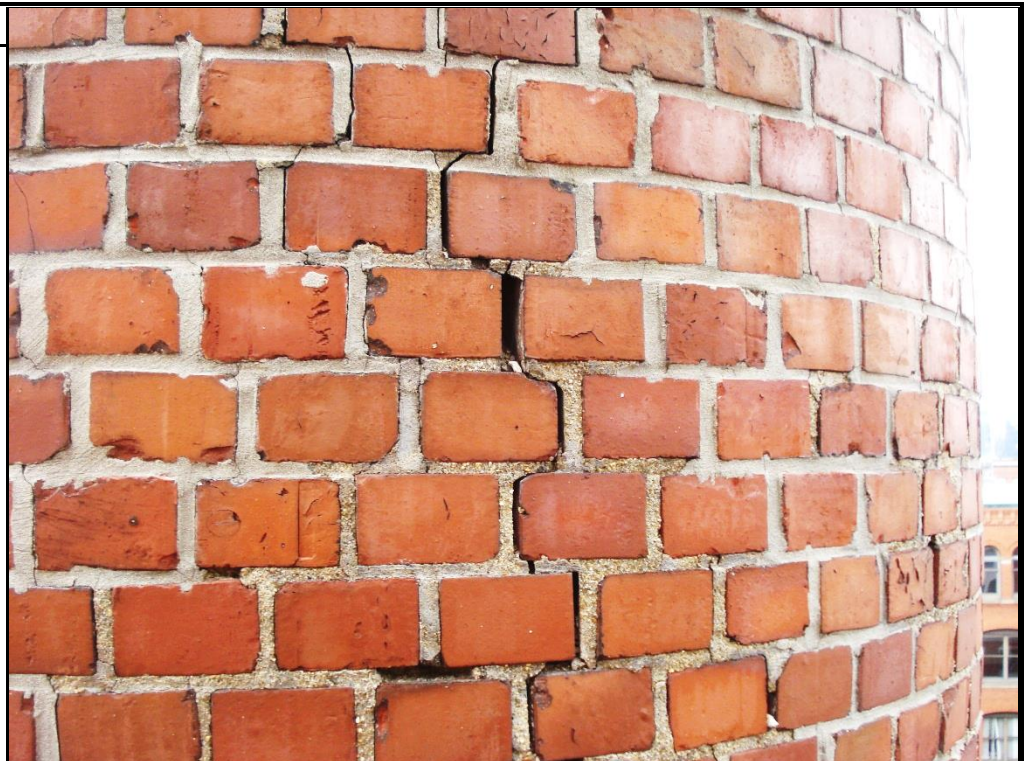
Figure 2

Numerous vertical cracks were observed in mortar joints that stair-step through the brick coursing, including cracking through bricks themselves. The nature of the cracking is indicative of radial expansion, a probable result of the freeze/thaw dynamic and likely combined with hygrothermal cycling and building movement in general. Such movement is exacerbated by the soft, absorbent setting mortar.

Typical Radial Separation Condition

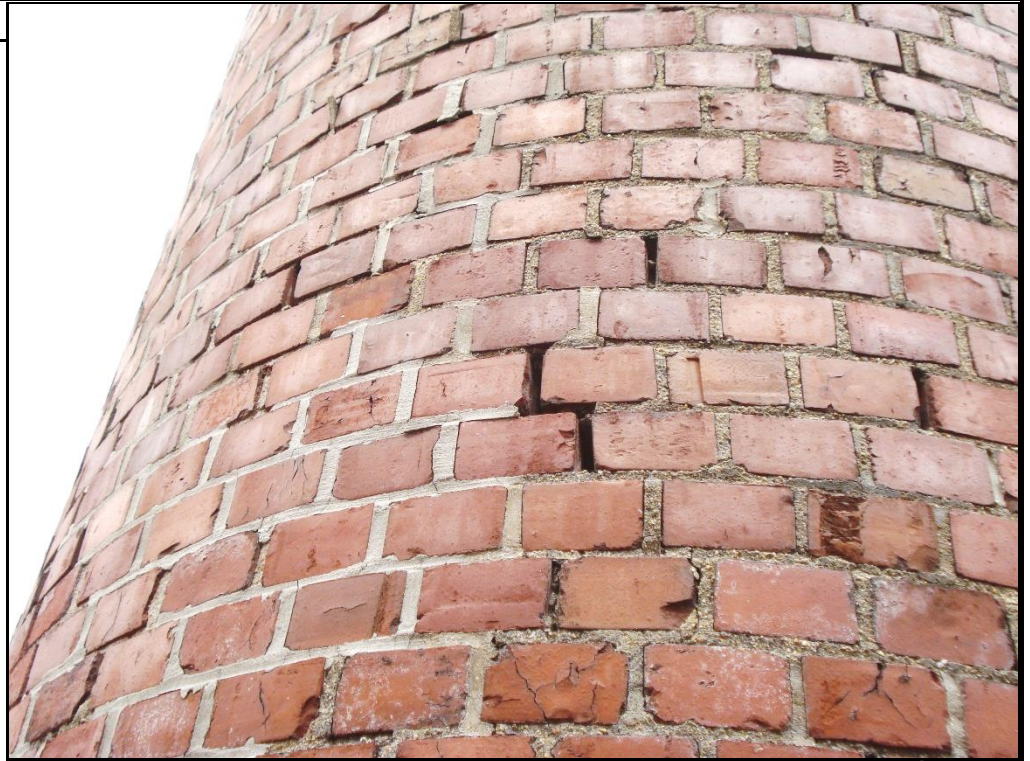
Figure 3

Typical Stack Condition

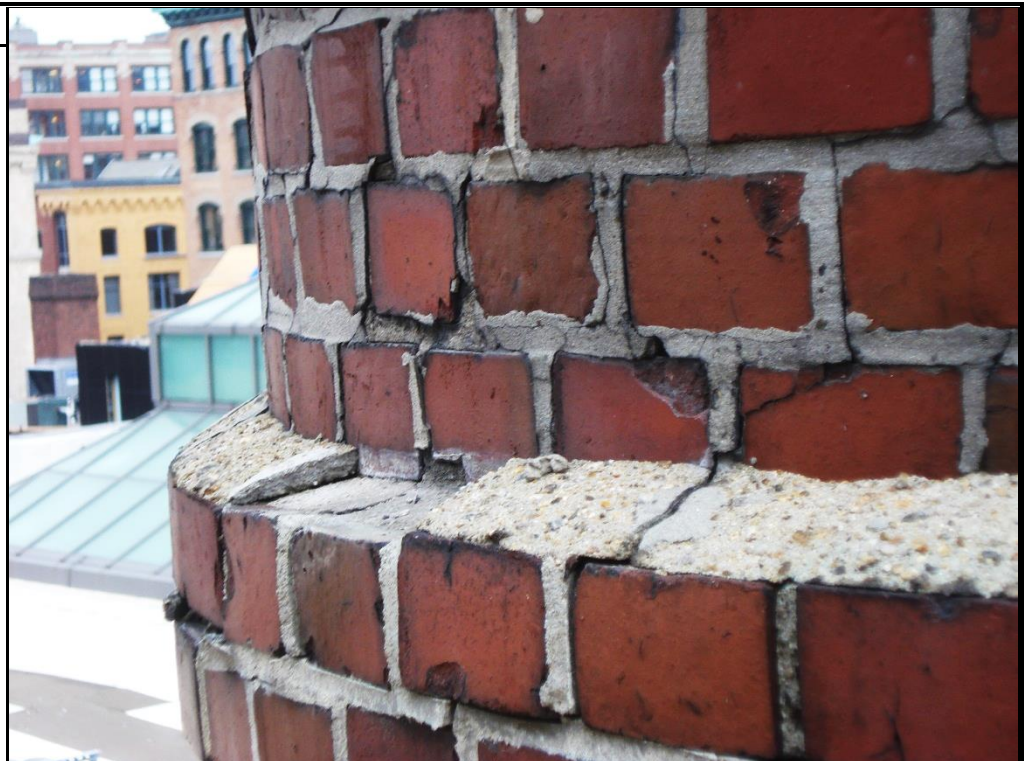
Figure 4

There is evidence that the missing mortar wash has fallen from the building. This is because the internal binding mechanics are no longer functioning.

Deteriorated Wash and Bricks at Top of Stack

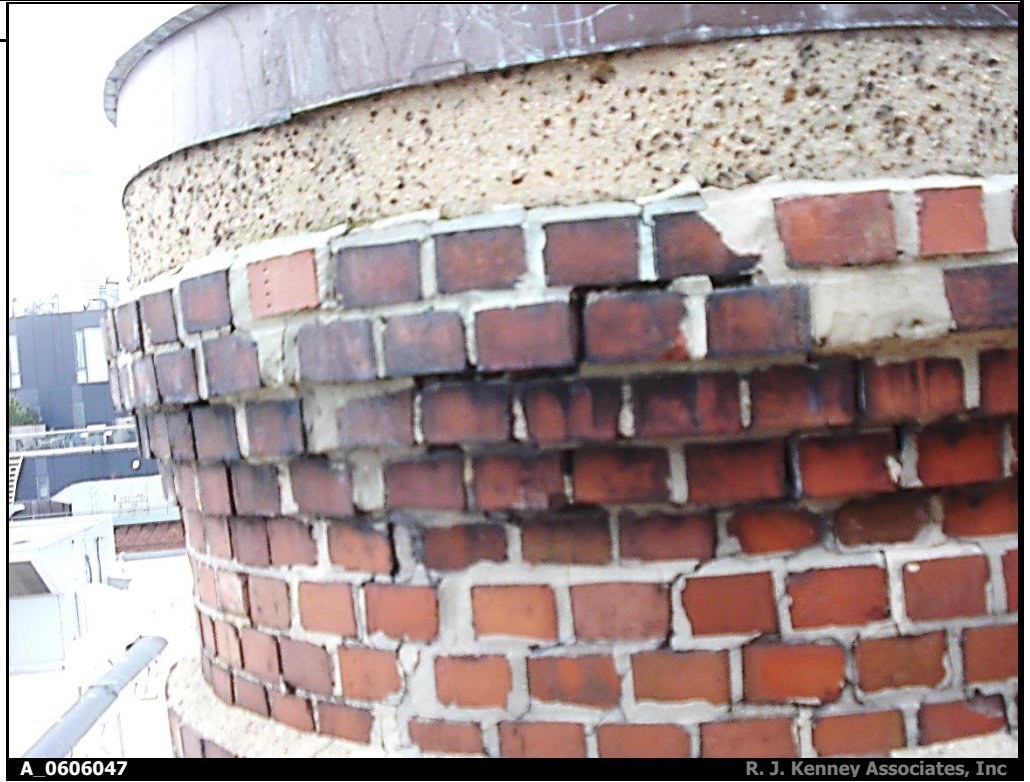
Figure 5

Top of Stack Cracked and Displaced

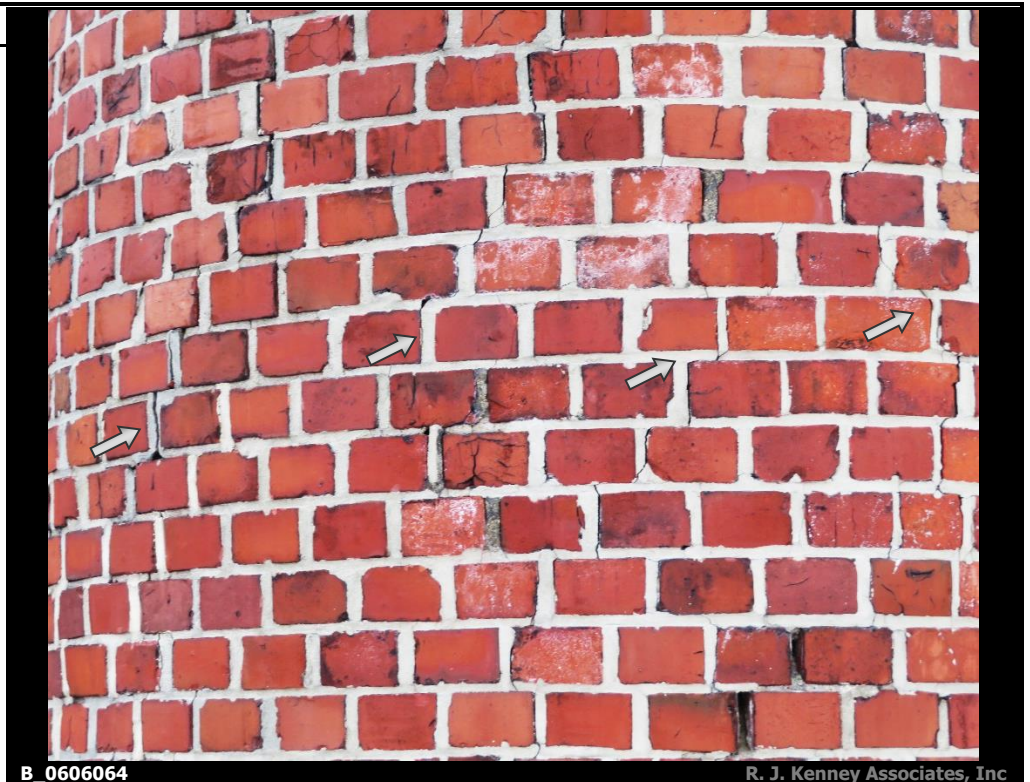
Figure 6

Various Vertical Step Cracks

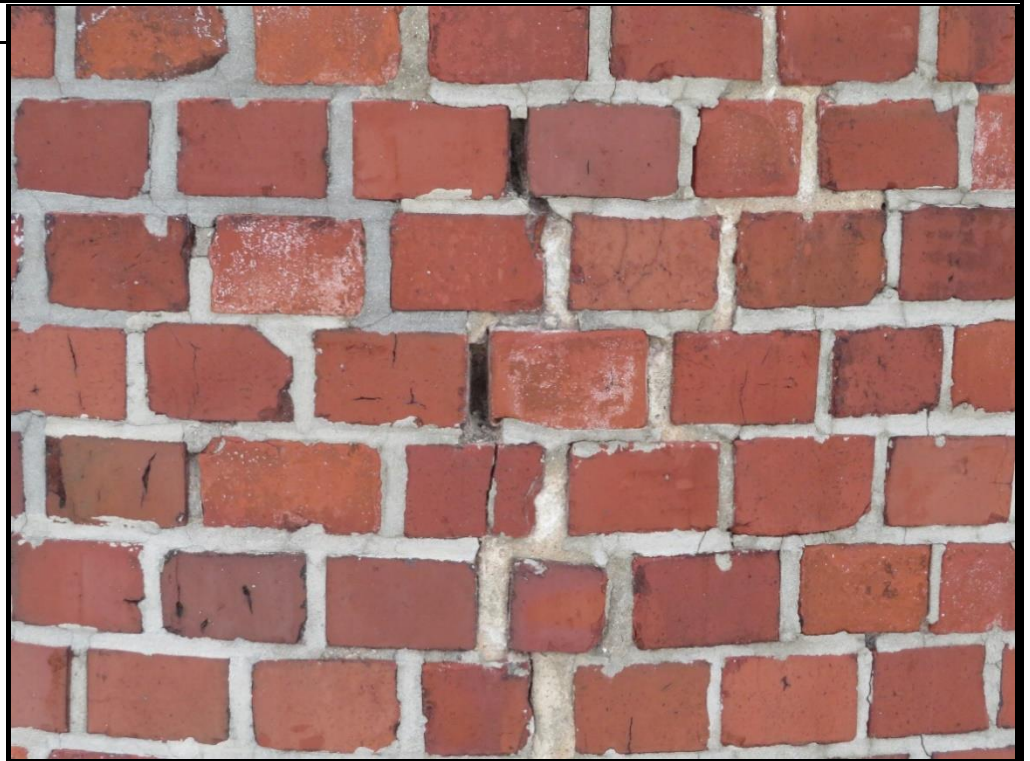
Figure 7

Various Mortar Pointing and Open Joints

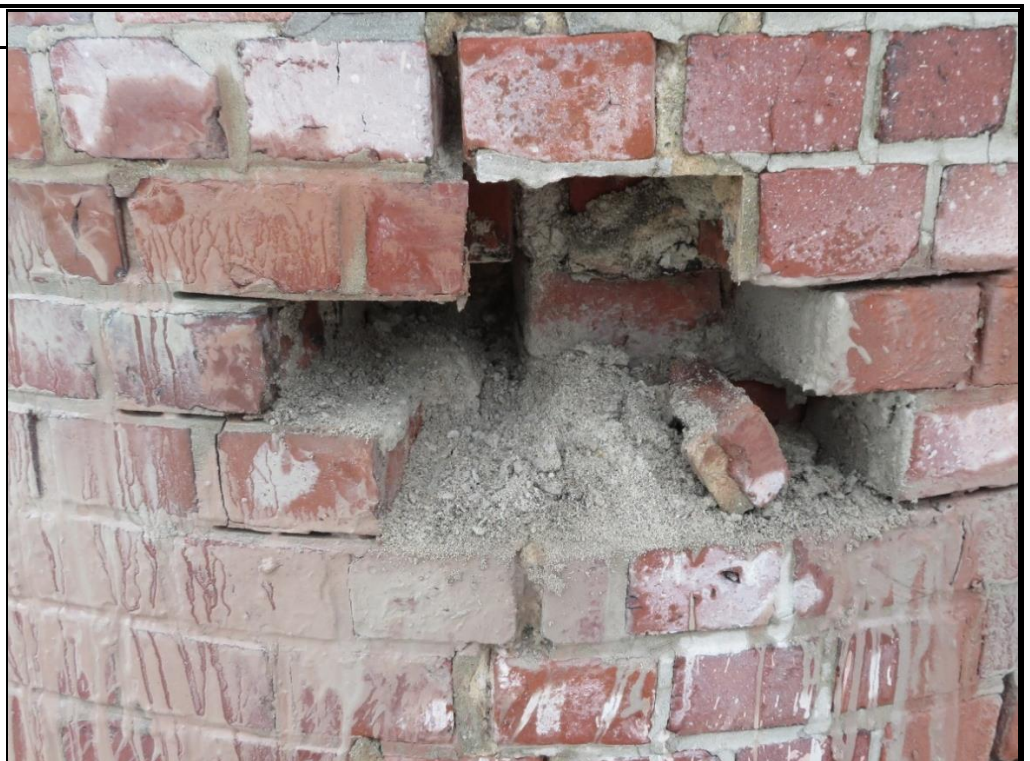
Figure 8

Partial removal of the exterior wythe of brick was observed to understand the collar joint condition. The collar joint and setting mortar interior to the stack is a loose lime/sand mix. The mix was

deteriorated, without rigidity or bond strength, and can be easily removed from the system. As a result, inner wythes of brick were found to be easily dislodged with hand pressure. The stack, therefore, has little structural integrity.

Test Cut

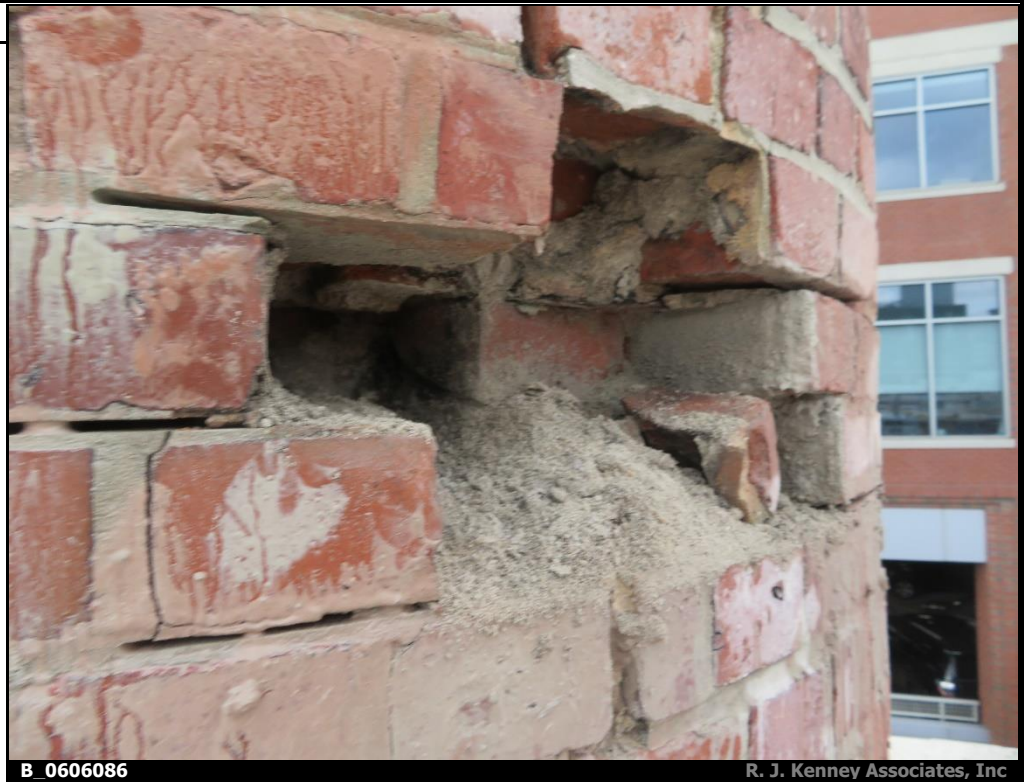
Figure 9

Setting Mortar at Test Cut is a Sand Consistency
