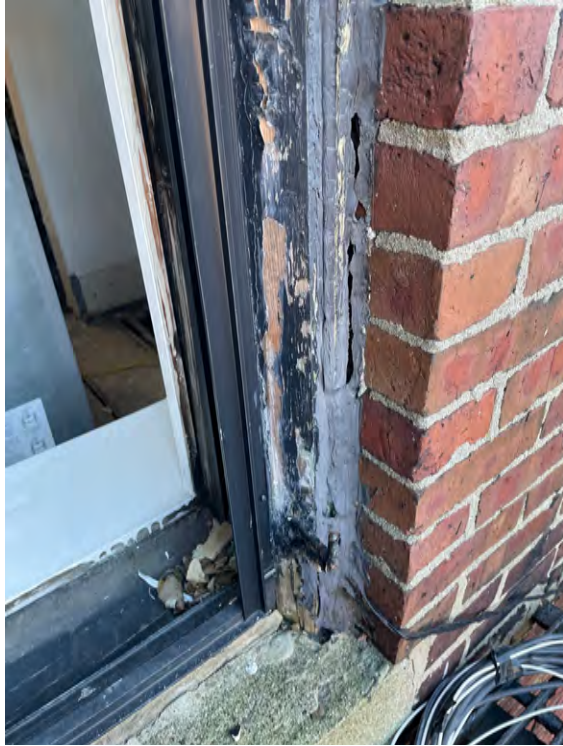
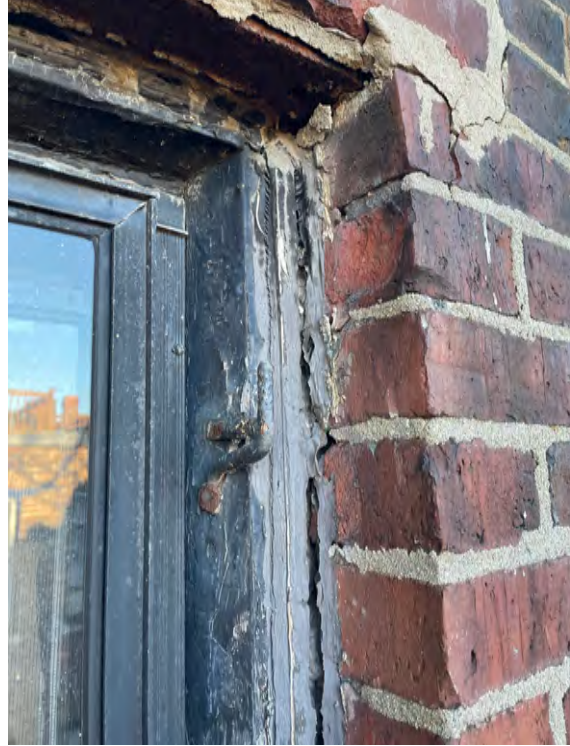
Examples of existing degradation at Brick/Wood meeting points

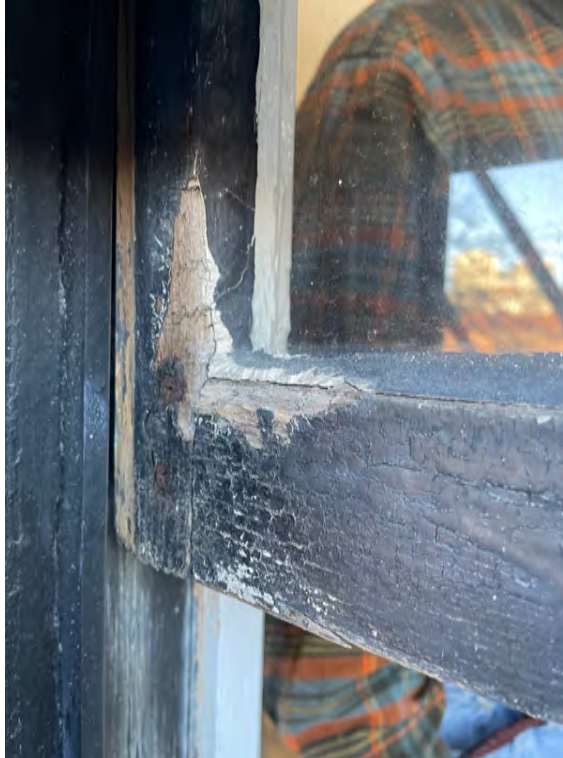
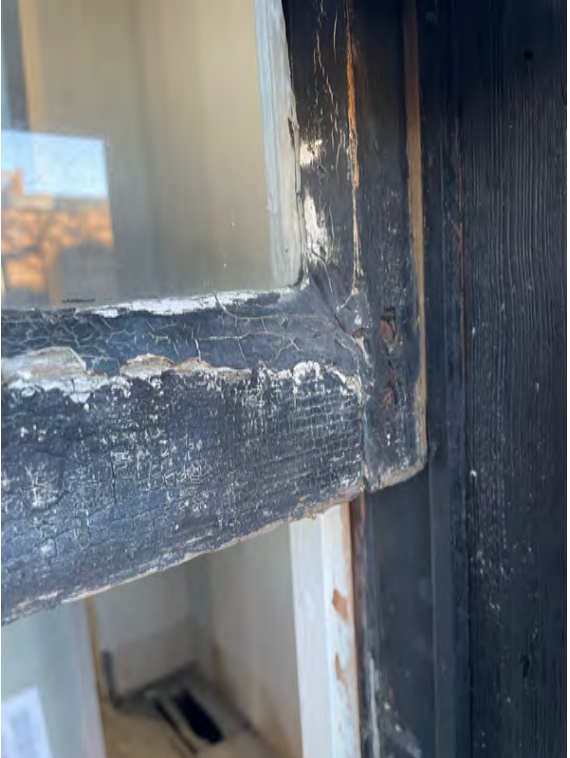
Examples of typical existing degradation at sash exterior

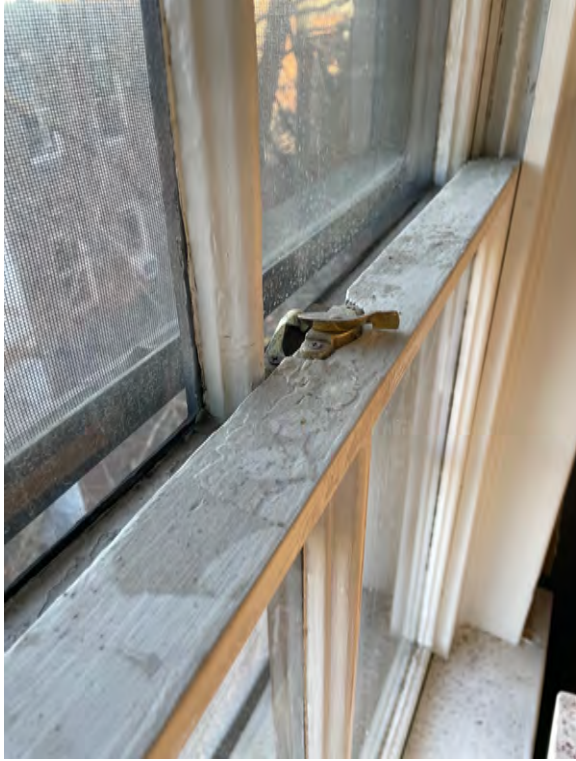
Example of existing degradation at 3<sup>rd</sup> floor sash

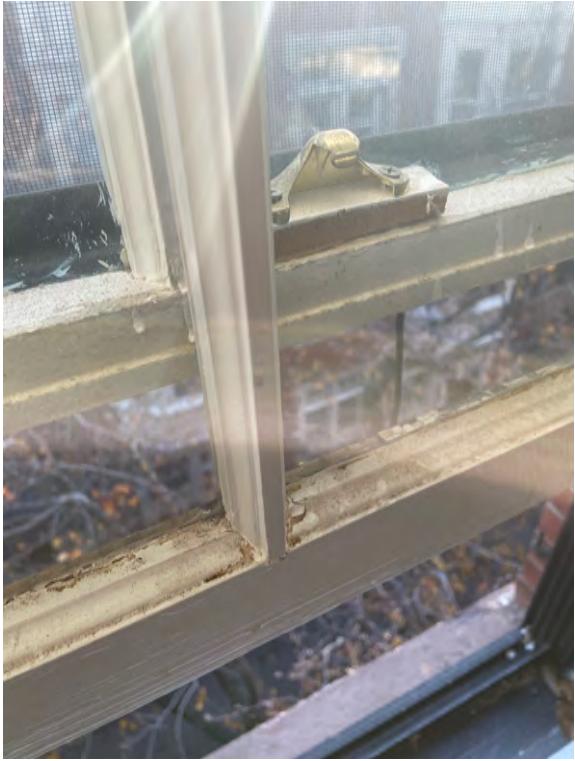
Example of 4<sup>th</sup> floor replacement window sash

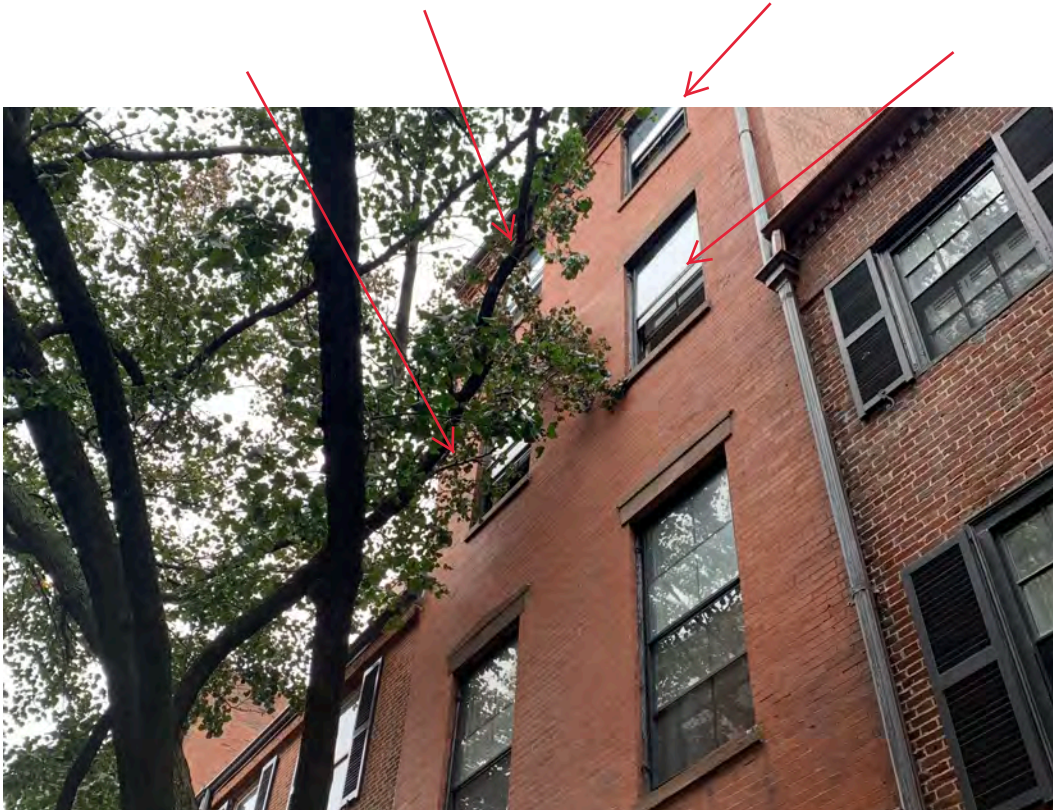
Front side of building (Pinckney Street) looking up at 3rd & 4th Floors with 2nd floor (not our unit) in bottom of picture.

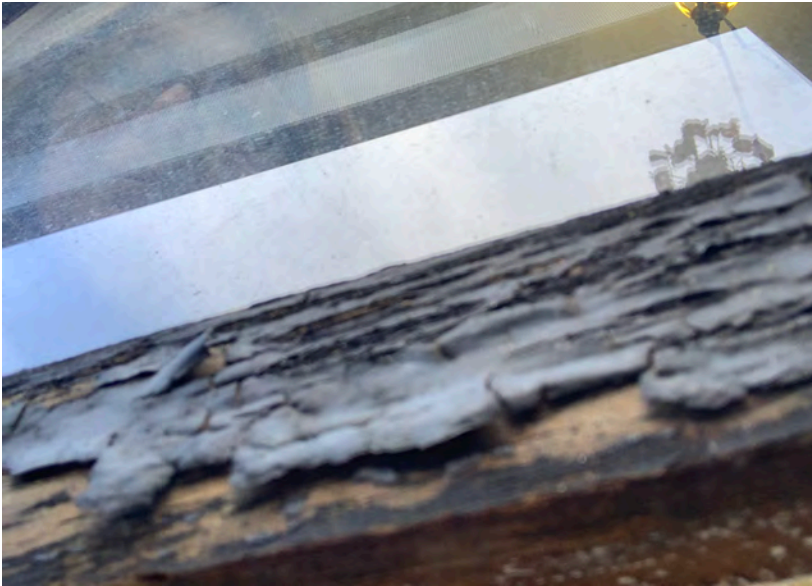
Window #2  
Exterior Rot.

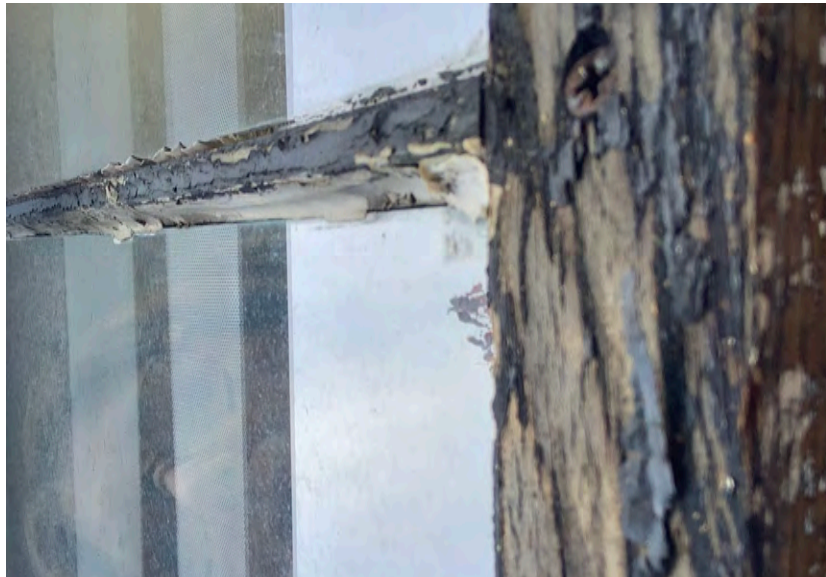
Window #2  
Exterior Window Rot with screw for temporary support.

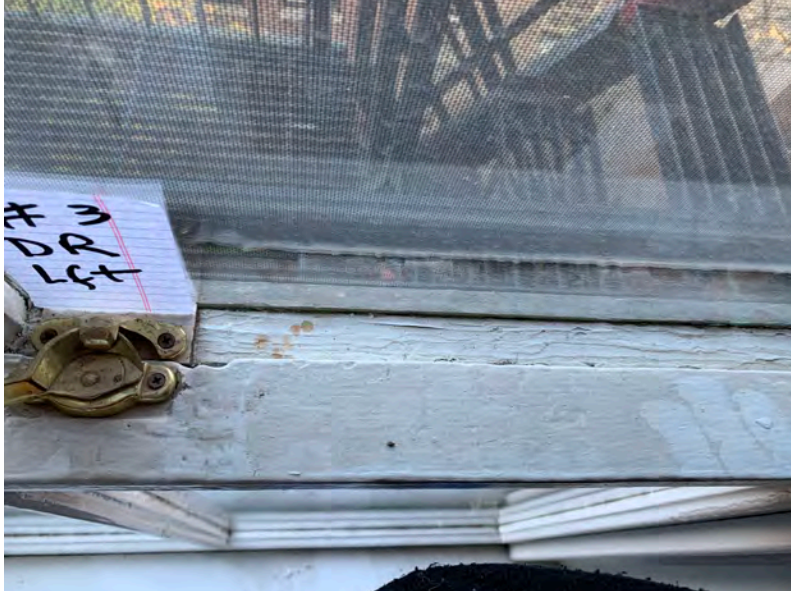
Window #3. 3rd Floor. West Side. Back side of building.  
Rails do not meet. Unable to lock.

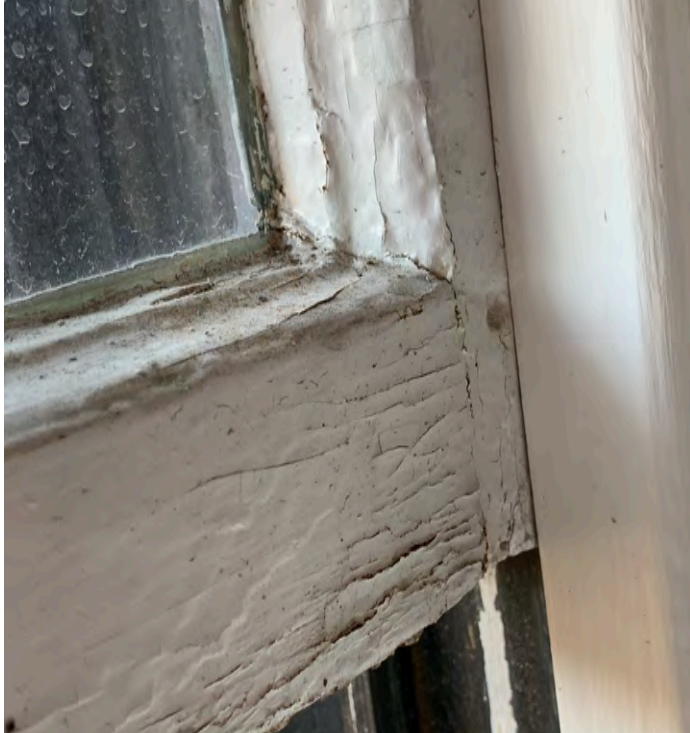
Window #4. 3rd Floor. East Side. Back side of building.  
Deterioration of lower sash.

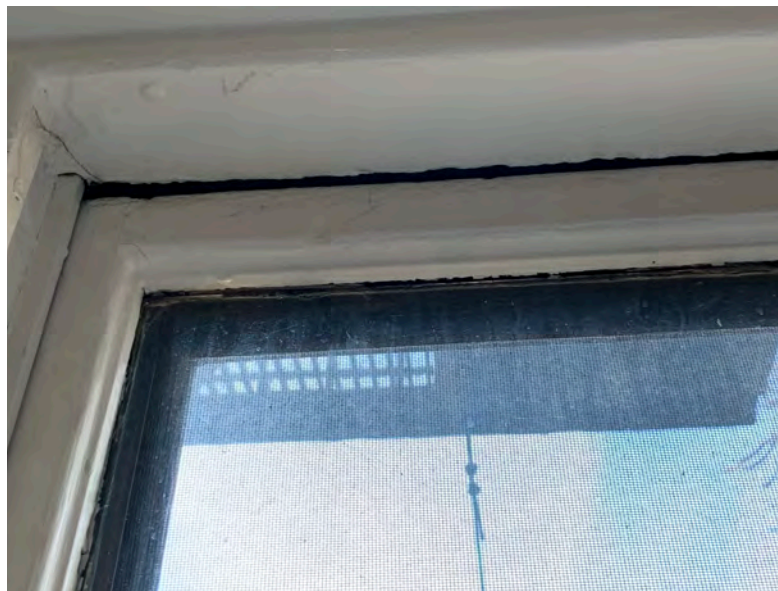
Window #4  
Top Rail and Head jamb maligned, not square,  
sash previously modified, windows not original.

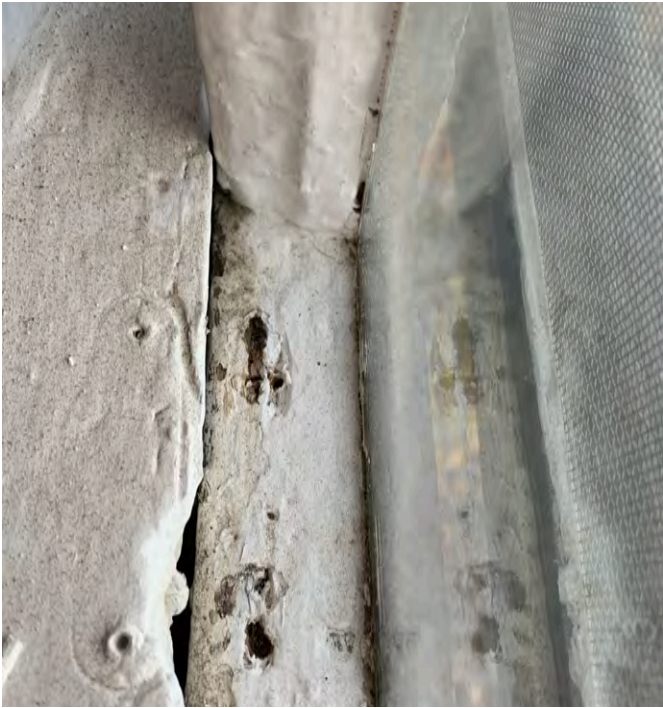
Window #8. 4th Floor. East Side. Back side of building.  
Lock missing due to interior rot. Poor wood integrity.

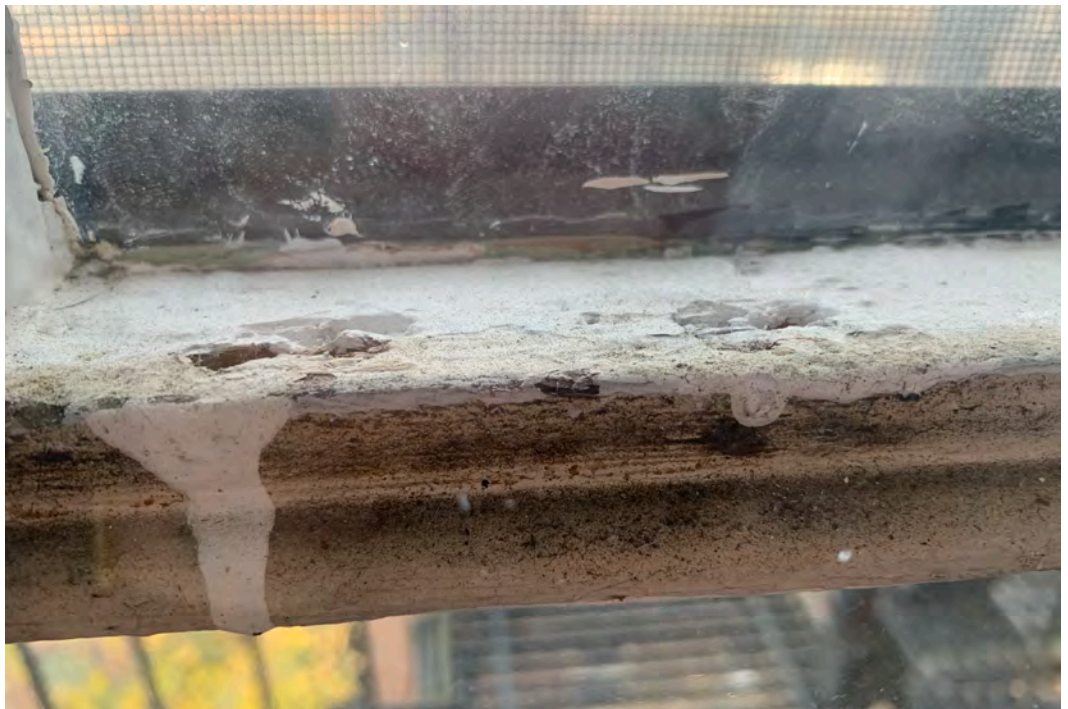
Window #8  
Rot and mold

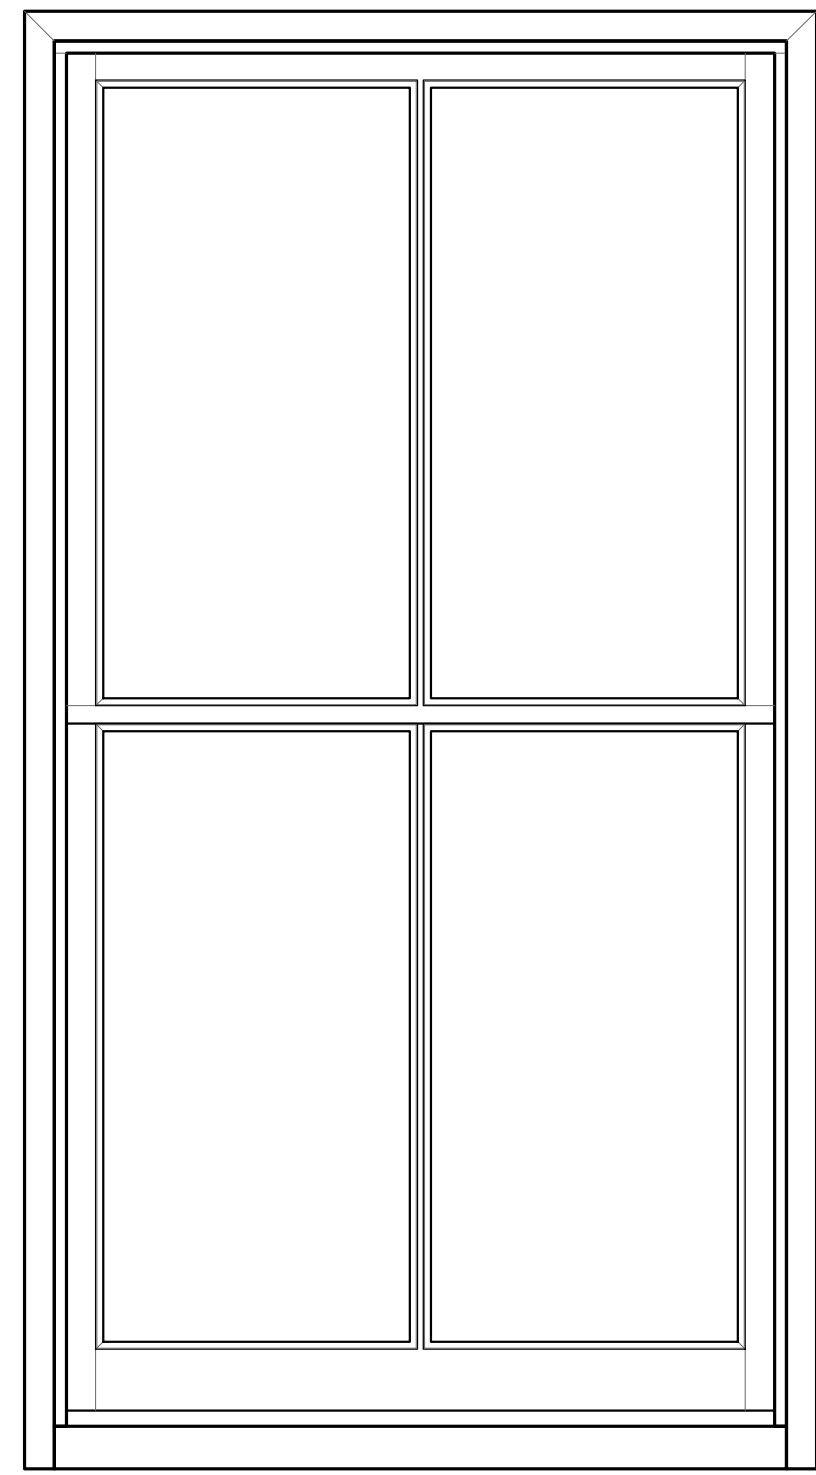
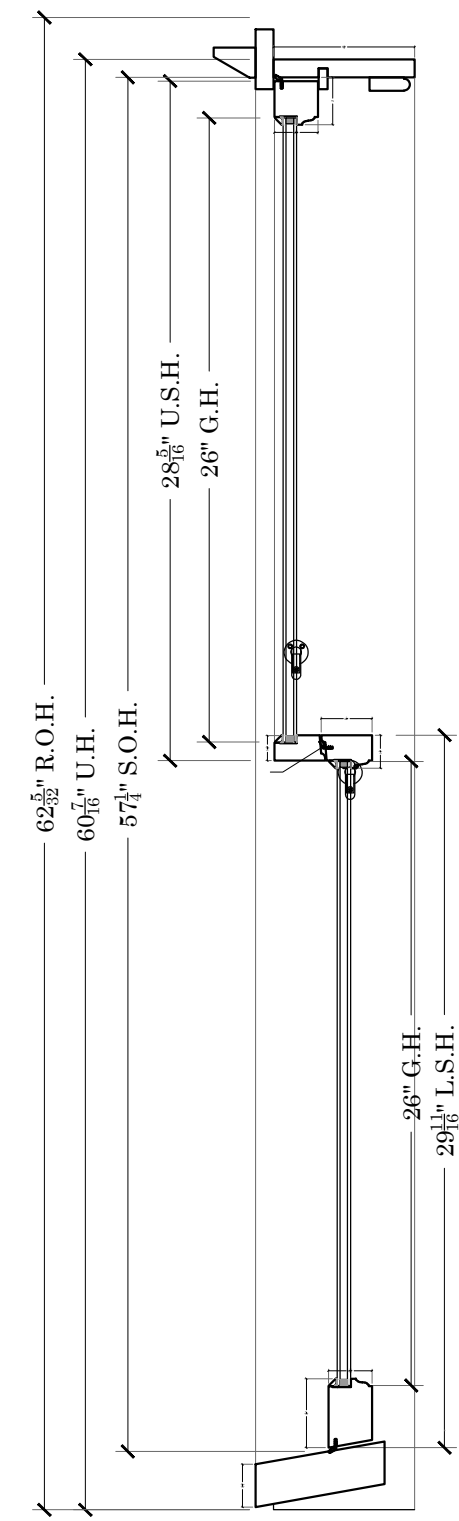
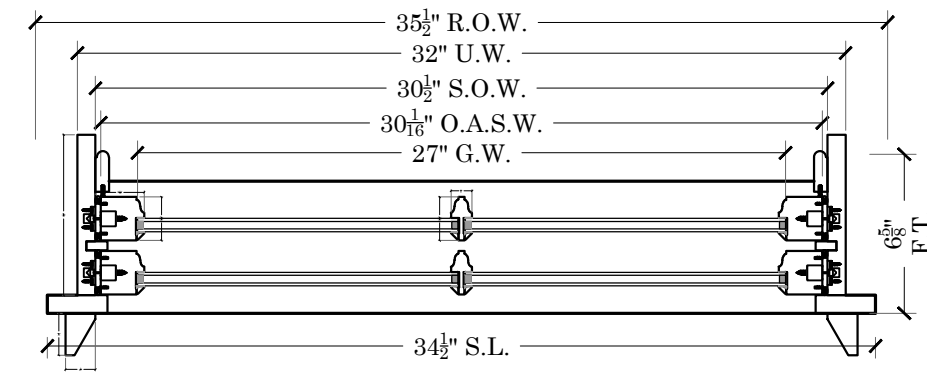
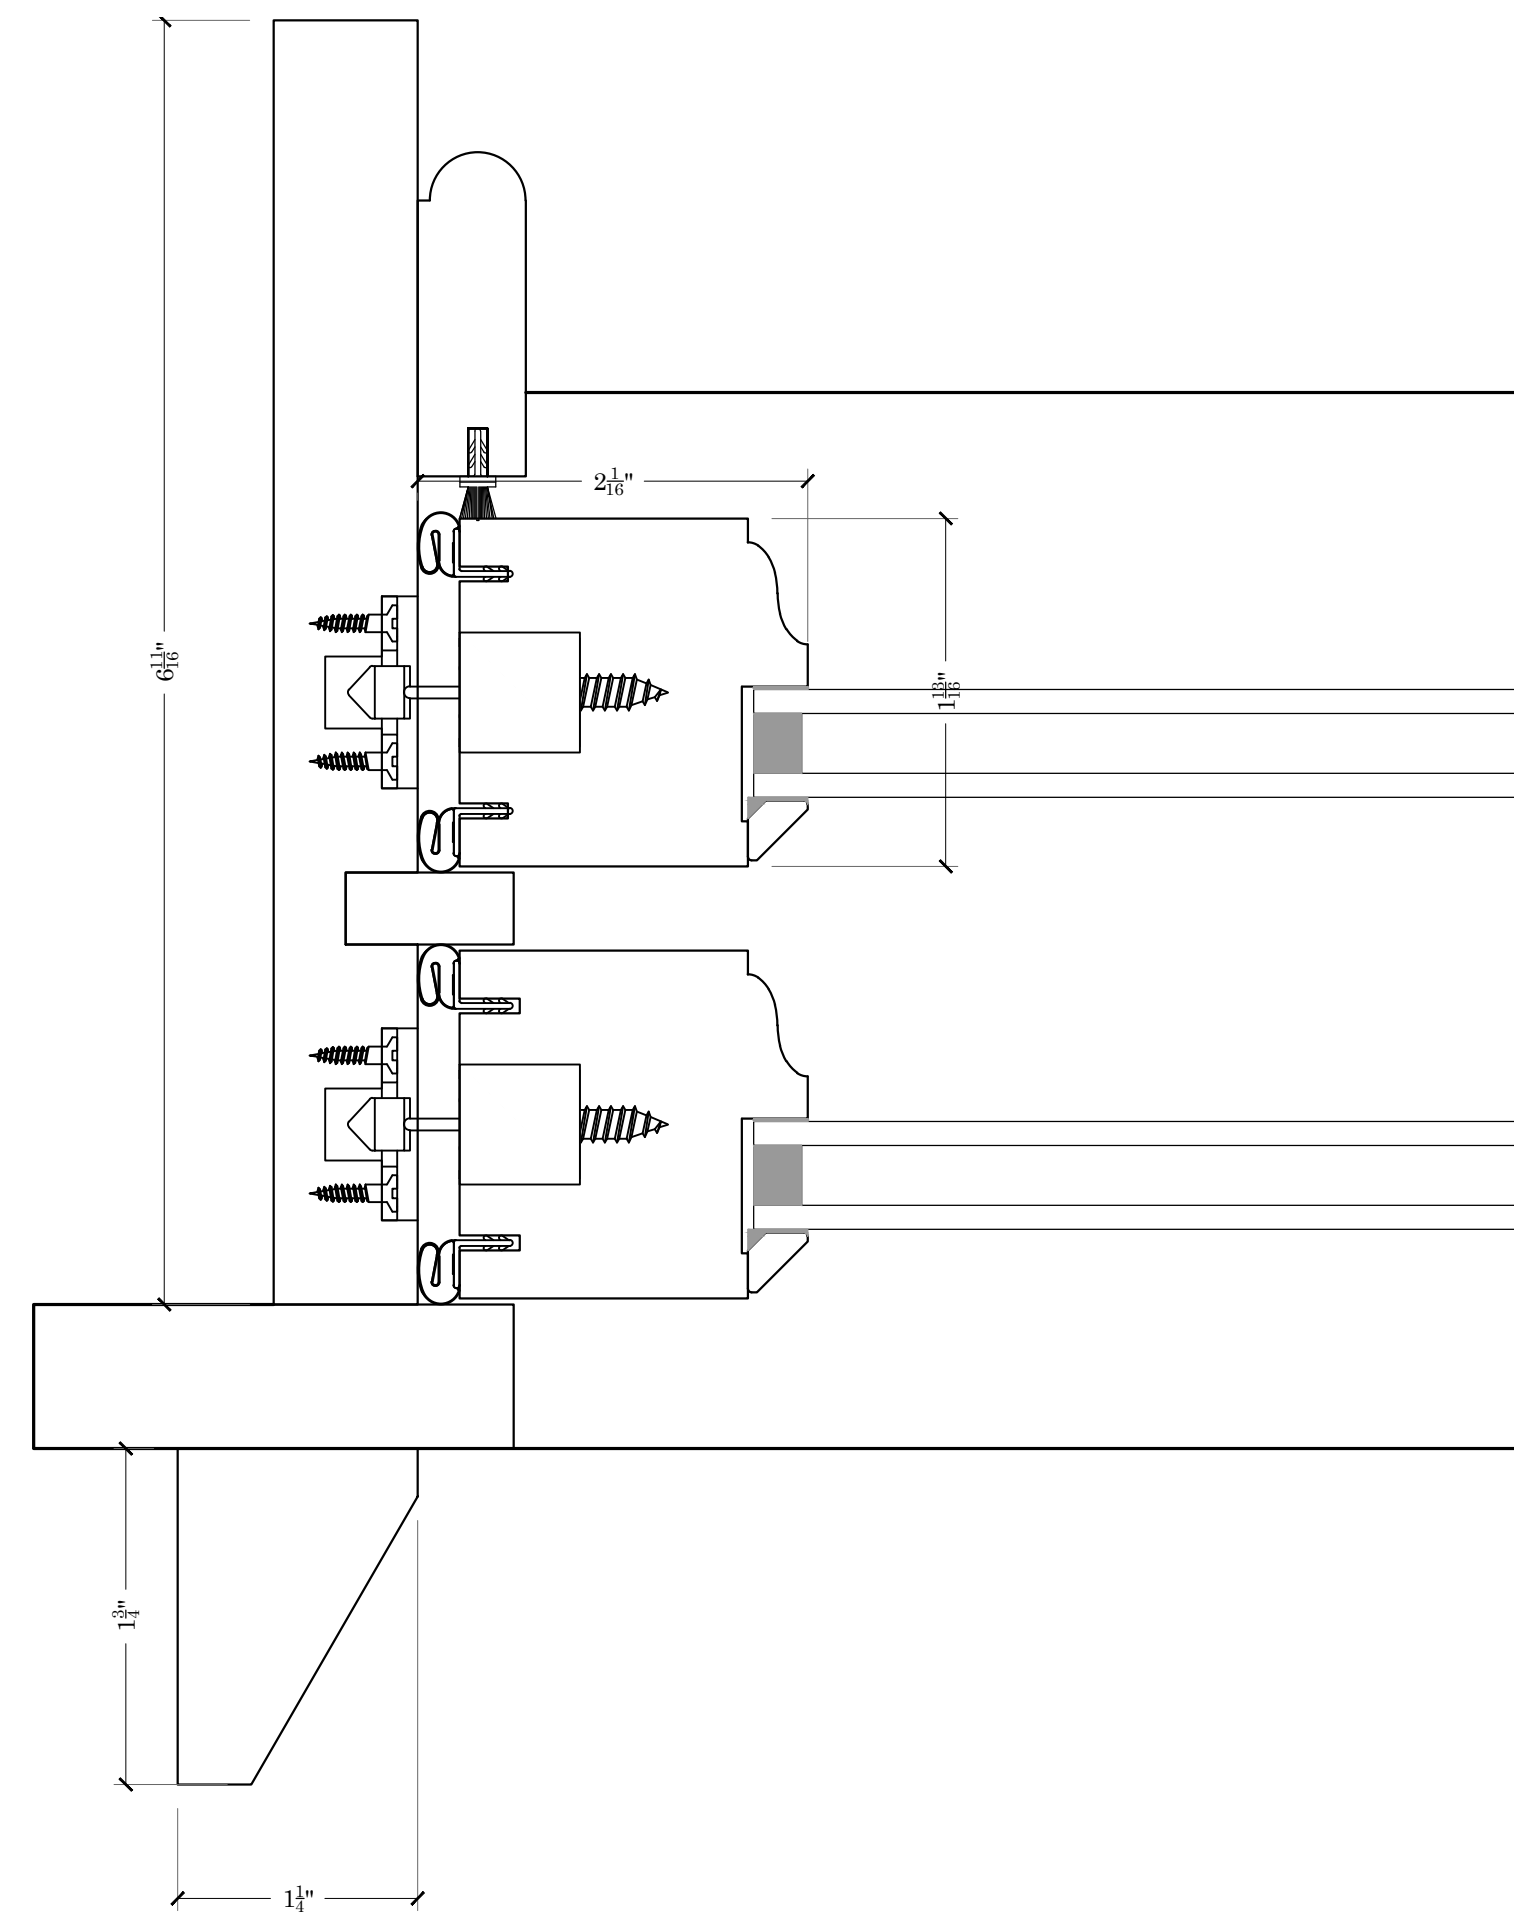
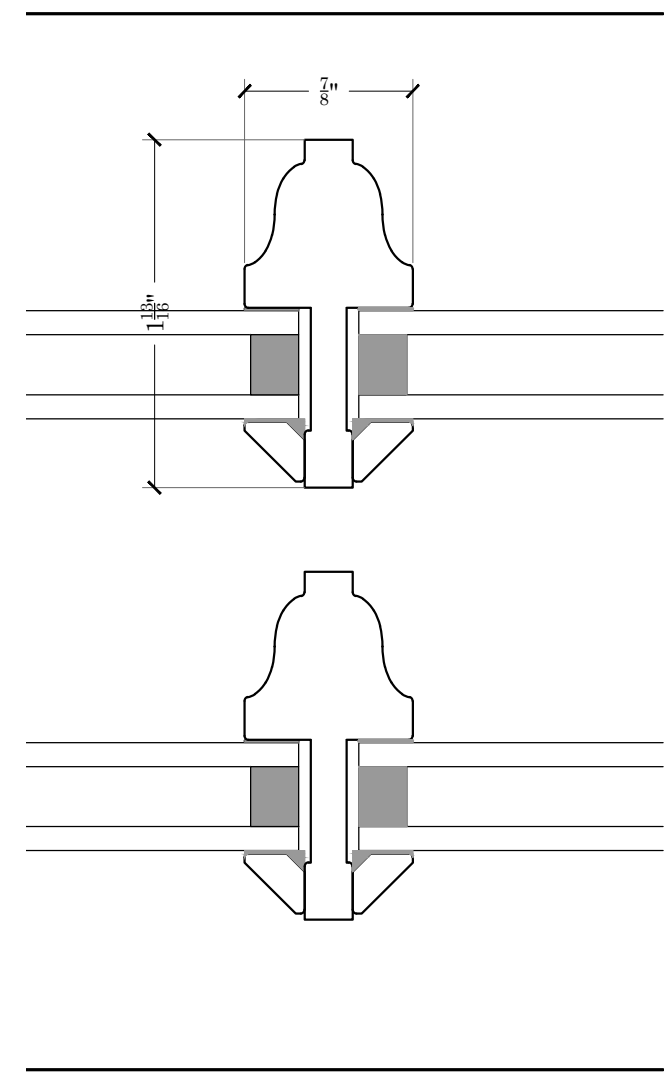
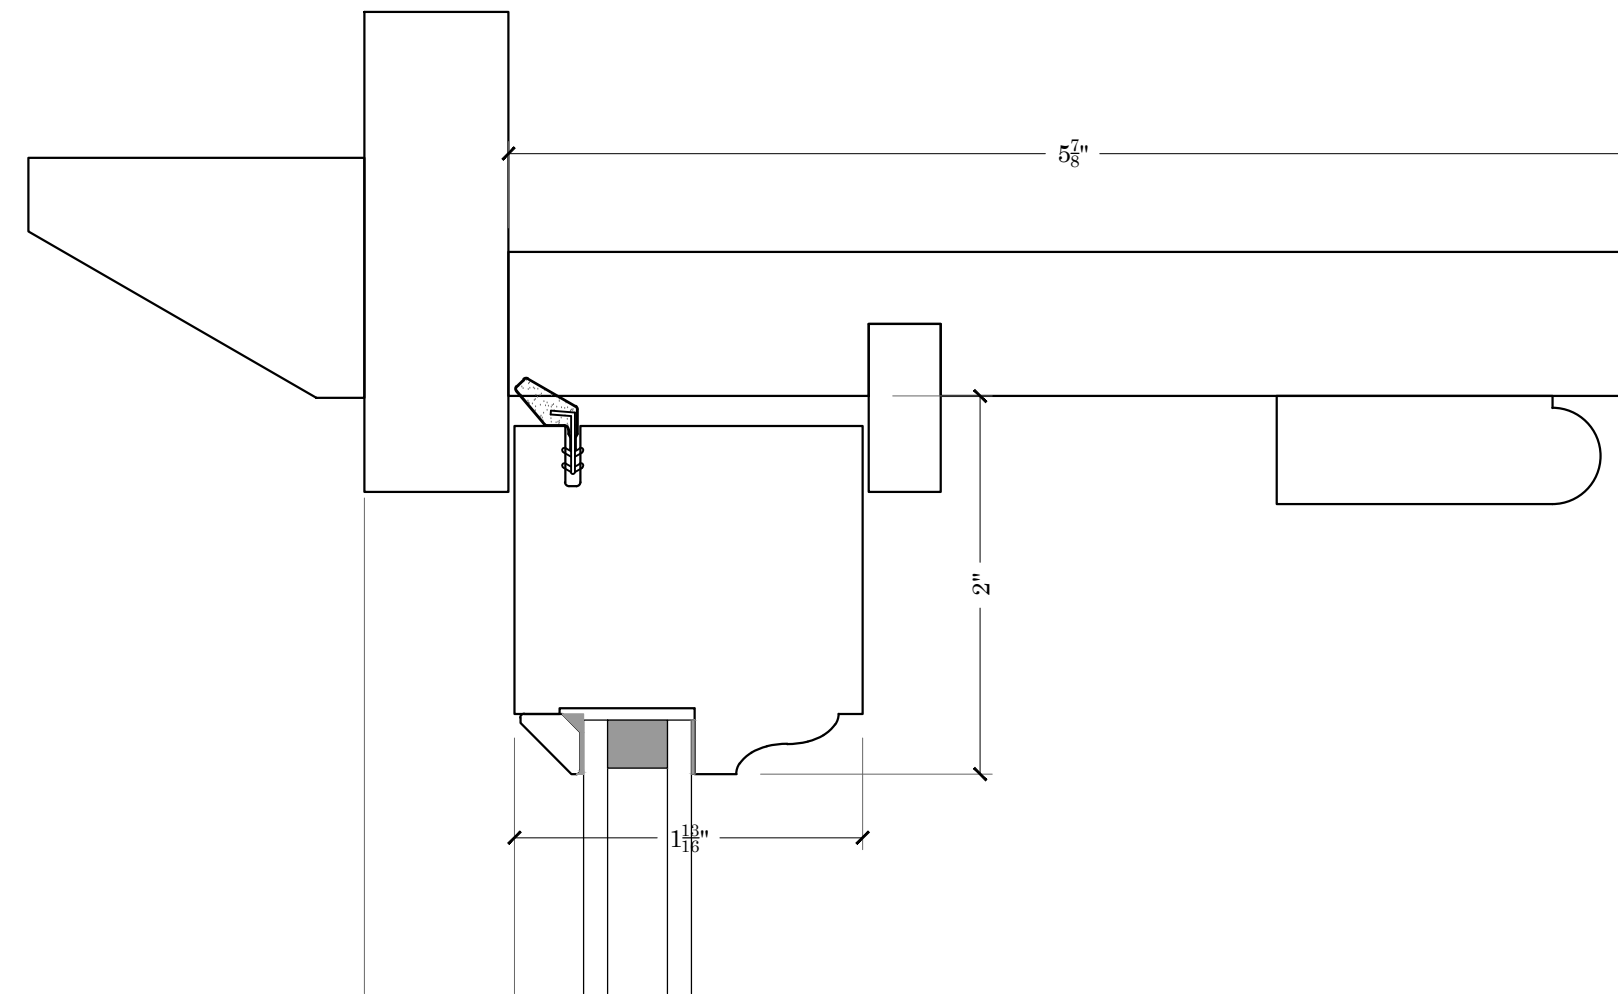
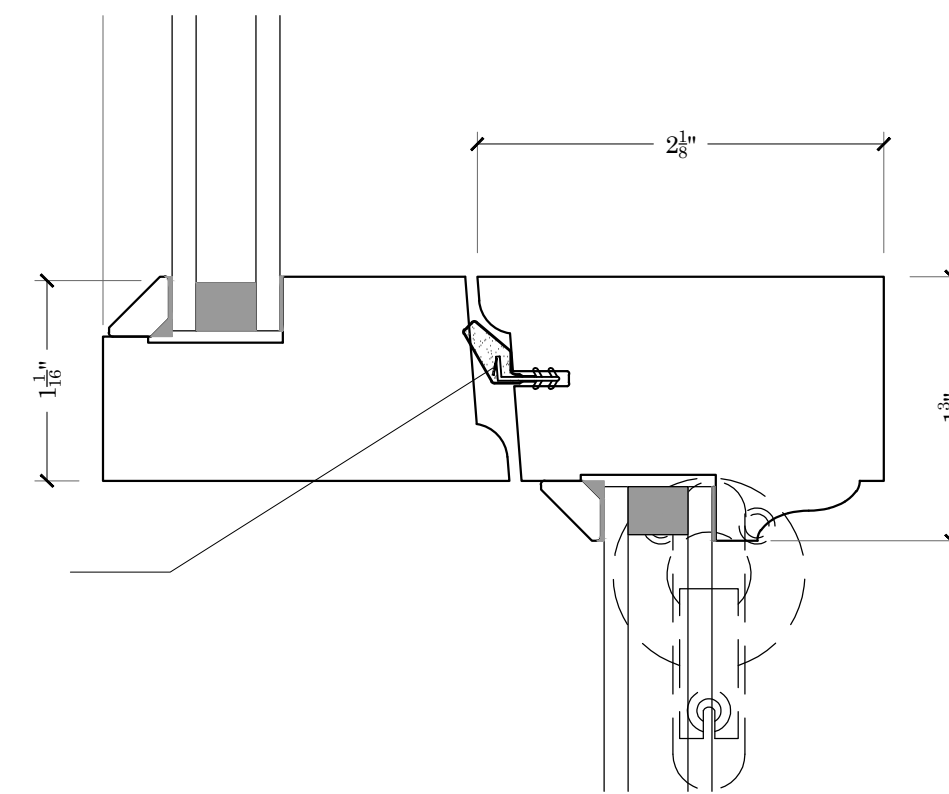
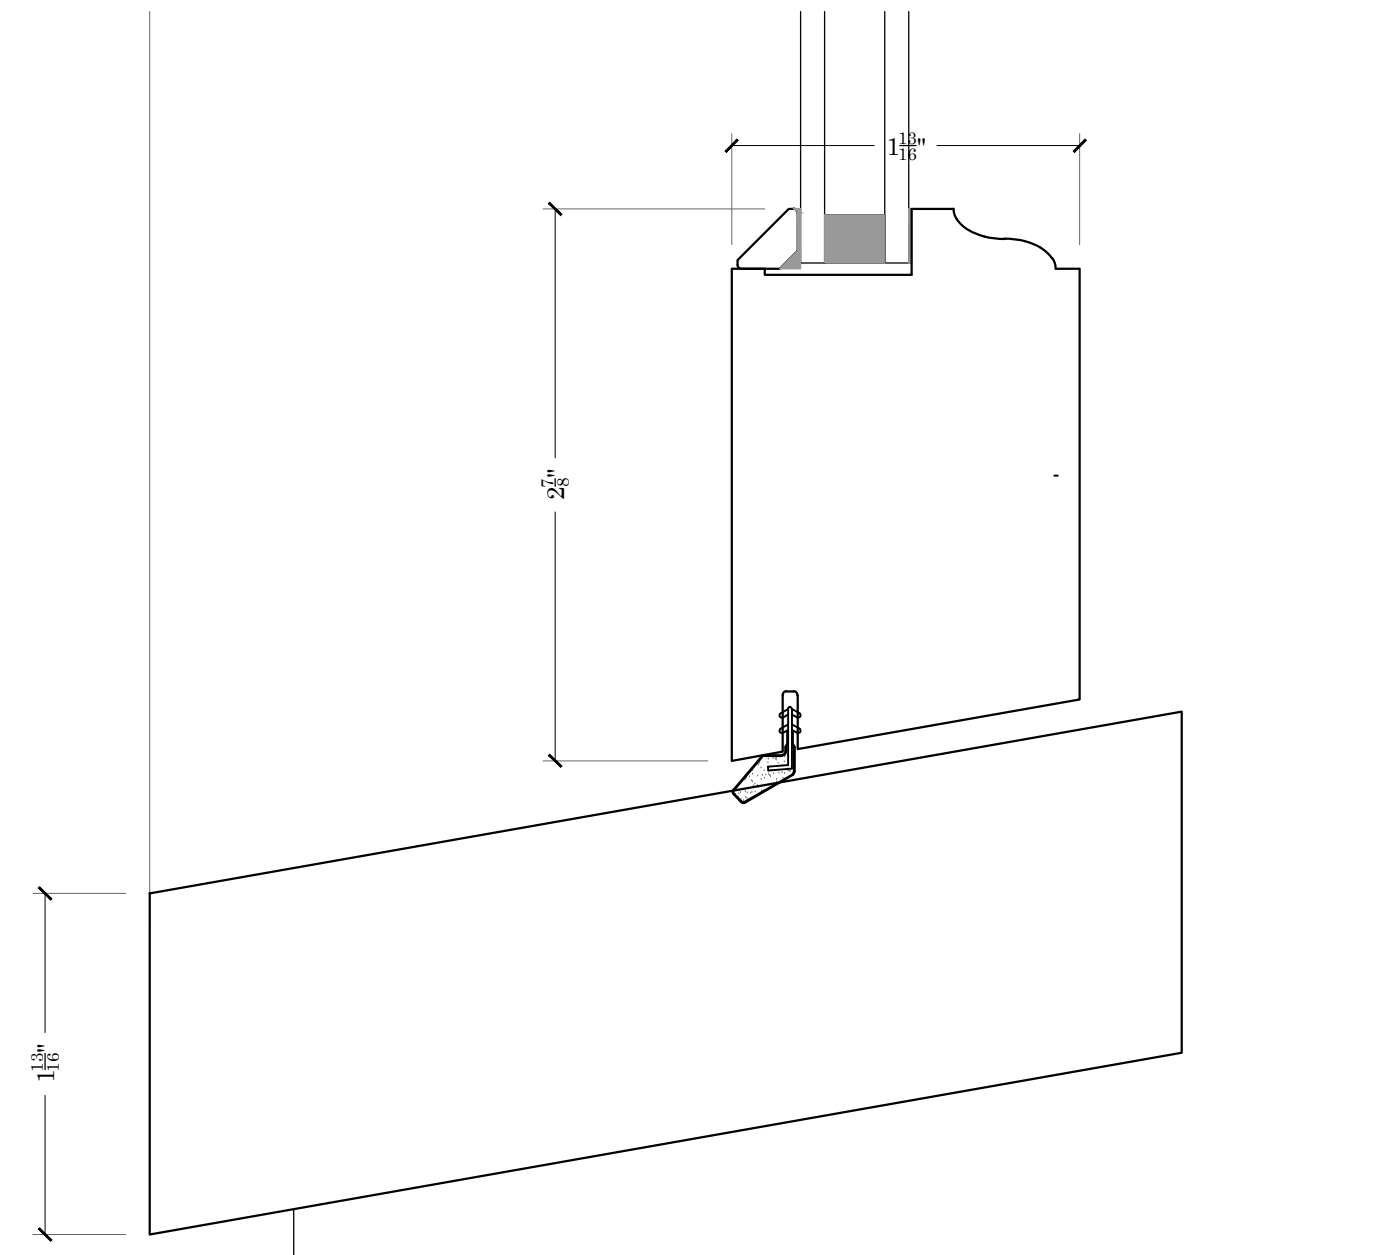
**BOSTON**  
SASH & MILLWORK
