80 + 100 SMITH STREET / MISSION HILL

SALVAGE PLAN

JUNE 12, 2023

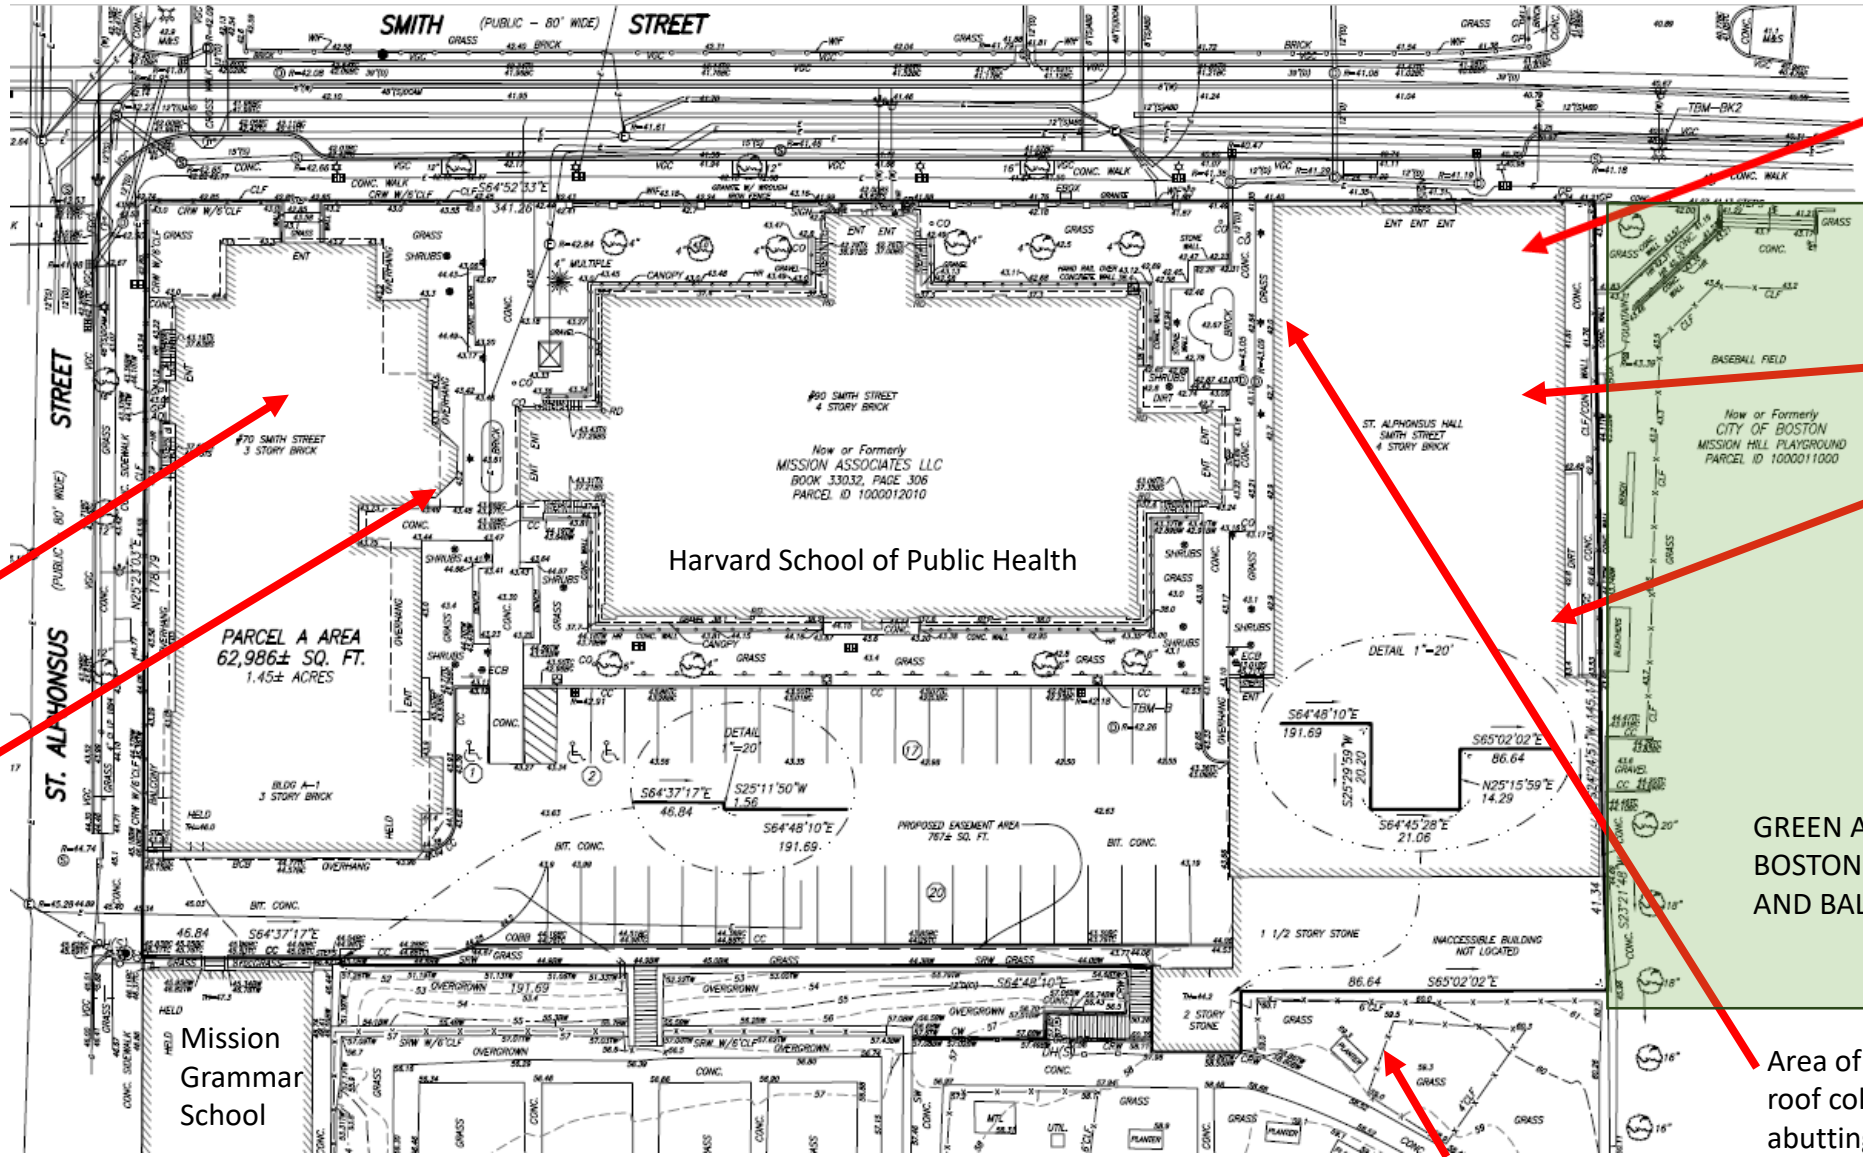
Area of Roof Collapse abutting sidewalk

Area of Roof Collapse and upper wall failure in immediate proximity to stands, dugout and ballfield.

Area of imminent roof collapse abutting gathering area of HSPH

Flooring System Failing

Area of Collapse

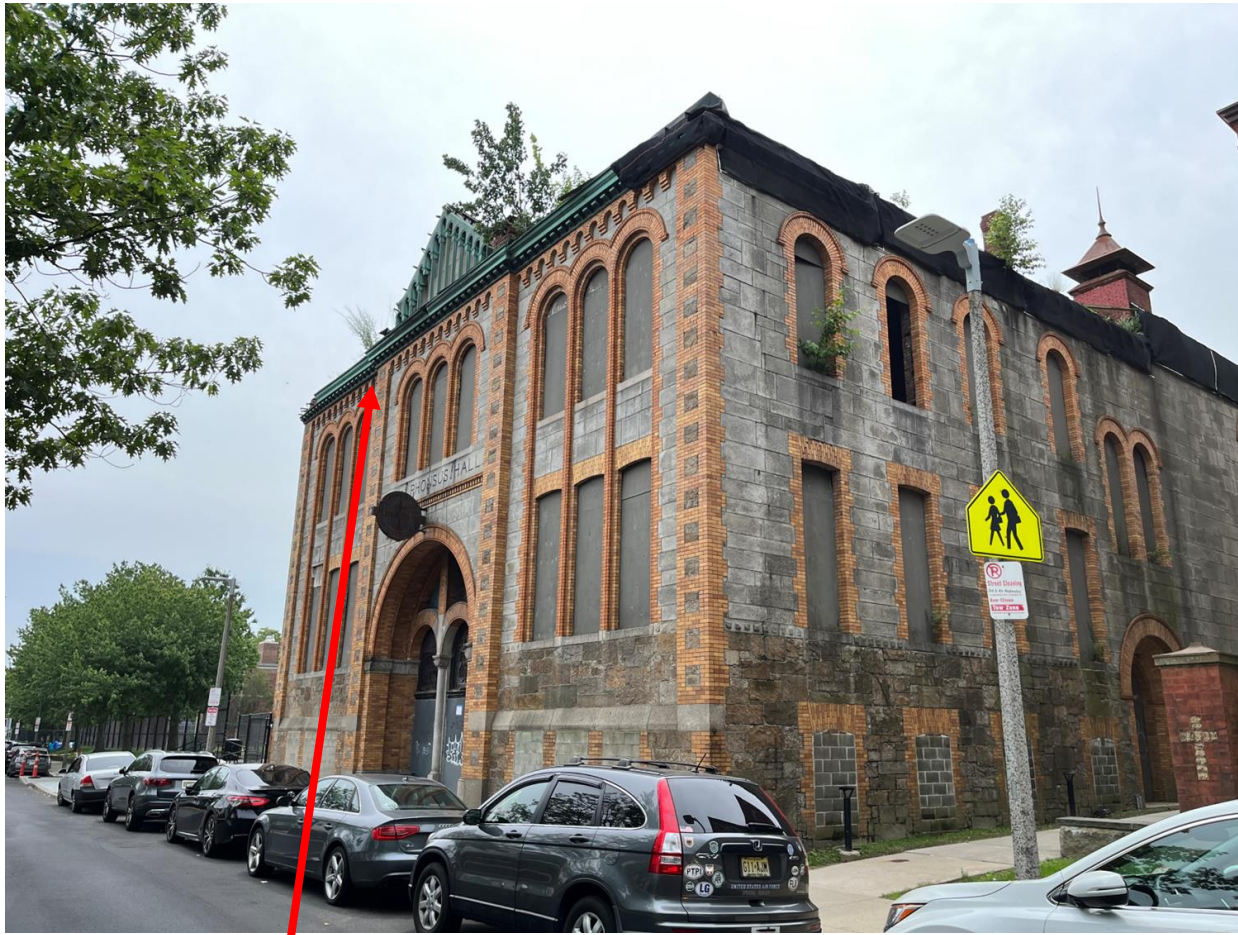
Area of Collapse

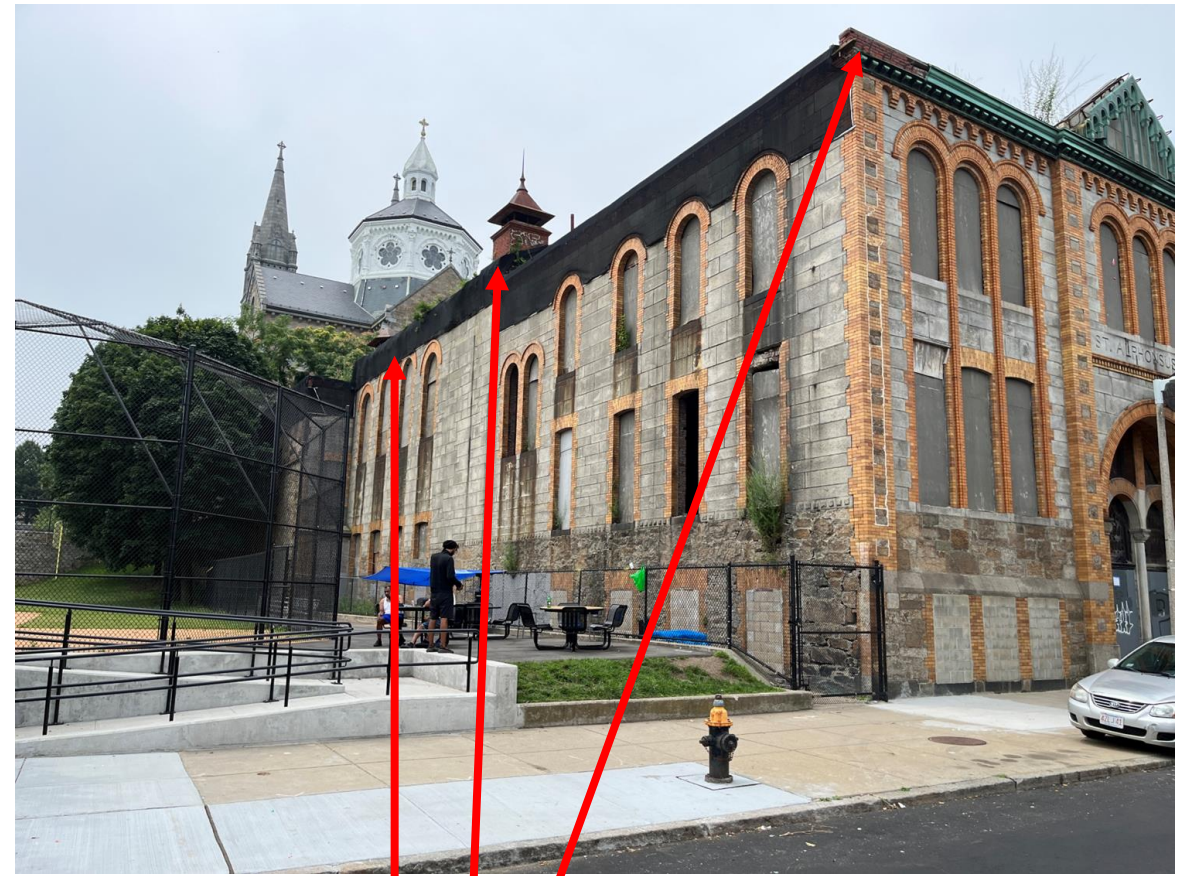
Areas of Collapse

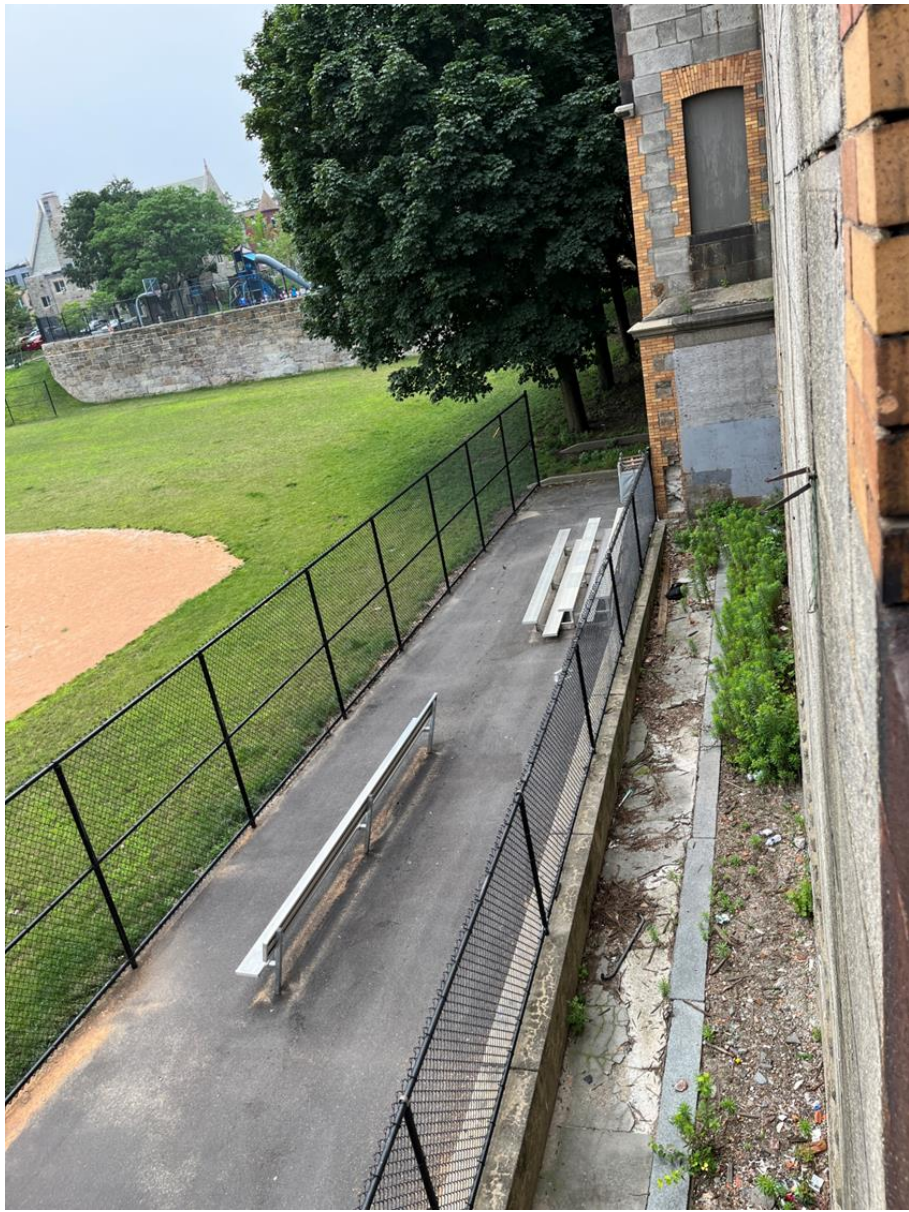
Ballfield dugout and stands

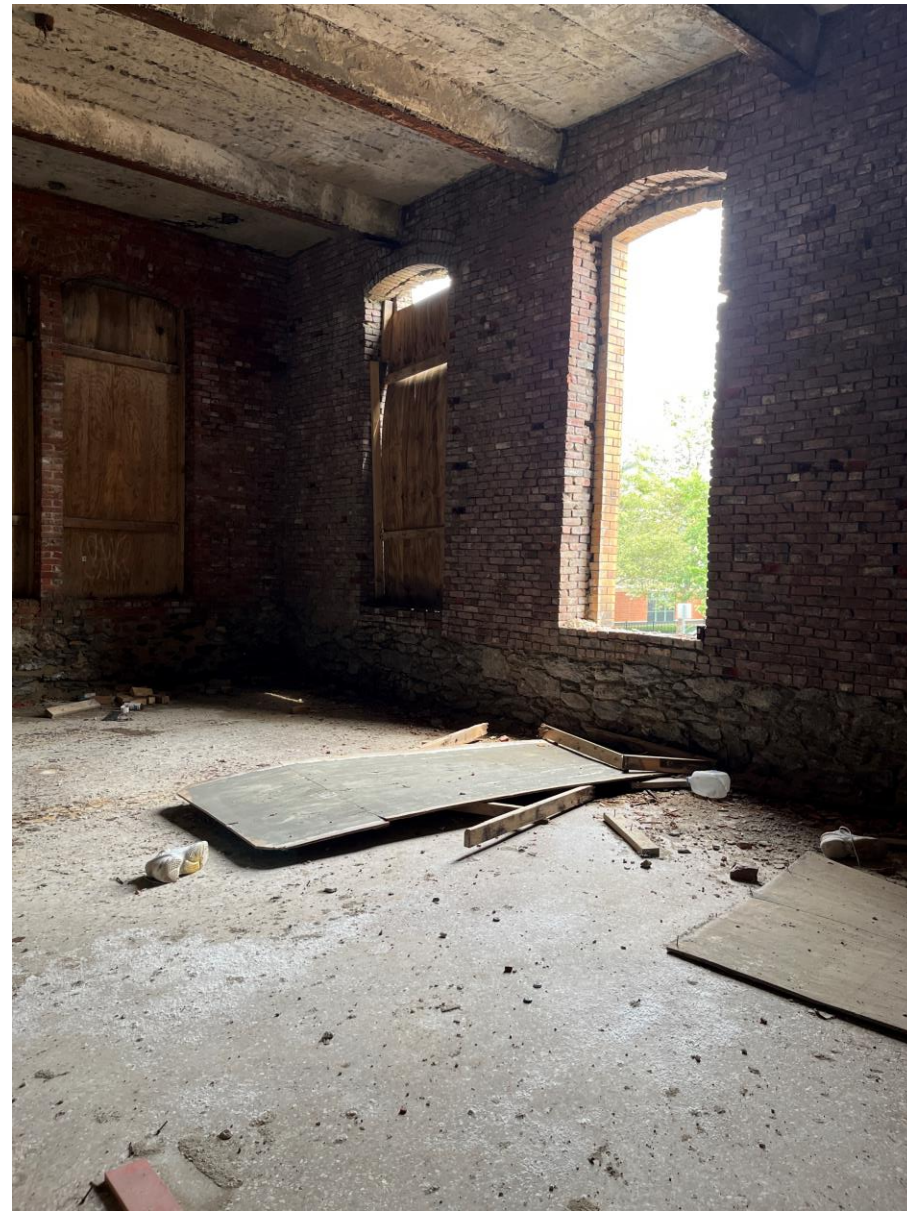
Newly discovered break-in next to ballfield

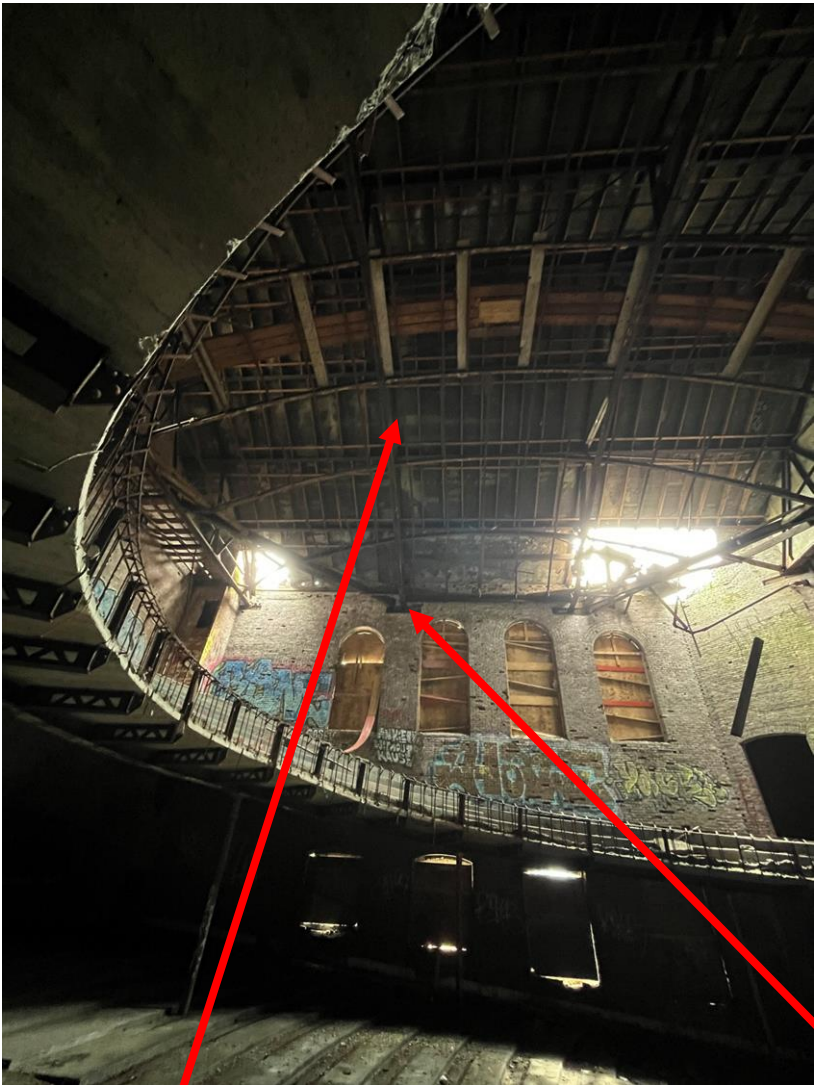
Ceiling and upper-wall collapse by ballfield

Severely deteriorated Steel truss at risk of catastrophic failure

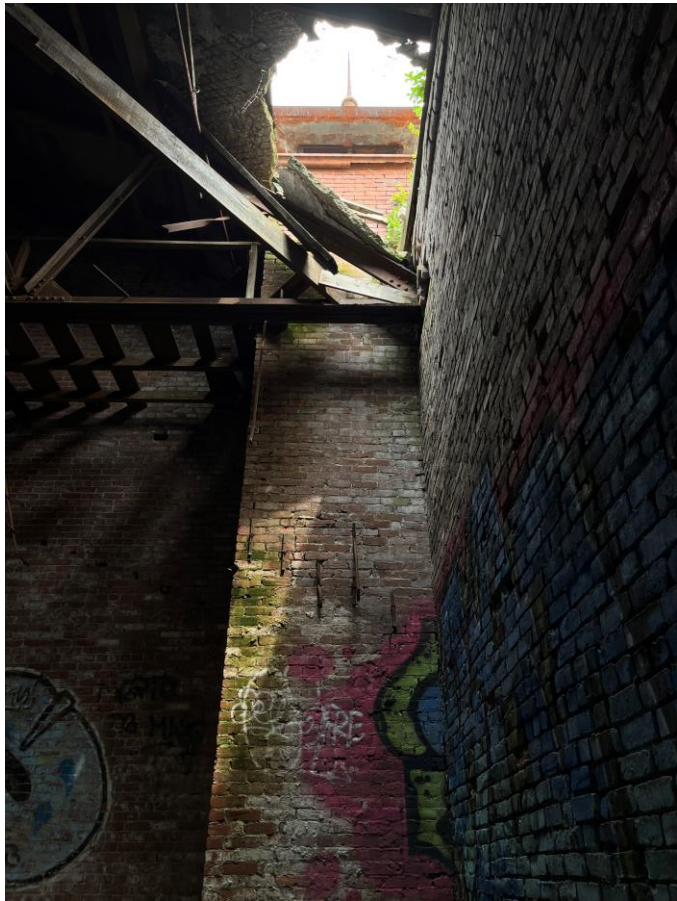
Collapse by Dugout

Severely deteriorated Steel truss at risk of catastrophic failure

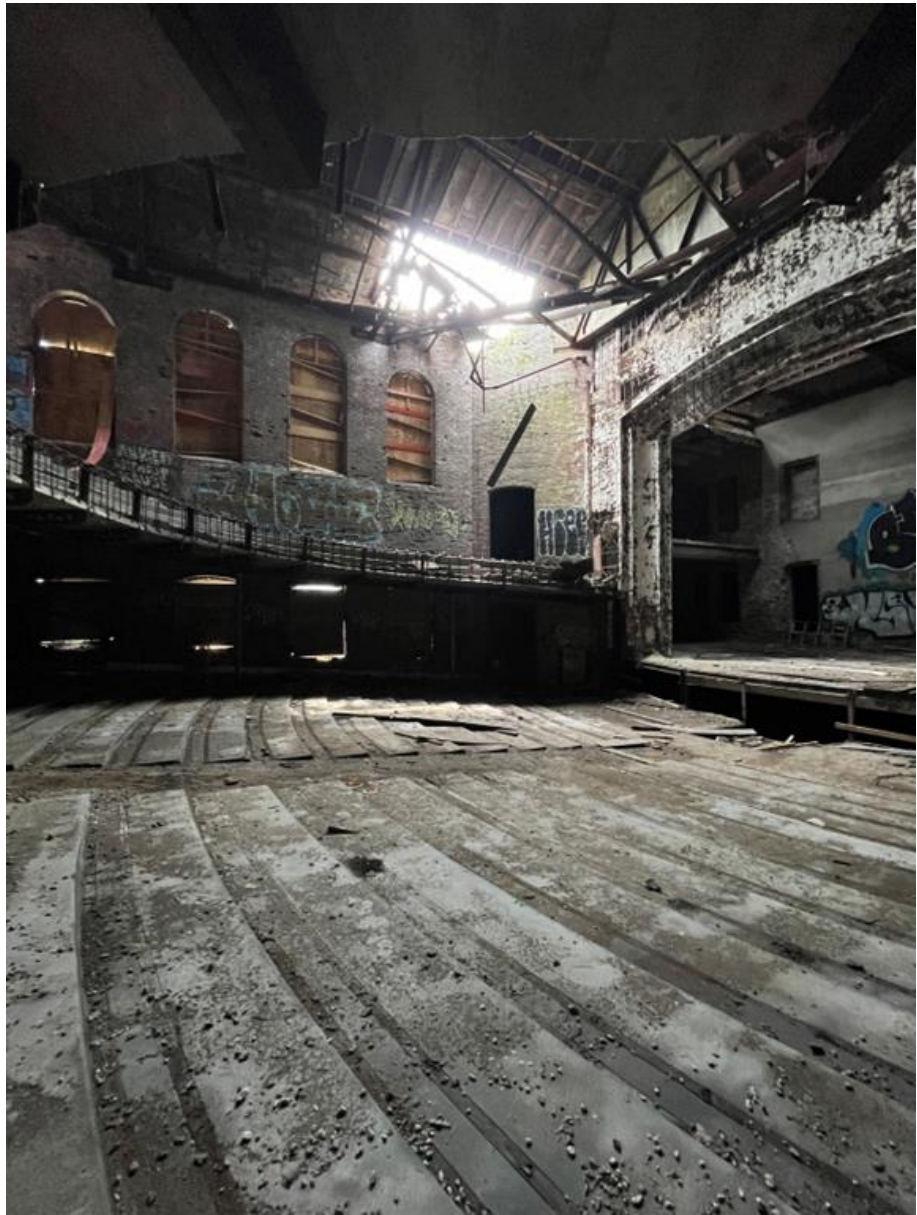
Ceiling and upper-wall collapse by stands

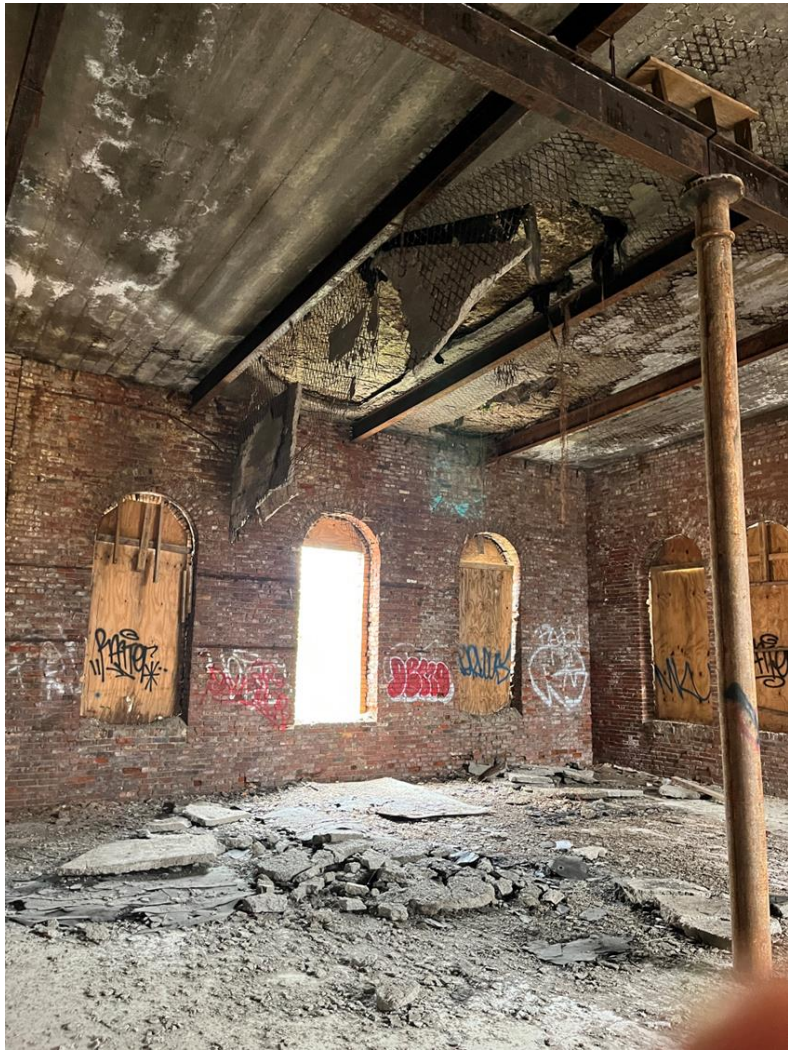
Newly failing ceiling section

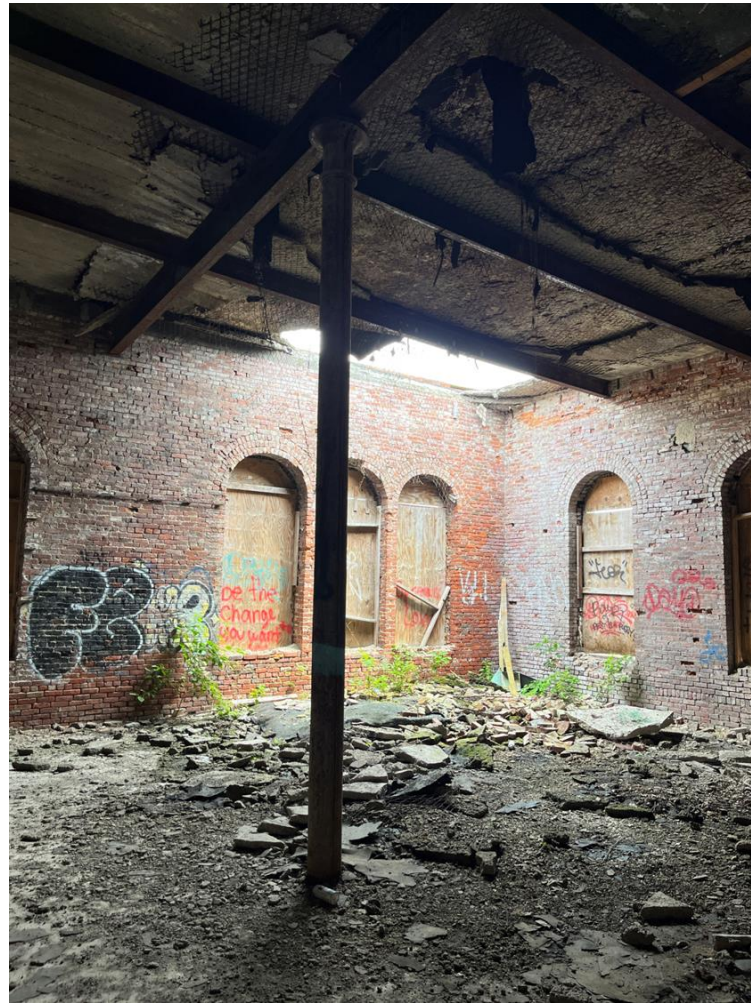
Area of Collapse by Sidewalk

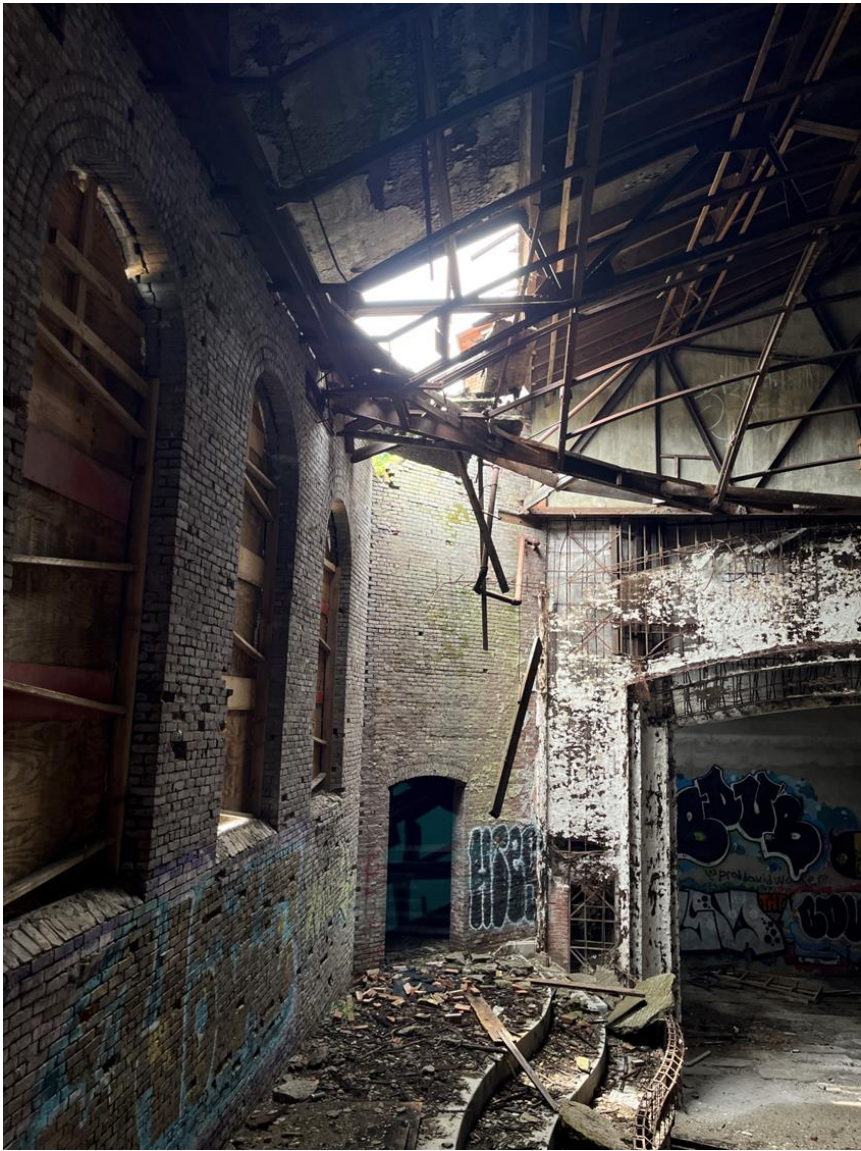
Collapse by Stands

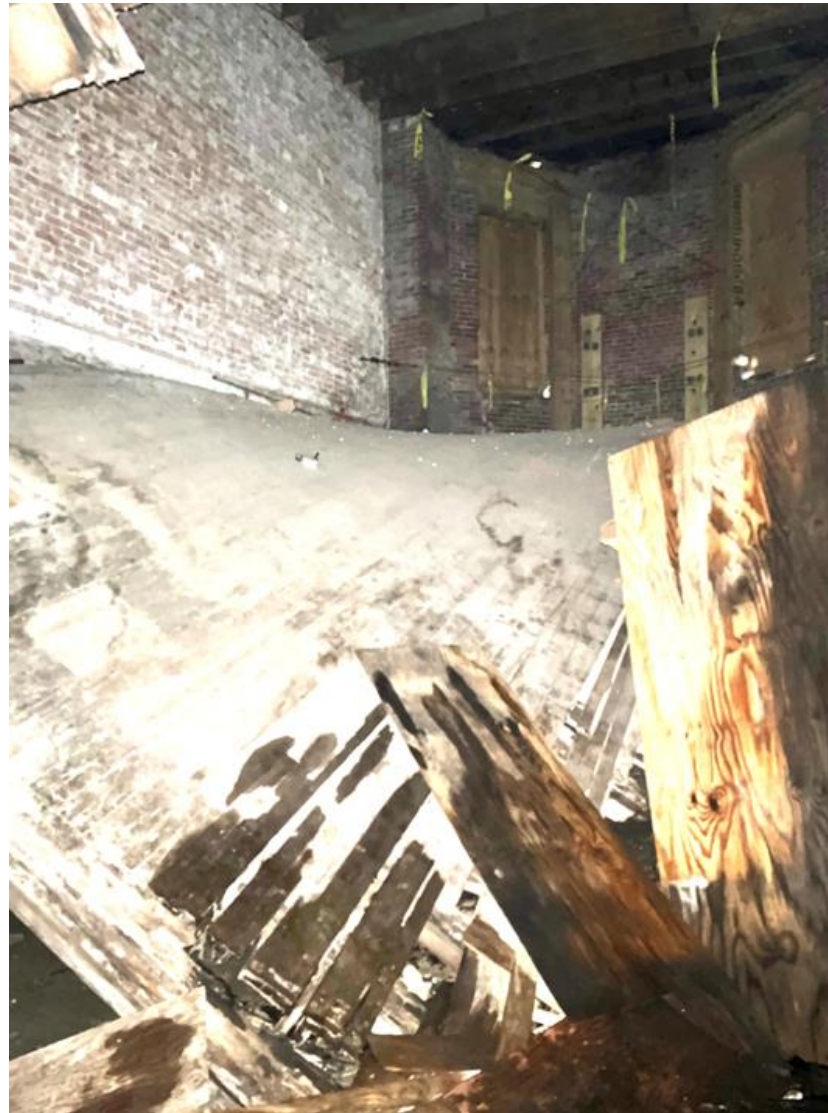
Areas of Collapse in Convent
