# 16-18 & 22 GARDNER ST.

# REASONS FOR DEMOLITION

# Structural Investigation Report

16-18 Gardner St, Boston, MA 02119

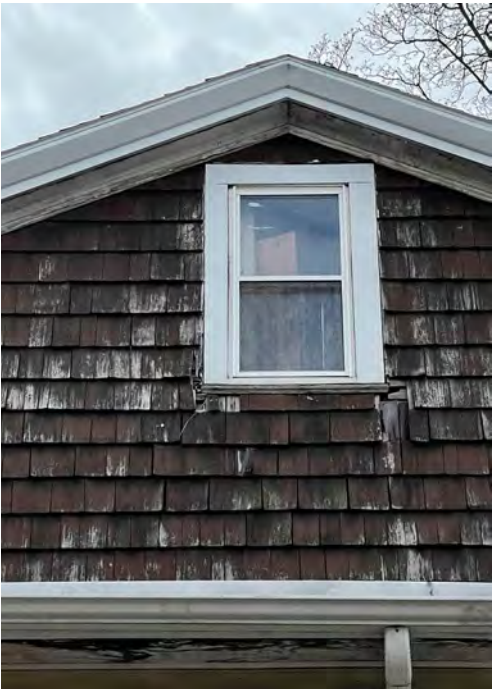
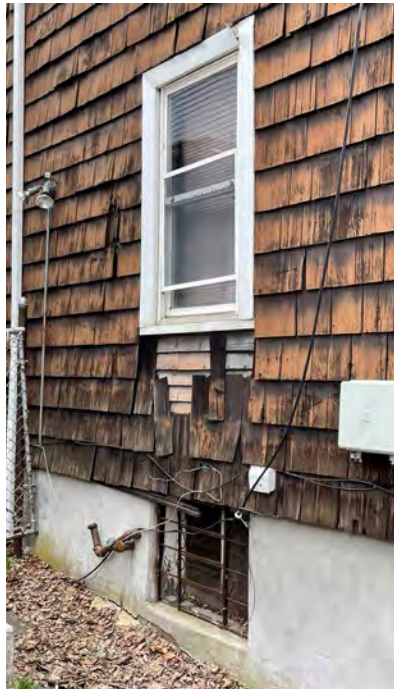
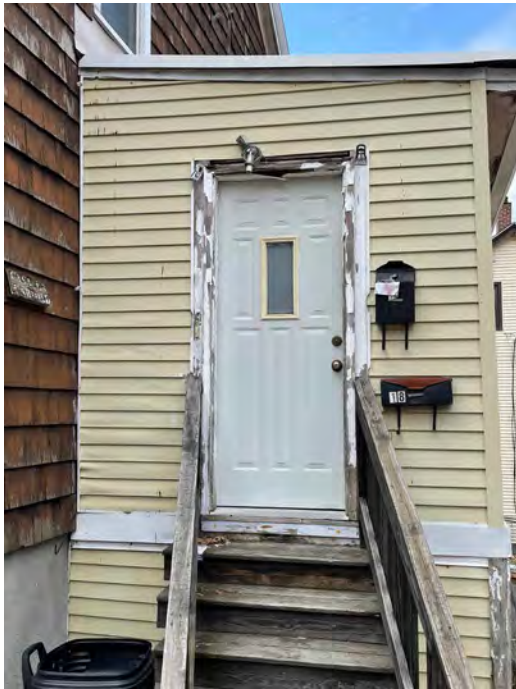
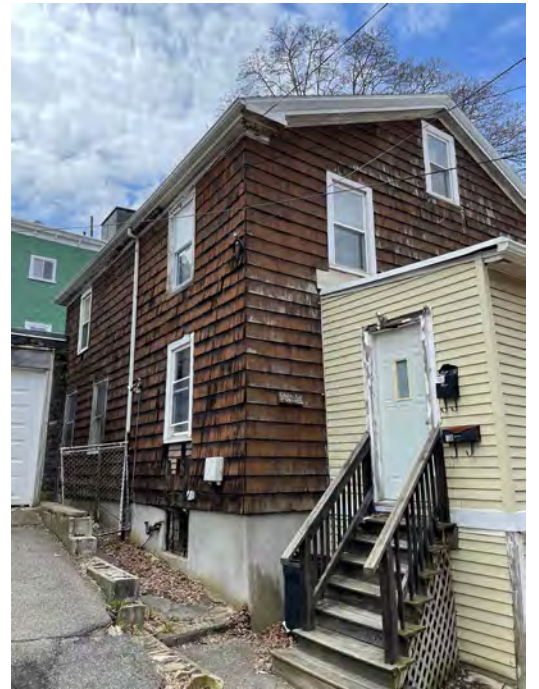
## Exterior

The building's exterior conditions exhibit failing materials. The wood deck, soffits, and trims are damaged, and the masonry shows signs of water leakage.

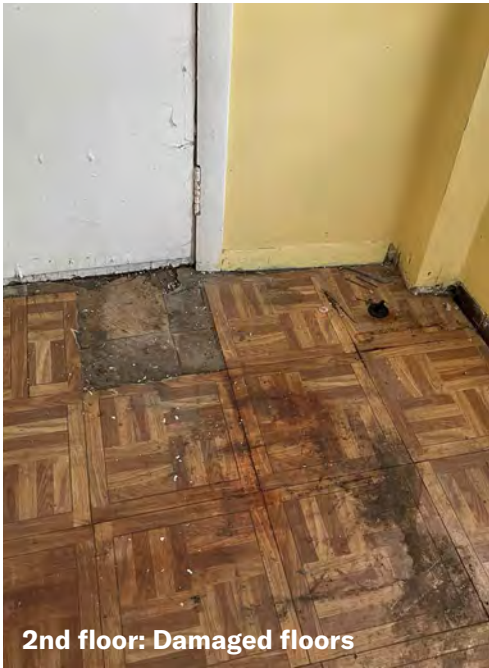
2nd floor: Damaged floors

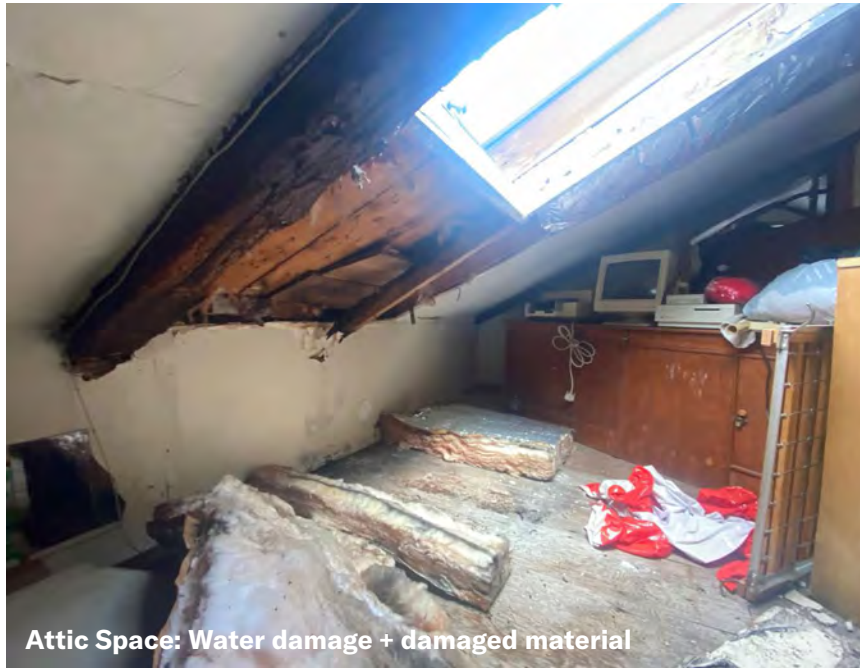
Attic Space: Water damage + damaged material

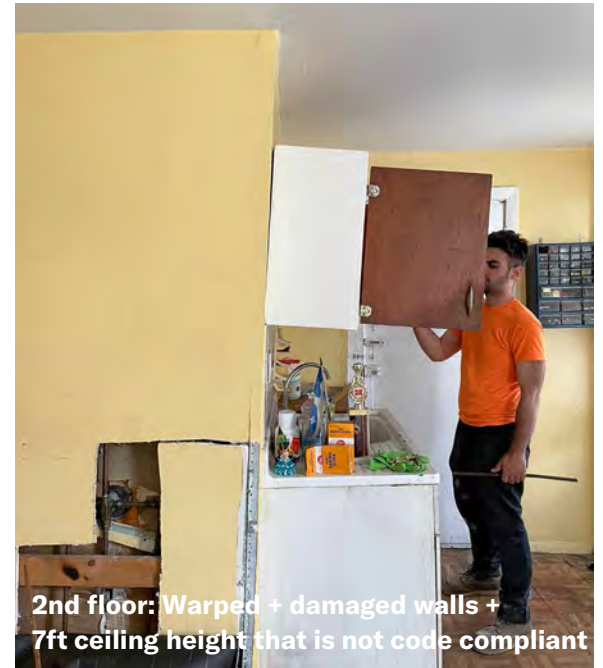
2nd floor: Warped + damaged walls + 7ft ceiling height that is not code compliant

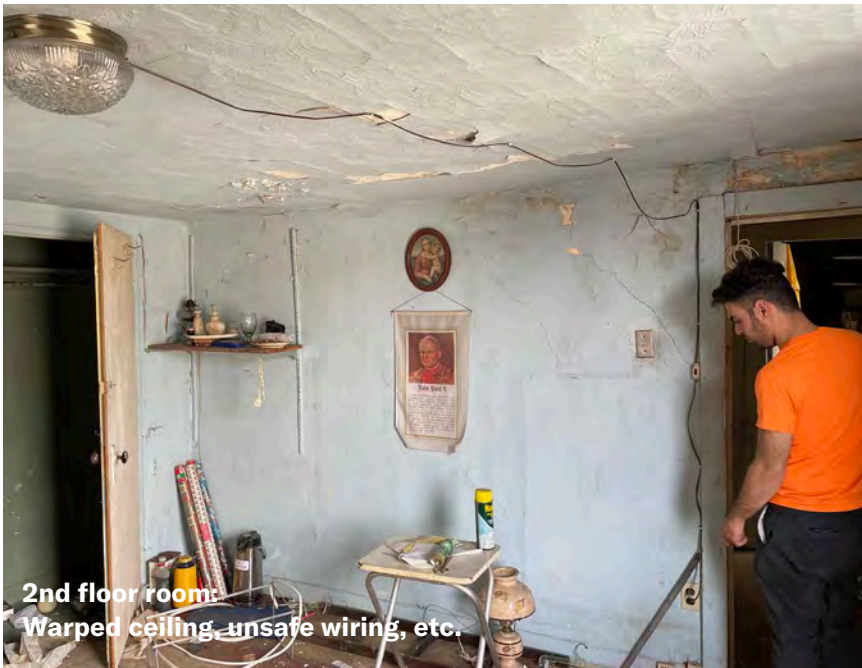
2nd floor room:  
Warped ceiling, unsafe wiring, etc.

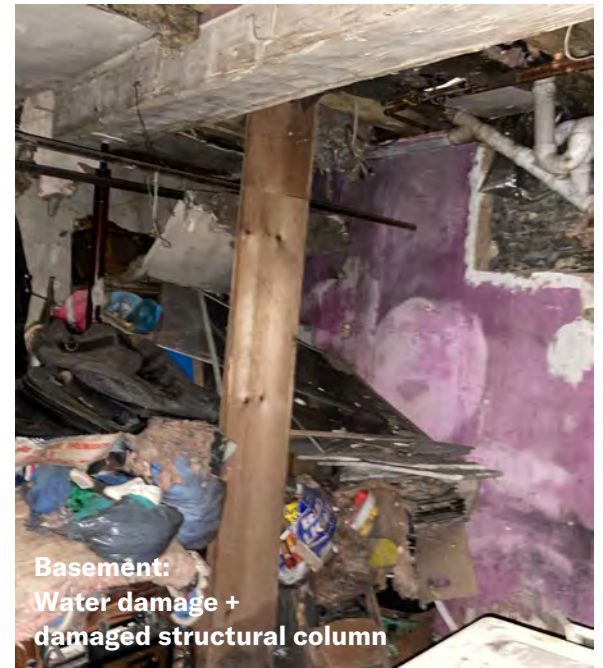
Basement:  
Water damage +  
damaged structural column

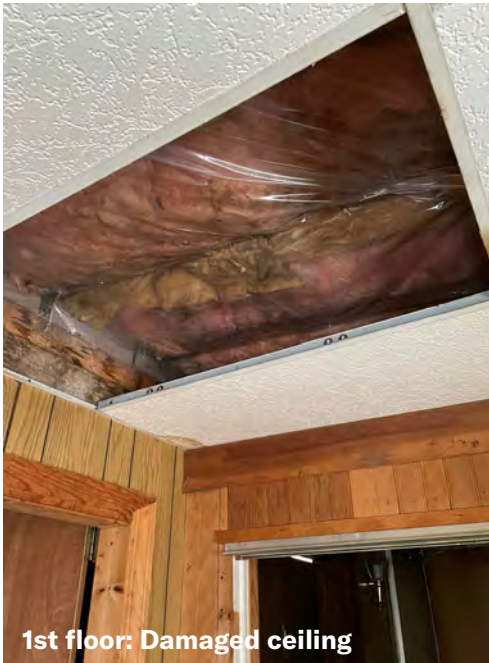
**1st floor: Damaged ceiling**

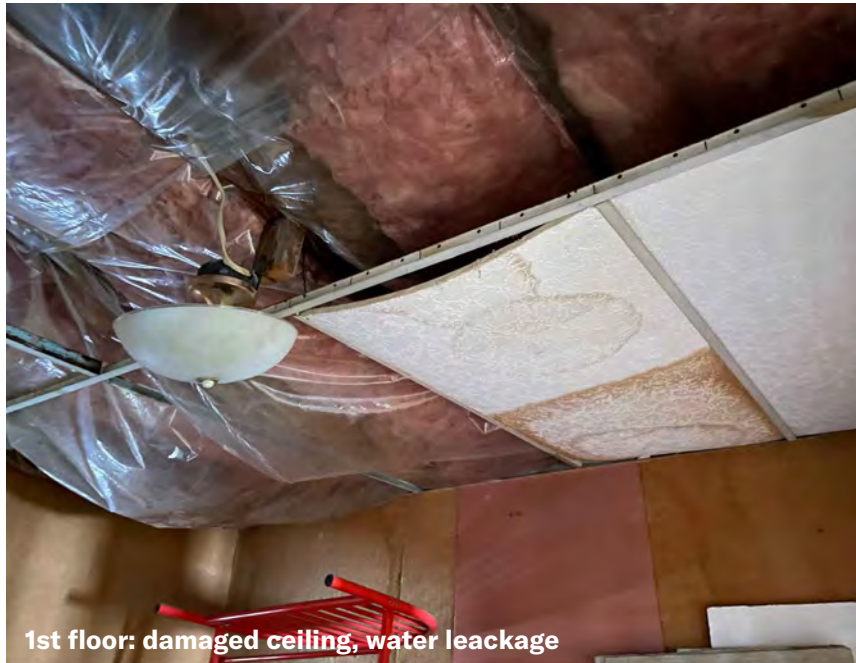
**1st floor: damaged ceiling, water leakage**

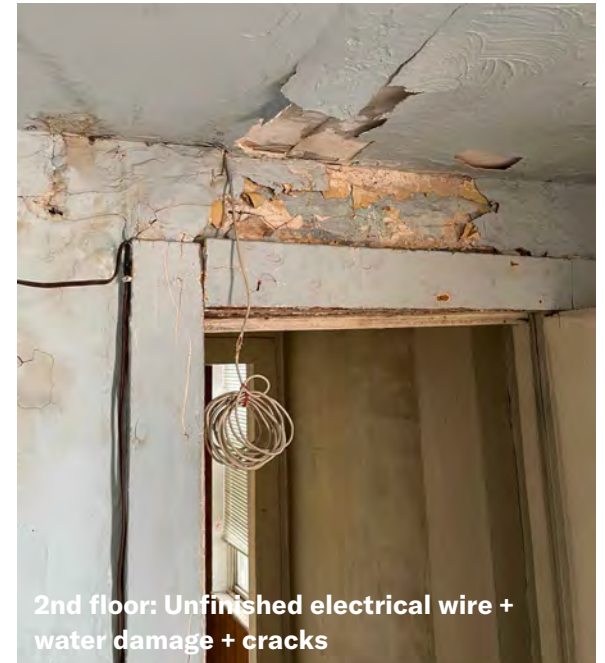
**2nd floor: Unfinished electrical wire + water damage + cracks**

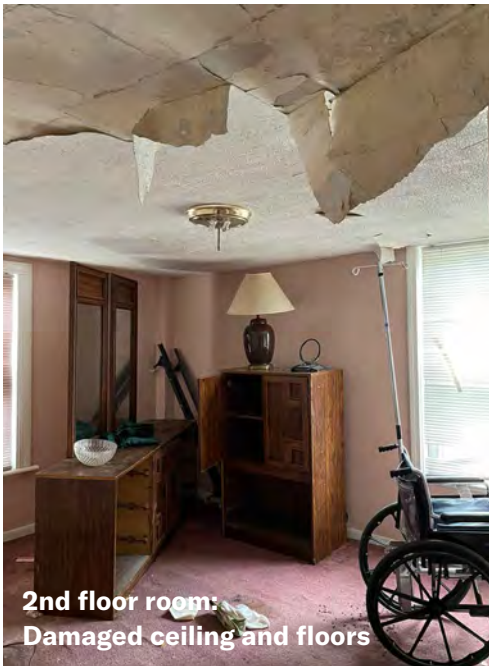
**2nd floor room:  
Damaged ceiling and floors**

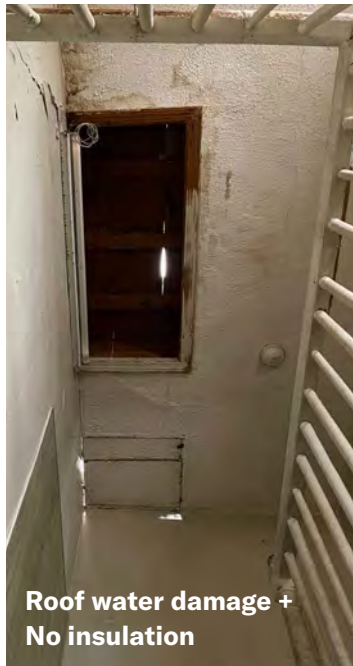
**Roof water damage +  
No insulation**

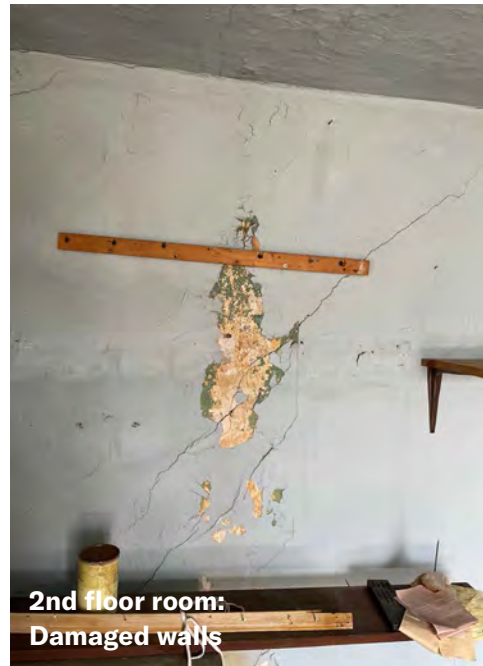
**2nd floor room:  
Damaged walls**

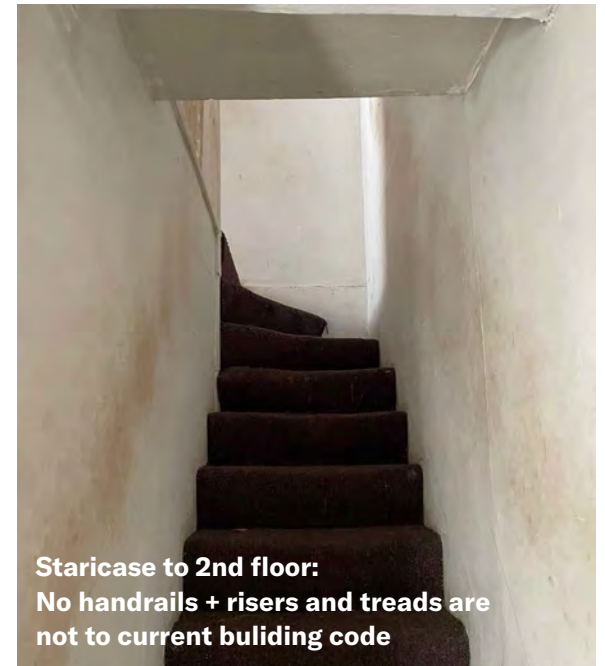
**Staircase to 2nd floor:  
No handrails + risers and treads are  
not to current building code**

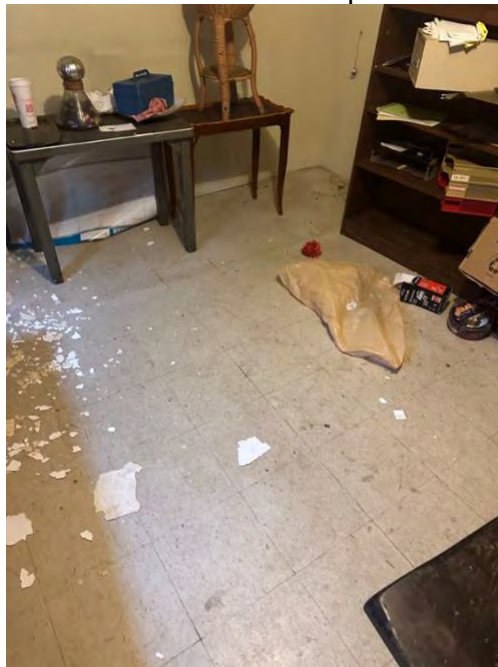
1. There is a significant slope (4-6 inches over the 10') on the first-floor living room. The ceiling height is 7' and the has a noticeable slope toward the center of the house.

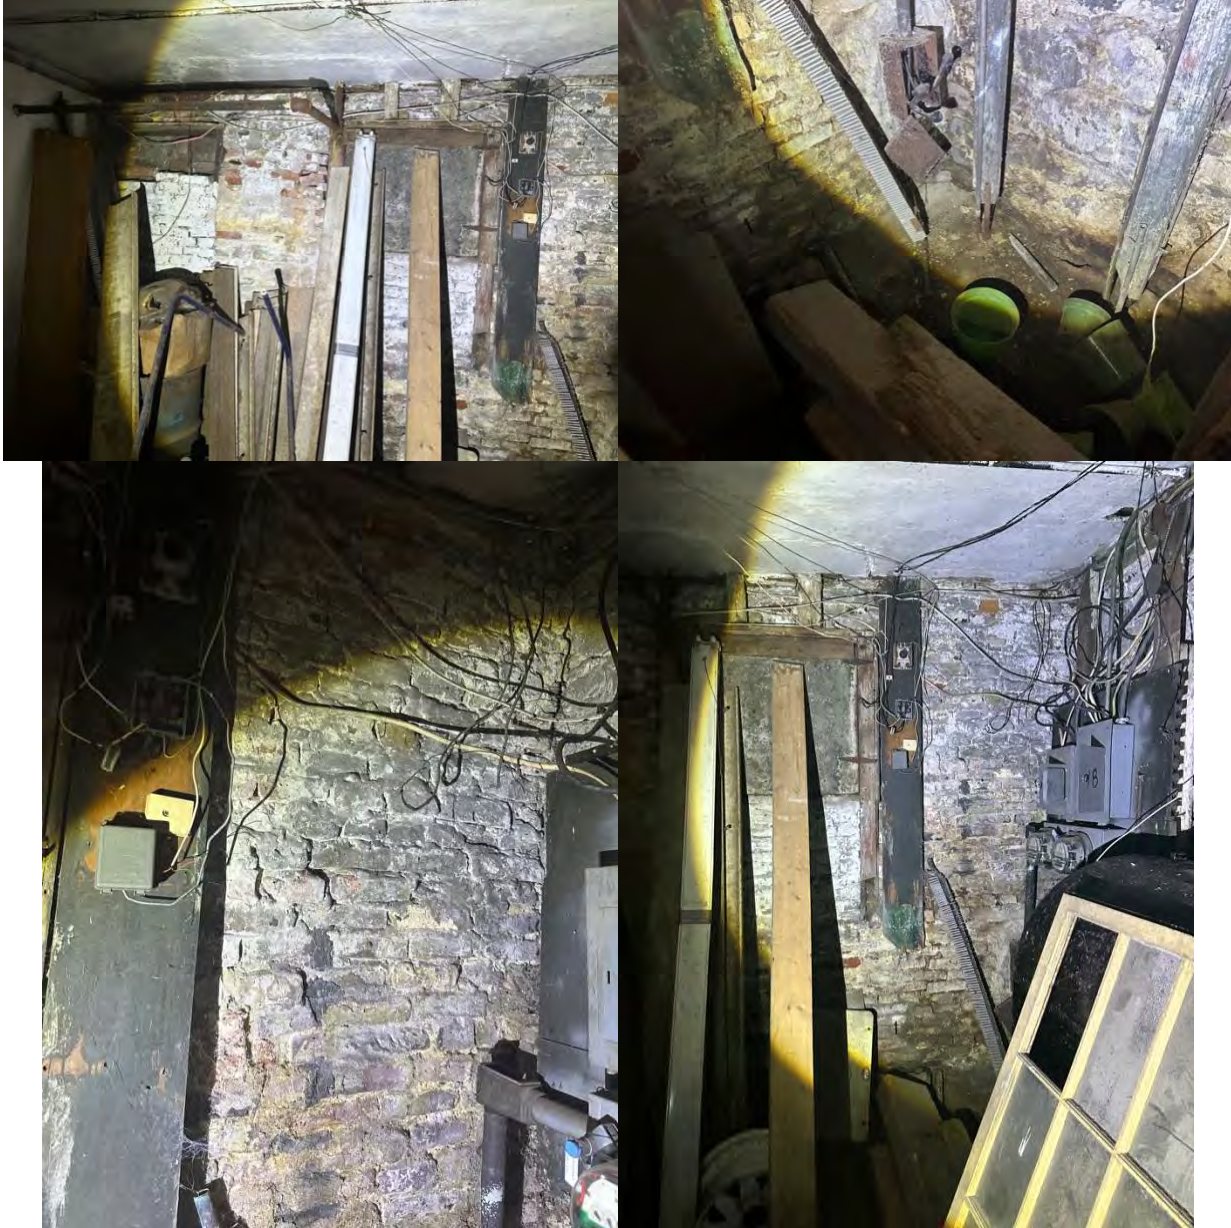
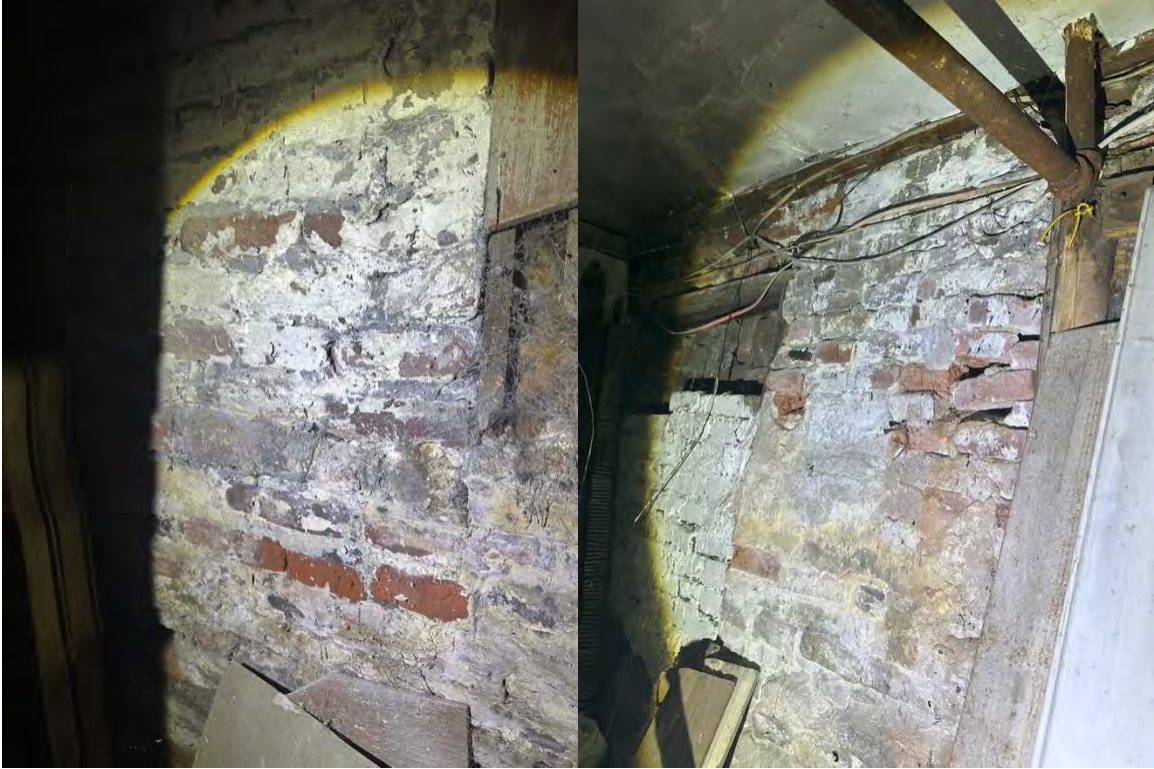
2. The stairs from the unit to the basement are not up-to-code with approximately 5' clearance and are not safe.
3. The brick foundation wall on the right side of the building is crumbling and has structural bulged, cracked, and needs to be replaced.

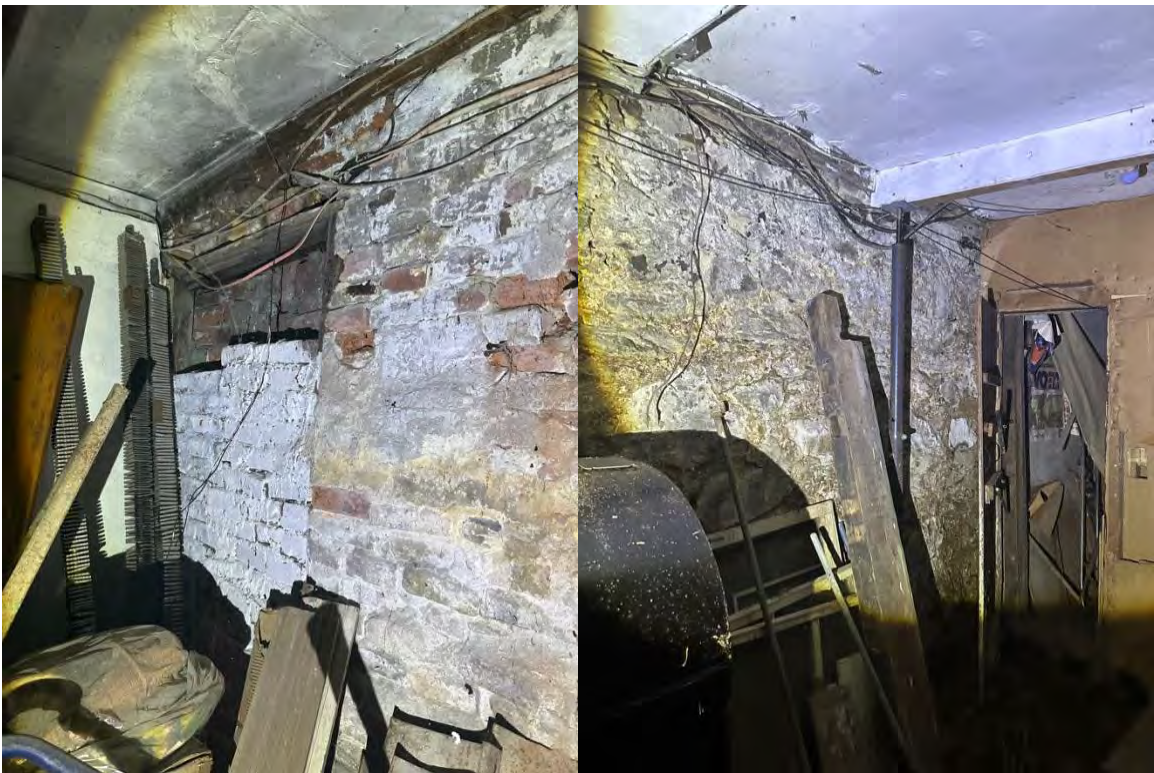
4. Extensive and long-term water and humidity exposure in the basement has caused brick foundation walls to dissolve and deteriorate. Replacement is recommended.

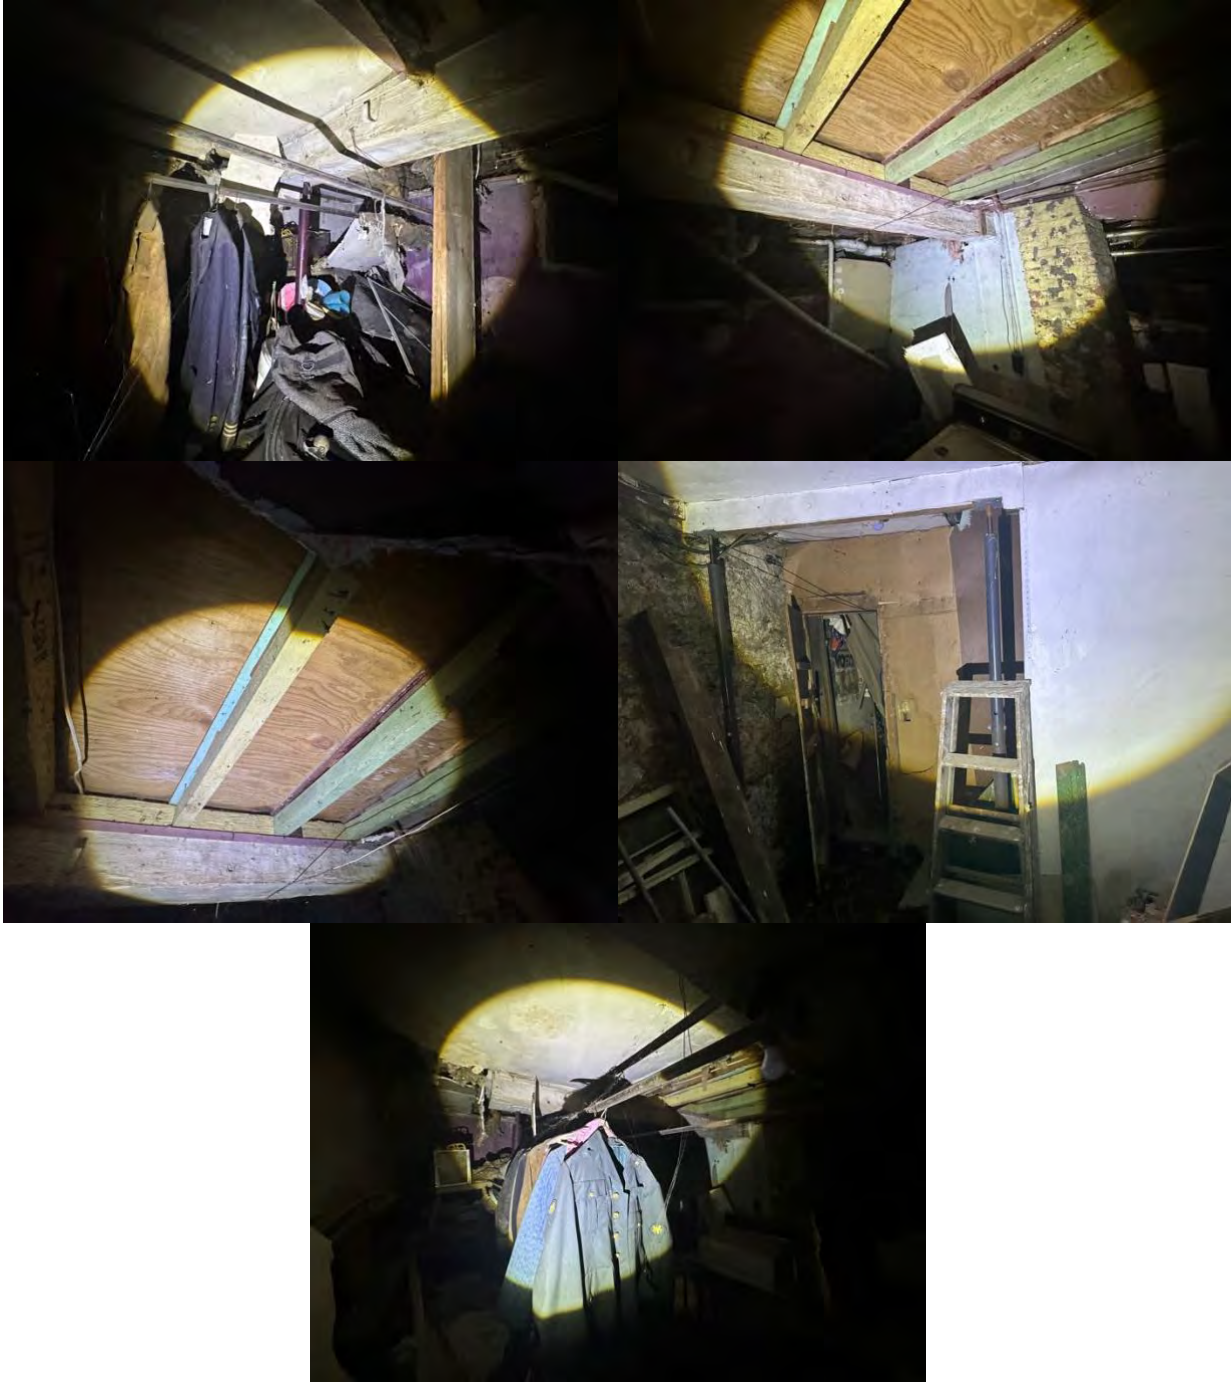
5. The main beam in the basement supporting the first-floor framing system is not properly supported and is not structurally sound. This beam is significantly slanted, cracked, and sits on a temporary screw jack. Screw jacks do not have any footing and are not permanent support. The beam end is cut at one side and floats. This beam needs to be replaced with an engineered beam to be installed on lally columns (on designed footings). The floor joists are 3x4 @ 2' spacing, are undersized for the span, and need to be reinforced.

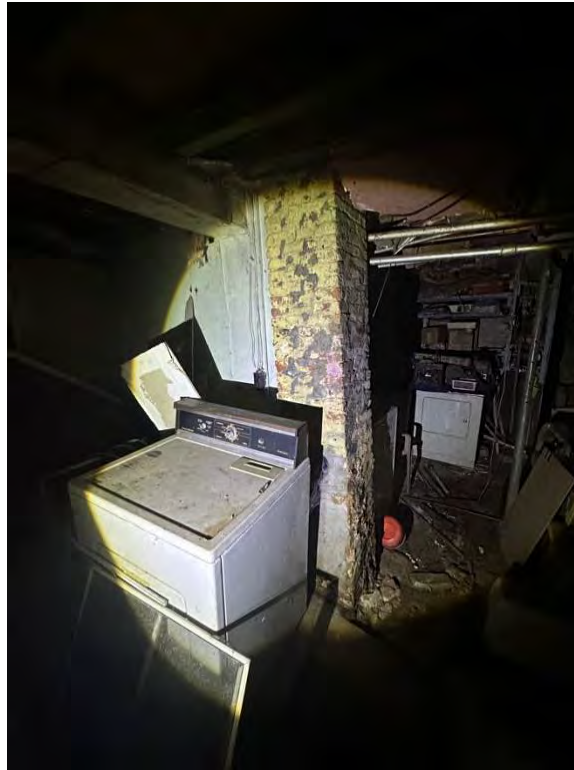
6. The chimney is significantly tilted (approximately 3" over 7 ft) and is compromised. This chimney needs to be rebuilt and is not salvageable/repairable.

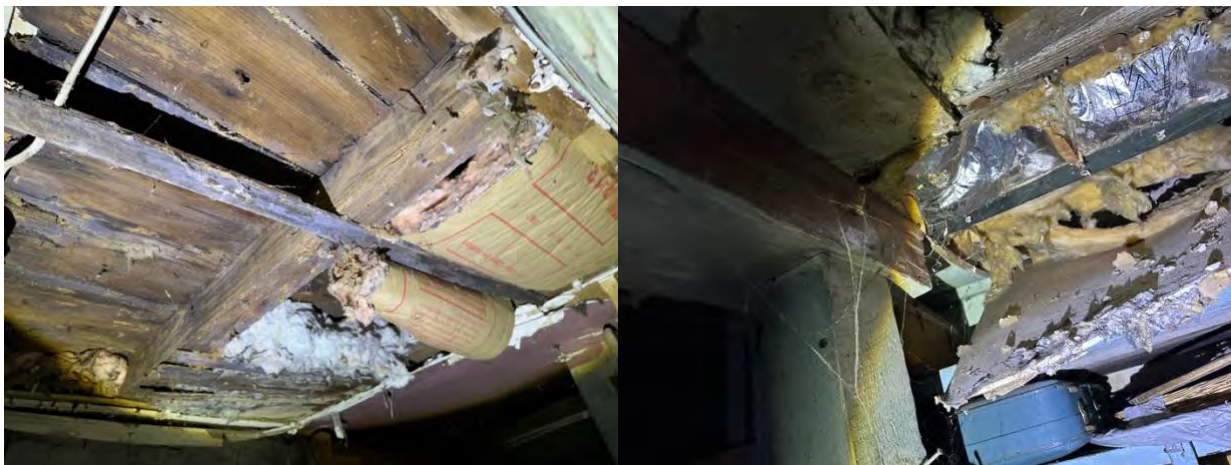
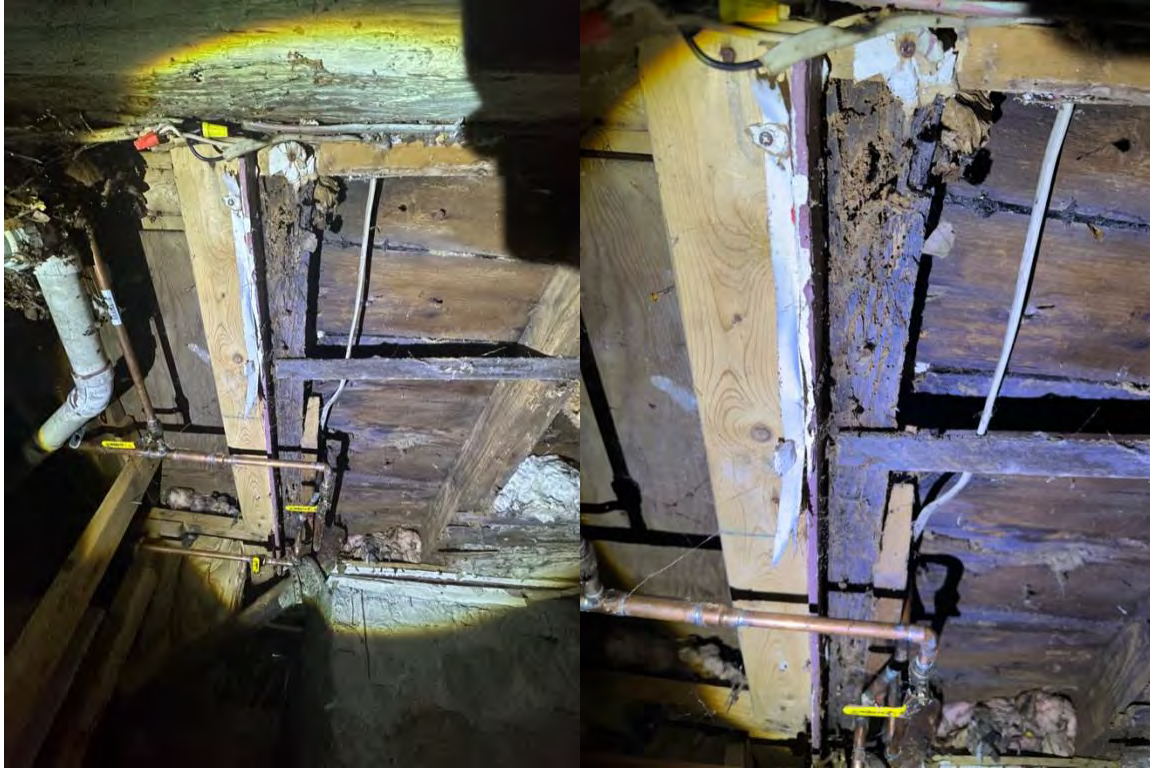
7. There are signs of severe boring insect damage on the floor framing on the southwest corner of the house. It is recommended to engage a qualified pest control contractor to inspect and treat as needed. The compromised members need to be completely replaced with designed members.

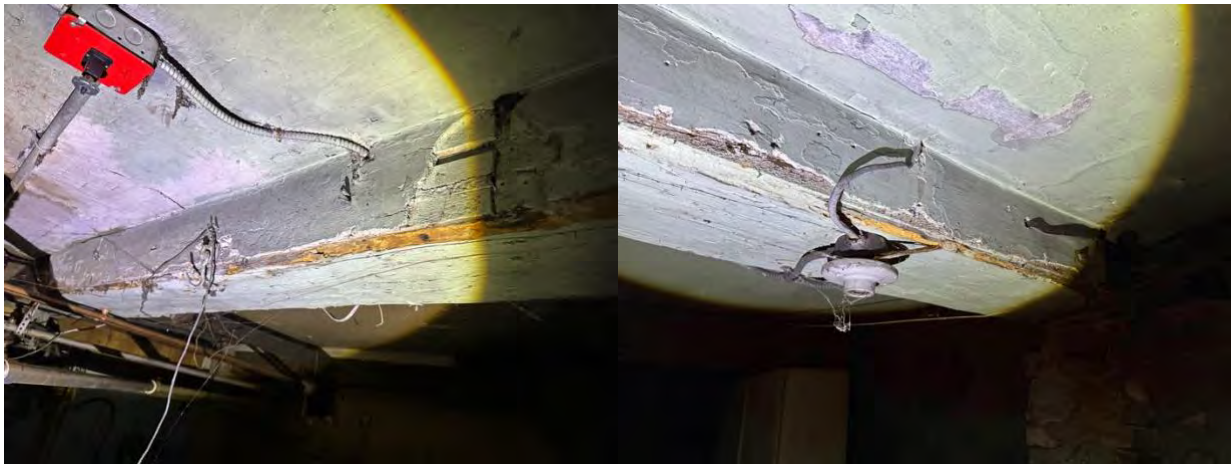
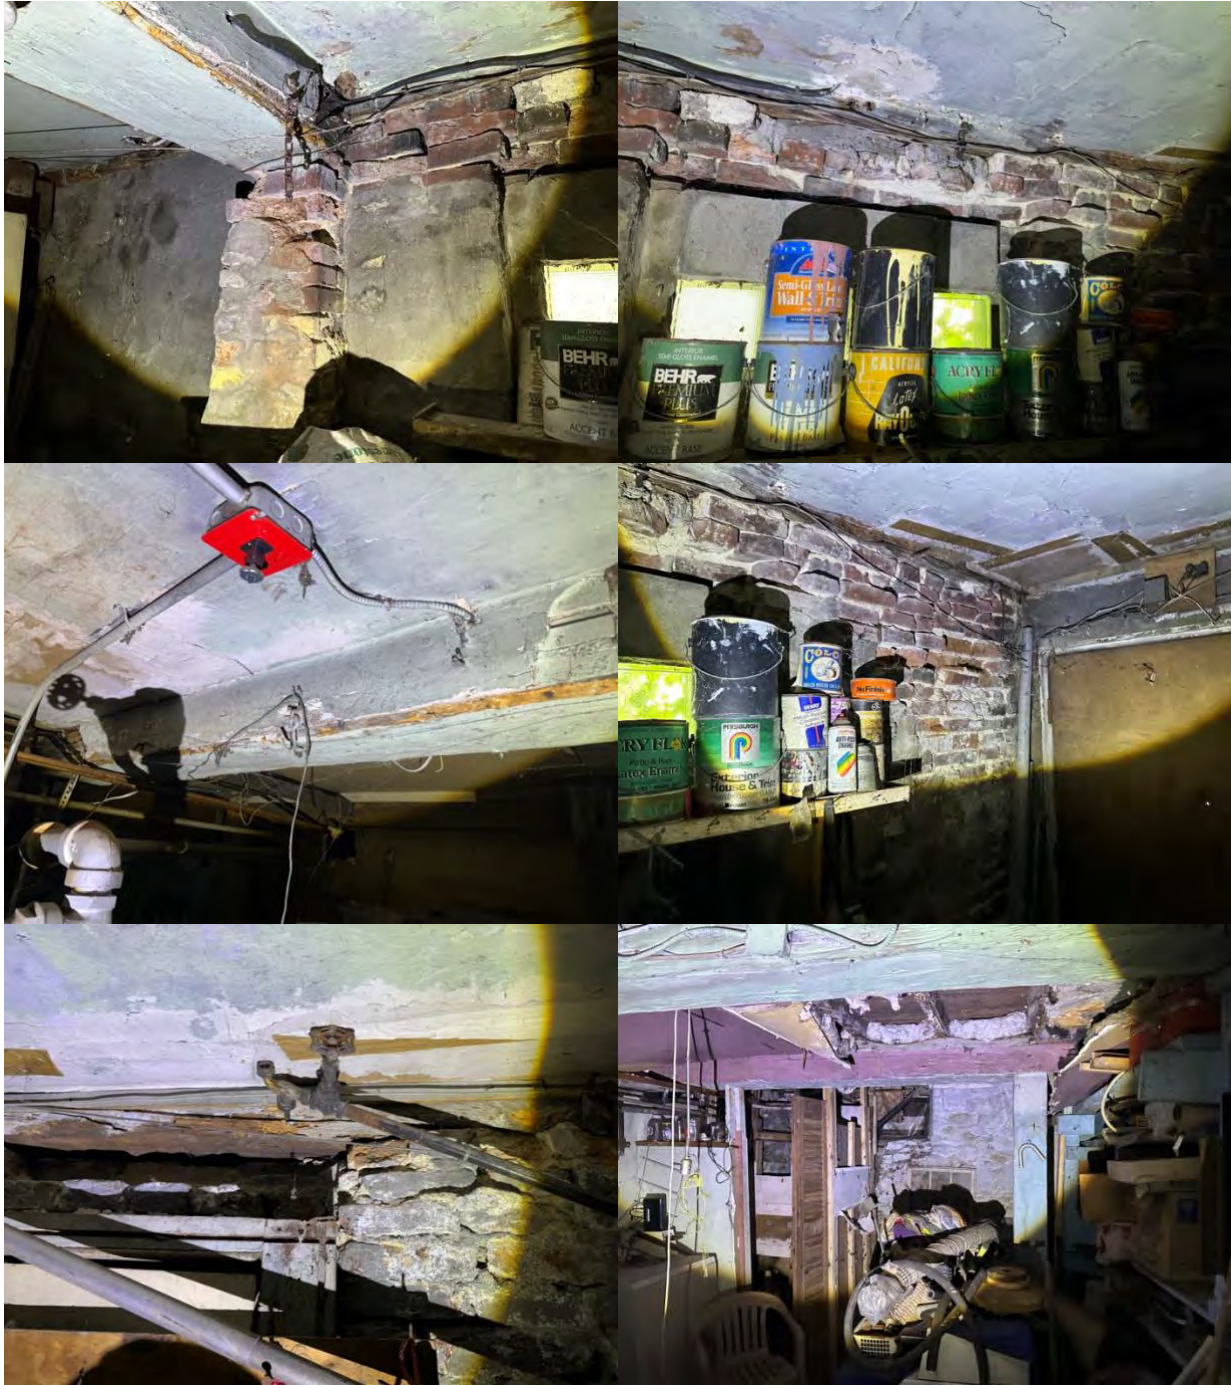
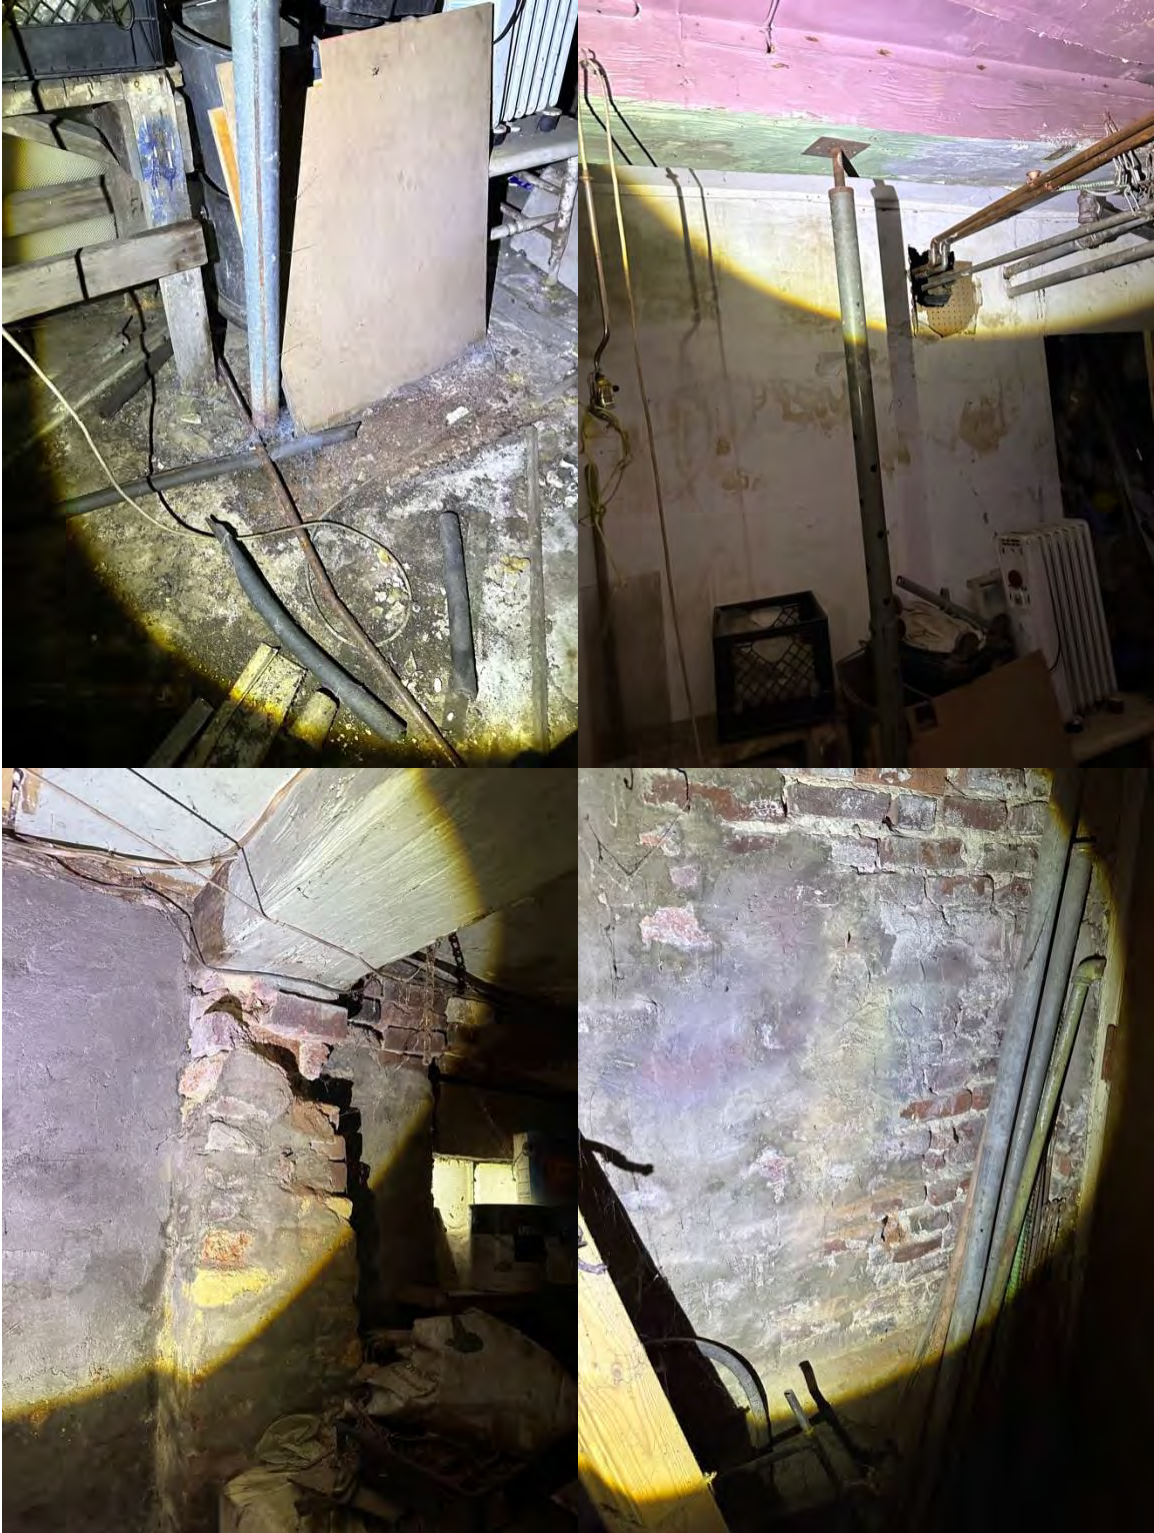
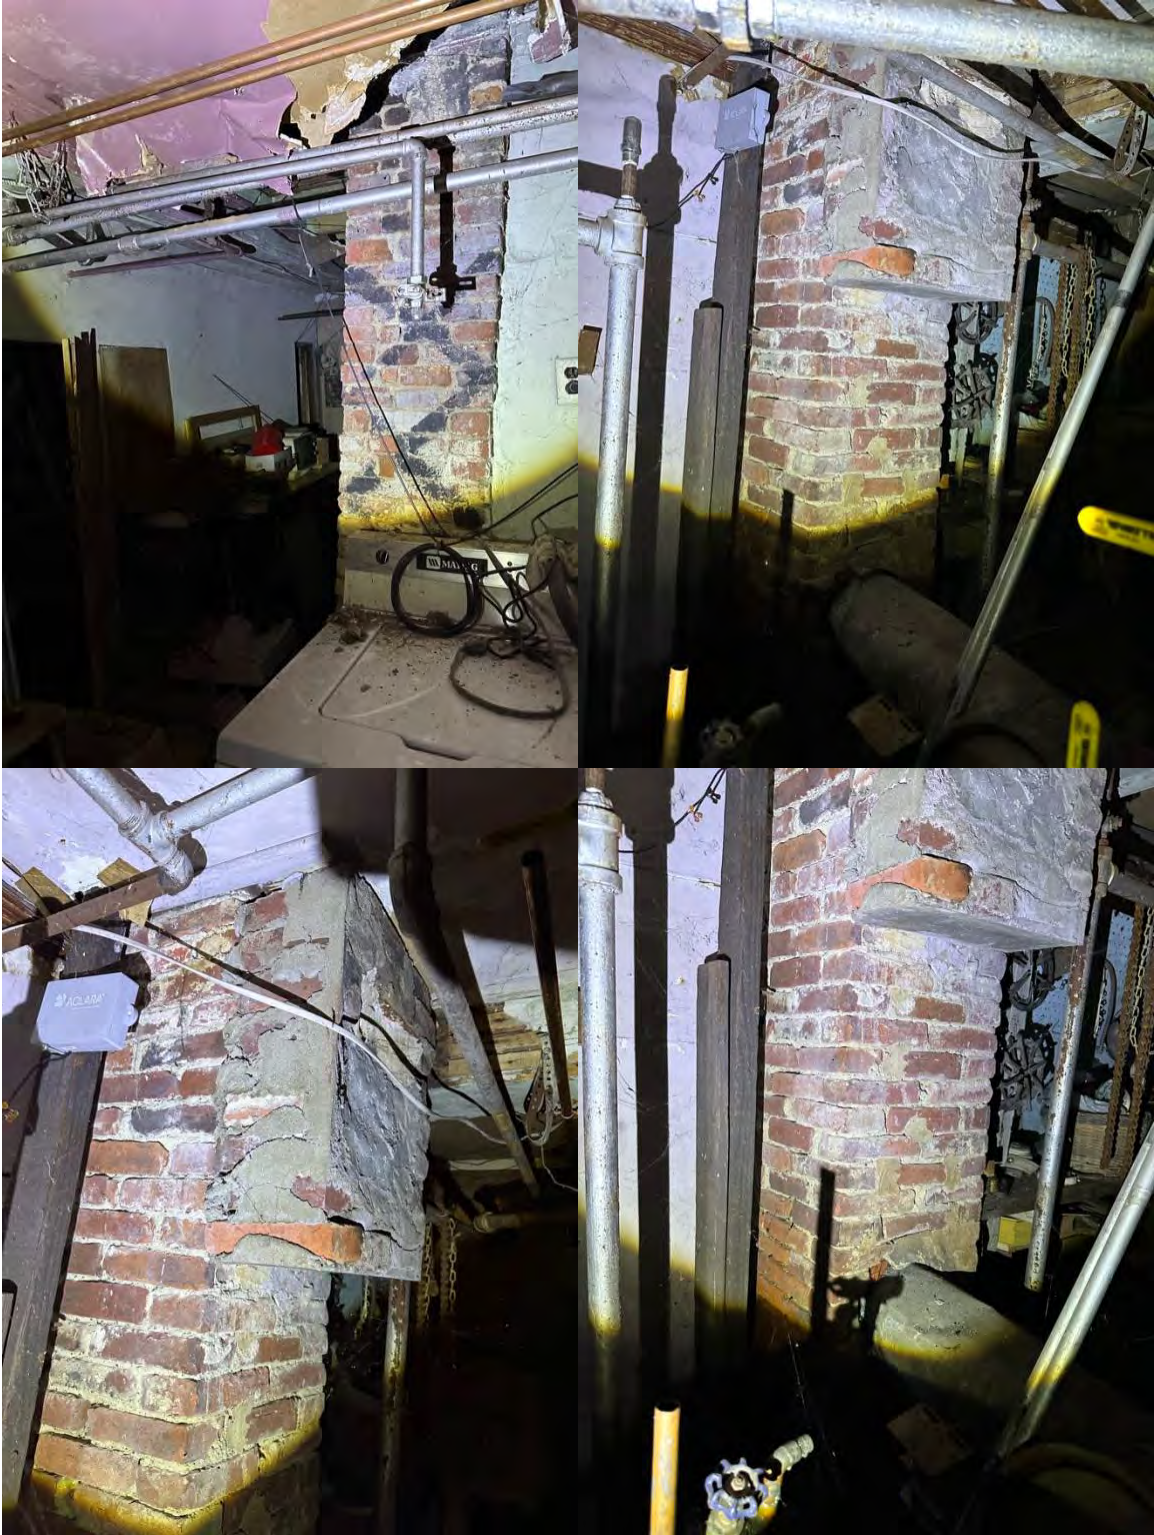
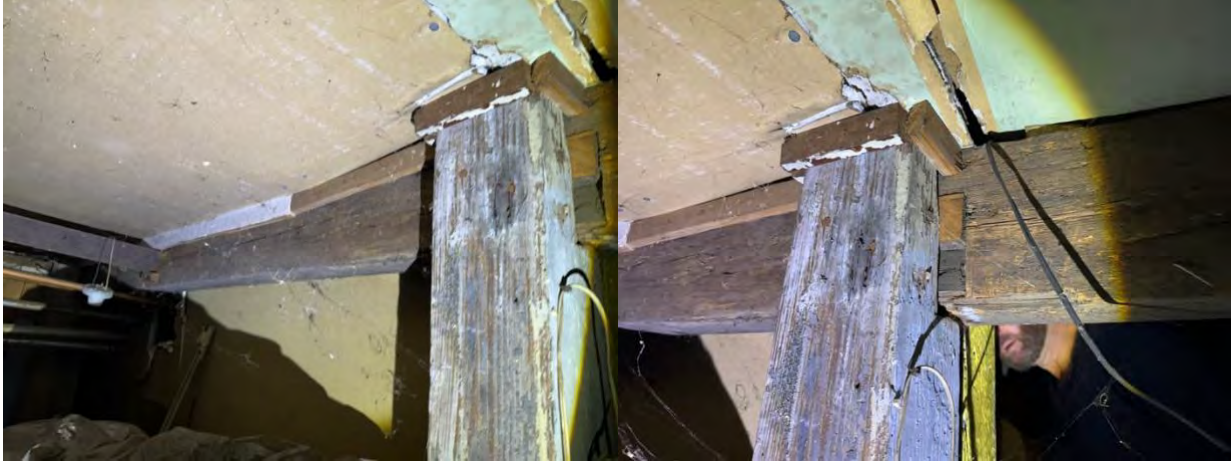
8. The two main beams supporting the other side of the house (northwest side – furnace room) are not structurally supported. One of the beams is supported by a compromised brick support at the end. This beam and the perimeter sill beam have signs of boring insect damage and need to be replaced. The existing floor framing is not safe to walk and needs temporary shoring before complete construction.

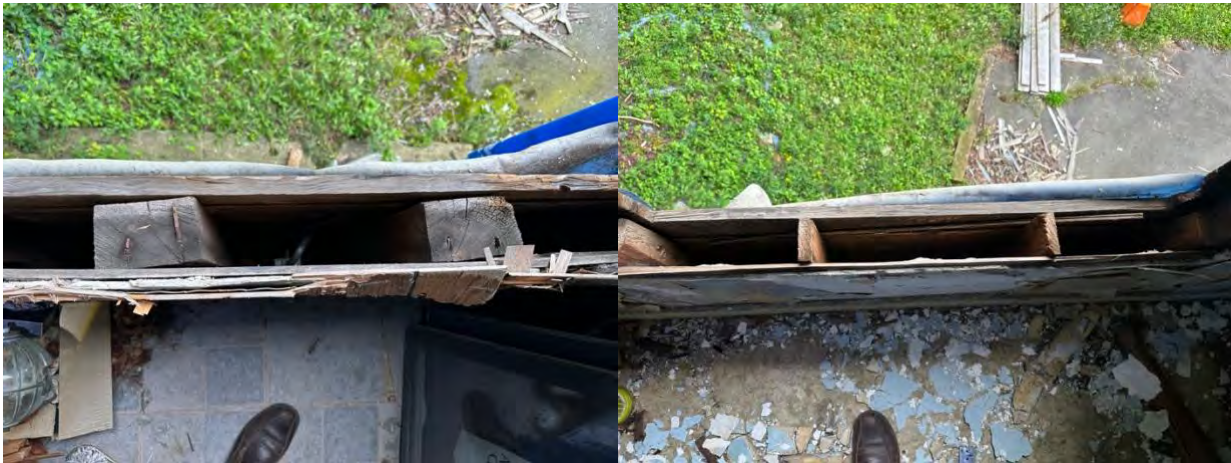
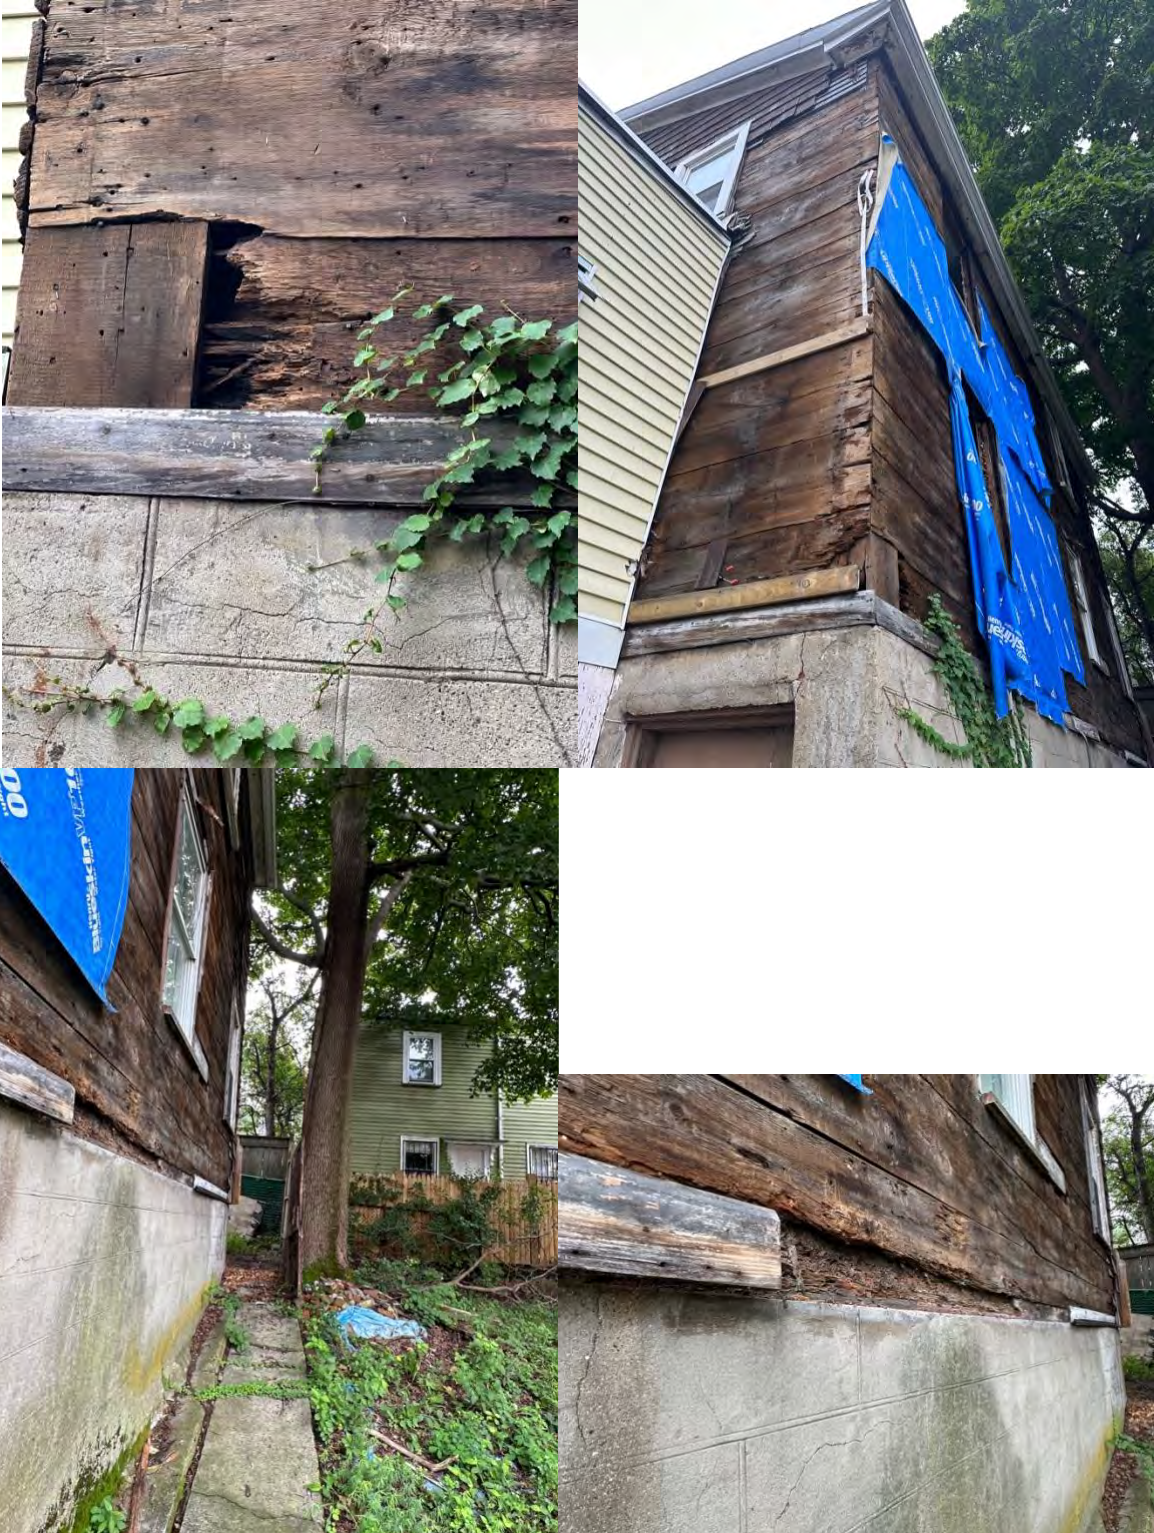
9. The Exterior wall framing exposed on the first and 2<sup>nd</sup> floor (right side looking from the front) shows a 3x4 stud on the flat. This exterior wall framing appears to be insufficient for insulation. The exterior wall studs on the 2<sup>nd</sup> floor are smaller (1" thick) and need to be reframed completely for lateral load-bearing strength. The exterior siding has signs of significant boring insects and needs to be completely redone.
