# 16-18 & 22 GARDNER ST.

# REASONS FOR DEMOLITION

# Structural Investigation Report

16-18 Gardner St, Boston, MA 02119

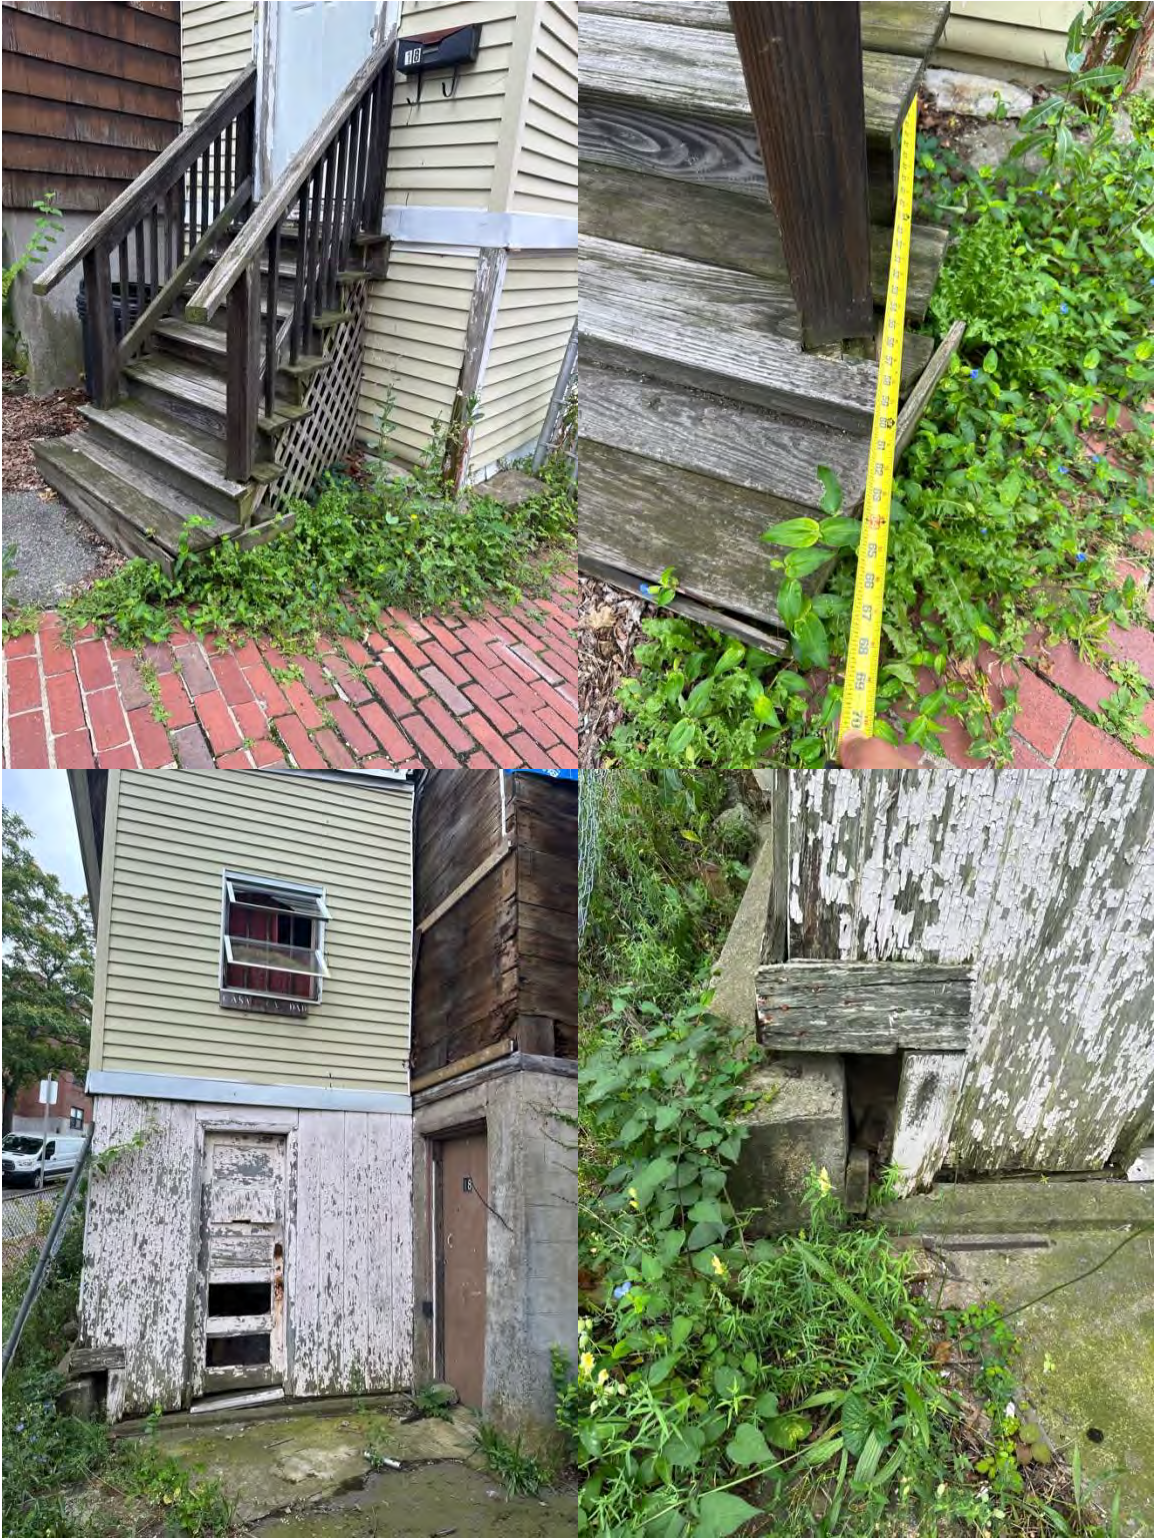
10. The attic was not safely accessible for inspection at the time of the visit.
11. The front addition appears to have not been built in a designed footing and the stairs are not up to code.
