139 W Canton Street, Boston, Massachusetts
02118

SELDC - Window Repair & Replacement

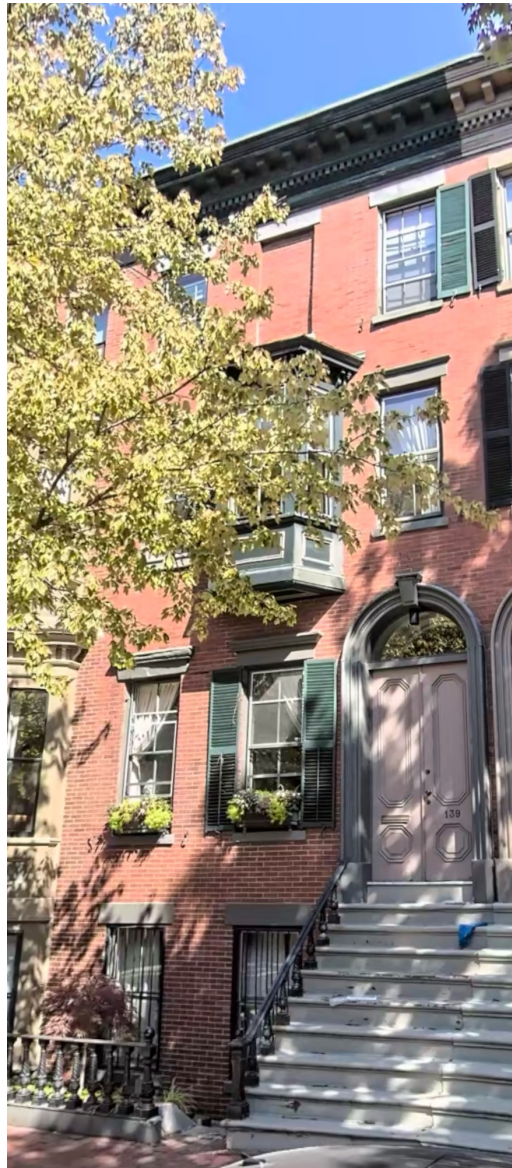
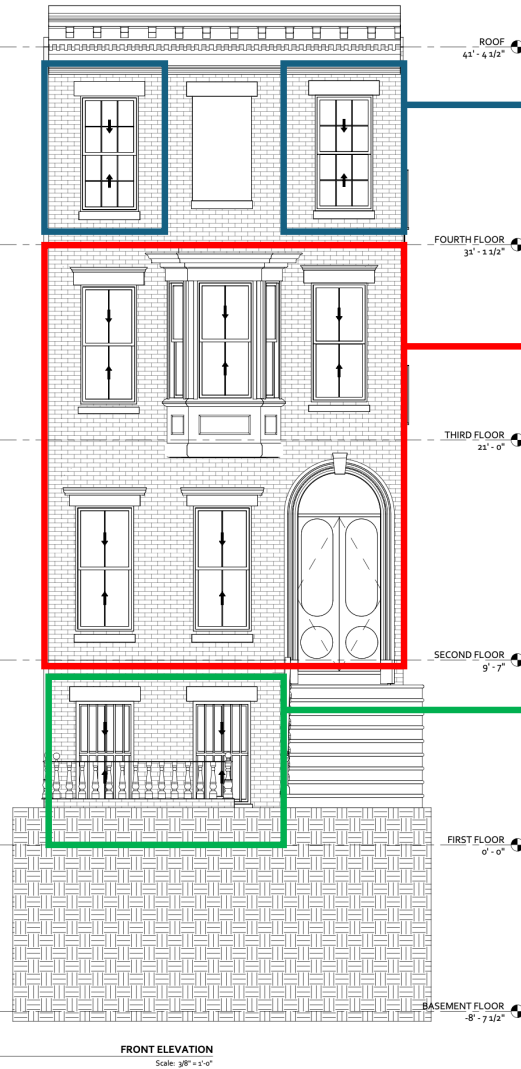
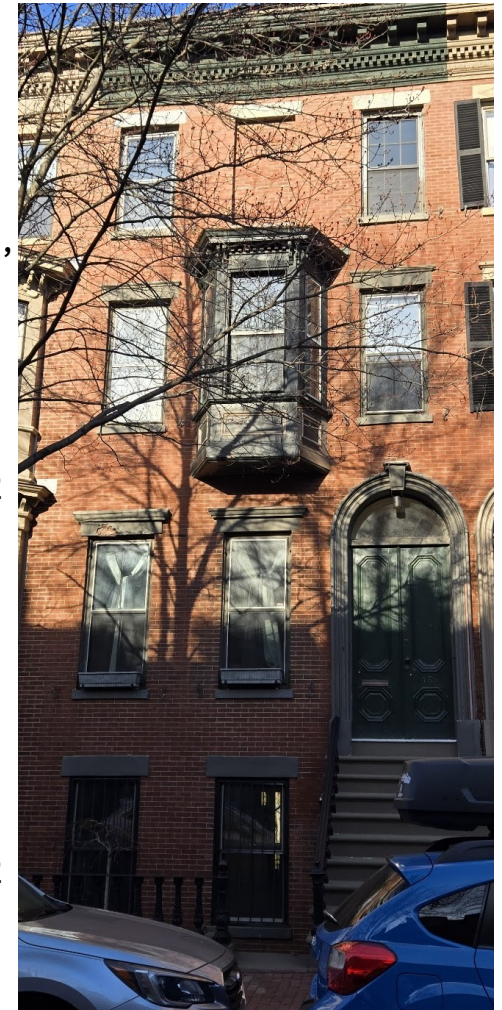
Replaced non-original
6 over windows in kind,
simulated divided lite.

Preserved and
replaced with in kind 2
over 2, , simulated
divided lite.

Non-restorable,
replaced in kind with 2
over 2, , simulated
divided lite.

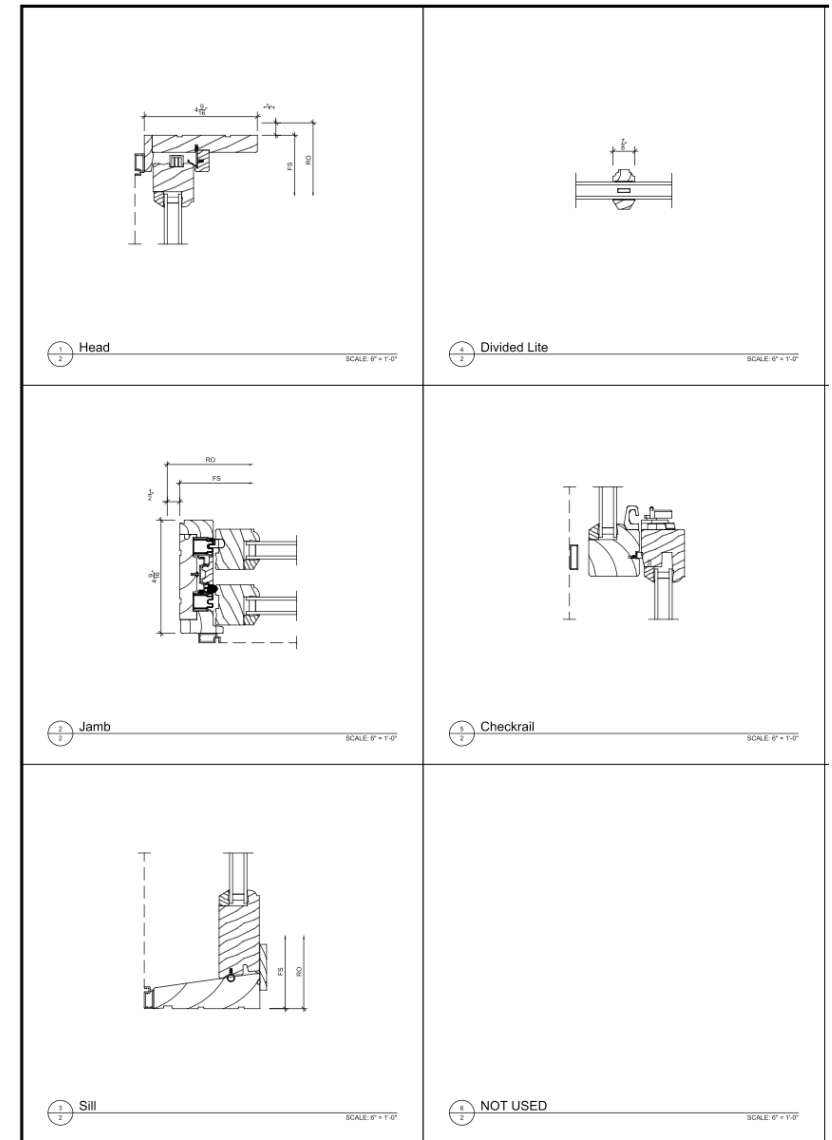
B

We were asked by Pedro Ojeda of 139 West Canton Street LLC to conduct an assessment of windows at 139 West Canton Street in the South End neighborhood of Boston. After conducting our assessment, it is our professional opinion that windows on the parlor level and level above can be restored. Windows on the garden level should not be restored. The window sashes and window frames need more than 50% in new material and would therefore not make it financially viable. It is in our professional opinion that these windows are rebuilt completely with “like in kind” new windows.

Additionally, the windows on the 4th floor should be replaced with “like in kind” new windows due to their inaccuracies. The two windows on either side are a different mullion profile (6 over 6 installed in the 1960’s) than the original 2 over 2 style windows and the center windows was closed in with bricks therefore there is nothing there to restore.
