204 BEACON STREET BOSTON, MA 02116

**EXISTING CONDITIONS PHOTOS**

APRIL 2, 2025 NOT TO SCALE

RE: 204 Beacon Street – Letter of Incompliance

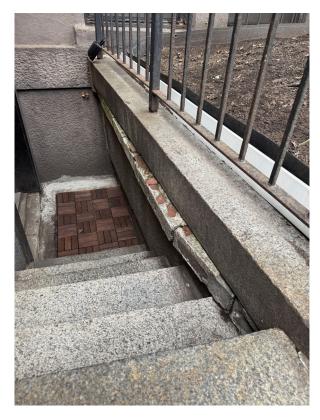
VIEW FROM SIDEWALK

TREE IN QUESTION HAS BECOME OVERGROWN - ROOT SYSTEM IS CAUSING THE RETAINING WALL AT THE GARDEN LEVEL UNIT'S ENTRY STEPS TO COLLAPSE. THIS POSES AN INCREASING LIFE SAFETY ISSUE AND REPRESENTS CONTINUED DAMAGE TO THE BUILDING'S FOUNDATION IF NOT ADDRESSED.

RETAINING WALL COLLAPSE CAUSED BY

OVERGROWN TREE ROOT SYSTEM

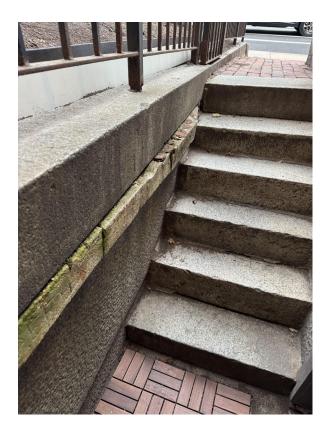
VIEW FROM BELOW (GARDEN LEVEL ENTRY)
RETAINING WALL COLLAPSE CAUSED BY
OVERGROWN TREE ROOT SYSTEM

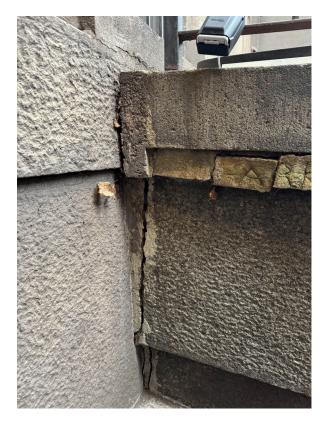
VIEW FROM BELOW (GARDEN LEVEL ENTRY)
RETAINING WALL COLLAPSE / BUILDING
FOUNDATION DAMAGE CAUSED BY
OVERGROWN TREE ROOT SYSTEM

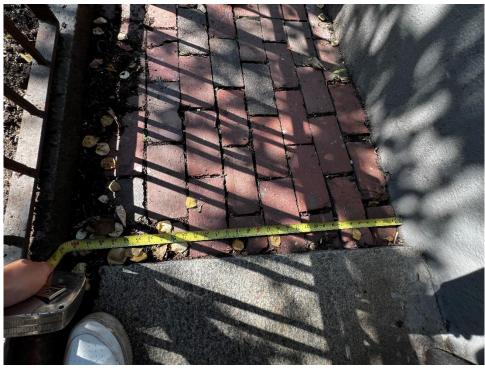
The current stairway path varies in width from 32" to 27" (see Image 1 and Image 2). In some cases, there is a 2" deviation between courses of granite blocks (see Image 3). This indicates that movement is apparent between the courses, likely due to degradation in the mortar between courses combined with excessive lateral forces from the retained soil. The lateral pressure of the saturated soil and the roots of the overgrown pear tree within the adjacent garden area have shifted segments of the wall to a degree where bowing is visible and causing an unsafe egress condition (see Image 4 and Image 5). Our team recommends removing the adjacent soil, along with replacing the tree, and installing a structural concrete retaining wall with steel reinforcement to withstand the lateral pressure. If the board or client prefers the styling of the granite blocks, then granite blocks or equivalent can be installed as a facade on the face of the wall closest to the stairway area. The current retaining wall also appears to be separating from the exterior wall system (see Image 6). The proposed retaining wall can be designed to appropriately fasten to the existing exterior wall system.

Image 1: Segment with a 32" Width

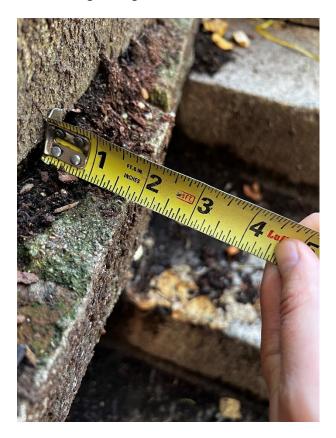
Image 3: 2" Deviation Between Granite Block Courses

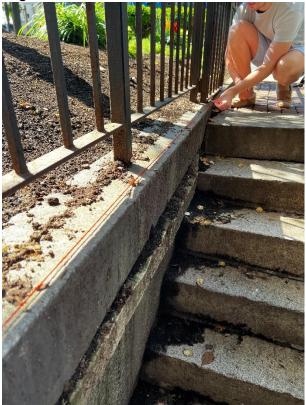
Image 4: Bowing Identified Through Use of Chalk Line

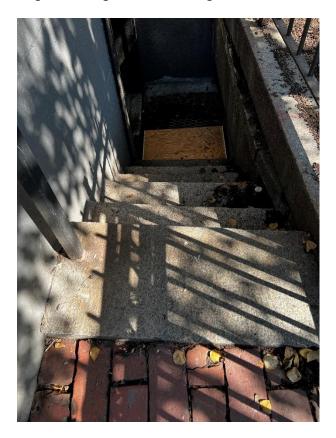
Image 5: Bowing Visible from Upper Segment of Stair Landing

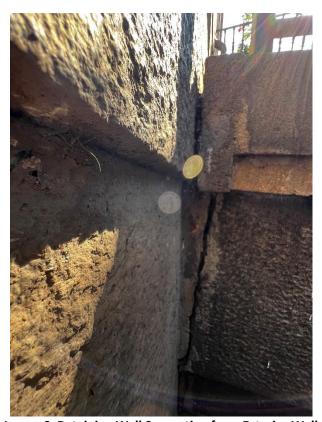
Image 6: Retaining Wall Separating from Exterior Wall

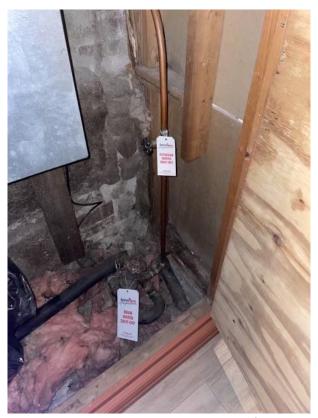
The exterior wall's rubble foundation system appears to have degraded mortar as well (see Image 7), which has allowed for moisture intrusion and has already led to mold infiltration within the vicinity due to the ongoing moisture exposure. Once the soil in the garden area is removed, we recommend that a mason investigates the current condition of the rubble foundation system in direct contact with the soil region to likely repoint the mortar between the rubble segments to mitigate moisture intrusion.

Image 7: Moisture and Dampness Found on Inner Face of Basement Rubble Wall
