Property Address: 67 Lambert Ave. Boston MA 02119

**Schwan's Tree Care**

Re: Arborist Assessment of 67 Lambert Ave

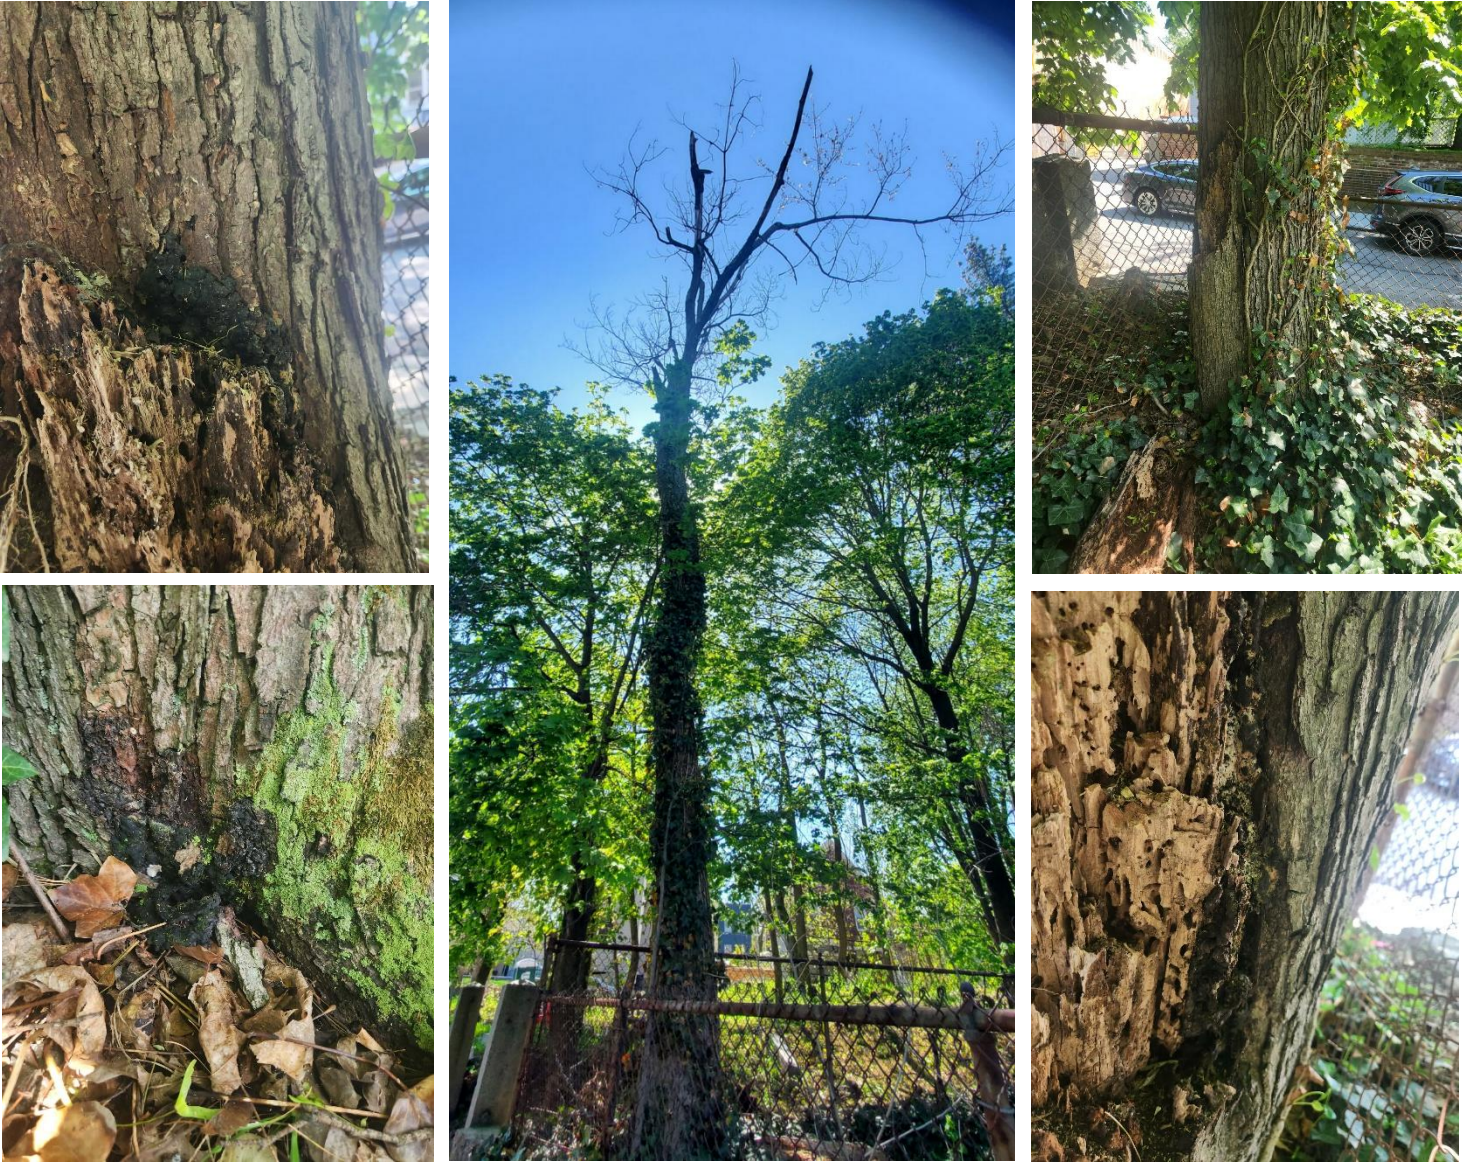
## Tree #1

**Photos:** Top left: Soft rot and *Kretzschmaria deusta* on the lower trunk. Bottom left: *Kretzschmaria deusta* on the root flare. Middle: Full view of tree. Top right: Soft rot on lower trunk. Bottom right: Soft rot close-up.

**Reasons for removal:** The tree is mostly dead. Dieback from the top. Large co-dominant leaders located about halfway up the tree. Fungus at the base located on the root flare and the lower trunk; I believe it to be *Kretzschmaria deusta*. Soft rot was observed on the lower trunk as well. Parts of this tree extend over the street and over the parking area.

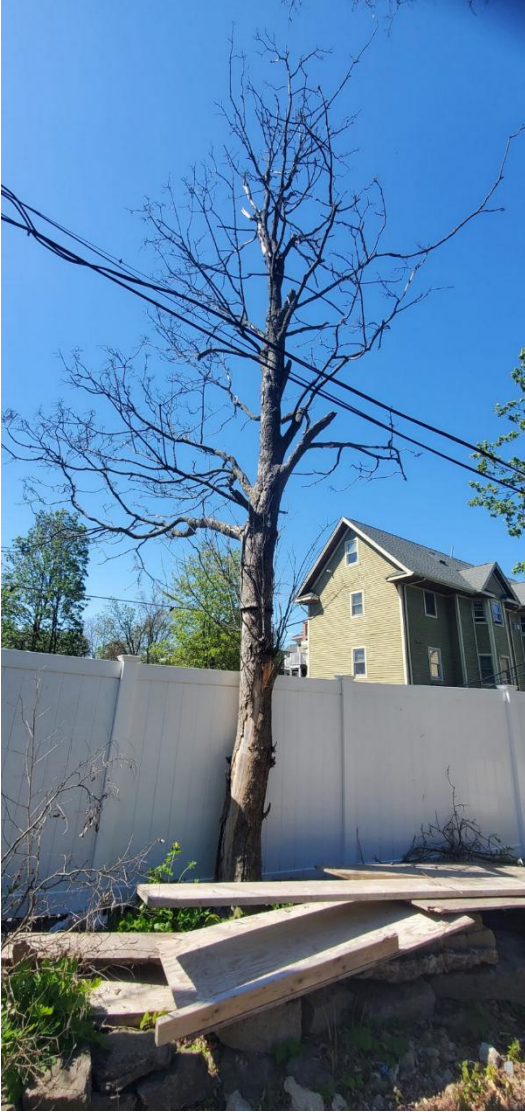
## Tree #2

**Photos:** Left: Full-view, peeling bark can be seen. Right: Close-up of the top, dead branches and breaks can be seen.

**Reasons for removal:** Tree is dead. Bark is peeling on the lower and mid trunk. It is beginning to shed limbs over owners' property and the neighbors.

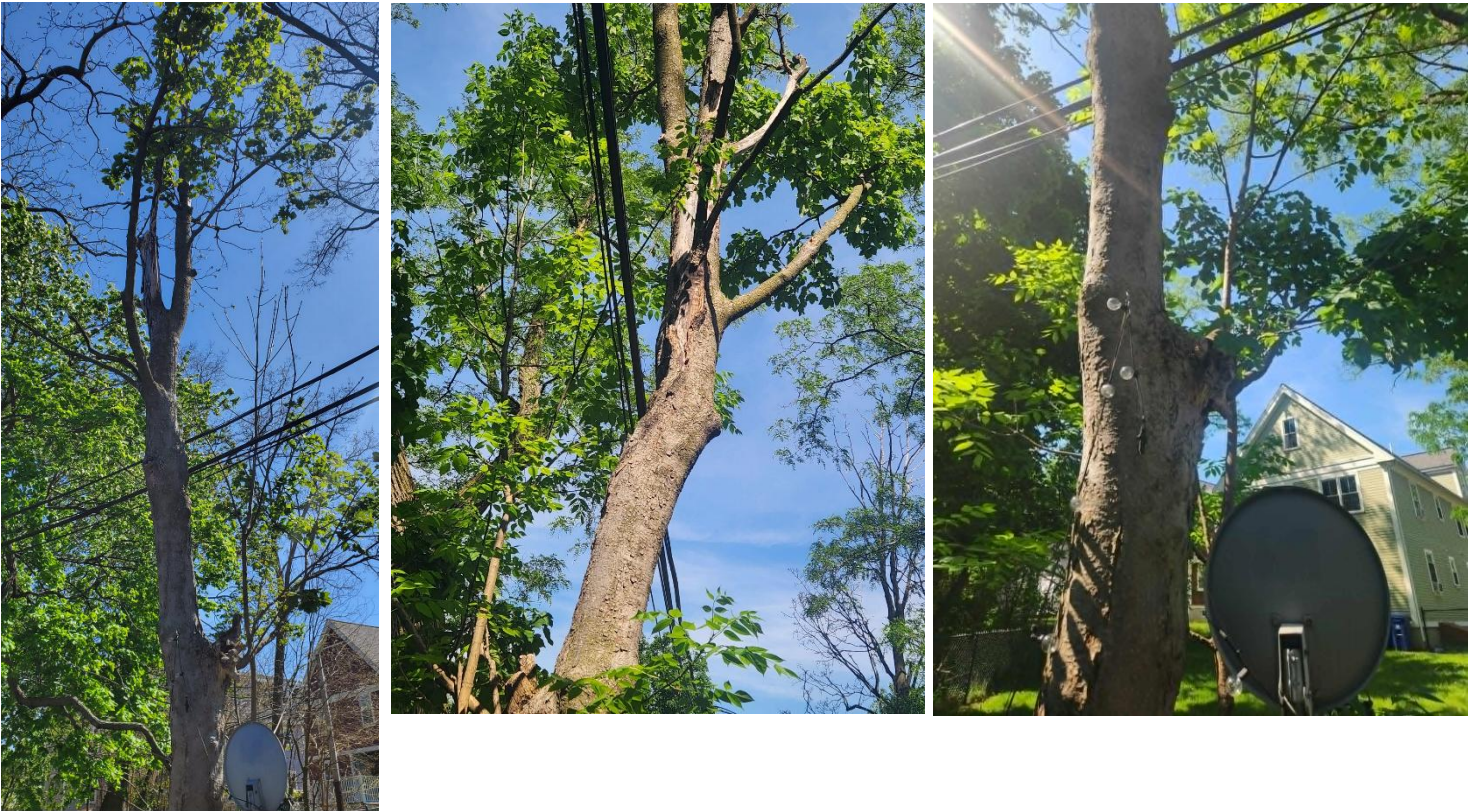
### Tree # 3

**Photos:** Left: Full view. Middle: Target canker level with utility lines. Right. Lower target canker.

**Reasons for removal:** Large target canker located around the height of the utility lines. Another target canker is located at about 8-10'. The top of the tree is dead. There is minimal live growth on this tree.
