# Attachment A PROJECT LOCATION MAP

CSS ARCHITECTS INC.  
ARCHITECTURE · PLANNING · INTERIOR DESIGN

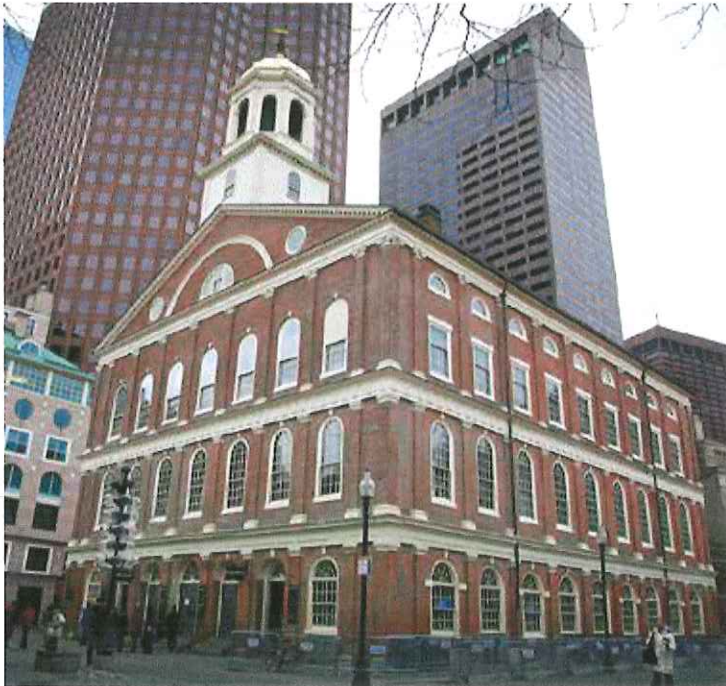
## Table of Contents

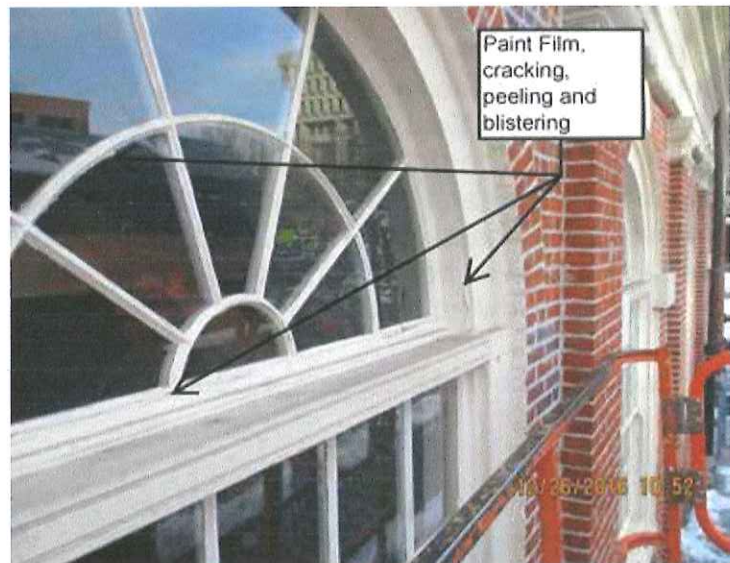
Each window sash was inspected to determine if the paint film was cracked, broken, blistered or peeled. If any of these conditions were found then the window sash was classified as "Paint Failure."

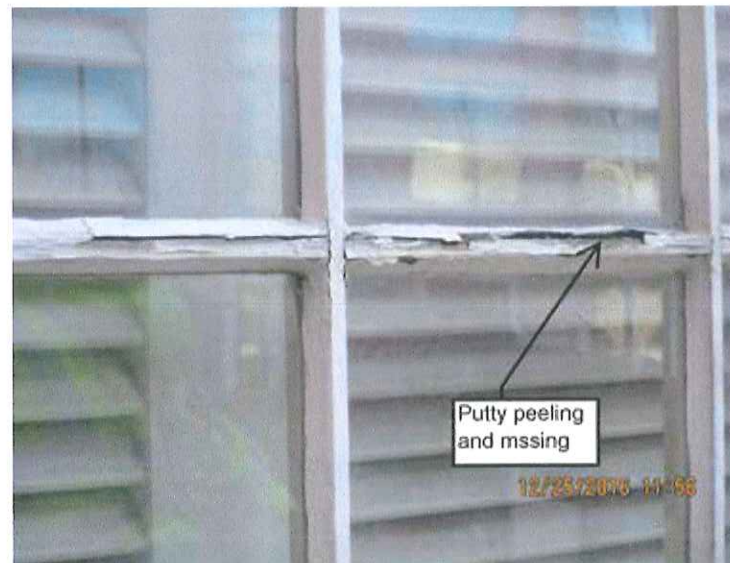
Each window sash was inspected to determine if the putty (glazing compound holding in the window glass) was intact – Not peeling or missing. If the putty was found to be either peeling or missing the window sash was classified as "Putty Failure."

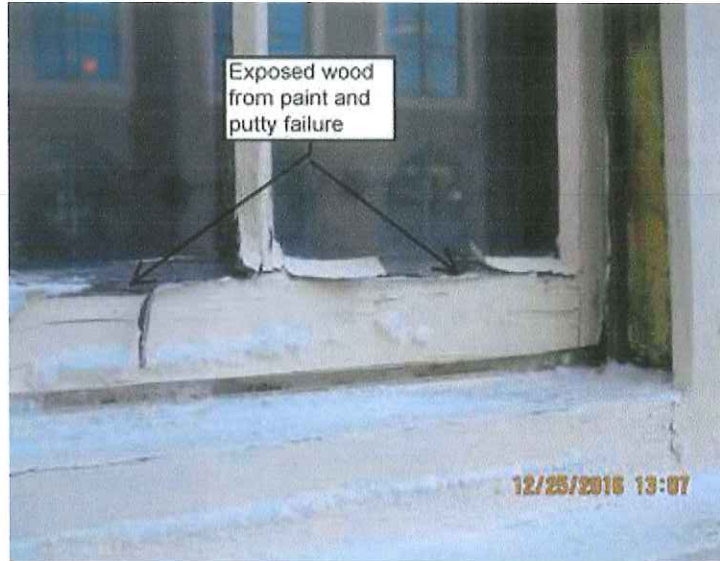
Each window sash was inspected to determine if there was exposed wood either from missing paint or putty. If paint and or putty were found to be missing the window sash was classified as “Exposed Wood.”

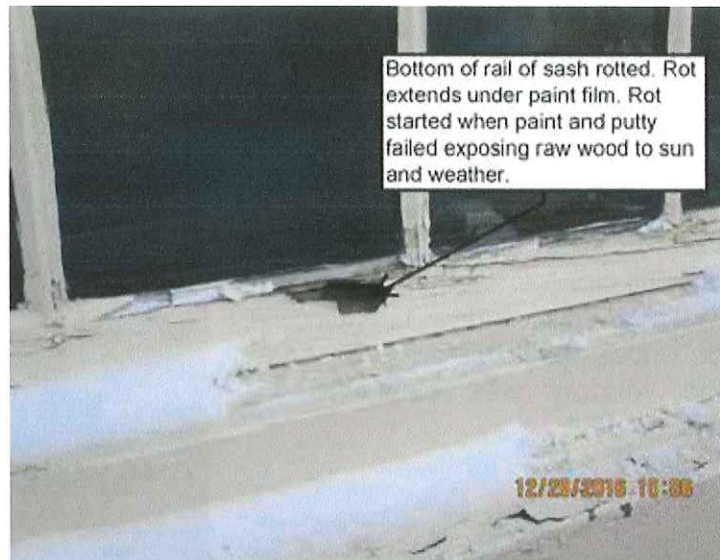
Sash Components Rotted

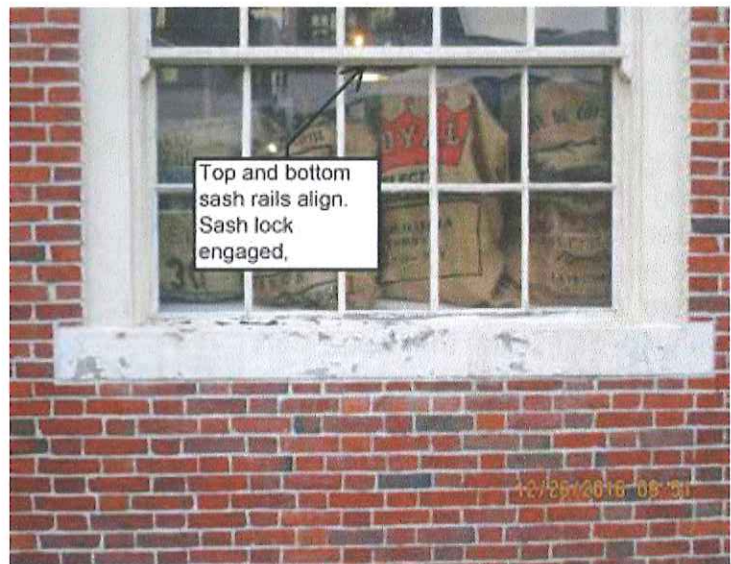
Meeting Rails Aligned

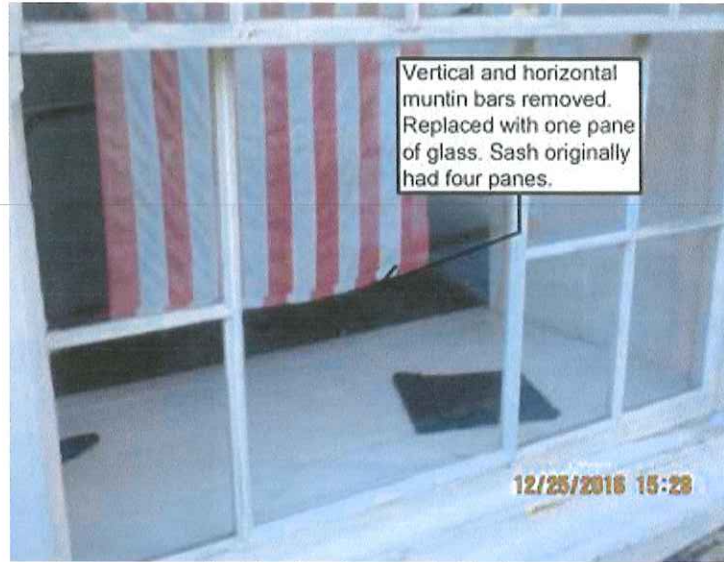
Cracked or Incorrect Glazing

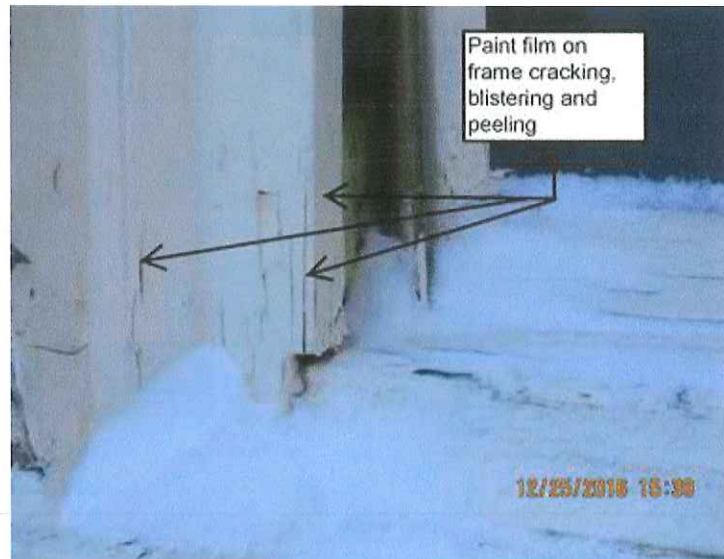
Each window frame was inspected to determine if the paint film was cracked, broken, blistered or peeled. If any of these conditions were found then the window frame was classified as "Paint Failure."

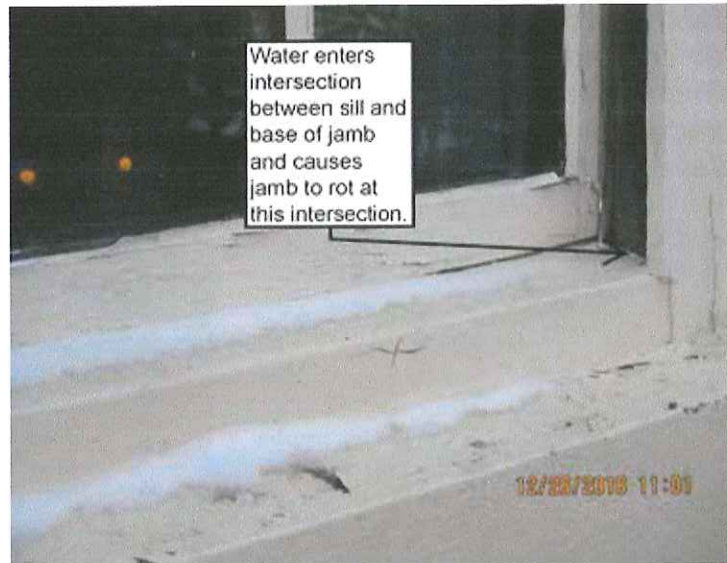
At each double hung window where the window frame jambs are exposed adjacent to the lower sash the jambs at the intersection with the sill were probed with the sharp point of a knife to explore for rot. If rot was found the window frame was classified as "Rot at Base of Jambs."

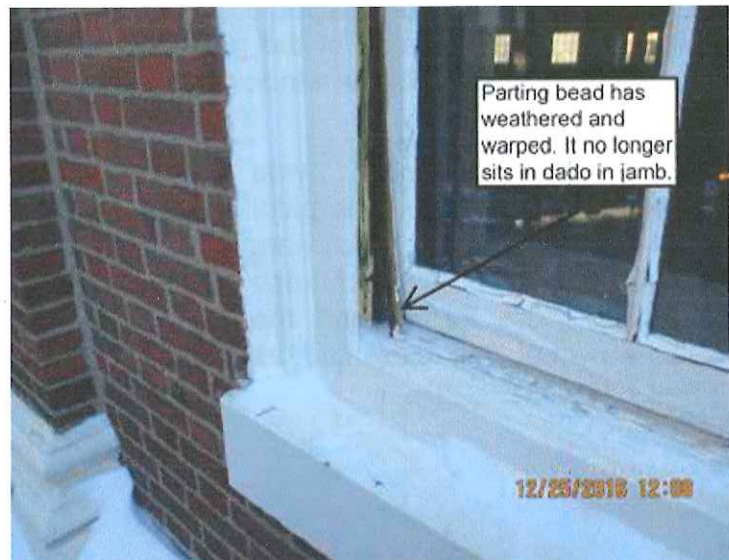
Parting Bead Displaced

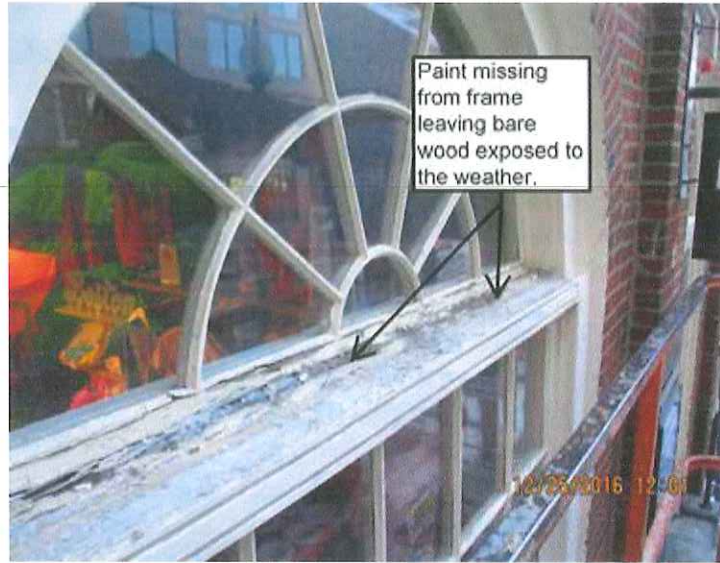
Bare Wood of Window Frame Exposed

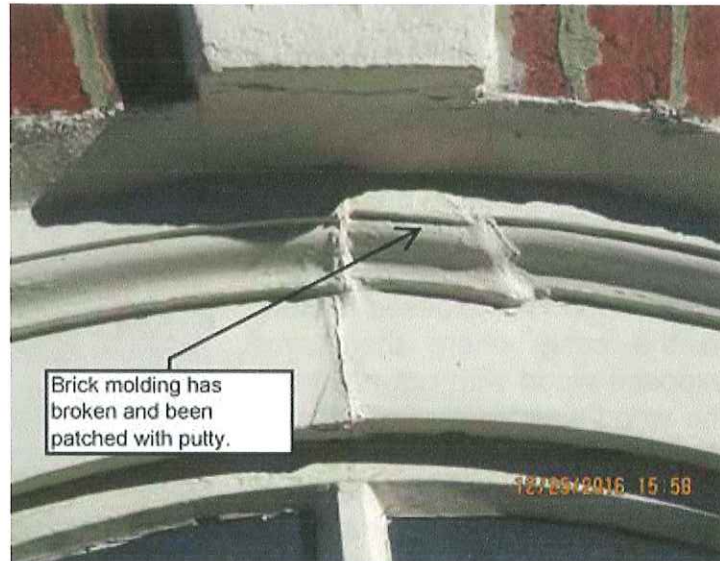
Brick Molding Broken

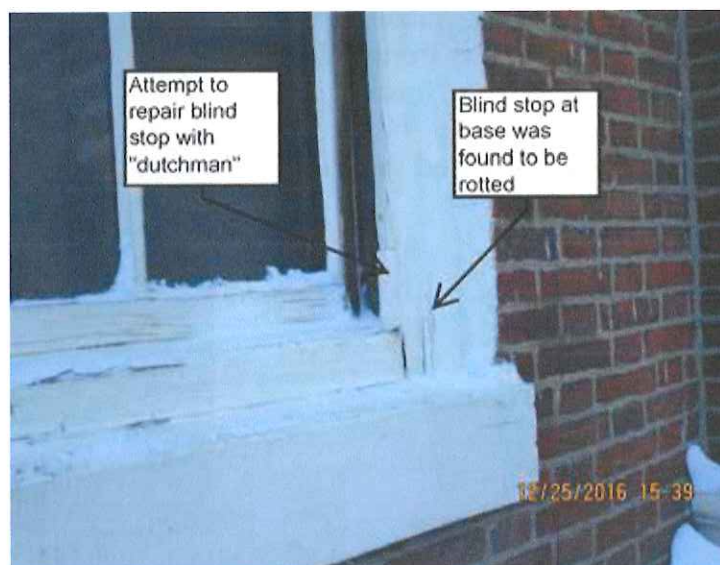
Blind Stop at Base Rotted

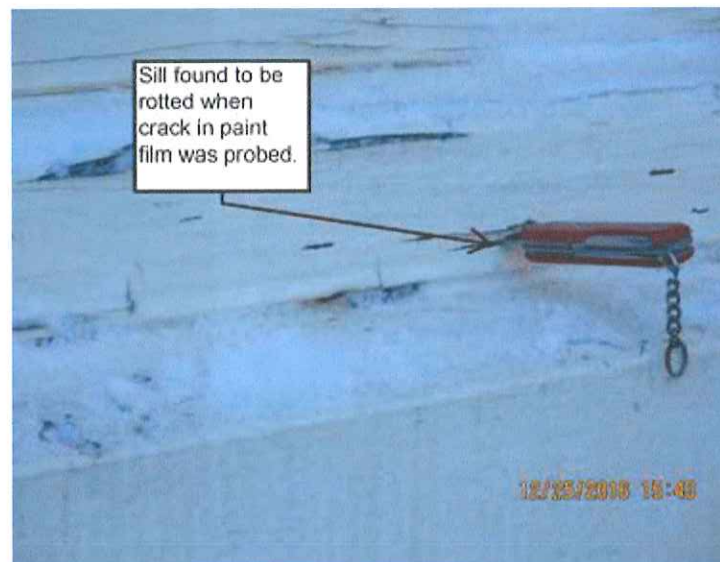
The sill of each window frame was inspected to determine if the any of the sill was rotted. This was done through observation were rotted wood could be observed either under the paint or rotted wood was exposed to view. In the case where there was exposed wood with not paint film the wood was gently probed with the sharp point of a knife to explore for rot. Where the paint film was intact and no rot could be observed the sill was not probed. If rot was found in the sill the sill was classified "Sill Rotted."

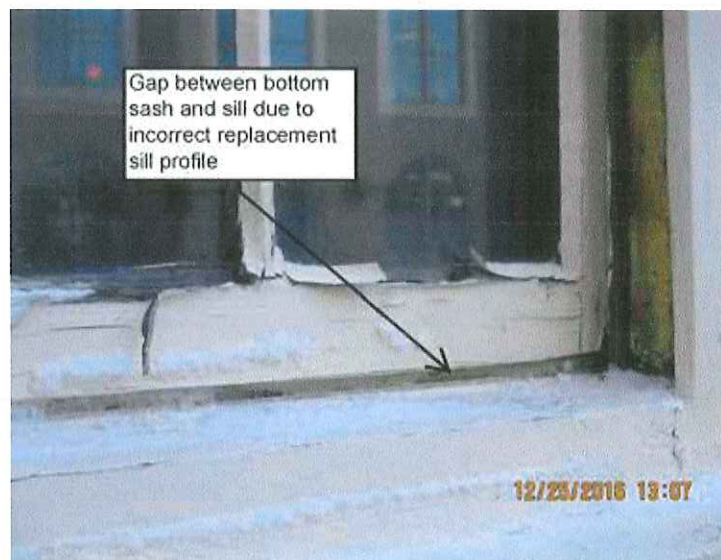
Bottom Rail of Lower Sash not closing tightly against sill

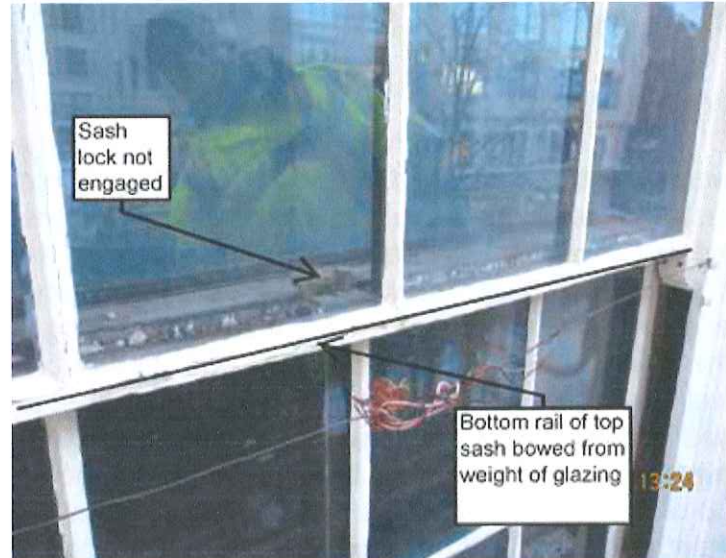
Bottom Rail of Top Sash Bowed

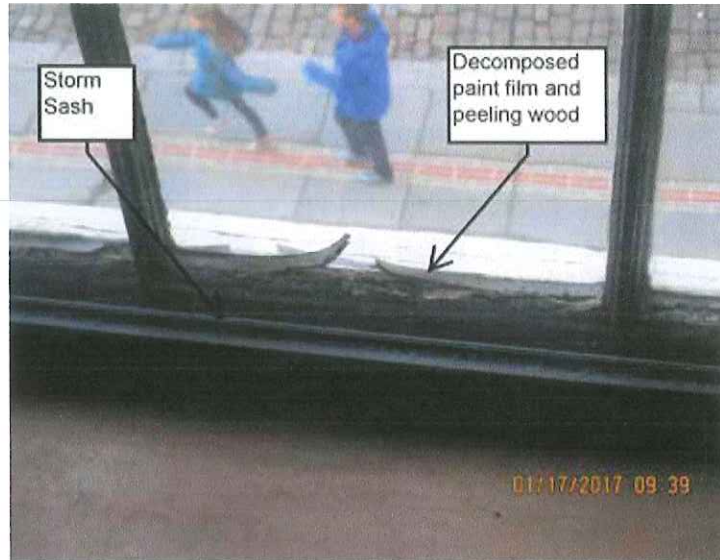
Major Deterioration of Bottom Rail of Sash at the Interior

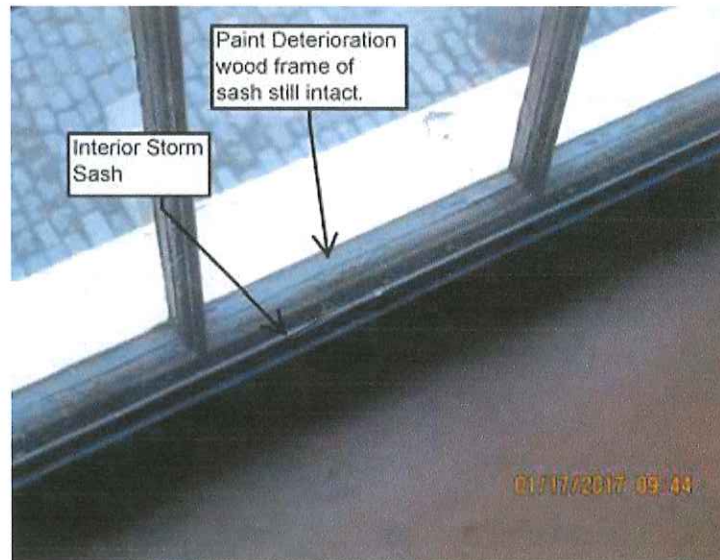
Minor Deterioration of Paint at Sash Interior

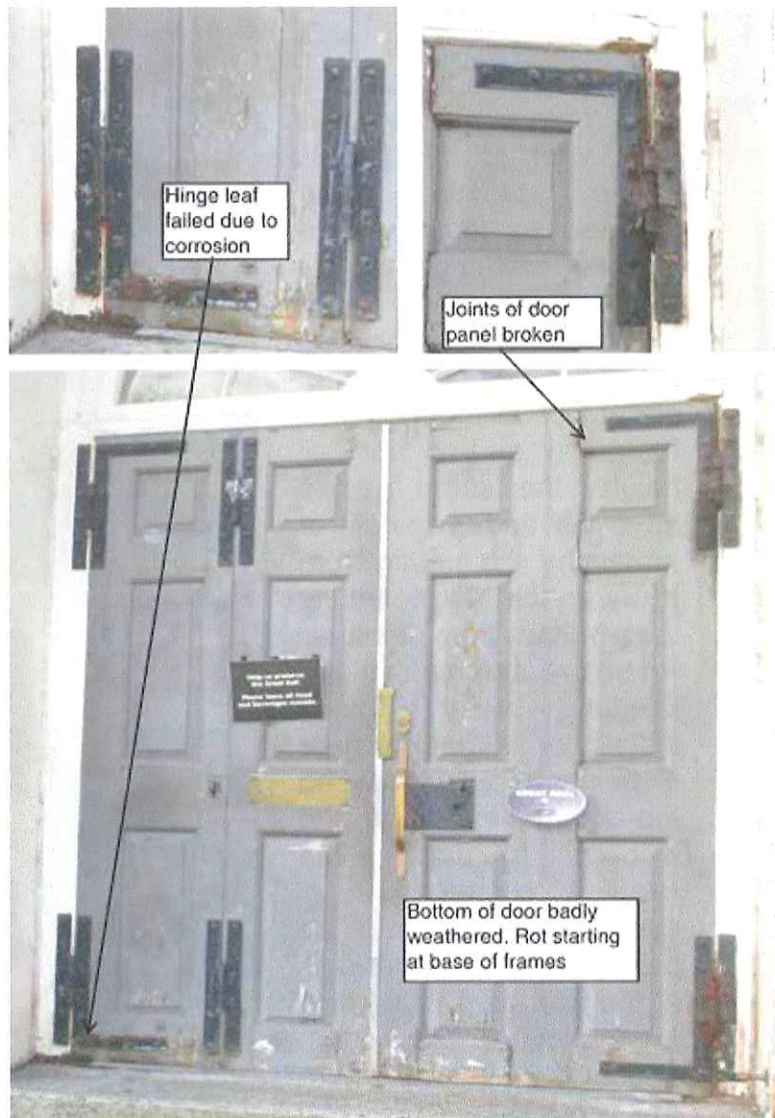
Center Door at Entrance to Great Hall

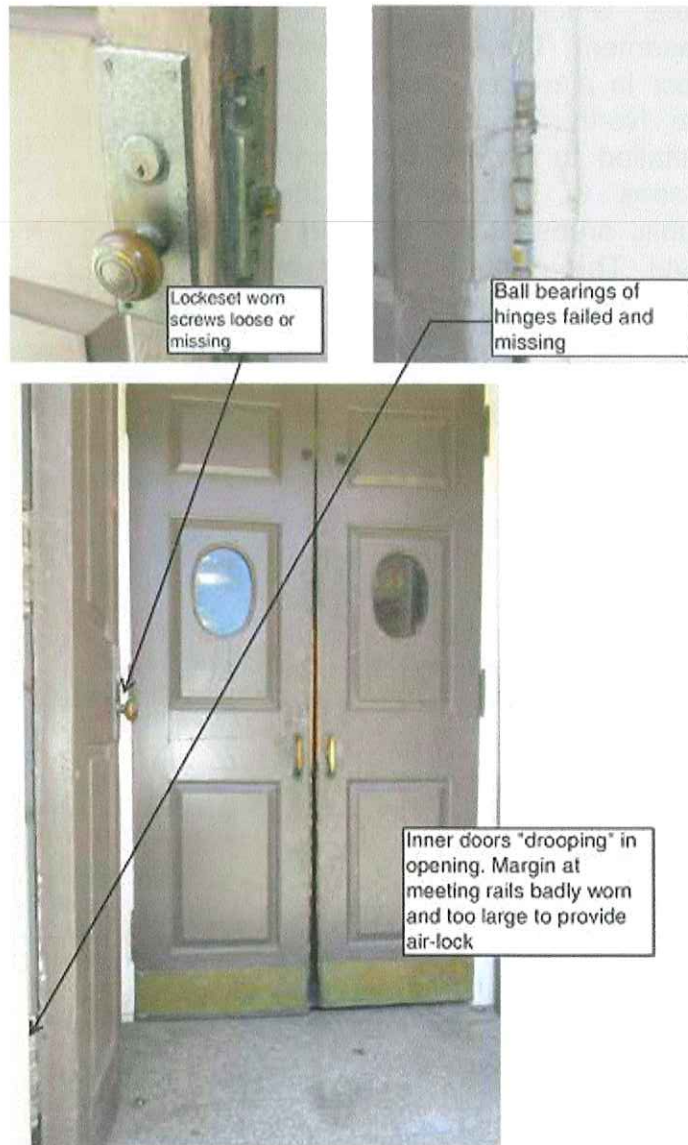
Double Exterior Doors to Market Hall

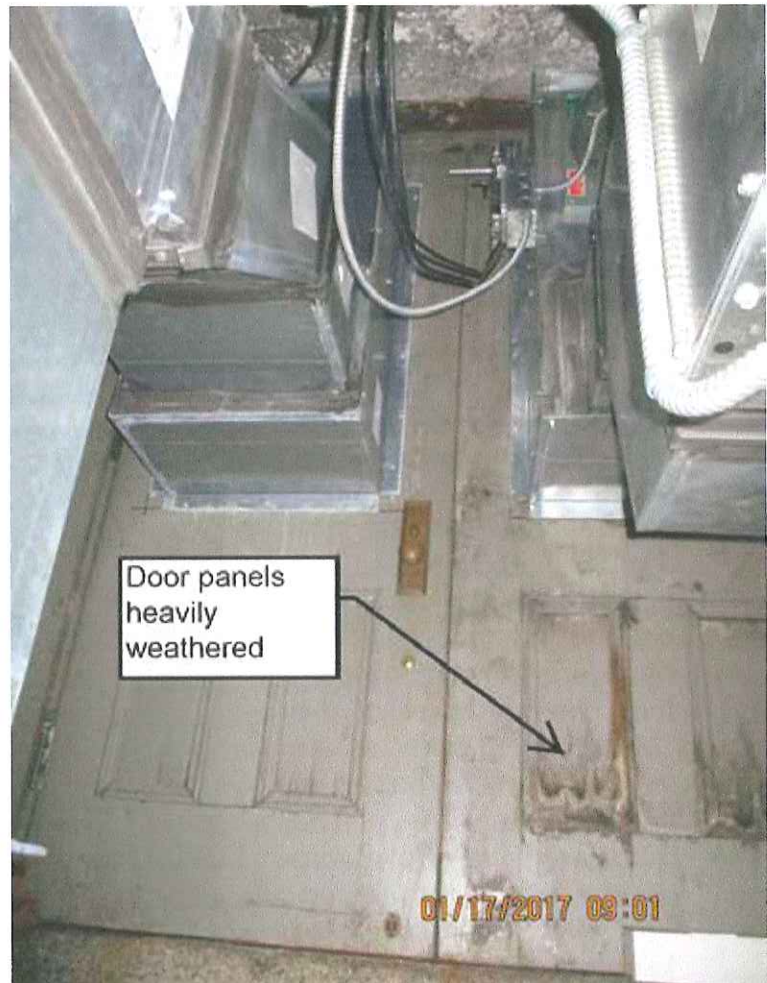
Basement Door Inoperable due to HVAC Ductwork

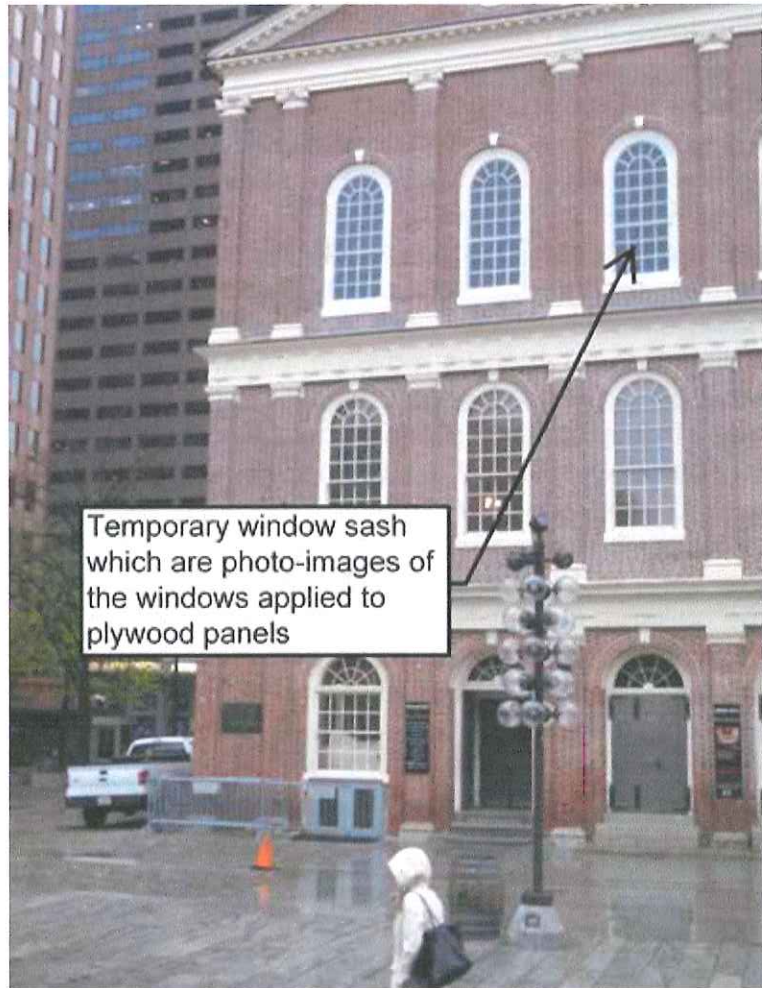
Temporary Windows at Third Floor

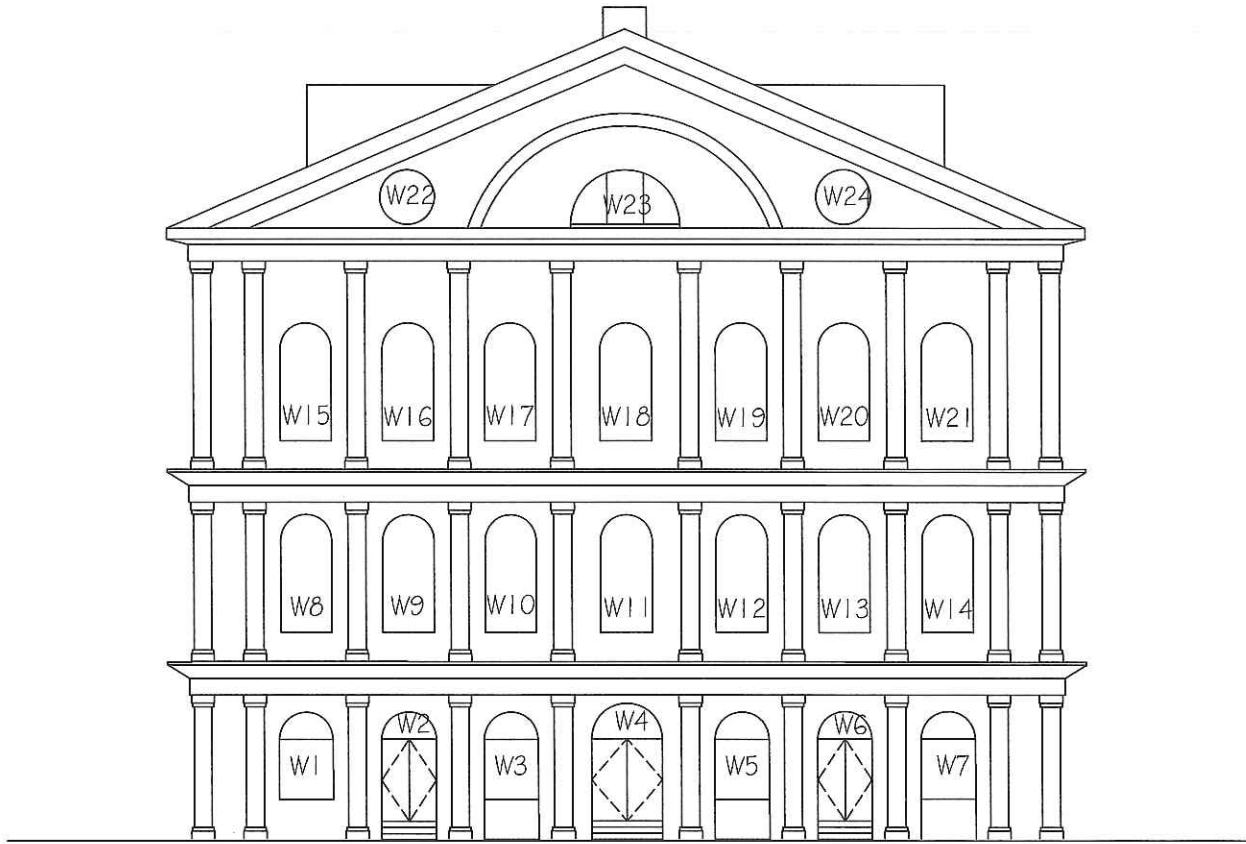
FANEUIL HALL WEST FACADE  
WINDOW KEY

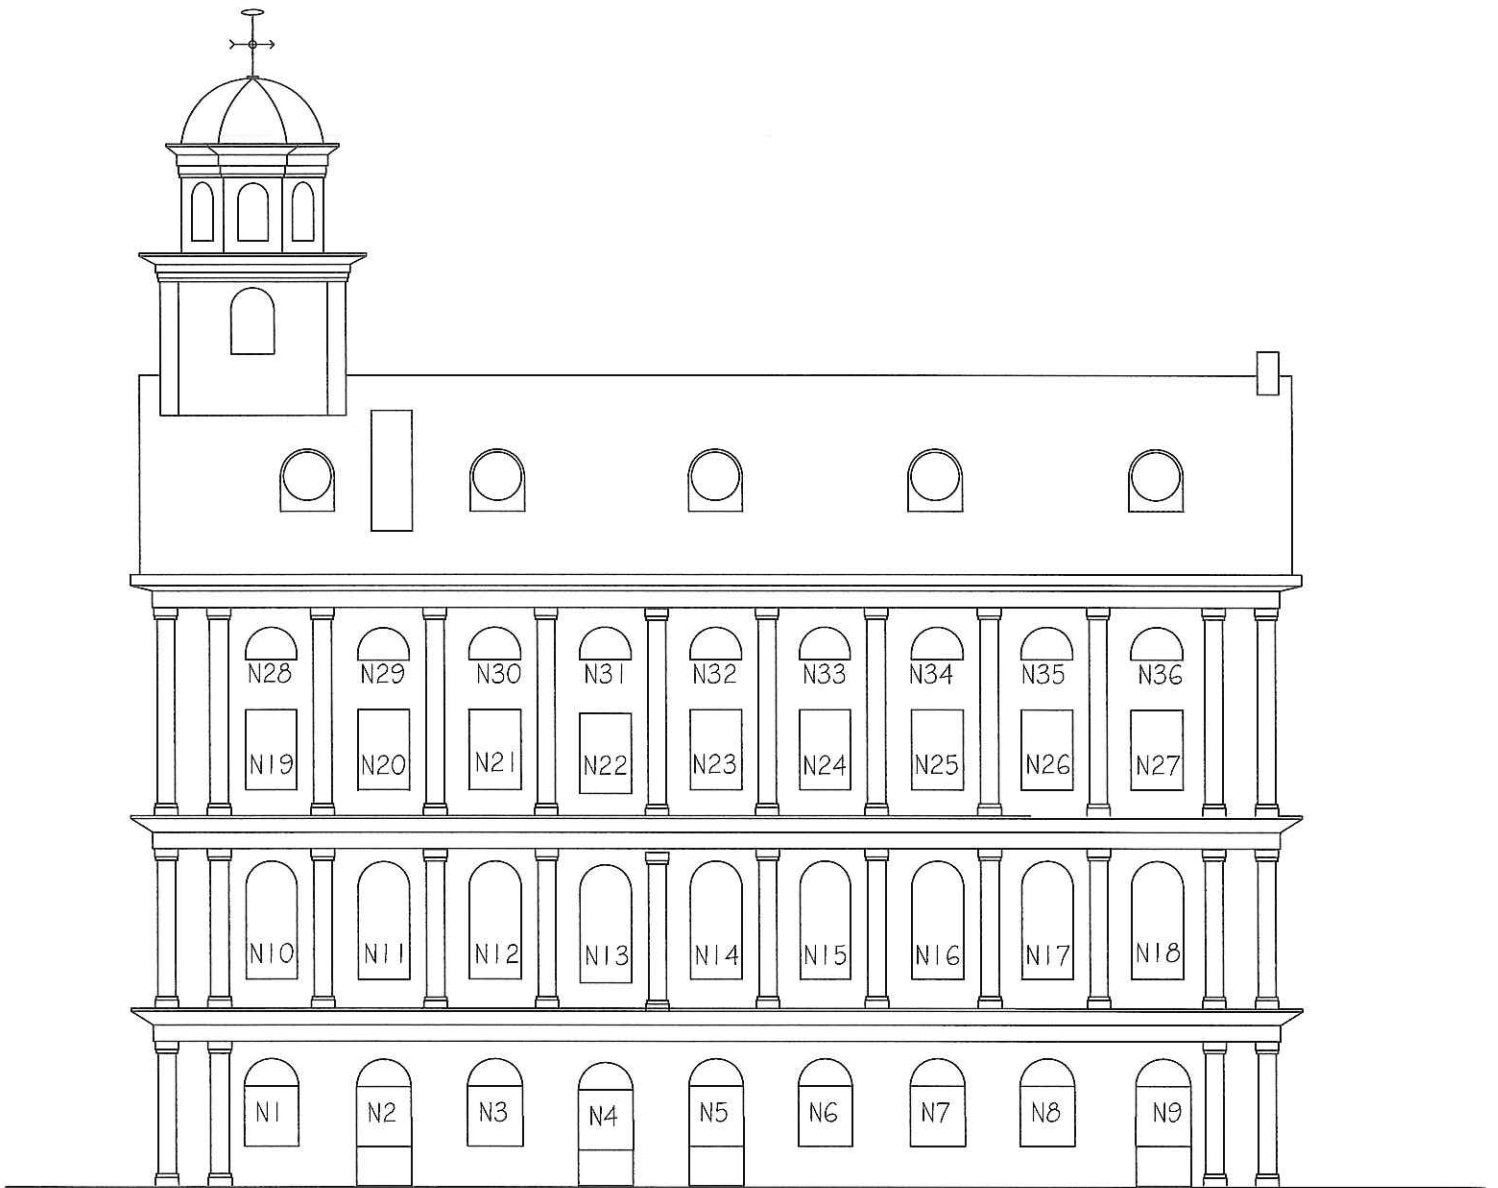
FANEUIL HALL NORTH FACADE  
WINDOW KEY

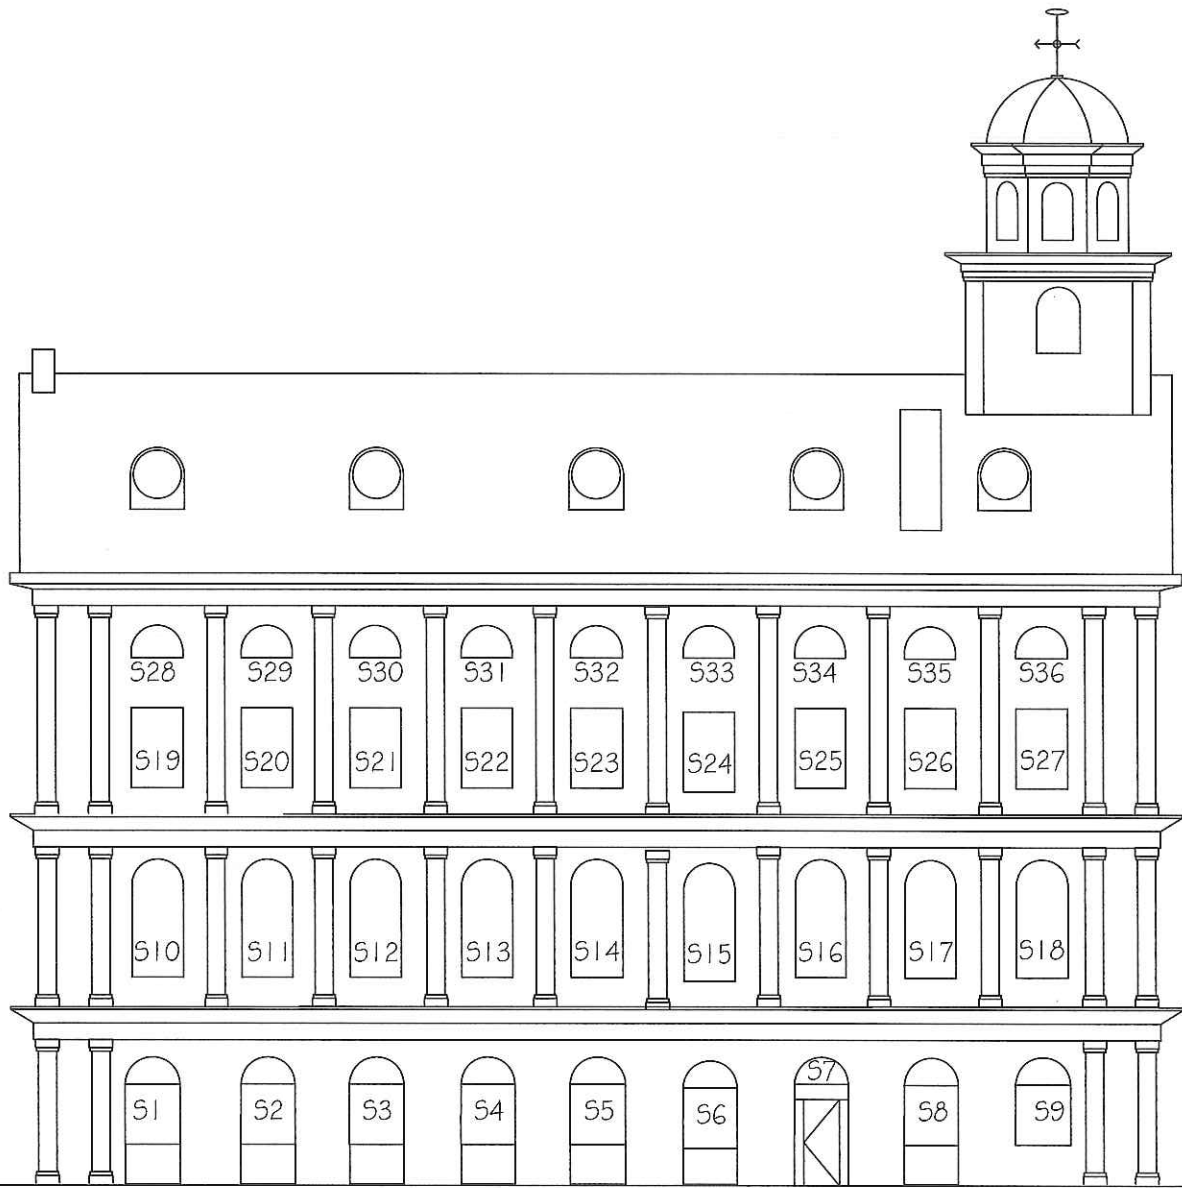
FANEUIL HALL SOUTH FACADE  
WINDOW KEY

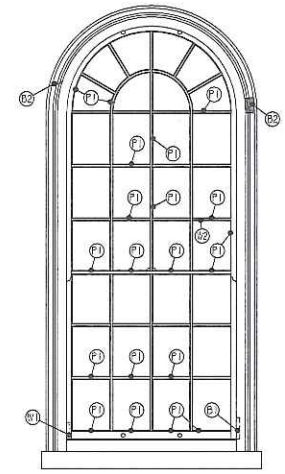
- REMOVE & REPAIR SPIDER GLASS BETWEEN EXTERIOR GLASS AND SILL AT JAMB REPAIRS.
- SCOFF AND PAINT ENTIRE EXTERIOR OF WINDOW.

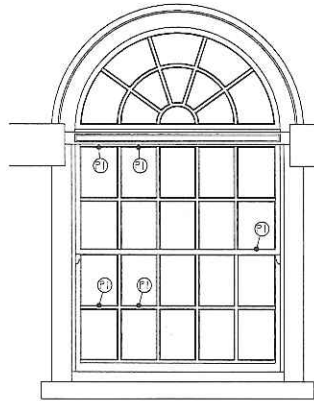
NORTH ELEVATION  
EXTERIOR

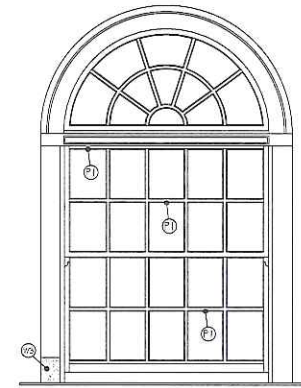
NORTH ELEVATION  
EXTERIOR

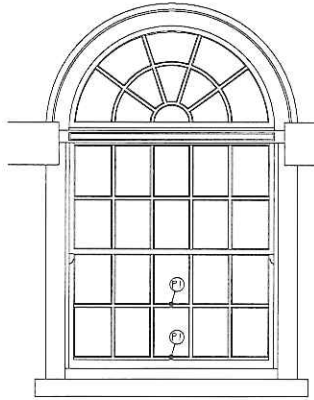
NORTH ELEVATION  
EXTERIOR

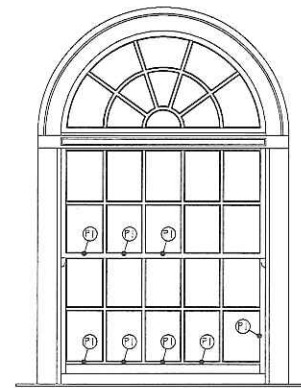
NORTH ELEVATION  
EXTERIOR

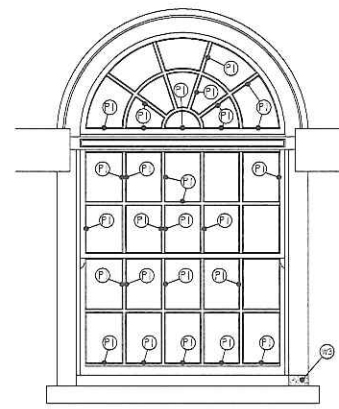
WINDOW REPAIR SCHEDULE	
B1	FOR WINDOW STOP
B2	PURTY AT BRICK MOLD
B3	LOOSE METRIC BRICK
G1	REPAIR BRICK ON SILL
G2	SEPARATORS ON SILL
F1	PURTY TO BE REFINISHED
W1	NOT REFINISHMENT AT JAMB, SILL, HEAD
W2	REWORKED MULLIN
W3	SURFACE TYP
W4	BRICKS VISIBLE ON SILL
W5	BRICKS ON SILL TYP
W6	SURFACE WEATHERING
GENERAL REPAIR NOTES	
• BRICKS & SURFACE SOLARLY REWORKED BRICK AND BY COL. STONE REFINISHED	
• SOLVE AND WEATHER DETAIL OF BRICKS

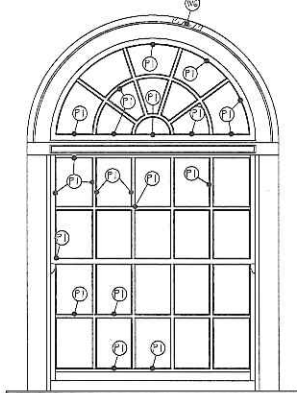
WINDOW REPAIR SCHEDULE	
B1	FOR WINDOW STOP
B2	PURTY AT BRICK MOLD
B3	LOOSE METRIC BRICK
G1	REPAIR BRICK ON SILL
G2	SEPARATORS ON SILL
F1	PURTY TO BE REFINISHED
W1	NOT REFINISHMENT AT JAMB, SILL, HEAD
W2	REWORKED MULLIN
W3	SURFACE TYP
W4	BRICKS VISIBLE ON SILL
W5	BRICKS ON SILL TYP
W6	SURFACE WEATHERING
GENERAL REPAIR NOTES	
• BRICKS & SURFACE SOLARLY REWORKED BRICK AND BY COL. STONE REFINISHED	
• SOLVE AND WEATHER DETAIL OF BRICKS

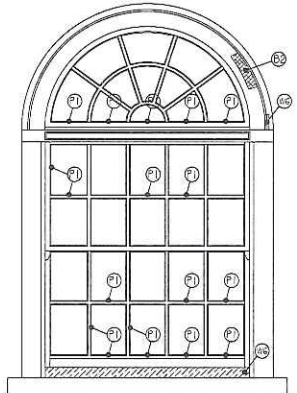
WINDOW REPAIR SCHEDULE	
B1	FOR WINDOW STOP
B2	PURTY AT BRICK MOLD
B3	LOOSE METRIC BRICK
G1	REPAIR BRICK ON SILL
G2	SEPARATORS ON SILL
F1	PURTY TO BE REFINISHED
W1	NOT REFINISHMENT AT JAMB, SILL, HEAD
W2	REWORKED MULLIN
W3	SURFACE TYP
W4	BRICKS VISIBLE ON SILL
W5	BRICKS ON SILL TYP
W6	SURFACE WEATHERING
GENERAL REPAIR NOTES	
• BRICKS & SURFACE SOLARLY REWORKED BRICK AND BY COL. STONE REFINISHED	
• SOLVE AND WEATHER DETAIL OF BRICKS

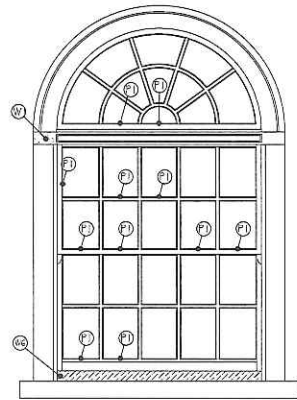
- REMOVE ALL BRONZE SURFACE REPAIRS AND REPAIRS TO BE REPLACED WITH BRONZE
- SCAFFOLD MUST BE ON THE EXTERIOR OF WINDOW

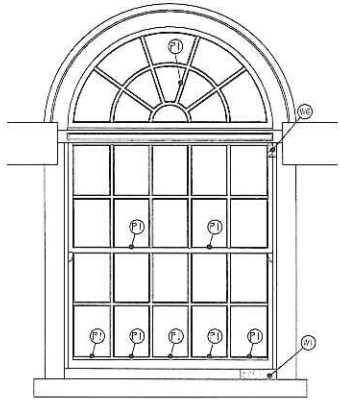
- REMOVE ALL BRONZE SURFACE REPAIRS AND REPAIRS TO BE REPLACED WITH BRONZE
- SCAFFOLD MUST BE ON THE EXTERIOR OF WINDOW

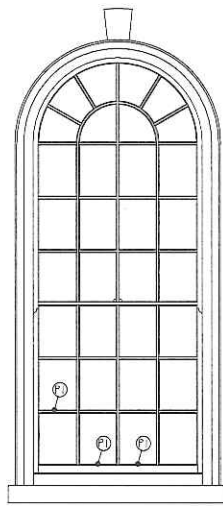
WINDOW REPAIR SCHEDULE	
B1	EDGE OF WINDOW STOP
B2	FURTY AT WINDOW SILL
B3	LOOSE PUTTING STAG
G1	REPAIR SCHEIN GLASS
G2	SCORAINS ON GLASS
F1	PUTTY TO BE REPAIRED
W1	FOR REPAIRS/REPLACE AT JAMB, SILL, HEAD
W2	EXTERIOR SIDE MULTUM
S1	SURFACE NOT
S2	REPAIR LAMINATE ON SASH
S3	REPAIR LAMINATE FRAME
S4	SURFACE REPAIRING
GENERAL REPAIR NOTES	
• REMOVE & REPLACE SASHES IN RESTORED PORTION HOLD AND SASHES TO BE REPAIRED	
• SCOVE AND PAINT ON THE EXTERIOR OF WINDOW

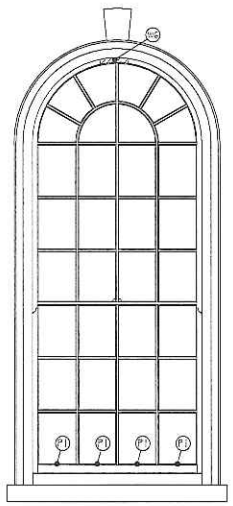
WINDOW REPAIR SCHEDULE	
B1	EDGE OF WINDOW STOP
B2	FURTY AT WINDOW SILL
B3	LOOSE PUTTING STAG
G1	REPAIR SCHEIN GLASS
G2	SCORAINS ON GLASS
F1	PUTTY TO BE REPAIRED
W1	FOR REPAIRS/REPLACE AT JAMB, SILL, HEAD
W2	EXTERIOR SIDE MULTUM
S1	SURFACE NOT
S2	REPAIR LAMINATE ON SASH
S3	REPAIR LAMINATE FRAME
S4	SURFACE REPAIRING
GENERAL REPAIR NOTES	
• REMOVE & REPLACE SASHES IN RESTORED PORTION HOLD AND SASHES TO BE REPAIRED	
• SCOVE AND PAINT ON THE EXTERIOR OF WINDOW

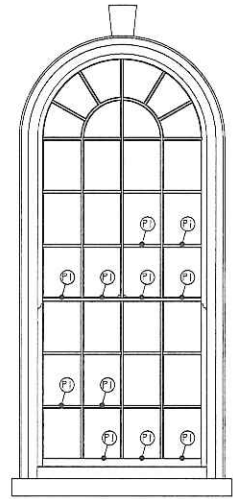
WINDOW REPAIR SCHEDULE	
B1	EDGE OF WINDOW STOP
B2	FURTY AT WINDOW SILL
B3	LOOSE PUTTING STAG
G1	REPAIR SCHEIN GLASS
G2	SCORAINS ON GLASS
F1	PUTTY TO BE REPAIRED
W1	FOR REPAIRS/REPLACE AT JAMB, SILL, HEAD
W2	EXTERIOR SIDE MULTUM
S1	SURFACE NOT
S2	REPAIR LAMINATE ON SASH
S3	REPAIR LAMINATE FRAME
S4	SURFACE REPAIRING
GENERAL REPAIR NOTES	
• REMOVE & REPLACE SASHES IN RESTORED PORTION HOLD AND SASHES TO BE REPAIRED	
• SCOVE AND PAINT ON THE EXTERIOR OF WINDOW

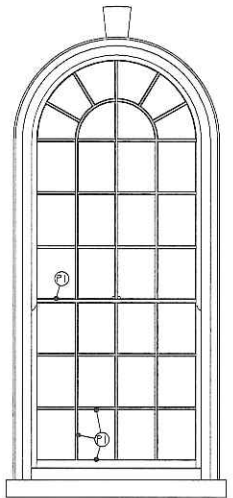
WINDOW REPAIR SCHEDULE	
B1	EDGE OF WINDOW STOP
B2	FURTY AT WINDOW SILL
B3	LOOSE PUTTING STAG
G1	REPAIR SCHEIN GLASS
G2	SCORAINS ON GLASS
F1	PUTTY TO BE REPAIRED
W1	FOR REPAIRS/REPLACE AT JAMB, SILL, HEAD
W2	EXTERIOR SIDE MULTUM
S1	SURFACE NOT
S2	REPAIR LAMINATE ON SASH
S3	REPAIR LAMINATE FRAME
S4	SURFACE REPAIRING
GENERAL REPAIR NOTES	
• REMOVE & REPLACE SASHES IN RESTORED PORTION HOLD AND SASHES TO BE REPAIRED	
• SCOVE AND PAINT ON THE EXTERIOR OF WINDOW

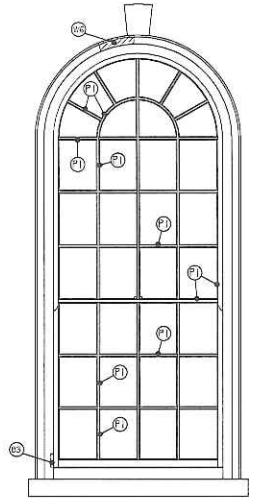
WINDOW REPAIR SCHEDULE	
B1	FIX H/REIN STOP
B2	PUTTY AT BRICK MOUND
B3	SCREW PATCHING BRICK
G1	REPAIR BRICK ON GLASS
G2	SCREWS ON GLASS
F1	PUTTY TO BE REPLACED
W1	FIX REPLACEMENT AT JAMB, SILL, HEAD
W2	DETENTION W/ SILL
W3	DETENTION W/ HEAD
W4	DETENTION W/ SIDE SASH
W5	DETENTION W/ TOP SASH
W6	DETENTION W/ PARTING
GENERAL REPAIR NOTES	
* REMOVE & REPLACE SILL/HEAD & DETENTION BRICKS, MOUND AND BRICK PATCHING PATCHES	
* SCREWS AND PATCHING TO BE DONE ON INTERIOR OF WINDOW

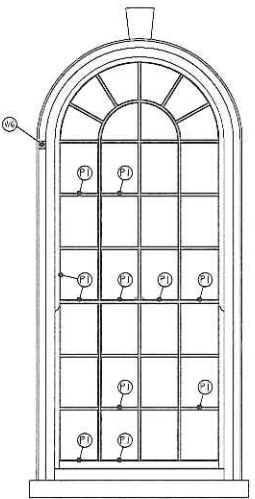
WINDOW REPAIR SCHEDULE	
B1	FIX H/REIN STOP
B2	PUTTY AT BRICK MOUND
B3	SCREW PATCHING BRICK
G1	REPAIR BRICK ON GLASS
G2	SCREWS ON GLASS
F1	PUTTY TO BE REPLACED
W1	FIX REPLACEMENT AT JAMB, SILL, HEAD
W2	DETENTION W/ SILL
W3	DETENTION W/ HEAD
W4	DETENTION W/ SIDE SASH
W5	DETENTION W/ TOP SASH
W6	DETENTION W/ PARTING
GENERAL REPAIR NOTES	
* REMOVE & REPLACE SILL/HEAD & DETENTION BRICKS, MOUND AND BRICK PATCHING PATCHES	
* SCREWS AND PATCHING TO BE DONE ON INTERIOR OF WINDOW

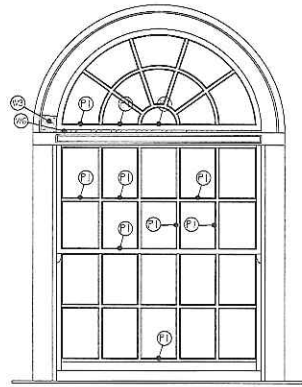
**WINDOW REPAIR SCHEDULE**

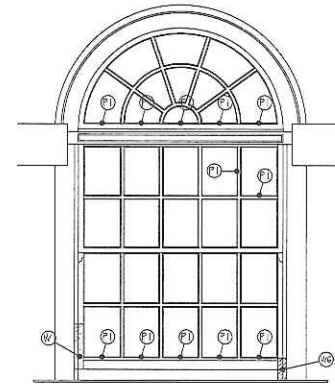
**WINDOW REPAIR SCHEDULE**

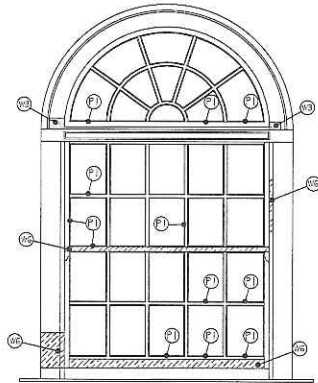
**WINDOW REPAIR SCHEDULE**

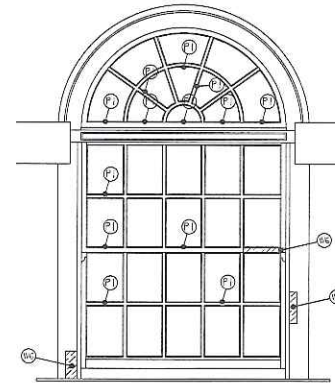
**WINDOW REPAIR SCHEDULE**

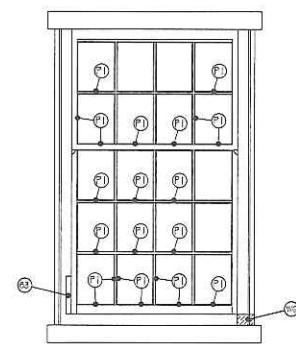
INTERIOR  
EXTERIOR  
INTERIOR/EXTERIOR WINDOW ELEVATION S22

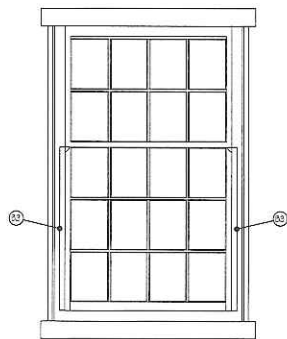
**WINDOW REPAIR SCHEDULE**

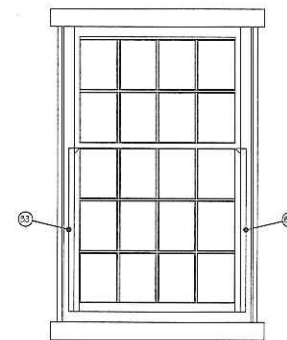
**WINDOW REPAIR SCHEDULE**

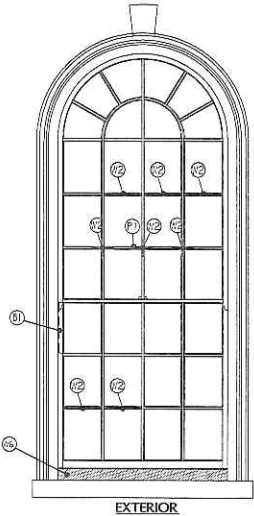
WINDOW REPAIR SCHEDULE	
B1	ROT AT SILL STOP
B2	FURTY AT SILL HOLD
B3	LOOKS FINISH HEAD
G1	REPAIR WINDOW GLASS
G2	SCAFFOLDS ON GLASS
F1	PURTY TO BE REPAIRED
W1	ROT REPLACEMENT AT JAMB, SILL, HEAD
W2	REPAIR WINDOW MOUTH
W3	SURFACE ROT
W4	REPAIR MOUTH OF SASH
W5	FRASIGATE MOUTH IRON
W6	SURFACE WEARINGS
GENERAL REPAIR NOTES	
• REMOVE & REPLACE SQUARE REPAIRS FROM EXTERIOR SIDE	
• SQUARE AND TRIM CORNER PORTIONS OF WINDOW

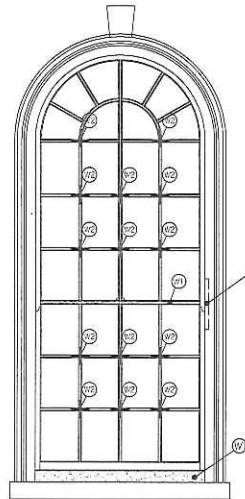
WINDOW REPAIR SCHEDULE	
B1	ROT AT SILL STOP
B2	FURTY AT SILL HOLD
B3	LOOKS FINISH HEAD
G1	REPAIR WINDOW GLASS
G2	SCAFFOLDS ON GLASS
F1	PURTY TO BE REPAIRED
W1	ROT REPLACEMENT AT JAMB, SILL, HEAD
W2	REPAIR WINDOW MOUTH
W3	SURFACE ROT
W4	REPAIR MOUTH OF SASH
W5	FRASIGATE MOUTH IRON
W6	SURFACE WEARINGS
GENERAL REPAIR NOTES	
• REMOVE & REPLACE SQUARE REPAIRS FROM EXTERIOR SIDE	
• SQUARE AND TRIM CORNER PORTIONS OF WINDOW

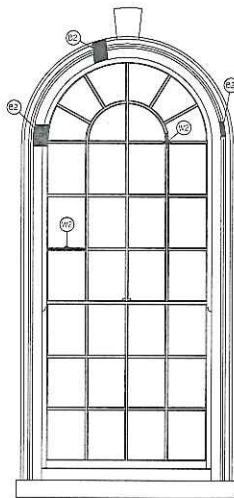
WINDOW REPAIR SCHEDULE	
B1	ROT AT SILL STOP
B2	FURTY AT SILL HOLD
B3	LOOKS FINISH HEAD
G1	REPAIR WINDOW GLASS
G2	SCAFFOLDS ON GLASS
F1	PURTY TO BE REPAIRED
W1	ROT REPLACEMENT AT JAMB, SILL, HEAD
W2	REPAIR WINDOW MOUTH
W3	SURFACE ROT
W4	REPAIR MOUTH OF SASH
W5	FRASIGATE MOUTH IRON
W6	SURFACE WEARINGS
GENERAL REPAIR NOTES	
• REMOVE & REPLACE SQUARE REPAIRS FROM EXTERIOR SIDE	
• SQUARE AND TRIM CORNER PORTIONS OF WINDOW

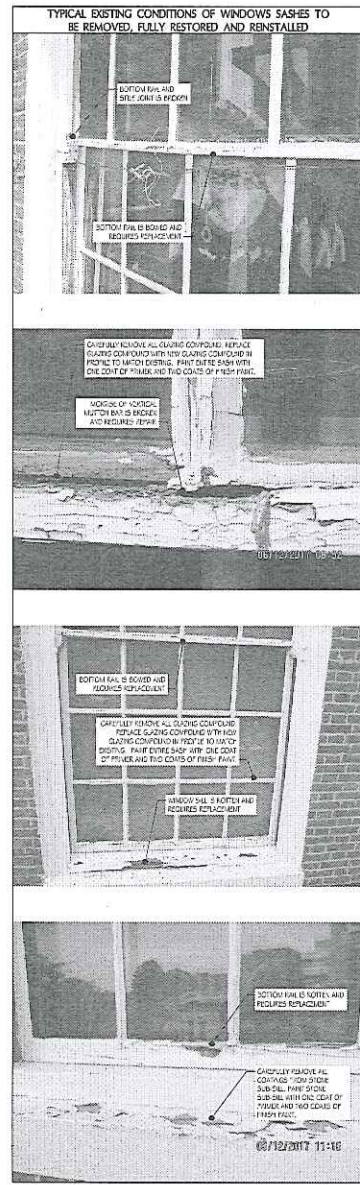
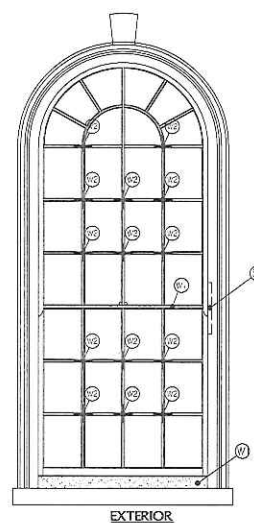
WEST ELEVATION  
EXTERIOR

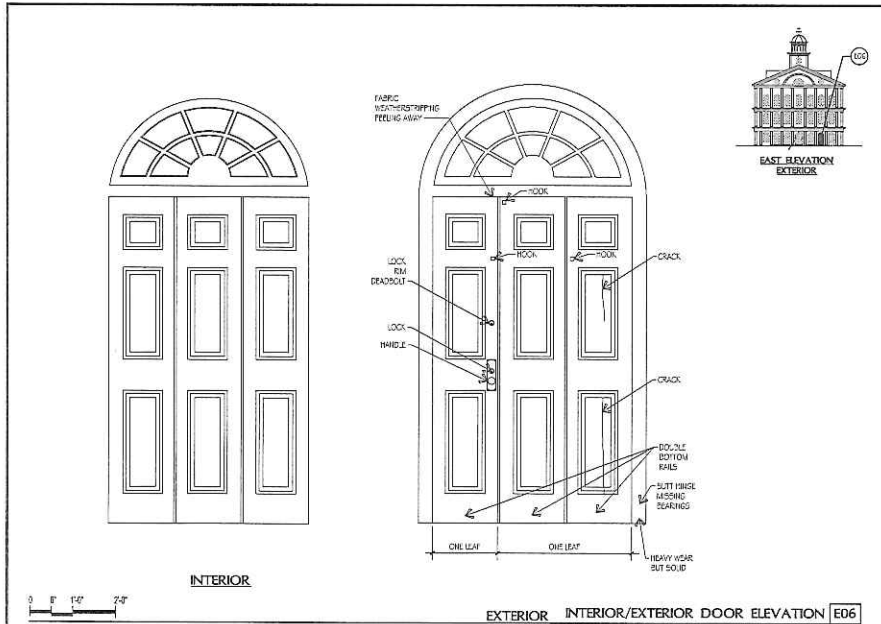
EXTERIOR INTERIOR/EXTERIOR DOOR ELEVATION E06

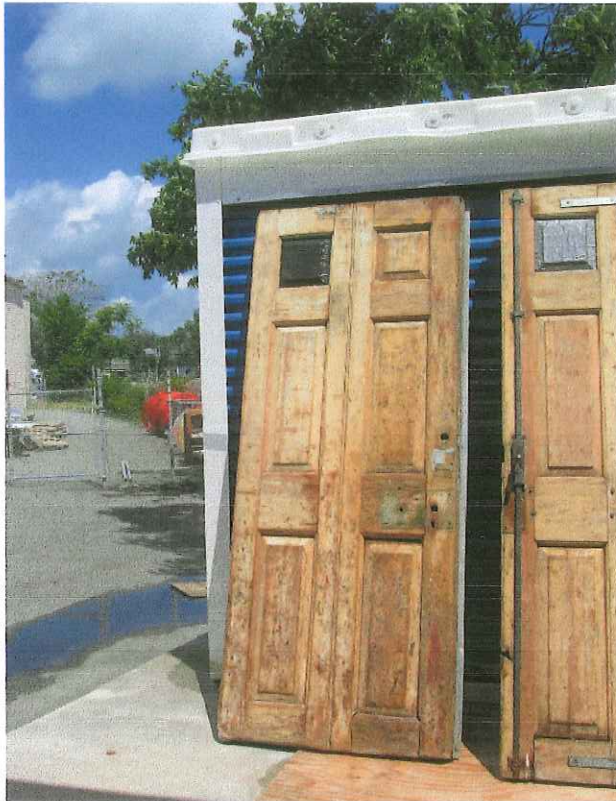
Great Hall Doors – East Elevation of Faneuil Hall with all coatings removed. Note: On the upper left raised panel the coatings have been retained to preserve the historical record.

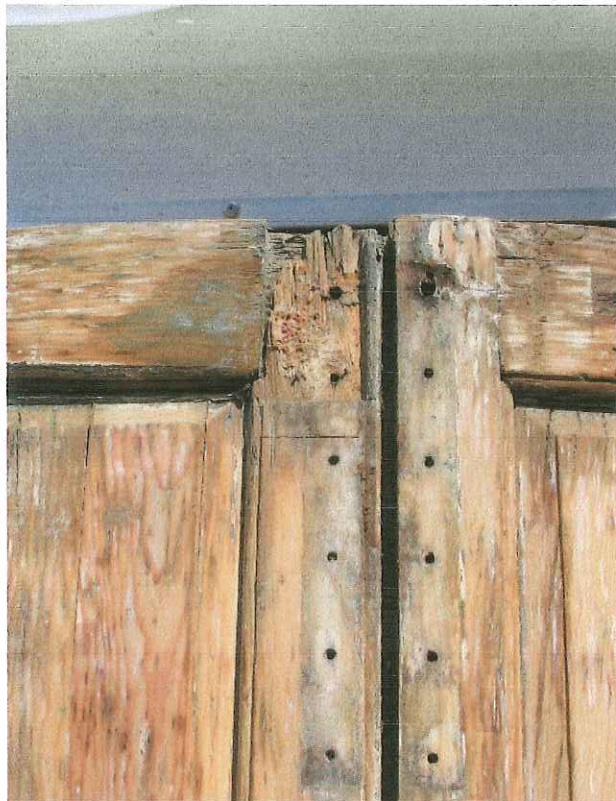
Damaged stile and rail joint of door which will be repaired with stainless steel rod reinforcement and wood "Dutchman" to recreate the original profile of stile.

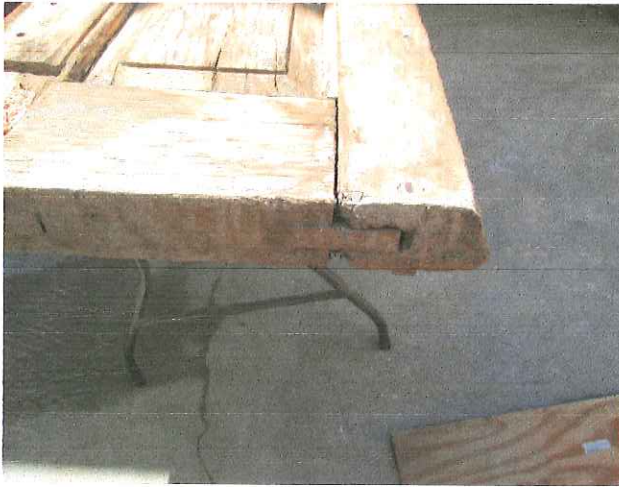
Typical joint between stile and rail with spline instead of a pinned through mortise and tenon. This joint is inherently not as strong as a through mortise and tenon joint which is more commonly found on large heavy doors. To reinforce this joint where the stile and rail have separated a stainless steel through bolt will be installed and hidden behind wooden plugs.
