# Attachment A PROJECT LOCATION MAP

CSS ARCHITECTS INC.  
ARCHITECTURE · PLANNING · INTERIOR DESIGN

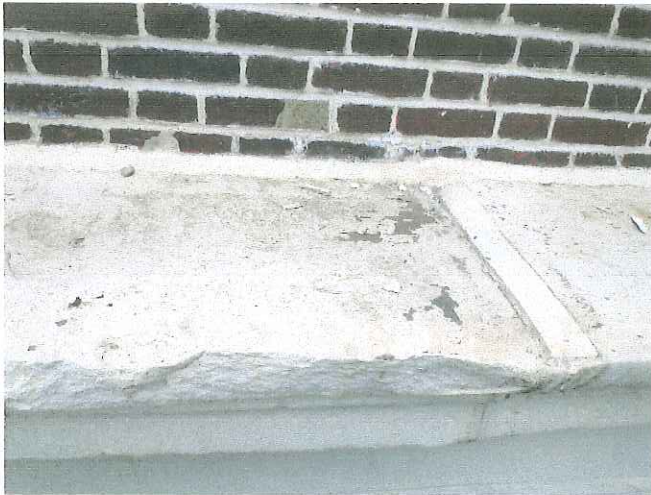
Previous erosion of the sky facing brown stone which has resulted in ponding on the brown stone surface causing failure of the elastomeric coating

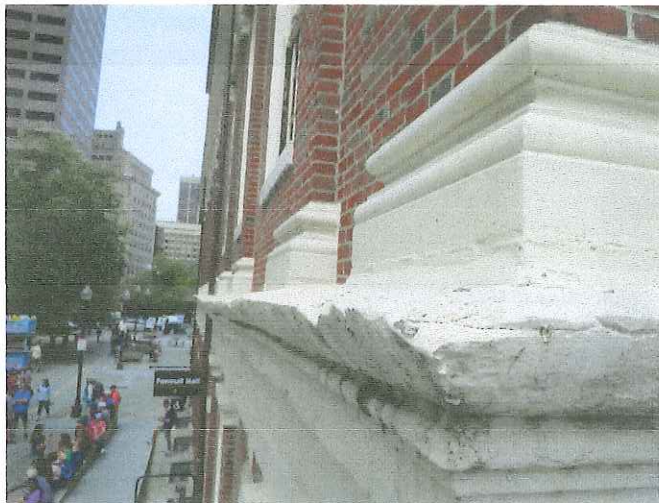
Damage to the edge of the brown stone cornice from water infiltration and abrasion .

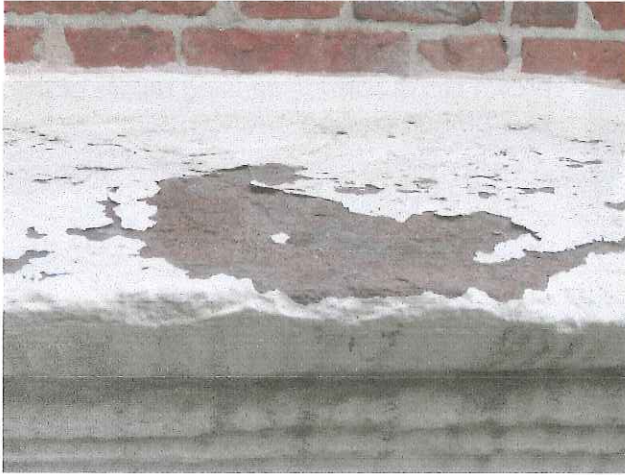
Deterioration of existing elastomeric coating which has exposed the sky facing brownstone to weathering and the freeze thaw cycle.

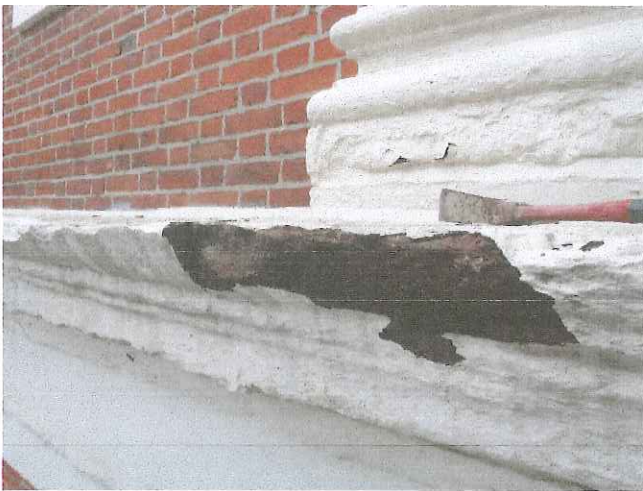
Damage to the brown stone cornice edge due to water infiltration and fracturing from the freeze thaw cycle.

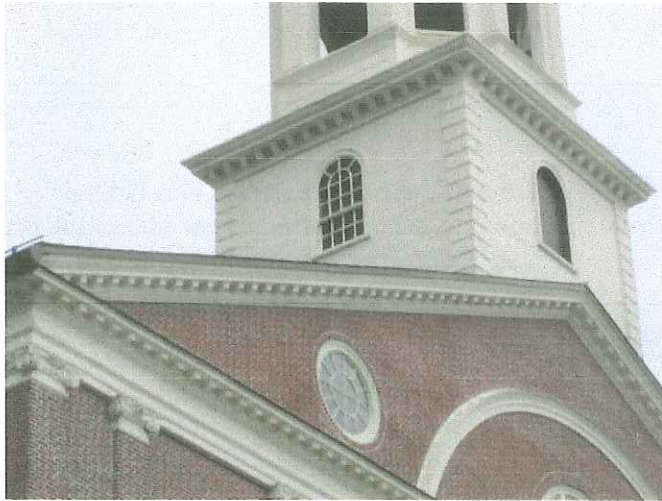
The condition of the paint coatings of the Faneuil Hall Bell tower in 2015

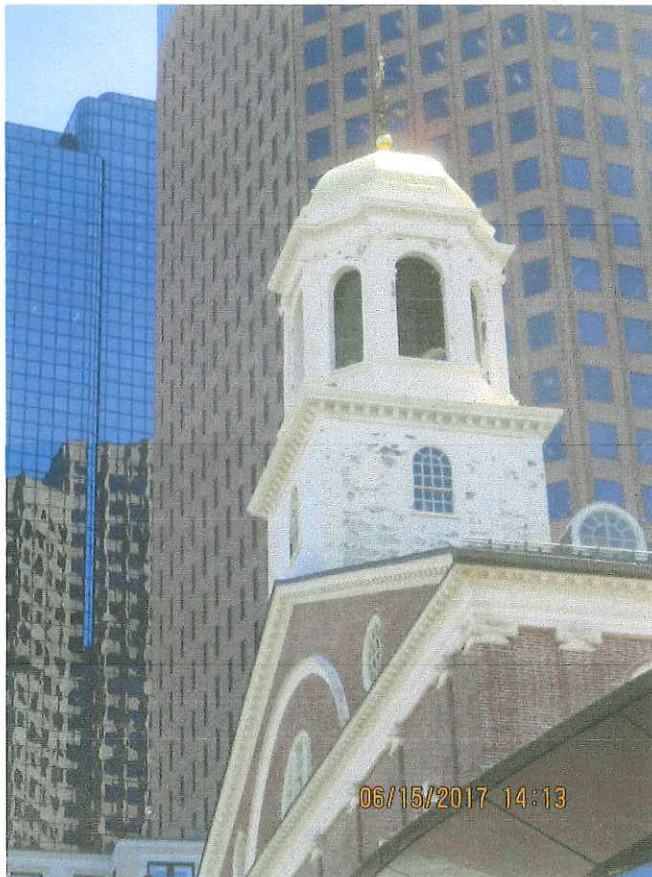
The condition of the paint coatings of the Faneuil Hall Bell Tower in 2017. The extensive failure of the paint coatings is the result of excessive re-coatings of the Bell Tower which has caused the paint film to finally pull away from the substrate due to excessive weight of the coatings.

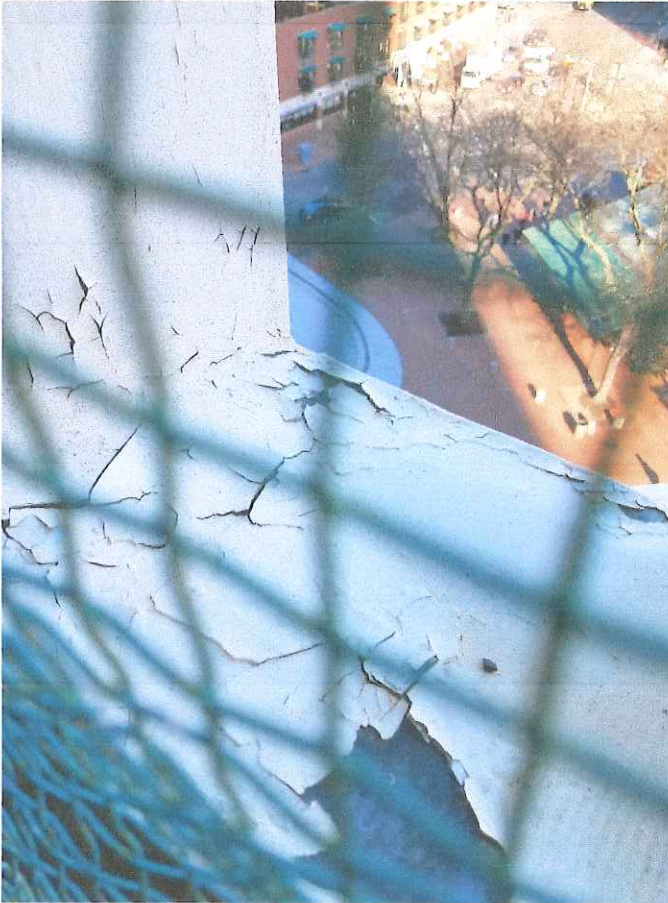
View of the paint coatings at a typical opening showing the copper substrate which has become exposed and the heavy thickness of the existing coatings.

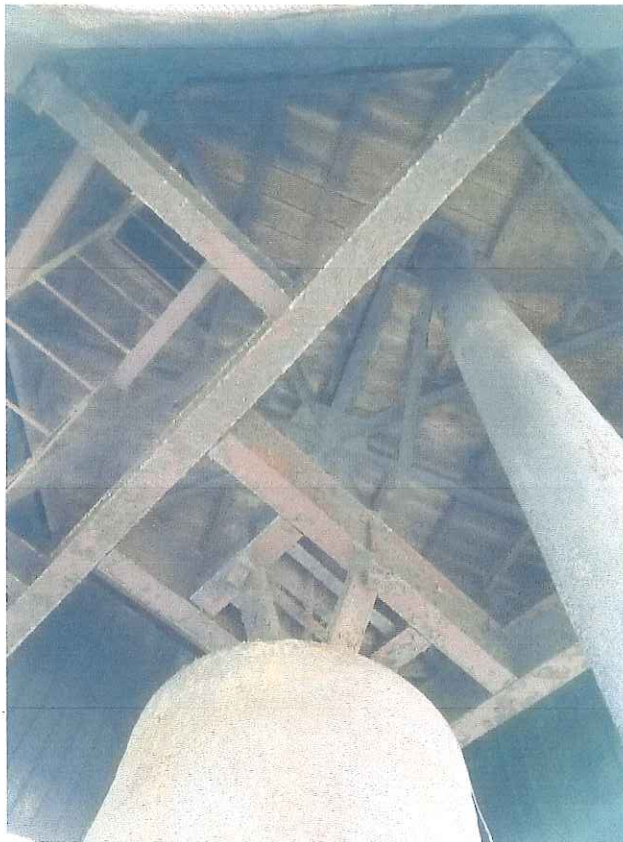
Iron supports for bell and bell tower. The iron has the original coating from 1898. Presently most of the coating has worn away and the iron exhibits superficial rusting. The rust will be removed and all the iron recoated with a rust inhibiting paint. The bell will not be touched as part of this project.
