**256 – 260 NEWBURY**

**Boston, MA**

# DESIGN PROPOSAL 256-260 Newbury

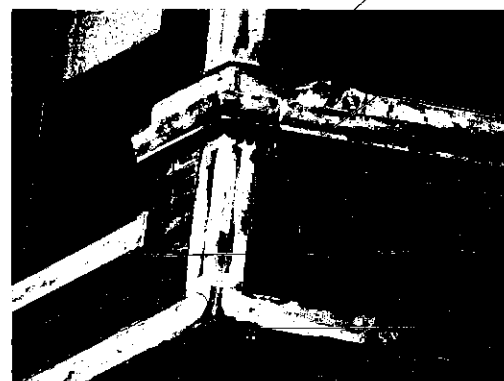
STONE SPALLING

CRACKED MASONRY JOINT, POSSIBLE WALL DELAMINATION

MORTAR DAMAGE

STONE DAMAGE CHIPPED AND WORN PAINT FINISH

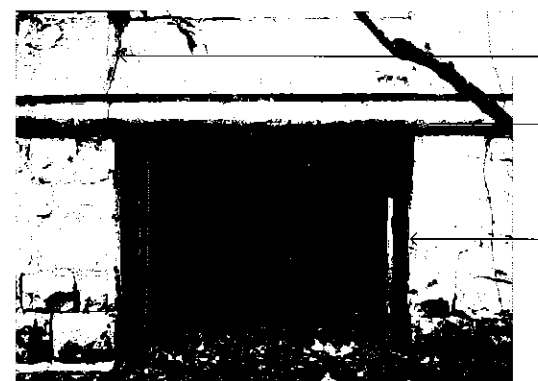
CRACKED STONE

DAMAGED METAL GRILLE

DAMAGED WOOD AND PAINT AT BRICK MOULD AND WINDOW FRAME

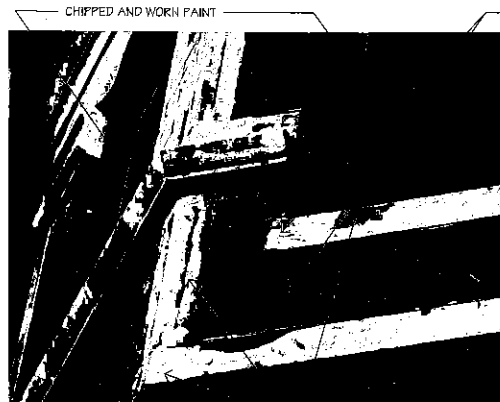
CHIPPED AND WORN PAINT

SPALLED STONE

CHIPPED AND WORN PAINT FINISH
