SPRUCE 4111

BEACON HILL ARCHITECTURAL COMMISSION

REMEDIAL ACTION ORDER

Re: Spruce Place

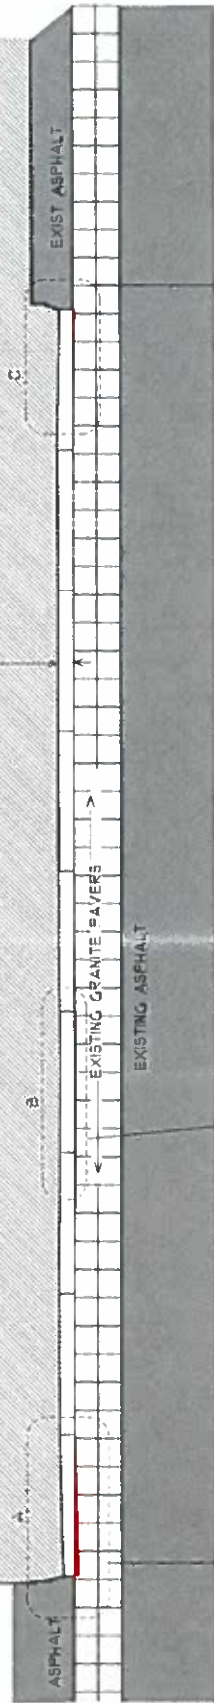
RED AREAS INDICATE CUTS INTO EXISTING PAVERS TO ACCOMMODATE NEW GRANITE CURB
