**EXISTING CONDITION**  
**EXTERIOR ELEVATION & SECTION**

#94 BEACON STREET, UNIT # 5  
 BOSTON, M.A. 02108

#94 BEACON STREET, UNIT #5 BOSTON, M.A. 02108
FRONT ELEVATION = EXISTING DORMER
CURRENT CONDITION
SHEET NO. 3 OF 4

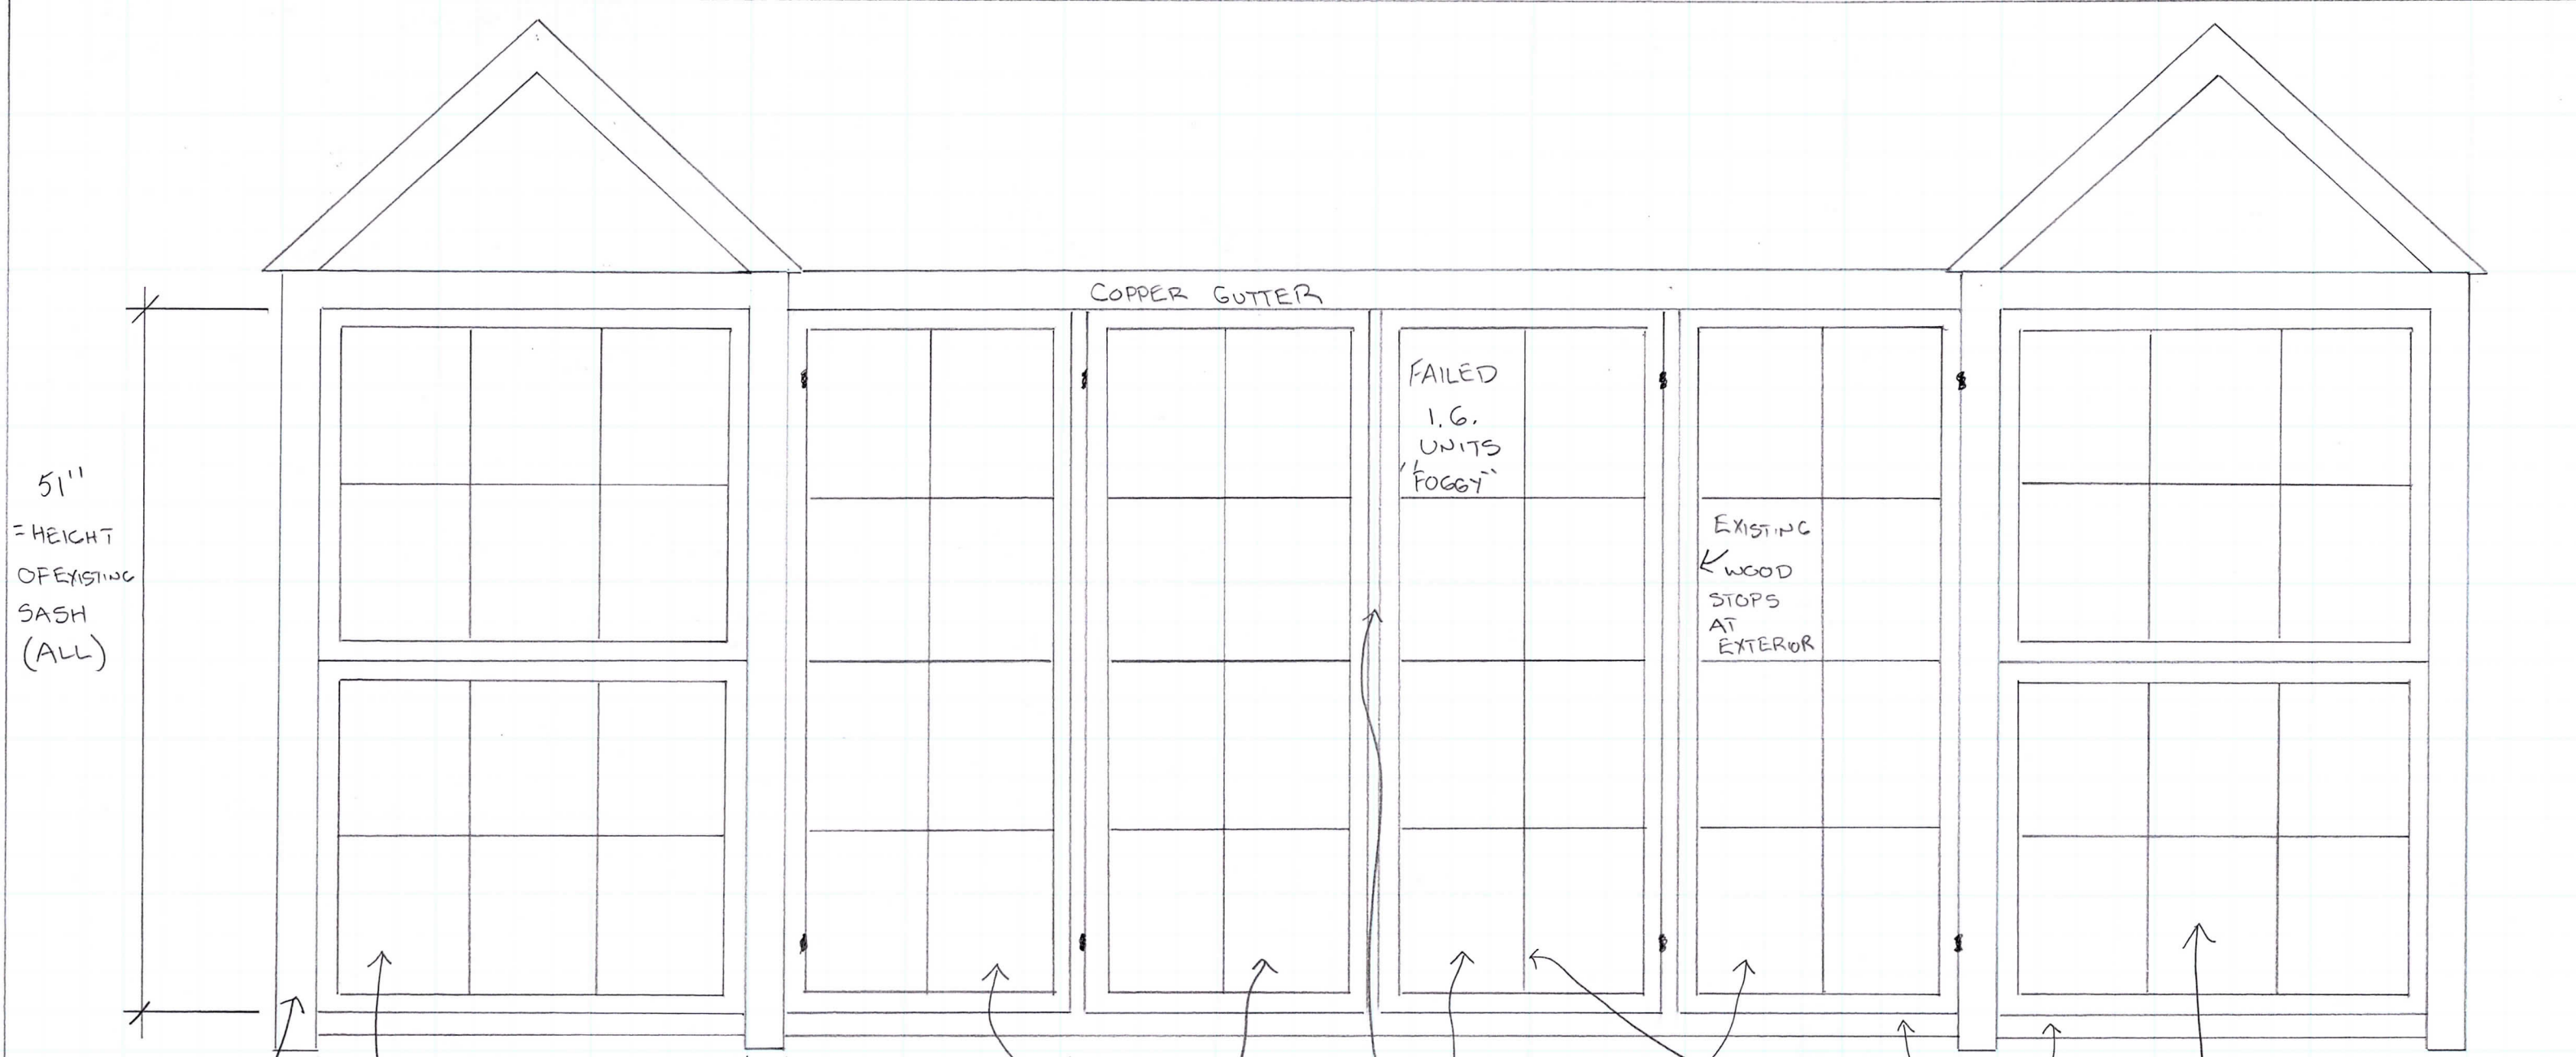
FAILED  
I.G.  
UNITS  
'FOGGY'

BEYOND  
REASONABLE  
REPAIR: FACING  
BOARDS = PINE

SASH SET = CORRECT  
BEACON HILL MUNTIN = 3/4"  
& CORRECT SIDE & TOP/BOTTOM  
RAILS

NON ORIGINAL "SWING OUT"  
8 LIGHT CASEMENT  
WINDOWS = 1/8" MUNTIN  
DESIGN / NON OPERATIONAL  
BROKEN HARDWARE,  
FAILED I.G. UNITS  
= 90'S WINDOW

ALL 90'S LATCHES  
& LOCKING MECHANISMS  
BROKEN / NON OPERATIONAL

ALL EXISTING WOOD  
SILLS/PINE = ROTTED

NON-ORIGINAL  
SASH SET =  
1/8" MUNTIN DESIGN,  
FAILED INSULATED  
GLASS UNITS,  
TRUTH HARDWARE  
= 90'S  
WINDOW

1/8" EXISTING NON-ORIGINAL  
MUNTIN DESIGN
