# RIORDAN RESIDENCE

6 OTIS PLACE

FOR BHAC REVIEW

06.22.21

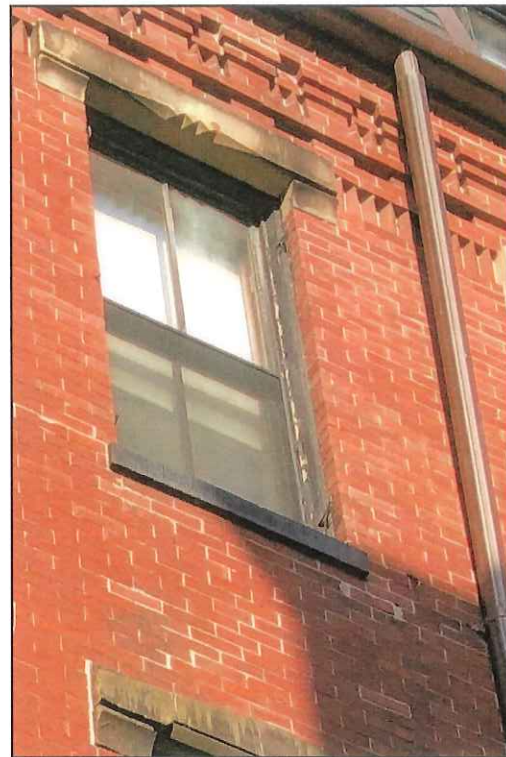
A

Existing sills and lintels to remain as-is and appear in good condition, PB to clean them.

PB to reuse existing brickmould where feasible

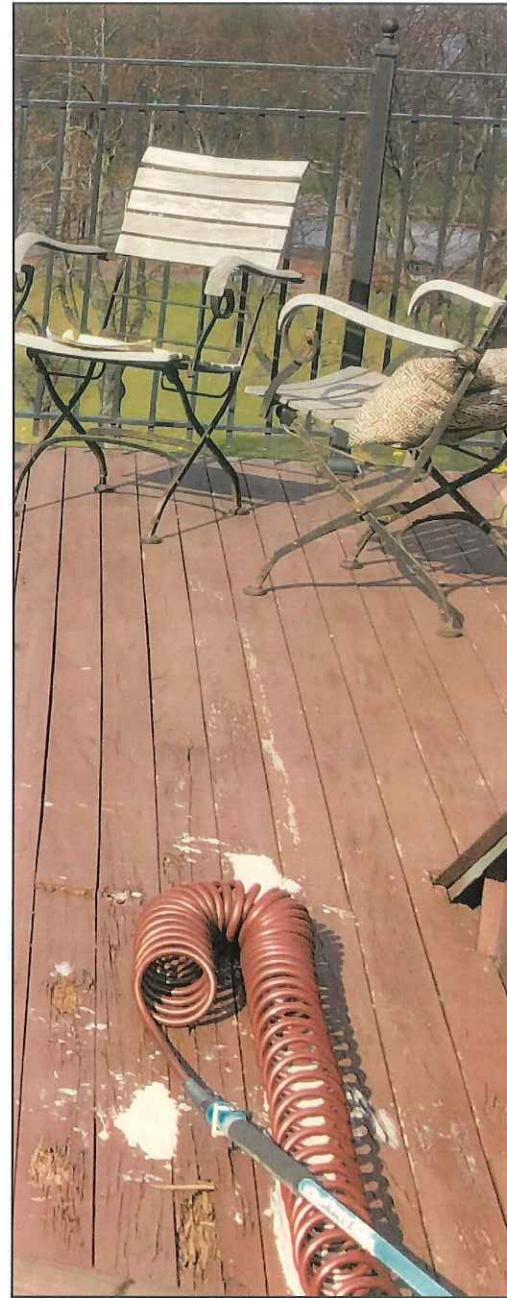
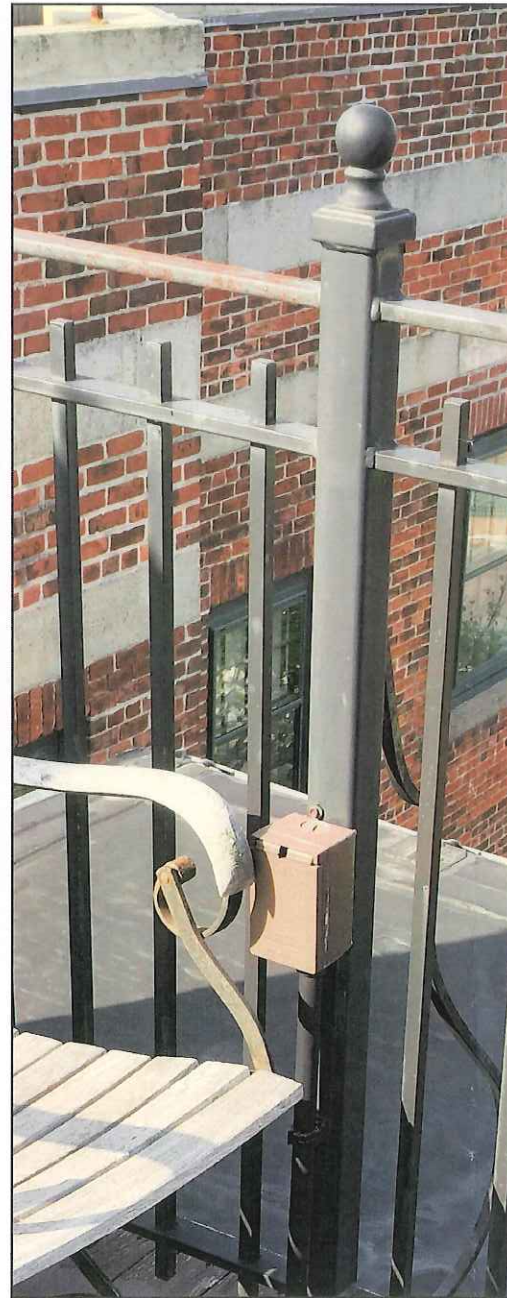
Images of existing upper decking railing. Existing decking to be replaced with mahogany or sapele decking. Existing railing to be removed, sanded, primed and painted in Ben Moore soft gloss black, reinstalled in existing configuration. No work at chimneys.

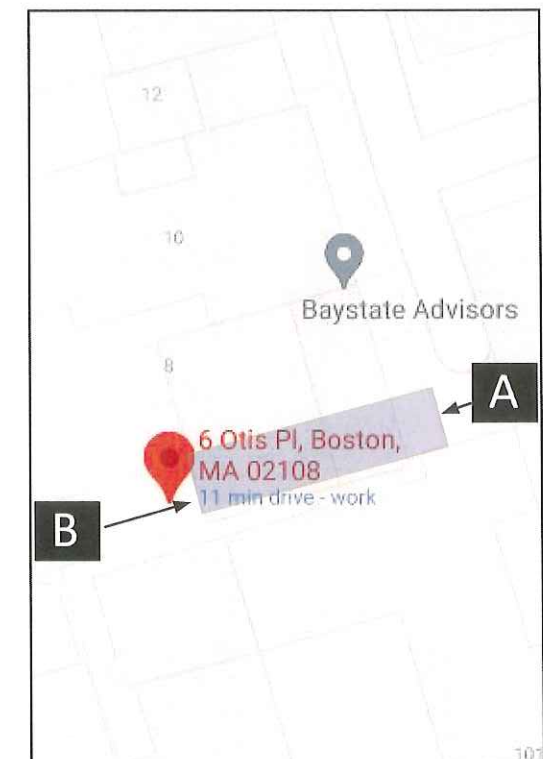
Plan of proposed roof deck with section of roof. We are seeking permission to rebuild decking in the same footprint as the roof with reinstall of existing iron railing. Seeking permission to remove all existing roofing from front deck and main roof area and install Carlisle 1/2" rigid insulation and Carlisle .060 EPDM to entire roof area. We are seeking permission to replace existing gutter with 20 oz custom gutter to match, requiring removal and reset of 2 rows of slate above gutter line.
