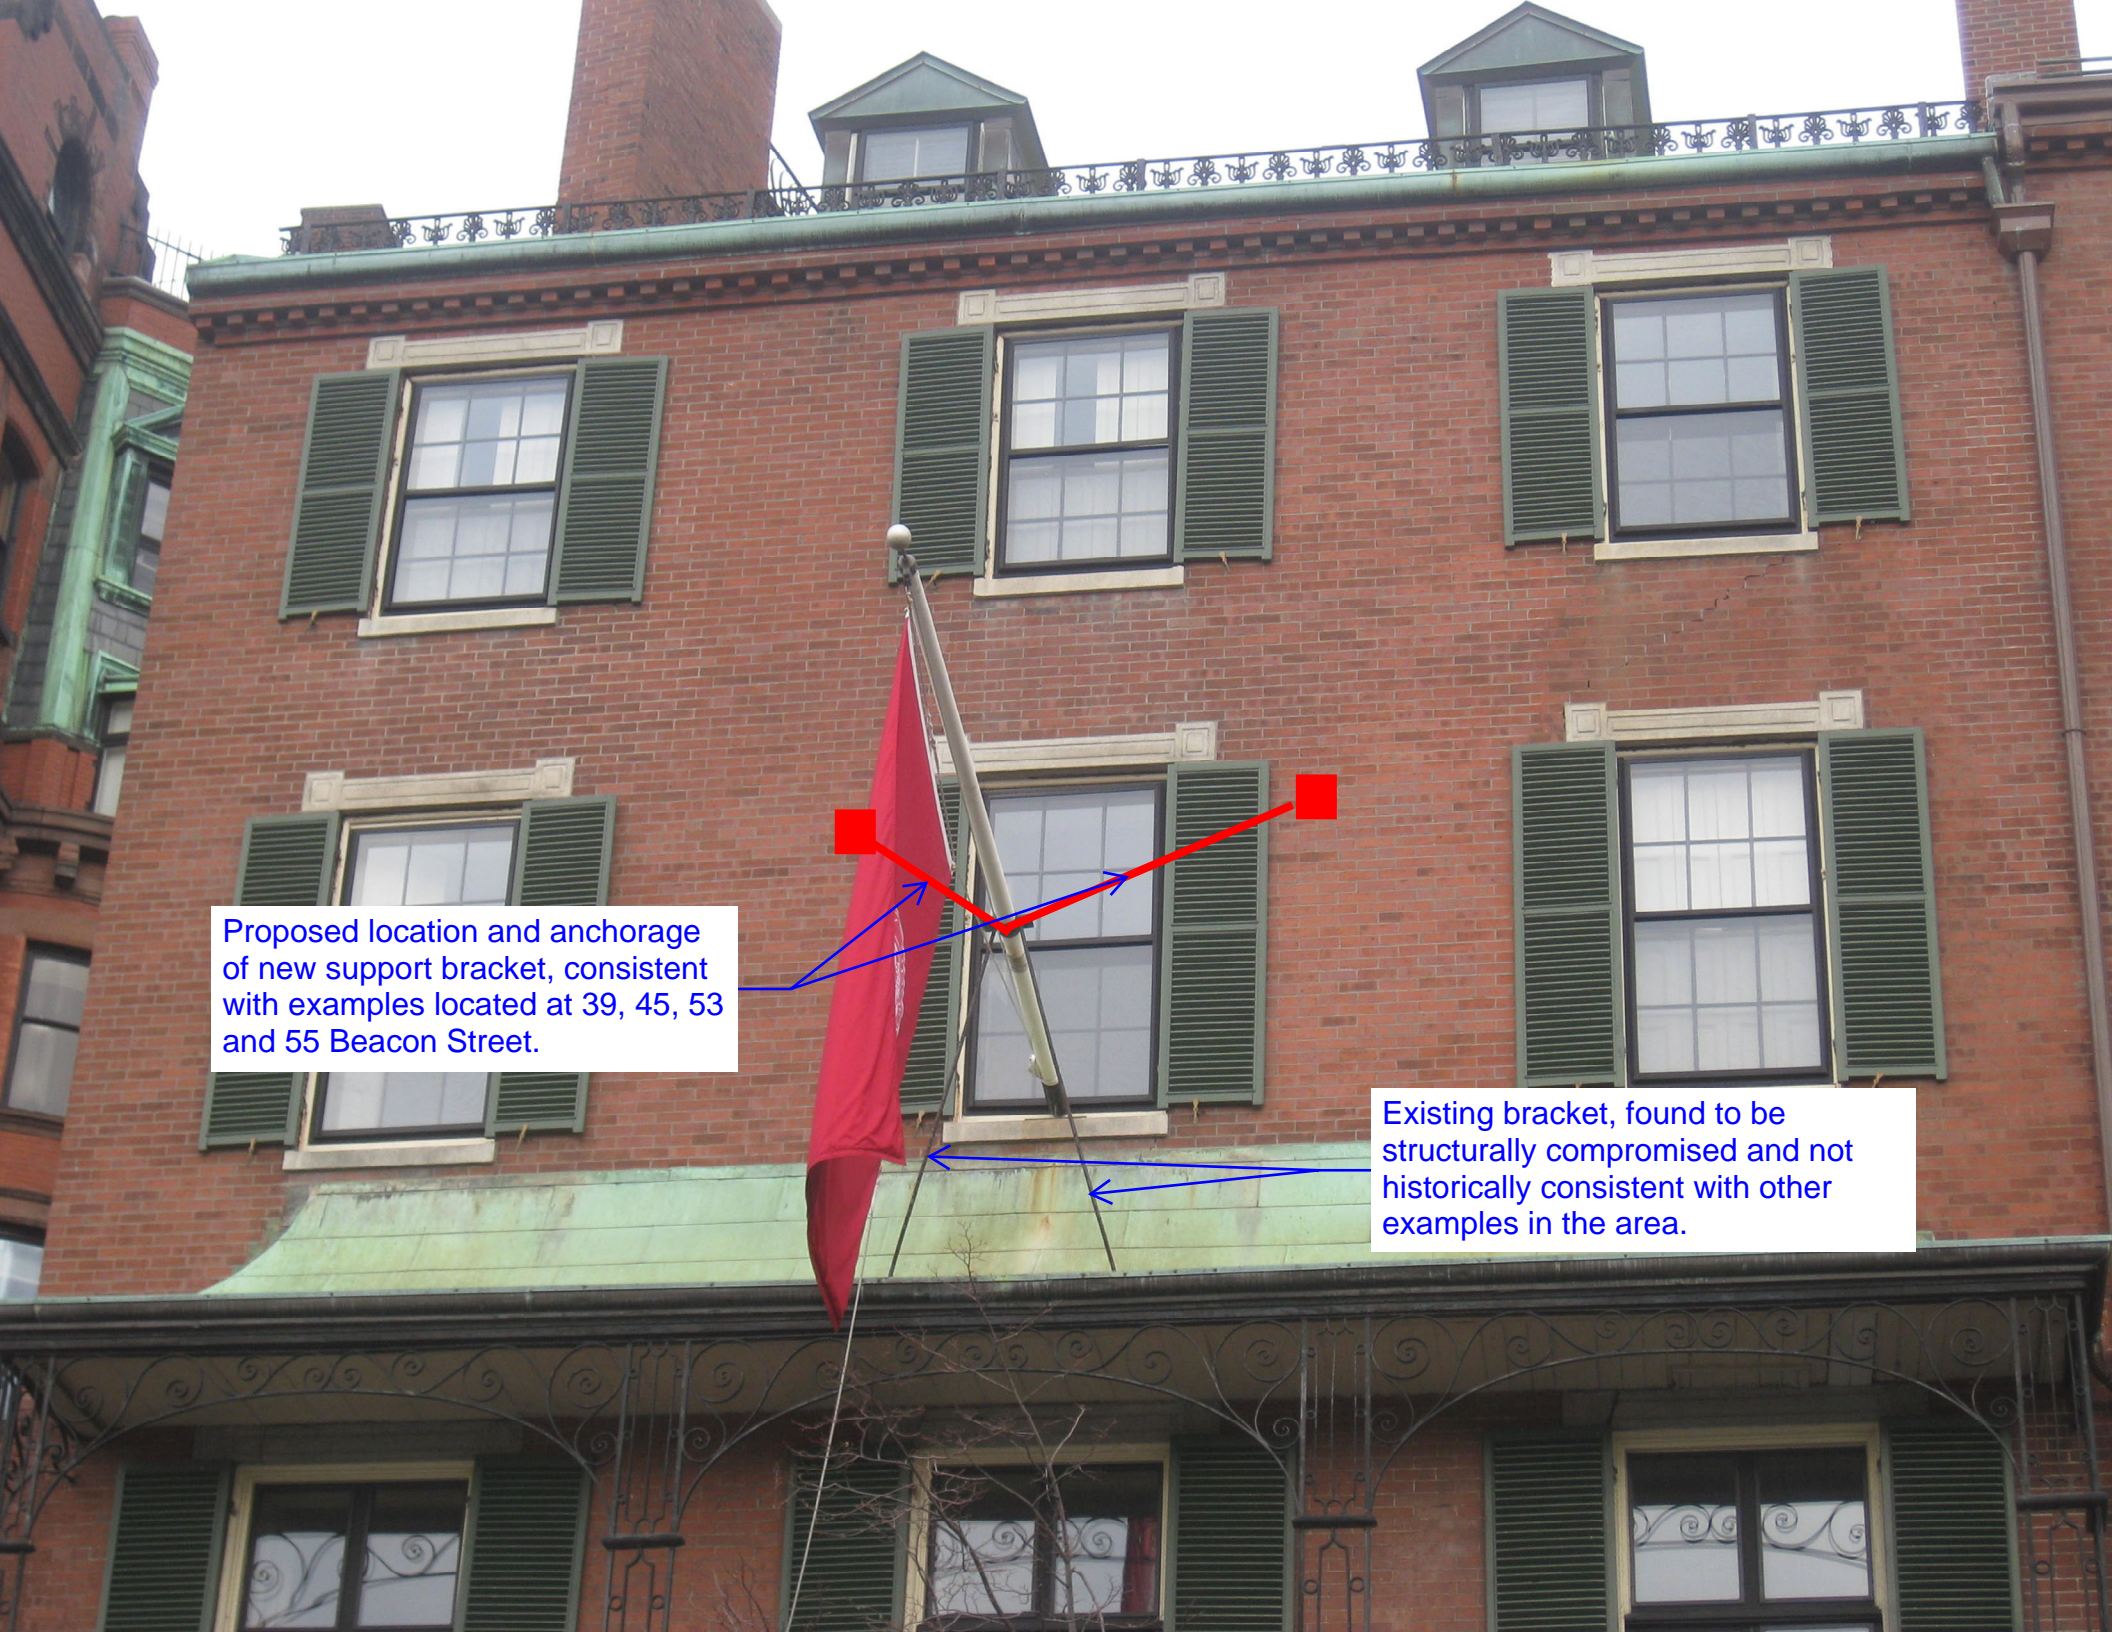
Existing bracket, found to be structurally compromised and not historically consistent with other examples in the area.

Proposed location and anchorage of new support bracket, consistent with examples located at 39, 45, 53 and 55 Beacon Street.
