DARTMOUTH ELEVATION SEE DIAGRAM 1A

ST JAMES STREET ELEVATION SEE DIAGRAM 1B

DIAGRAM 1A

DIAGRAM 1B

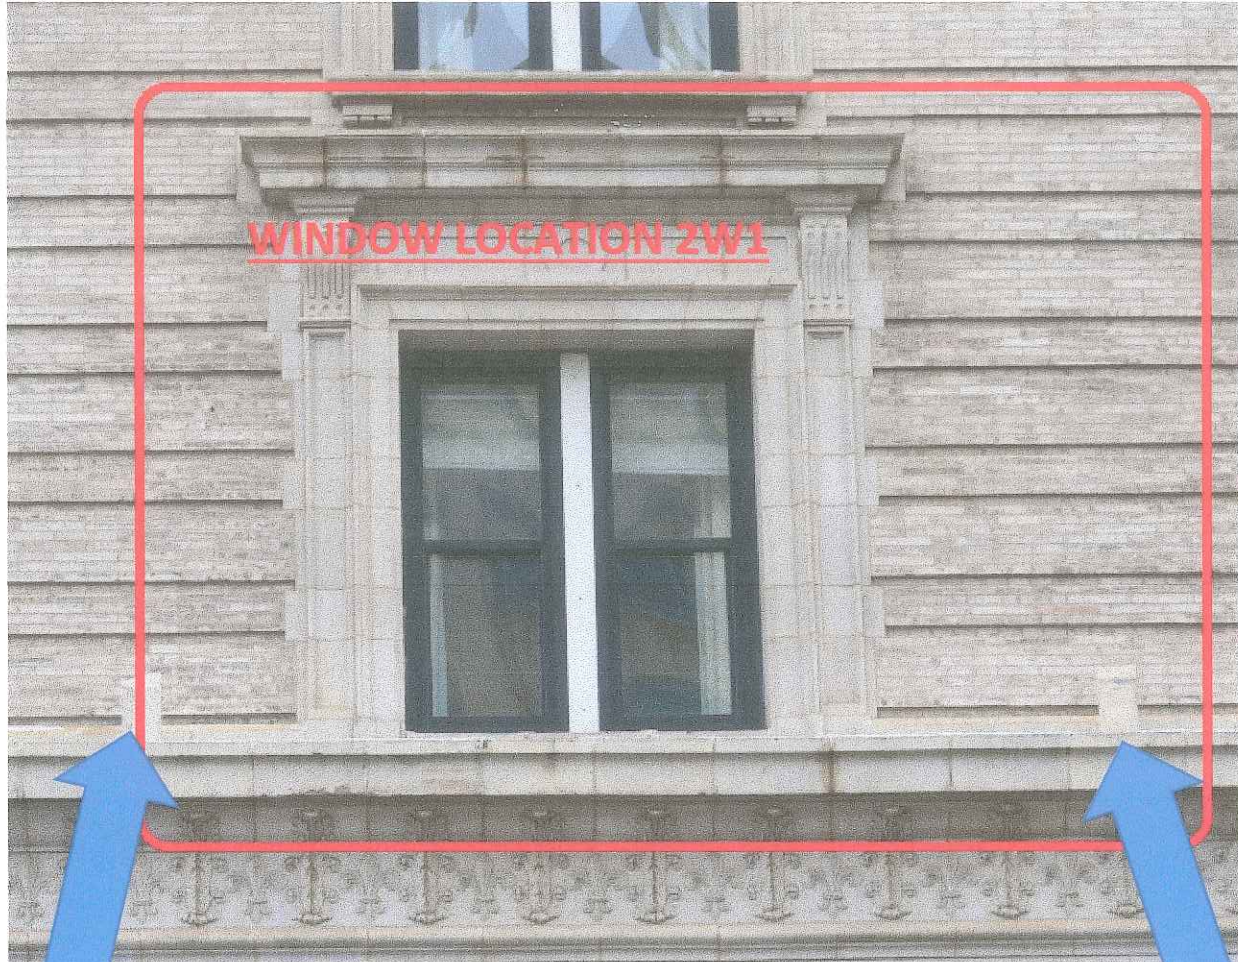
WINDOW LOCATION 2W1

This photograph is taken of the window 2W1. It is located at the far left of the Dartmouth Street elevation (west facing) second floor. Shown to the right and left of the window are incandescent lighting fixtures which are hidden behind decorative metal flashing. There are 13 of these fixtures across the side of the building. The hotel proposes to replace the existing fixtures with color changing type LED fixtures. There will be no visible physical changes to the building façade. The proposed lighting fixtures will be hidden behind the decorative metal flashing.

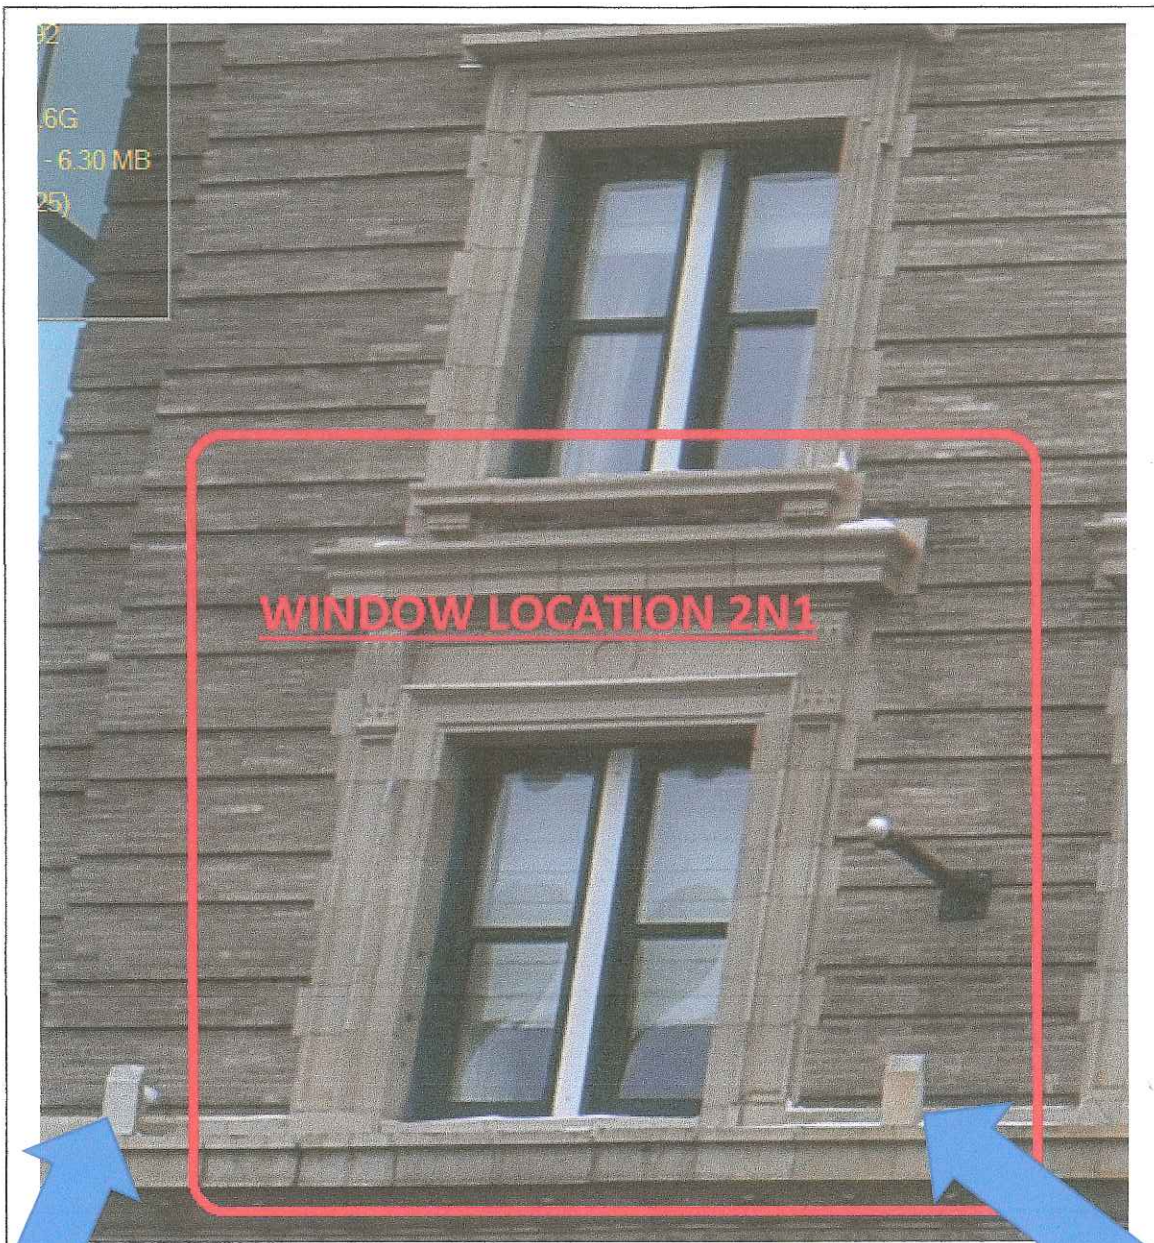
This photograph is taken of the window 2N1. It is located at the far left of the St James Street elevation (north facing) second floor. Shown to the right and left of the window are incandescent lighting fixtures which are hidden behind decorative metal flashing. There are 16 of these fixtures across the front of the building. The hotel proposes to replace the existing fixtures with color changing type LED fixtures. There will be no visible physical changes to the building façade. The proposed lighting fixtures will be hidden behind the decorative metal flashing.

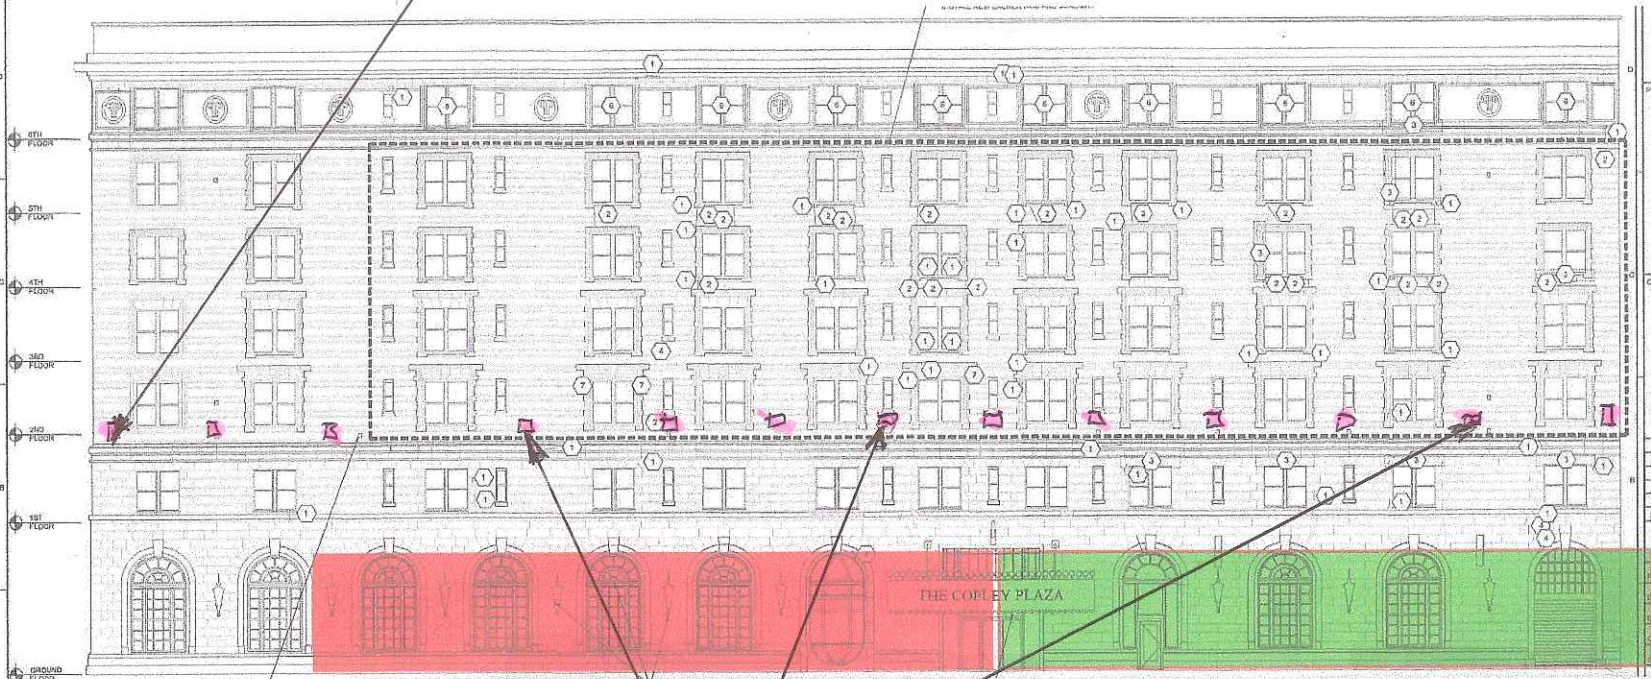
PROTECT ALL LIGHT FIXTURES AND FINISHES DURING WORK

1 DARTMOUTH STREET ELEVATION

EXISTING INCANDESCENT BULBS TO BE REPLACED WITH LED STRIPES TYPICAL 13 LOCATIONS DARTMOUTH ST.

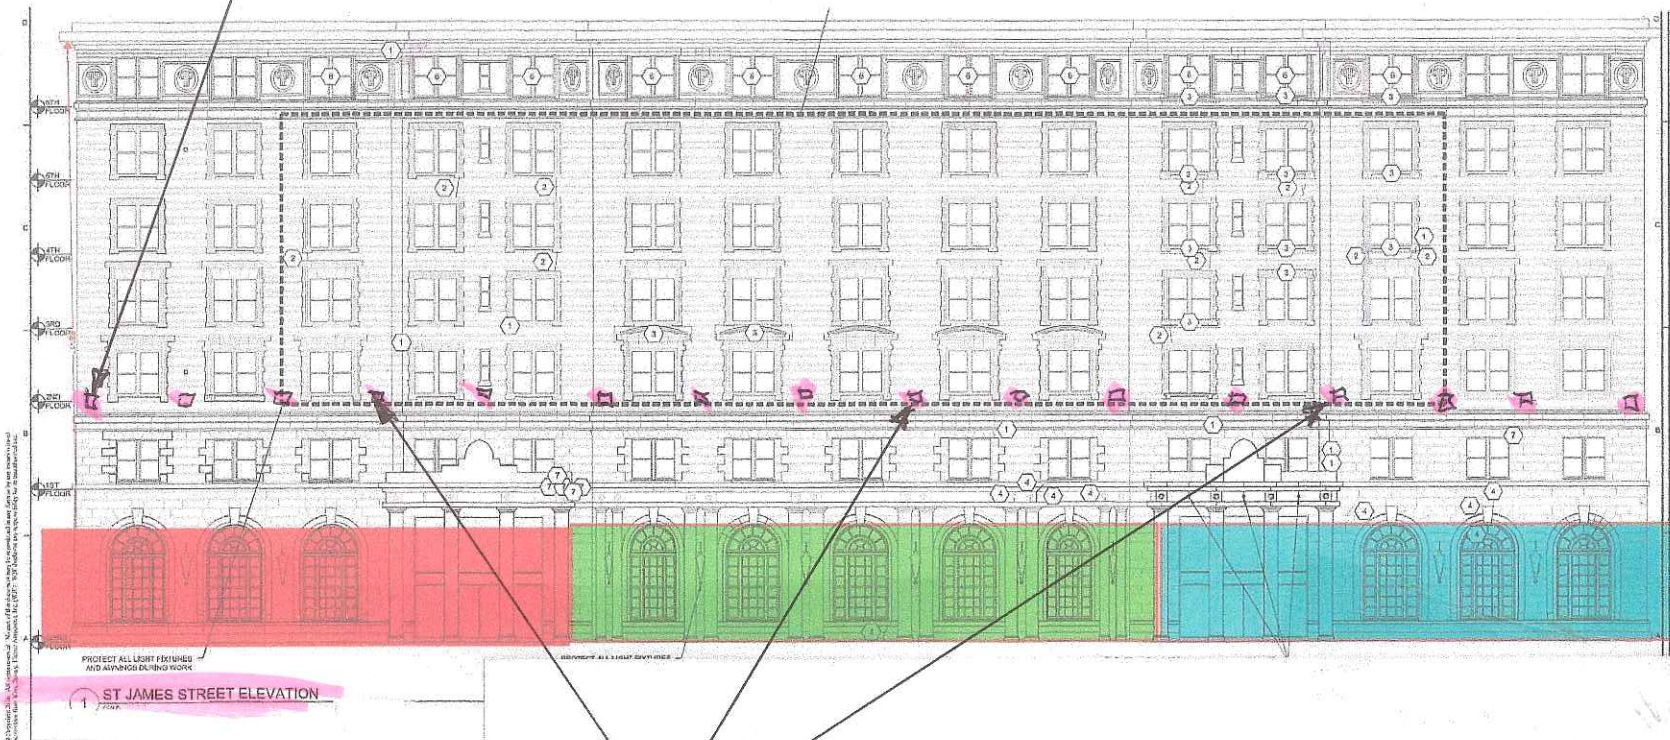
EXISTING INCANDESCENT BULBS TO BE REPLACED WITH LED FIXTURES TYPICAL 16 LOCATIONS ST JAMES AVE
