77 CHESTNUT STREET: EXTERIOR IMPROVEMENTS

Scope Narrative by Floor:

77 CHESTNUT STREET - EXTERIOR IMPROVEMENTS

77 CHESTNUT STREET - BUILDING SECTIONS DEMONSTRATING HEADHOUSE SETBACK

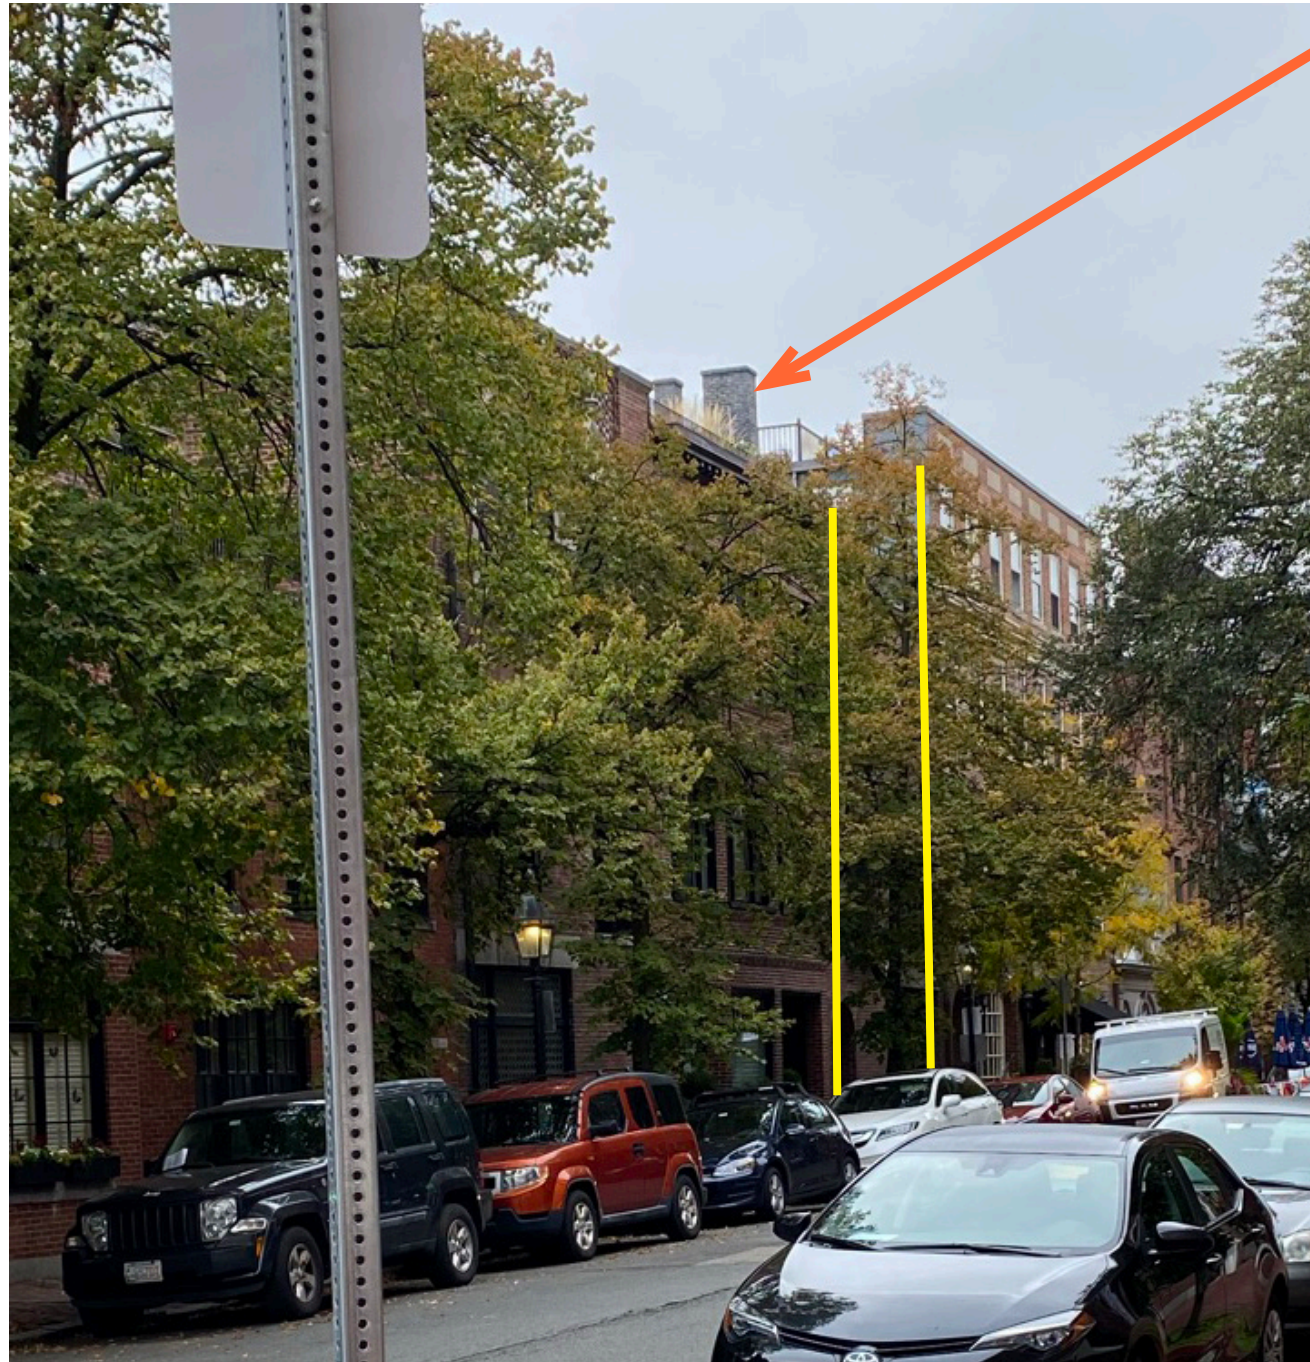
1

- NEW STANDING SEAM COPPER CLADDING AT CHIMNEY

- REPAINT ARCHITECTURAL IRONWORK IN EXISTING COLOR

- REPAINT WOOD WINDOWS, FRONT DOOR, AND GARAGE DOOR IN EXISTING COLOR

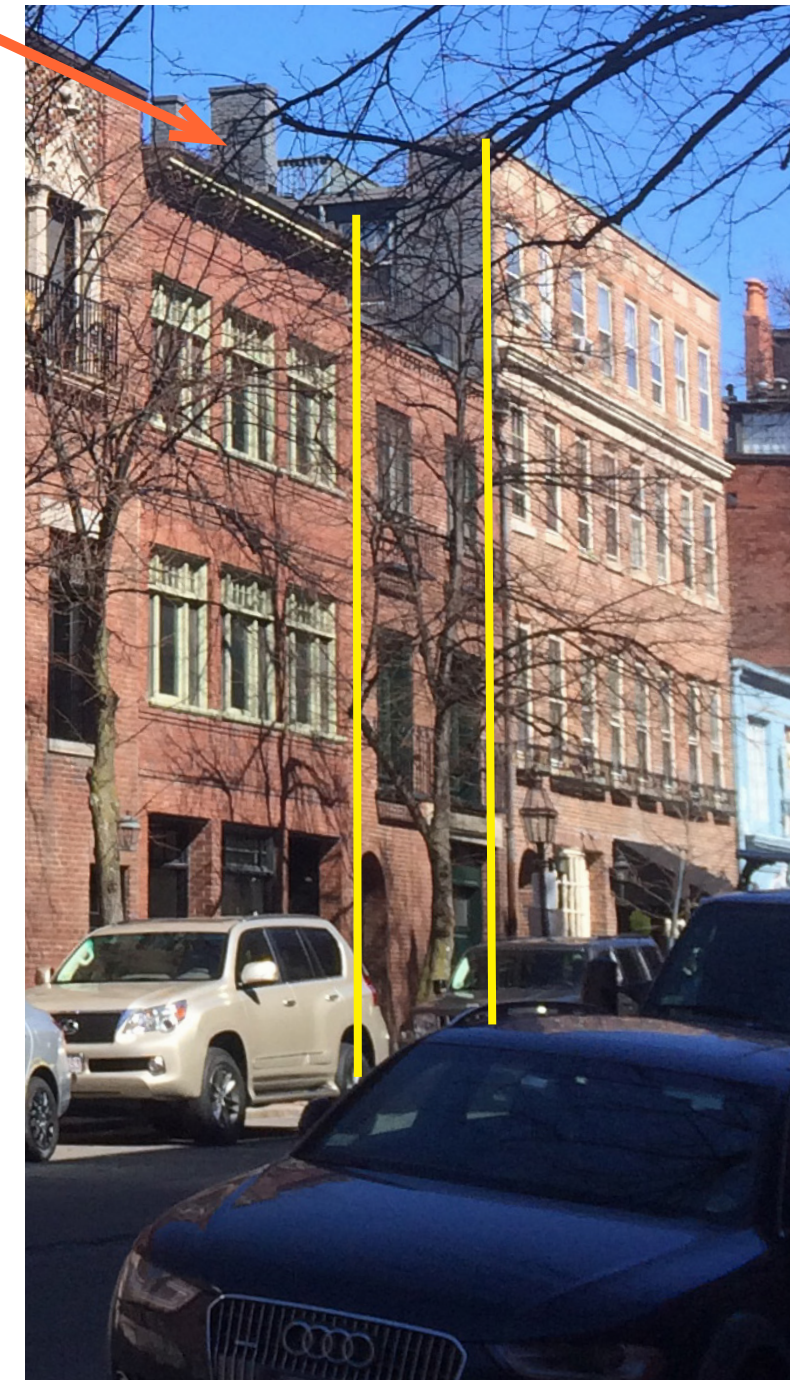
2

- NEW STANDING SEAM COPPER CLADDING AT CHIMNEY AND ELEVATOR HEADHOUSE

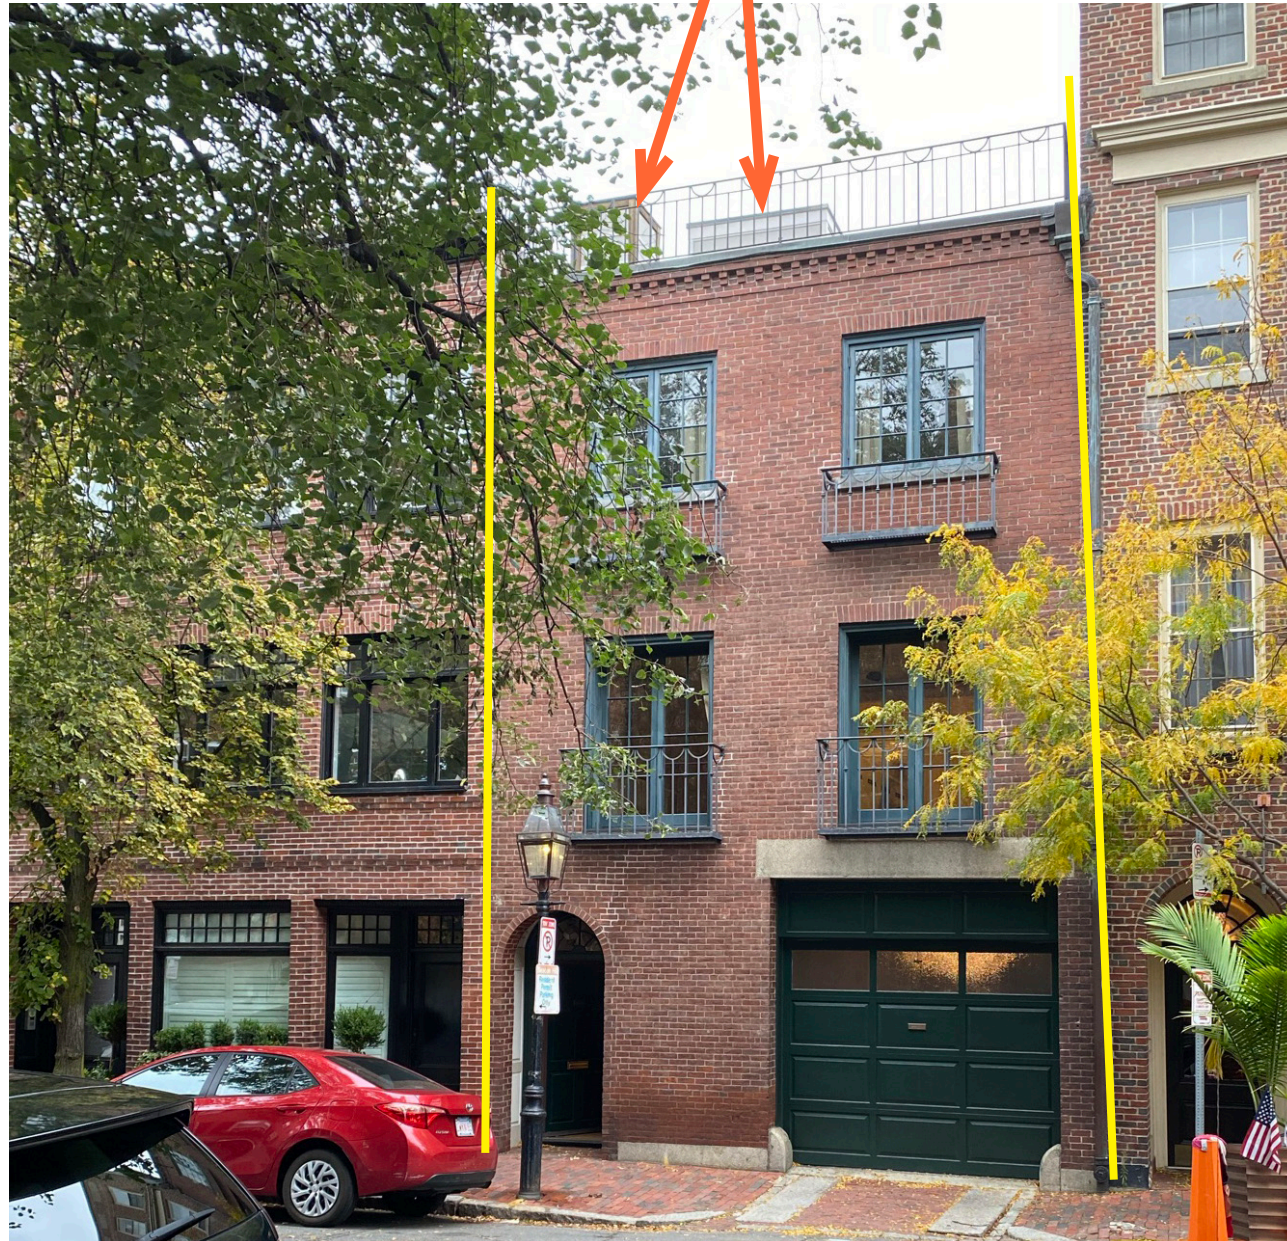
3

- REPAINT ARCHITECTURAL IRONWORK IN EXISTING COLOR
- REPAINT WOOD WINDOWS, FRONT DOOR, AND GARAGE DOOR IN EXISTING COLOR

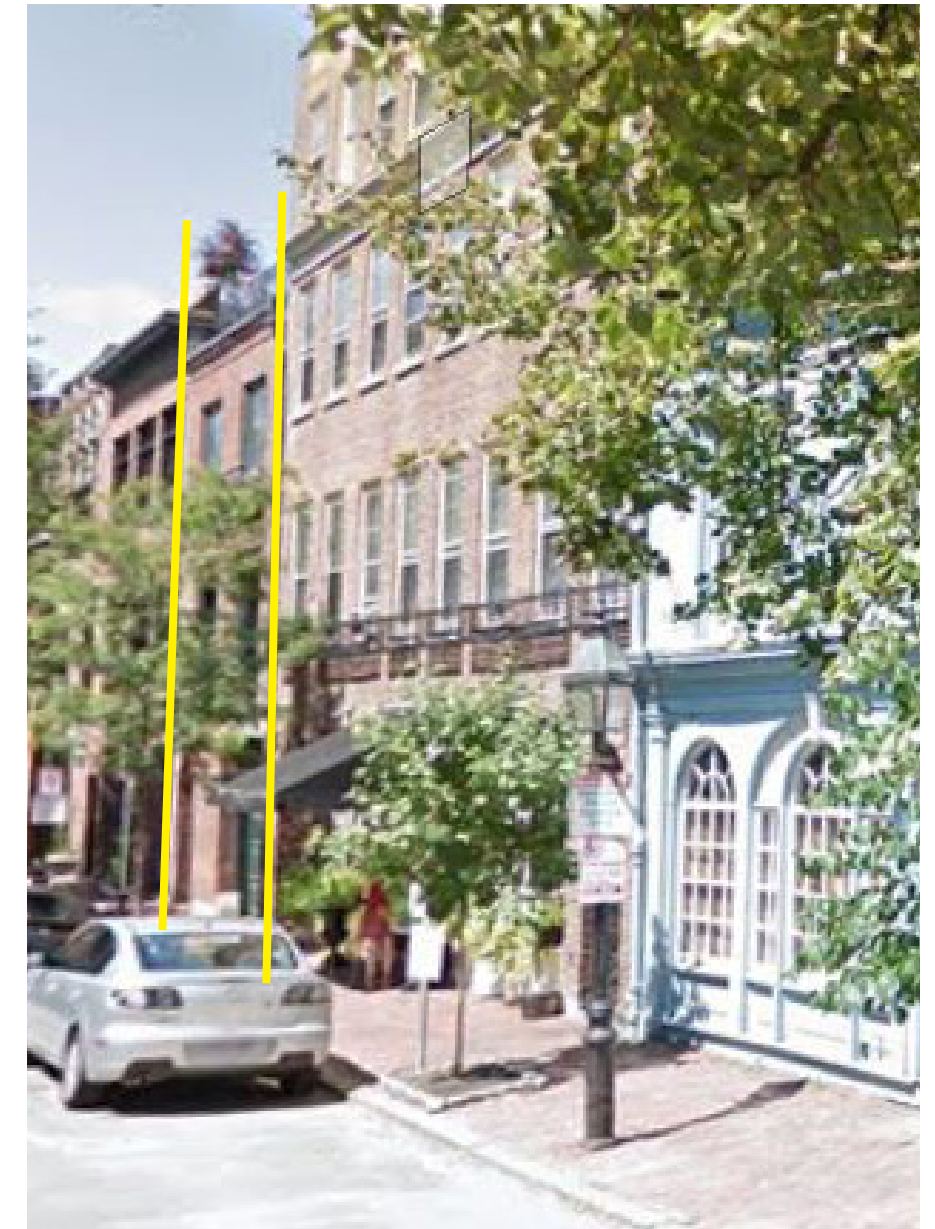
4

- NEW PICTURE WINDOWS AND DOORS AT HEADHOUSE - *NOT VISIBLE FROM STREET*

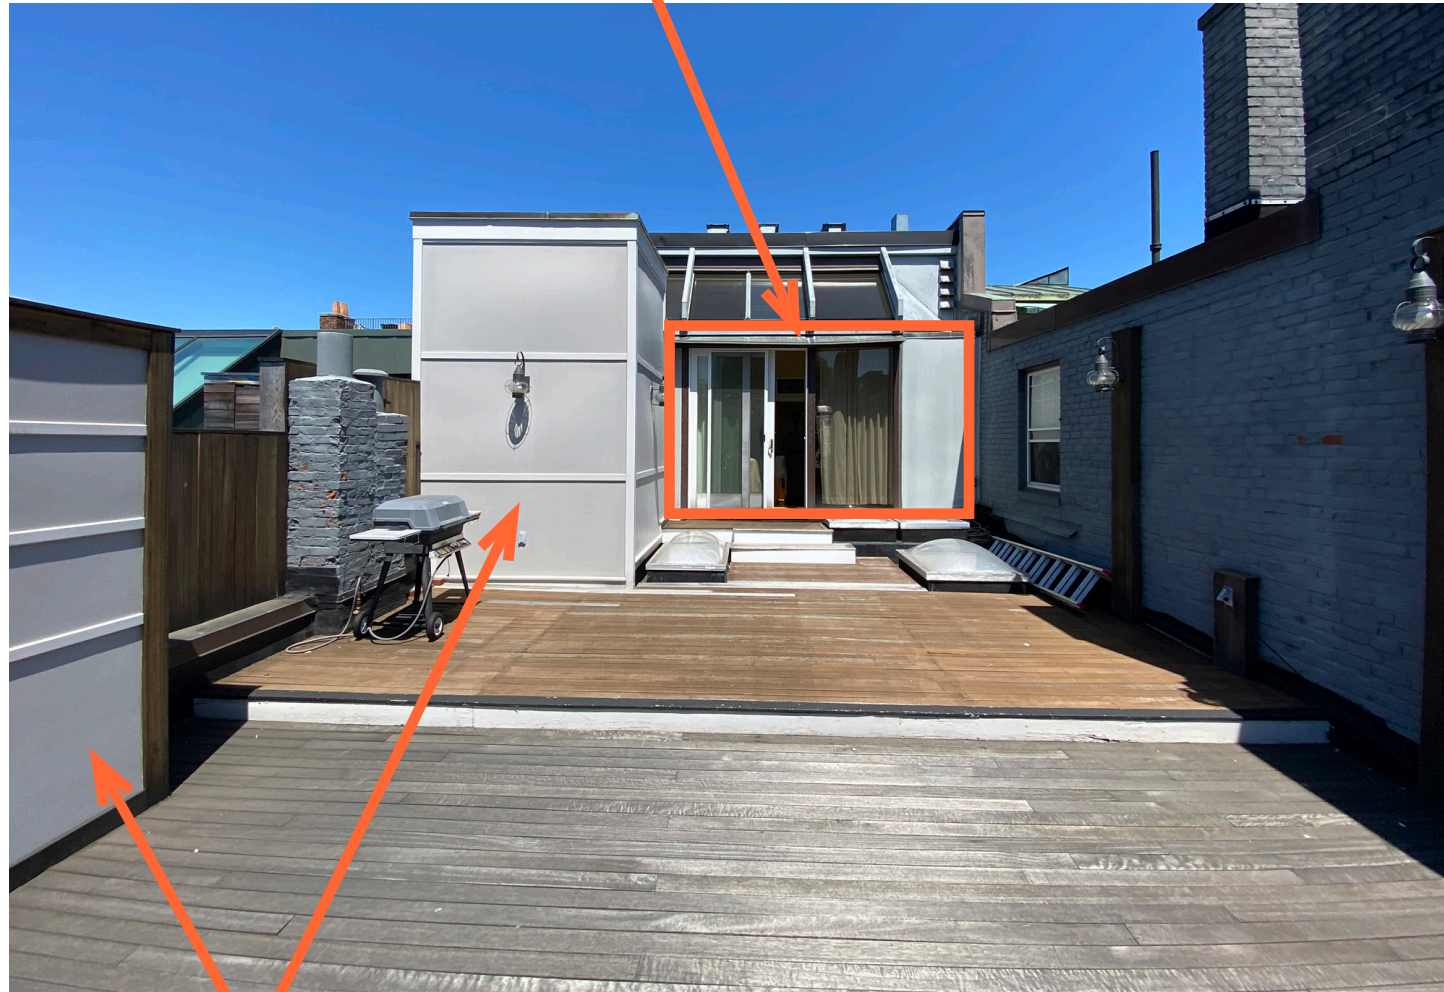
- NEW STANDING SEAM COPPER CLADDING AT CHIMNEY AND ELEVATOR HEADHOUSE
