123 Charles St

PRESENTATION TO BEACON HILL ARCHITECTURAL COMMISSION

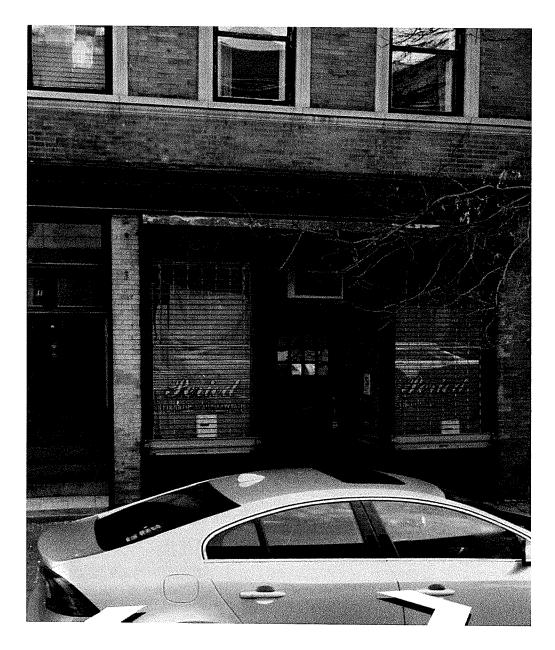
123 Charles façade before metal grilles' removal last month

Previous Demolition

- Removed metal roll up grilles
- Removed air conditioning unit

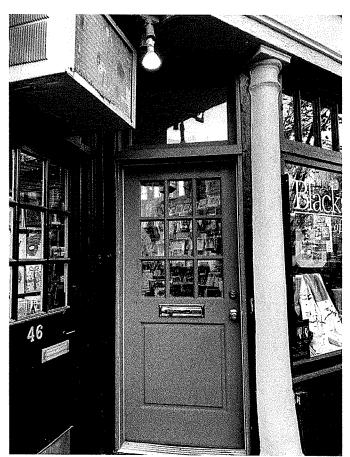
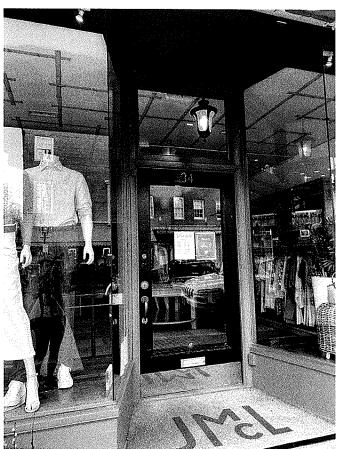
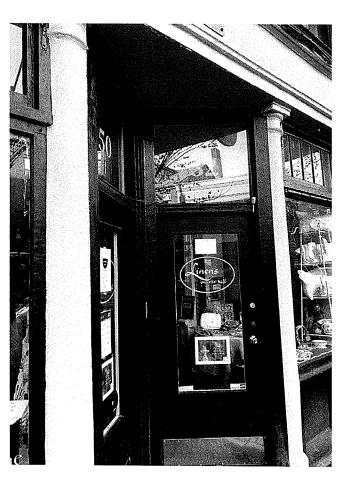
Examples of existing entry door transoms – Neighborhood Around 123 Charles St

- 1 Transom window-Remove existing ¼" clear plate glass infills and damaged mullions and replace with ¼" single-pane, clear safety glass 32" x 43" to match neighborhood examples.
- 2 In-kind repair gaps and scrape damaged exterior wood storefront as needed.
- 3 Remove all damaged plywood panels below windows and replace with exterior—grade MDO.
- 4 Paint all exterior wood storefront, with exterior-grade paint semi-gloss black.
- 5 Scrape and Paint existing door with exterior-grade paint semi-gloss black (alt dark green).
- 6 New wrought-iron (bracket) and wooden (signage). Location to match original placement.

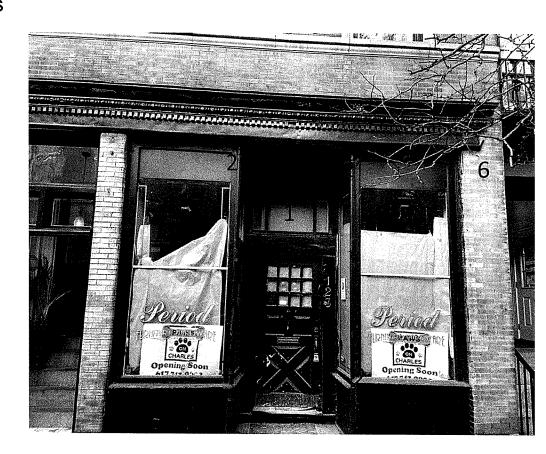
123 Charles' façade – Existing Conditions
