# THE RICHARDS-FOLLETT-PFAFF STABLES

Boston Landmarks Commission  
Study Report

Report on the Potential Designation of

**The Richards-Follett-Pfaff Stables**  
39 Stanhope Street, Boston, Massachusetts

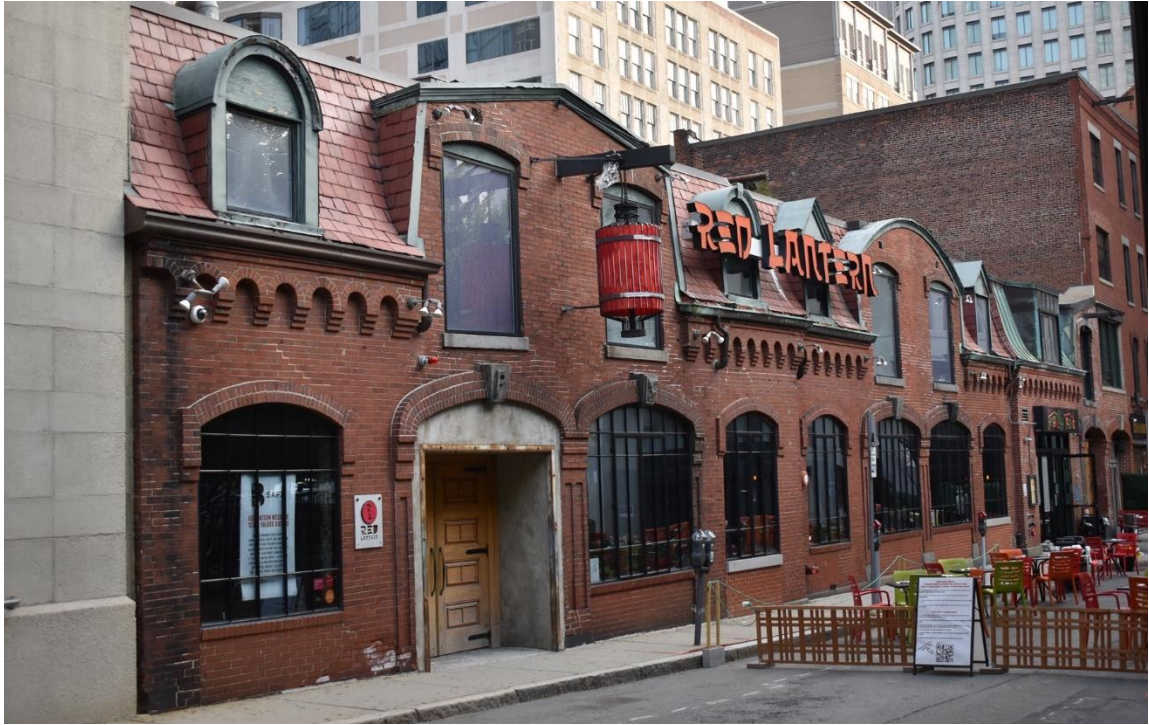
**Photo 1.** 39-45 Stanhope Street facade (south elevation), looking northeast.

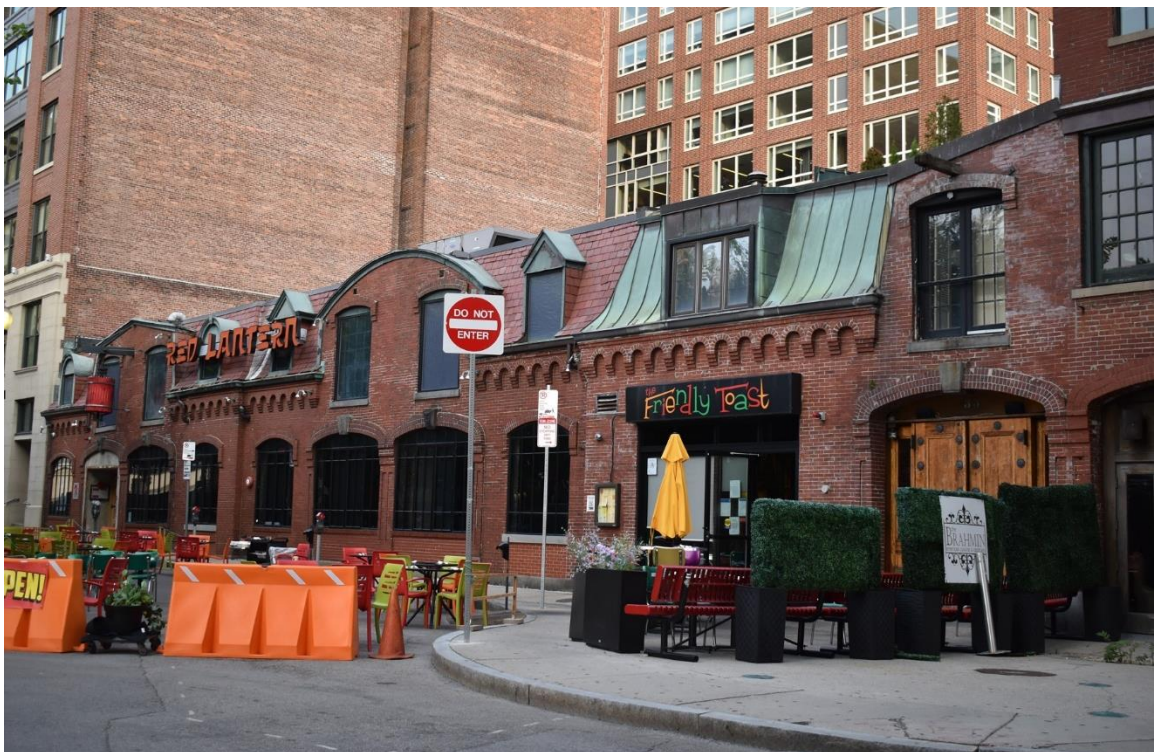
**Photo 2.** 39-45 Stanhope Street facade, looking northwest.

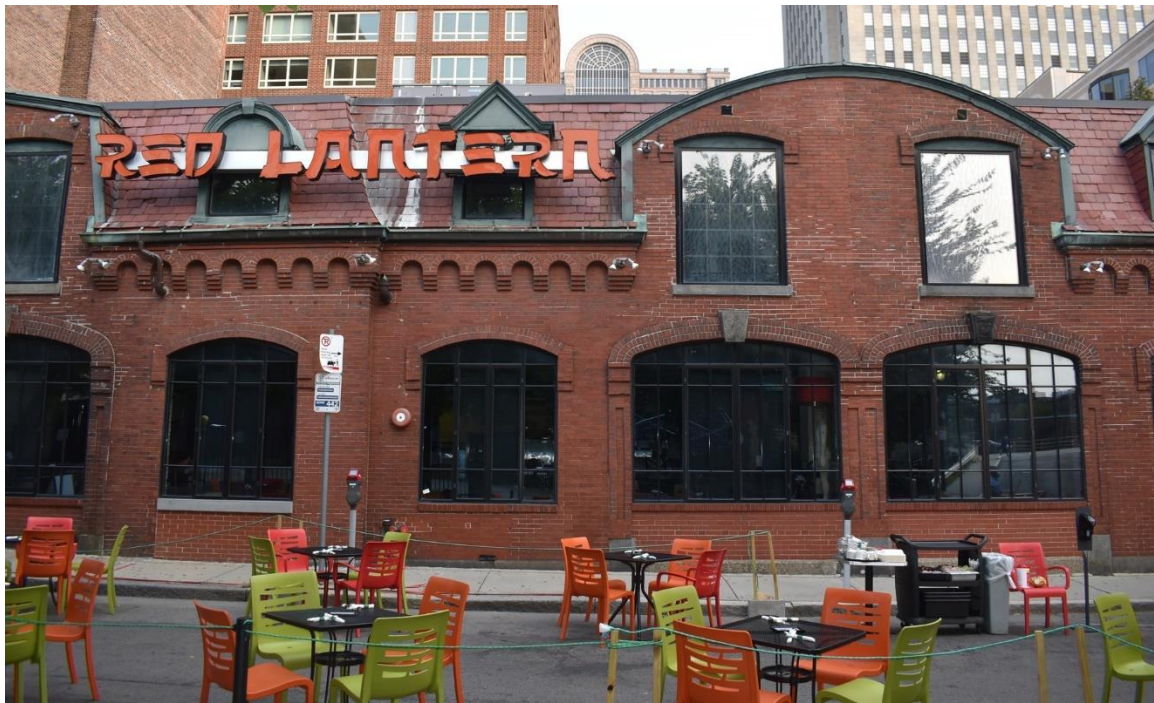
**Photo 3.** East half of 39-45 Stanhope Street facade, looking north.

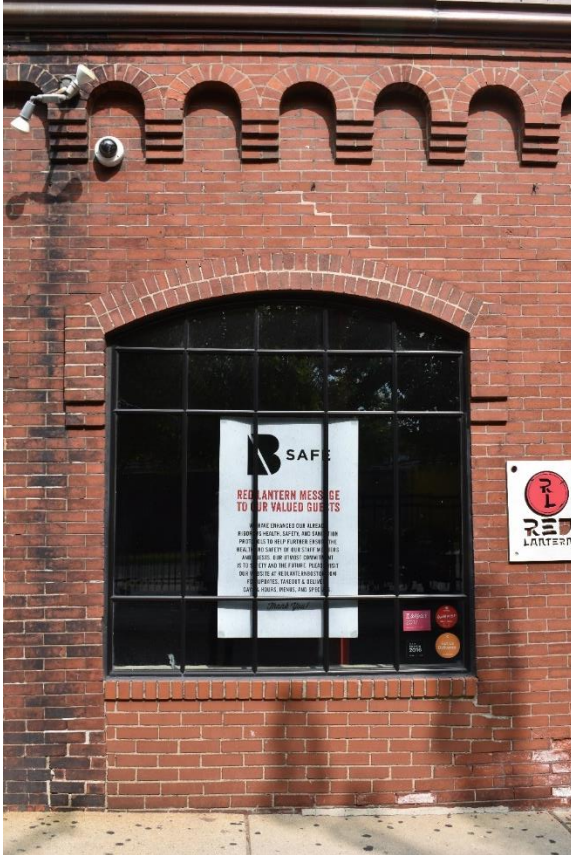
**Photo 5.** Window detail, west half of 39-45 Stanhope Street facade (first bay), looking north/northwest.

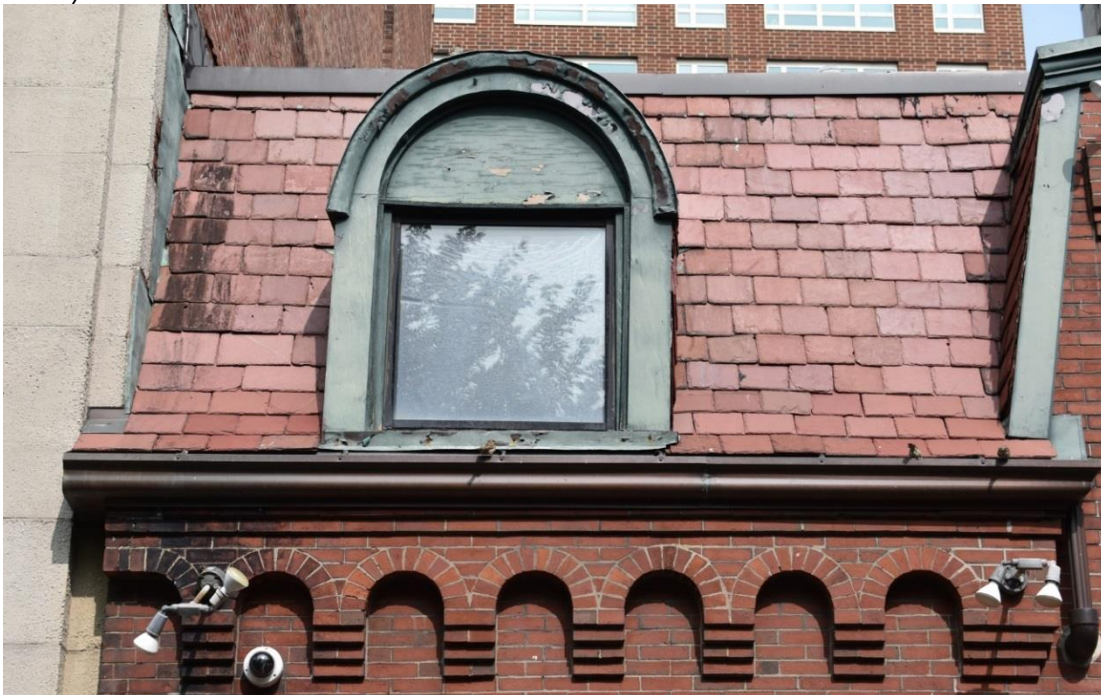
**Photo 6.** Detail of arched roof dormer, slate shingle Mansard roof, and corbeled cornice (west-half).

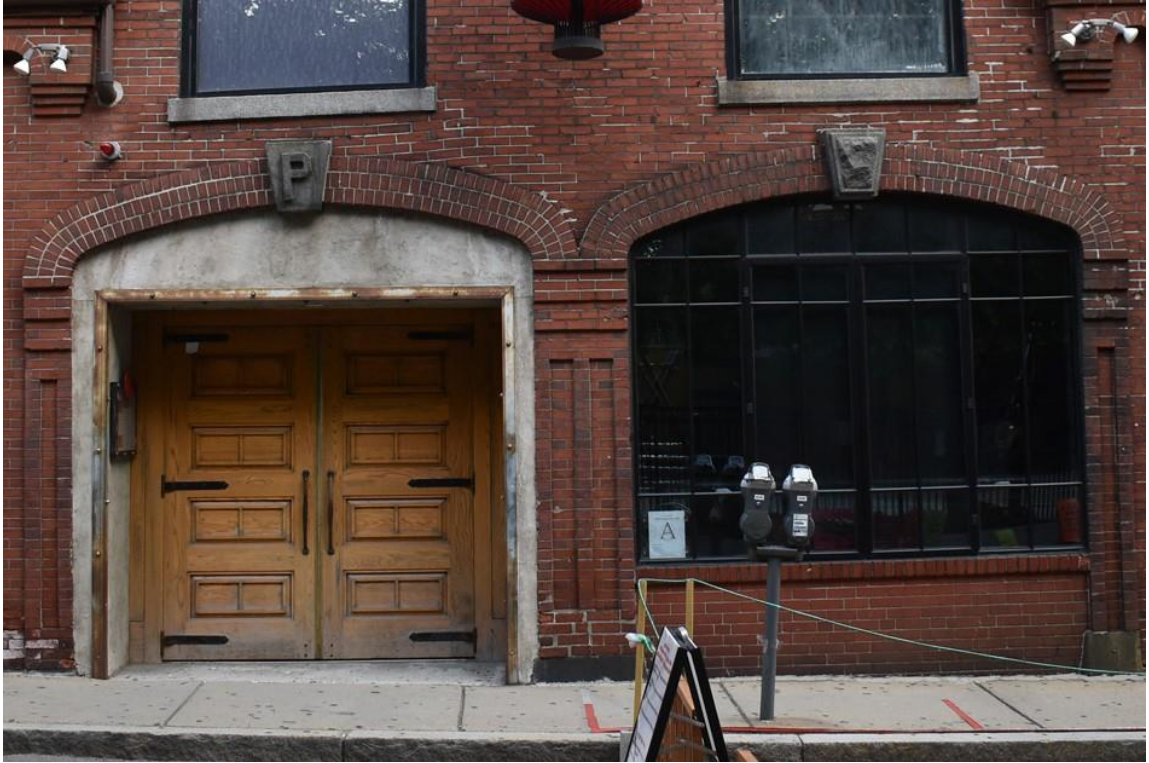
**Photo 7.** Detail of double carriage entrance, west half of 39–45 Stanhope Street facade, looking north/northwest.

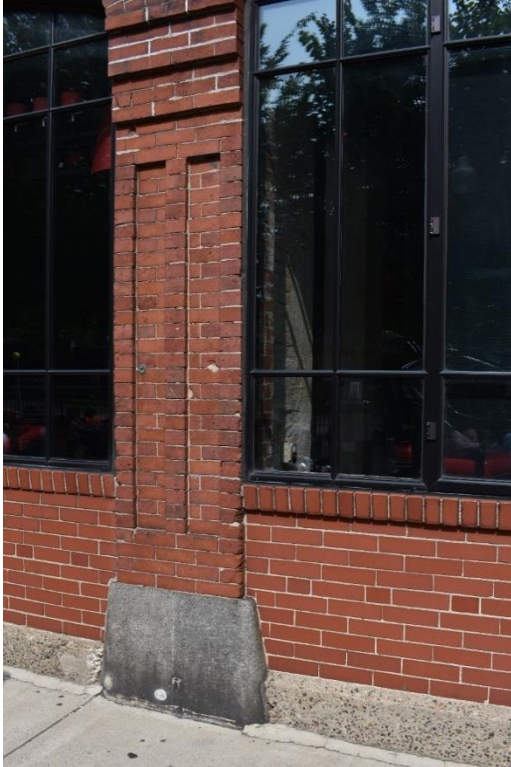
**Photo 8.** Detail of brick pilaster indicative of Panel Brick style and granite base blocks at carriage bays.

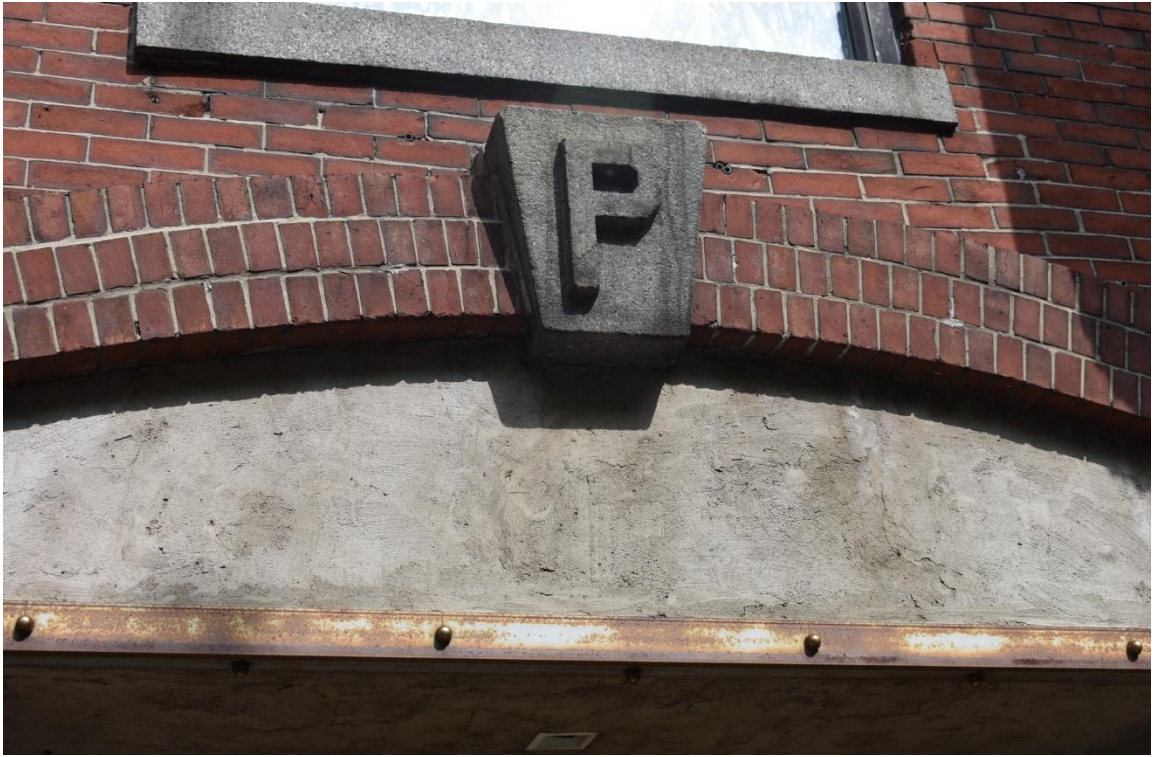
**Photo 9.** Detail of granite “P” keystone in the second bay (west half).

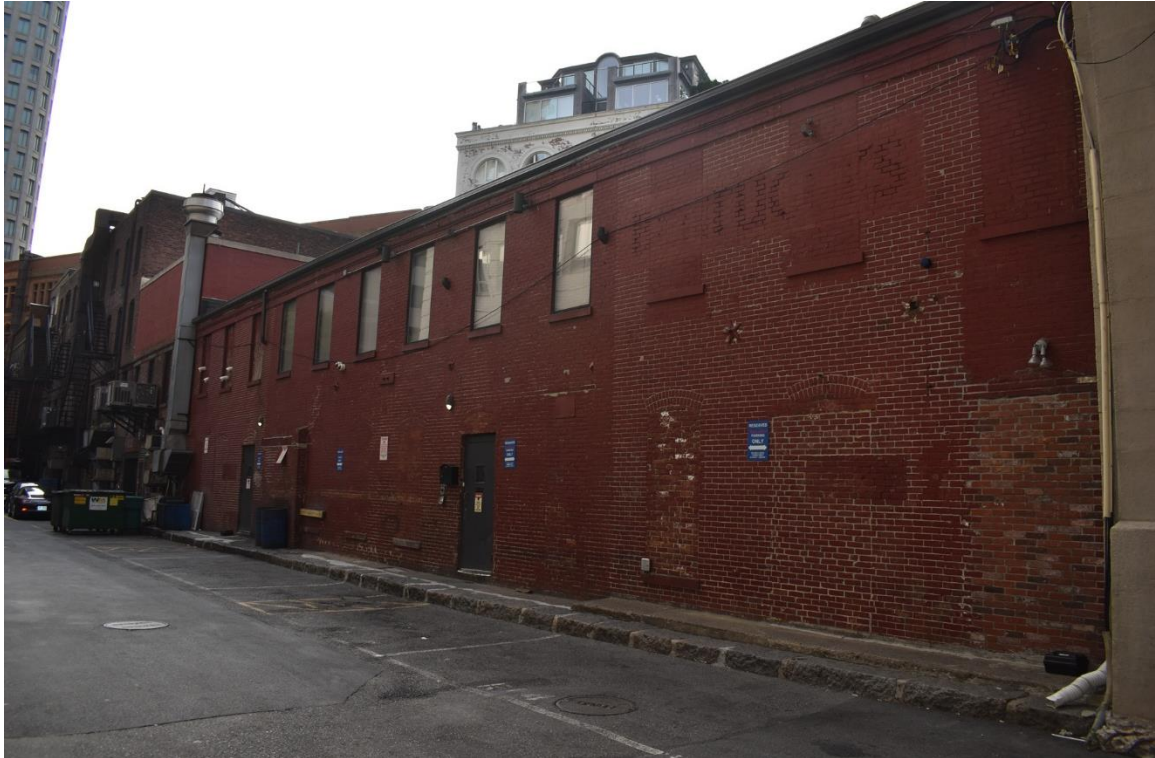
**Photo 10.** 39–45 Stanhope Street rear elevation, looking east.

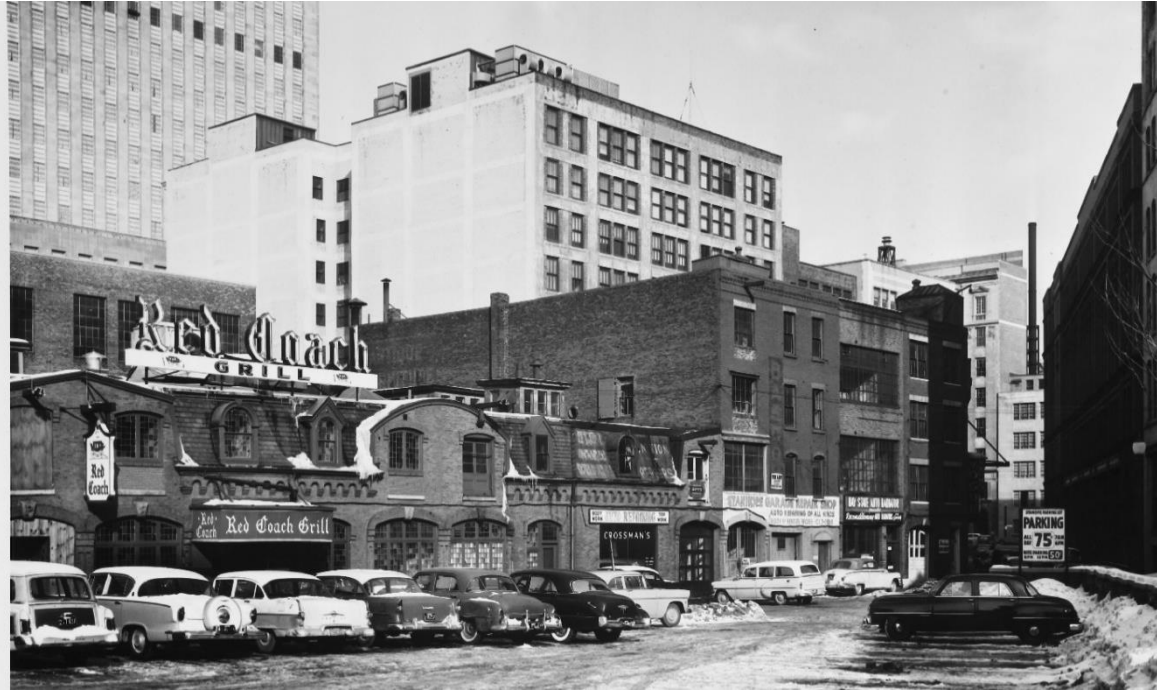
**Figure 6.** 1957 Photograph of 39–45 and 35–37 Stanhope Street by Nishan Bichajian (cropped), showing the Red Coach Grill restaurant (on file MIT Libraries).<sup>11</sup>
