## South End landmarks Commission

Design Review Hearing

10 Rutland Square

July 05, 2022

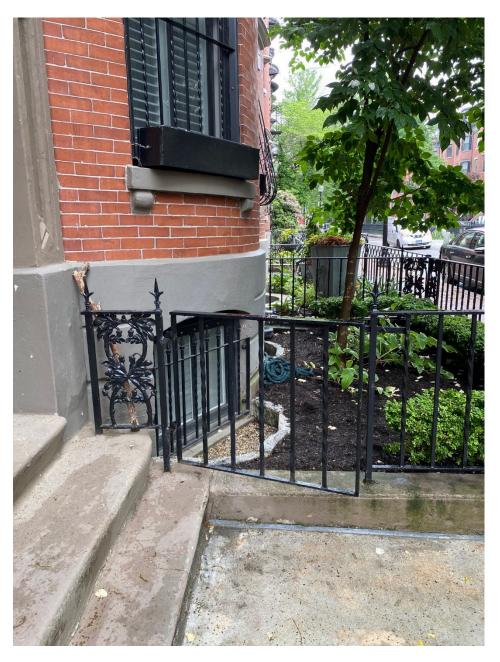
Existing Condition of front garden
