Sugimoto Residence

334 Marlborough Street, Boston, Massachusetts 02115

Existing Conditions Photos

Side Gate Plan/Elevation

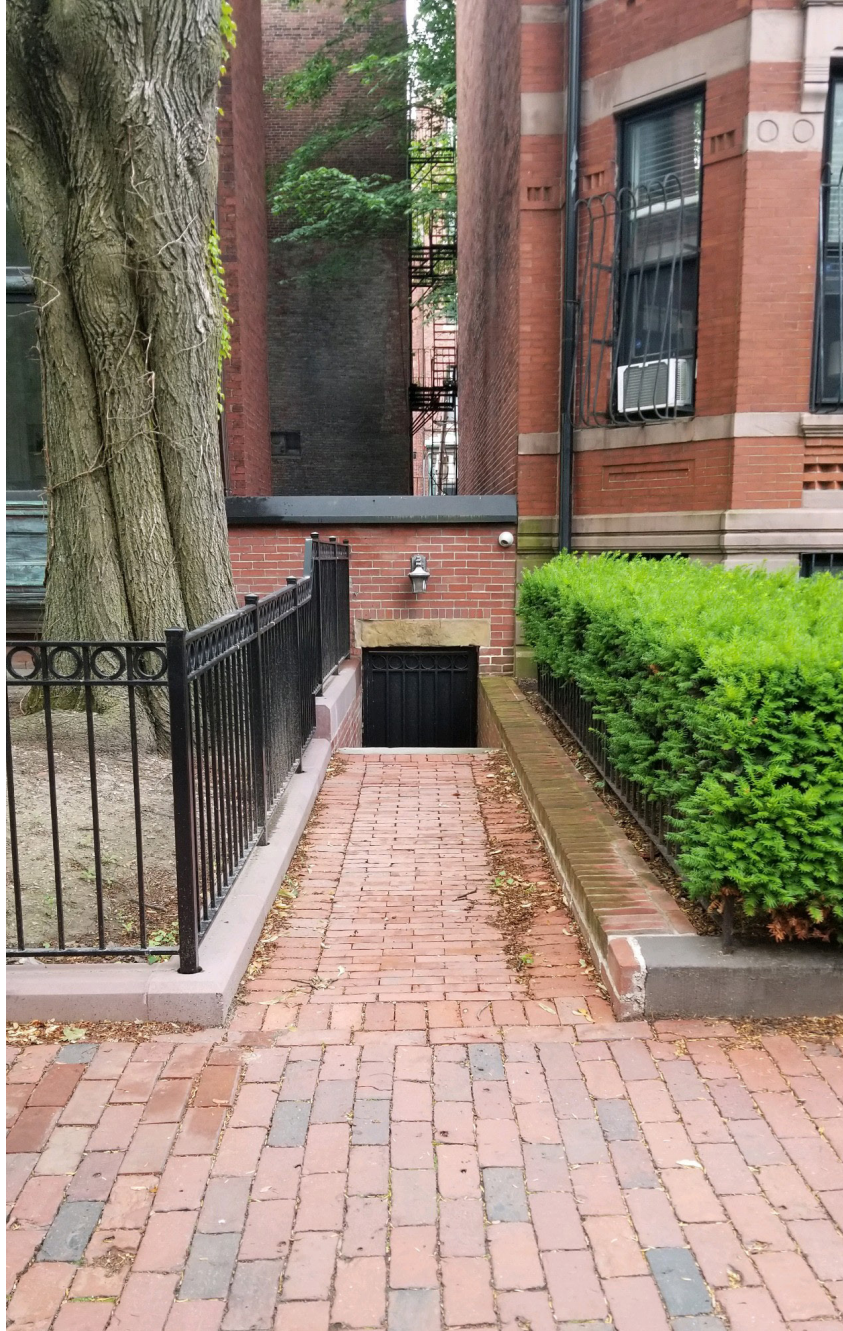
Gate Location at Side Entrance

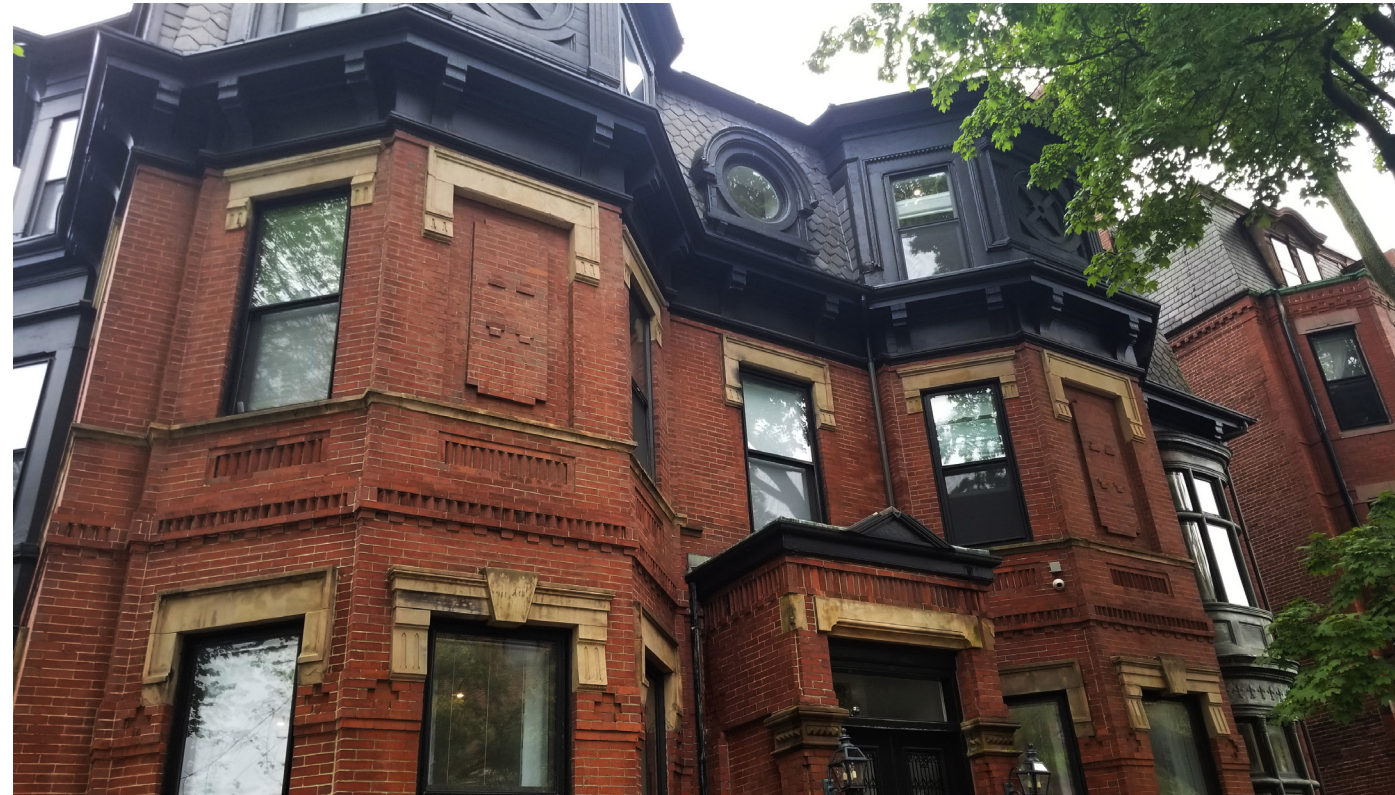
Existing Architraves and Trim on House Facade

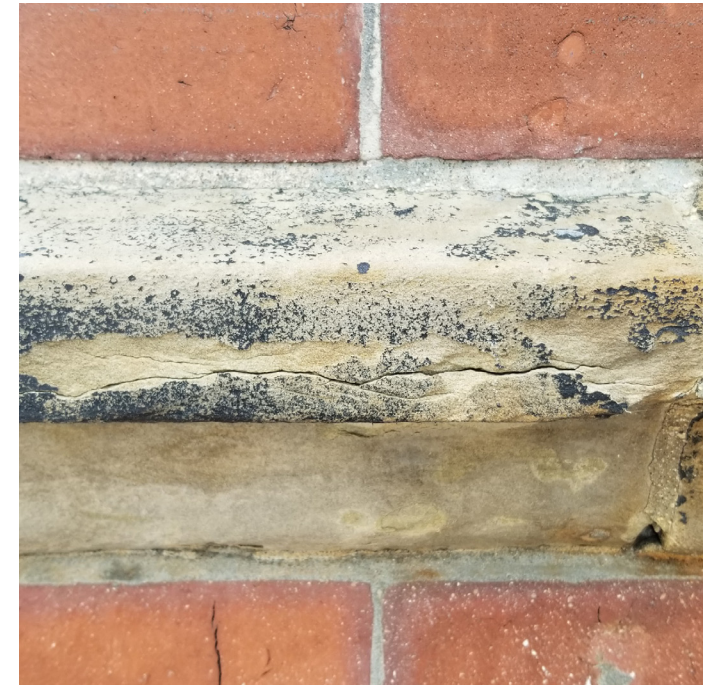
Existing Architrave Detail

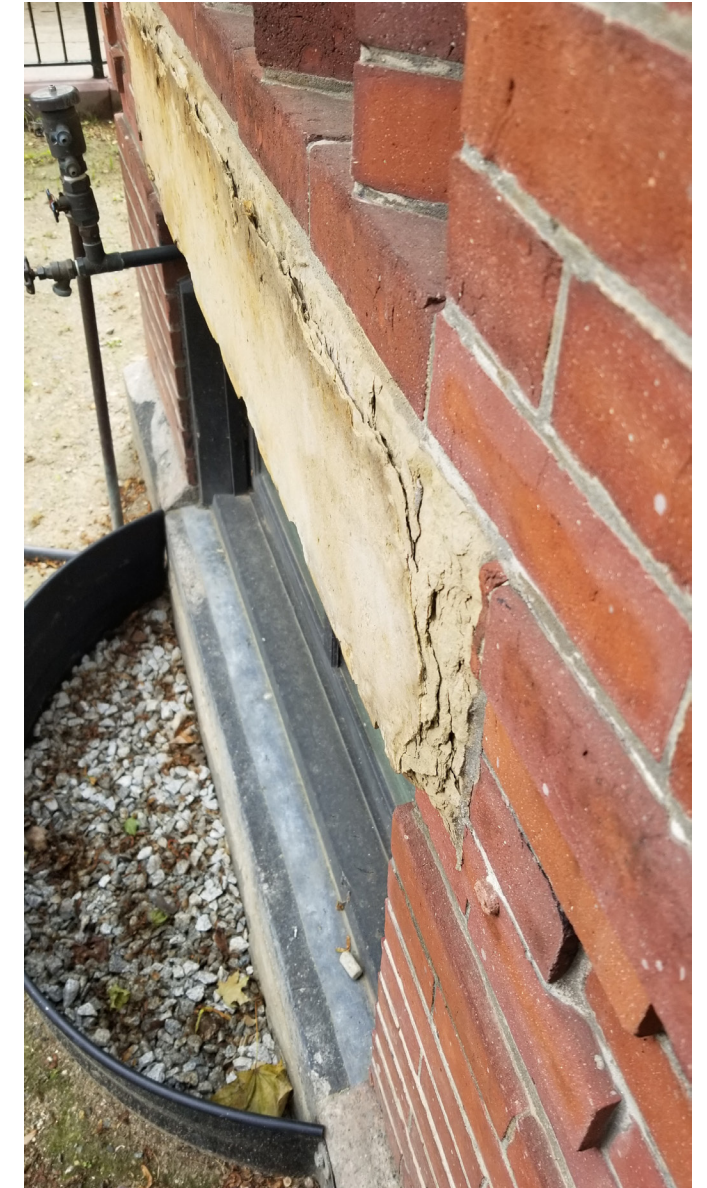
Existing Trim Detail

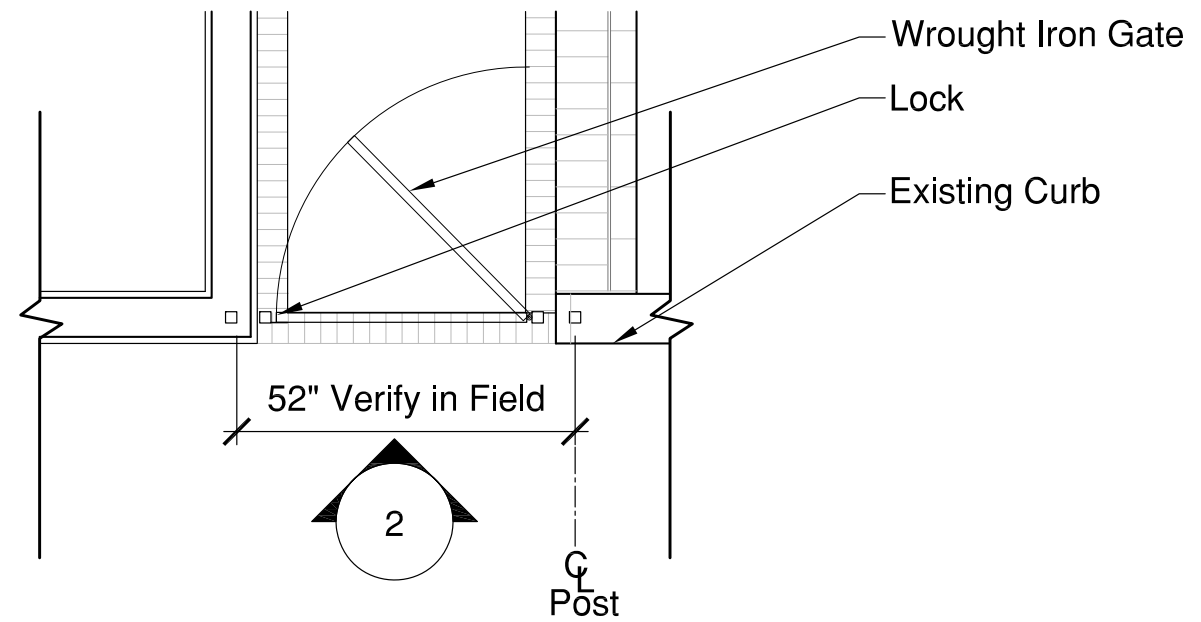
1 Side Gate Plan
SCALE: $\frac{3}{8}'' = 1'-0''$

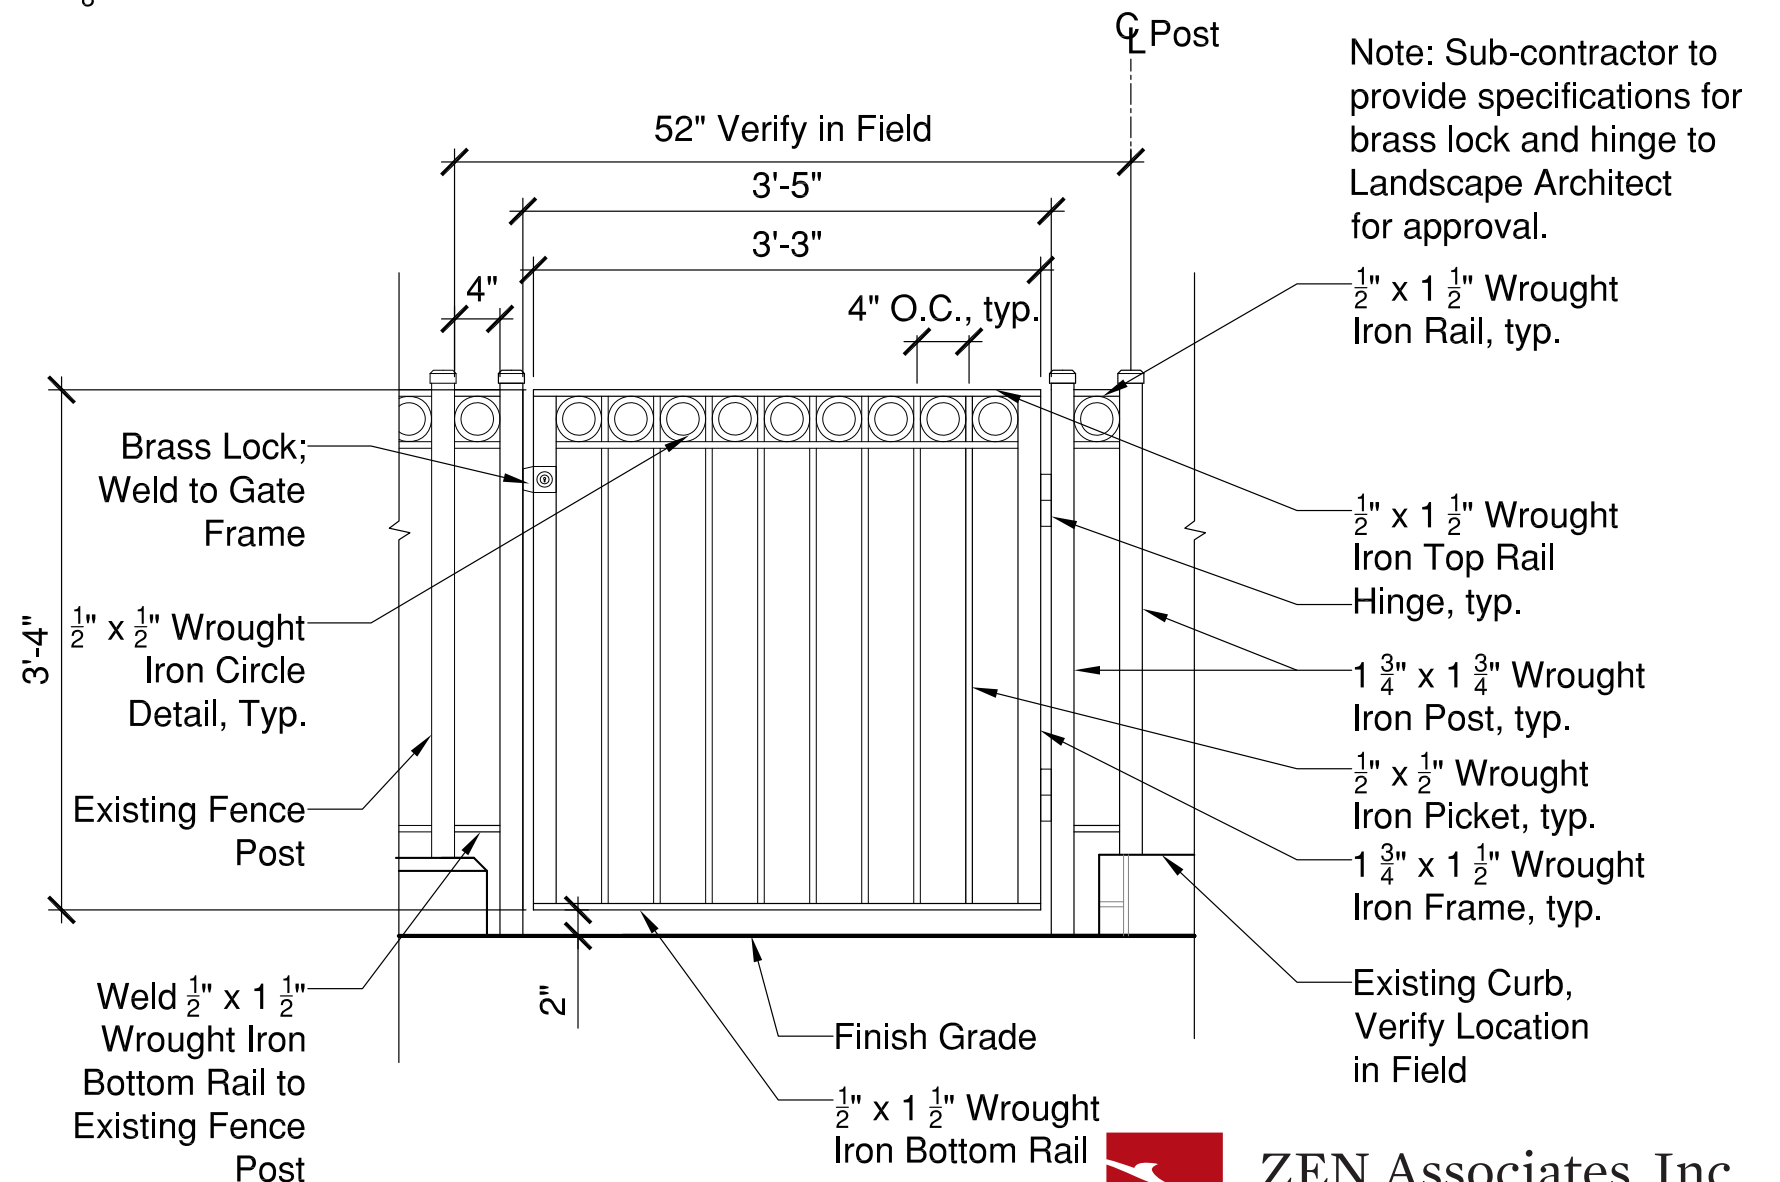
2 Side Gate Elevation
SCALE: $\frac{3}{4}'' = 1'-0''$

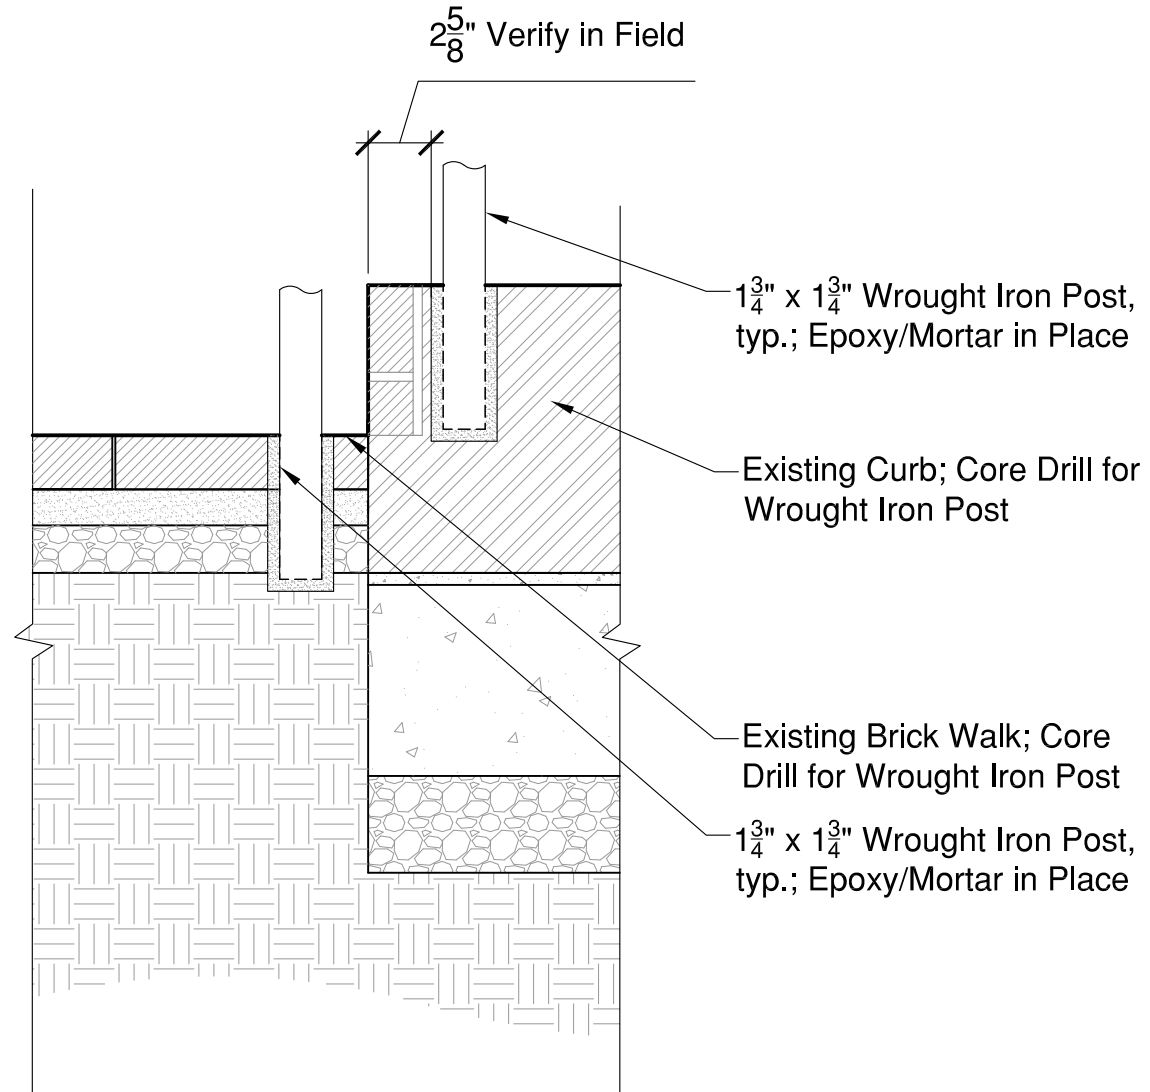
Gate Post Detail

SCALE: 1 1/2" = 1'-0"

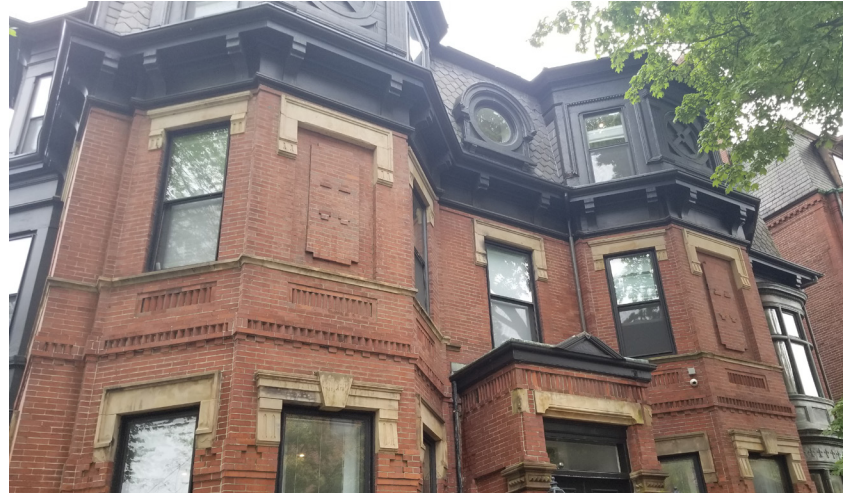
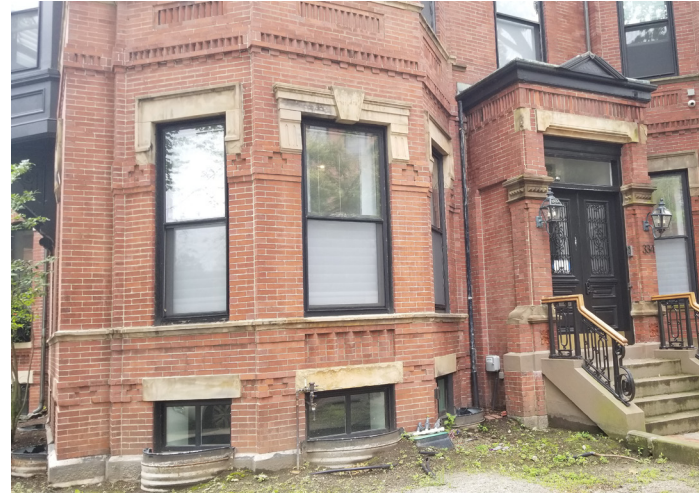
Before Cleaning

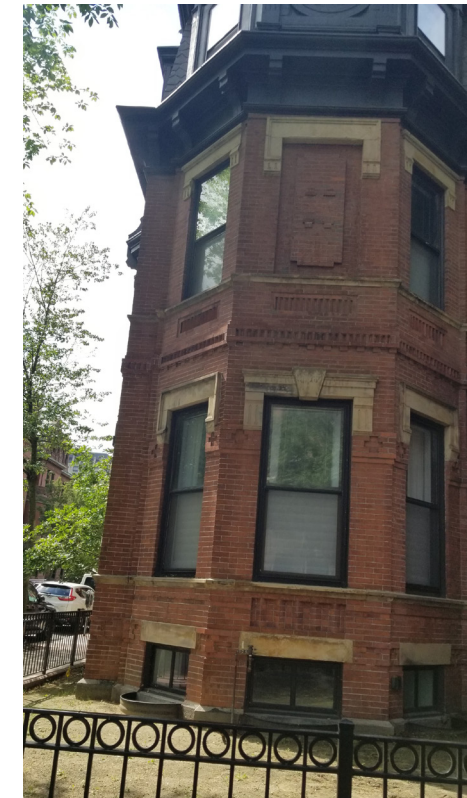
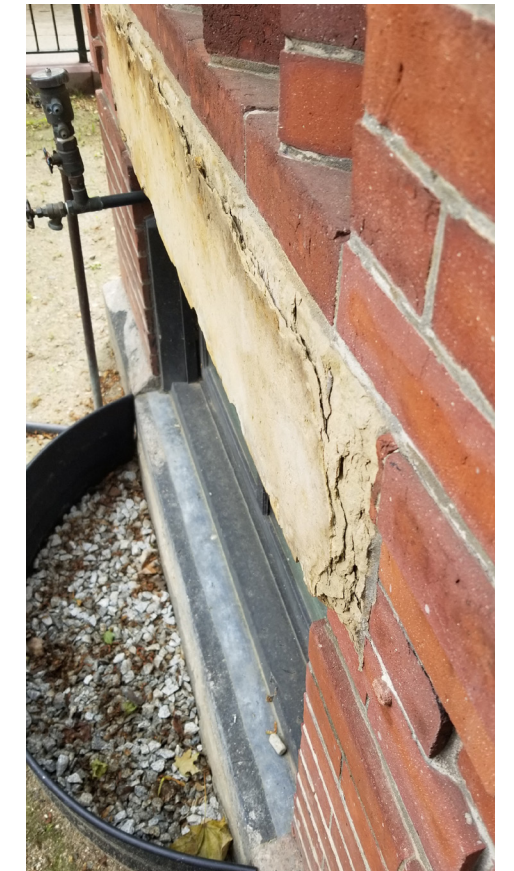
After Cleaning

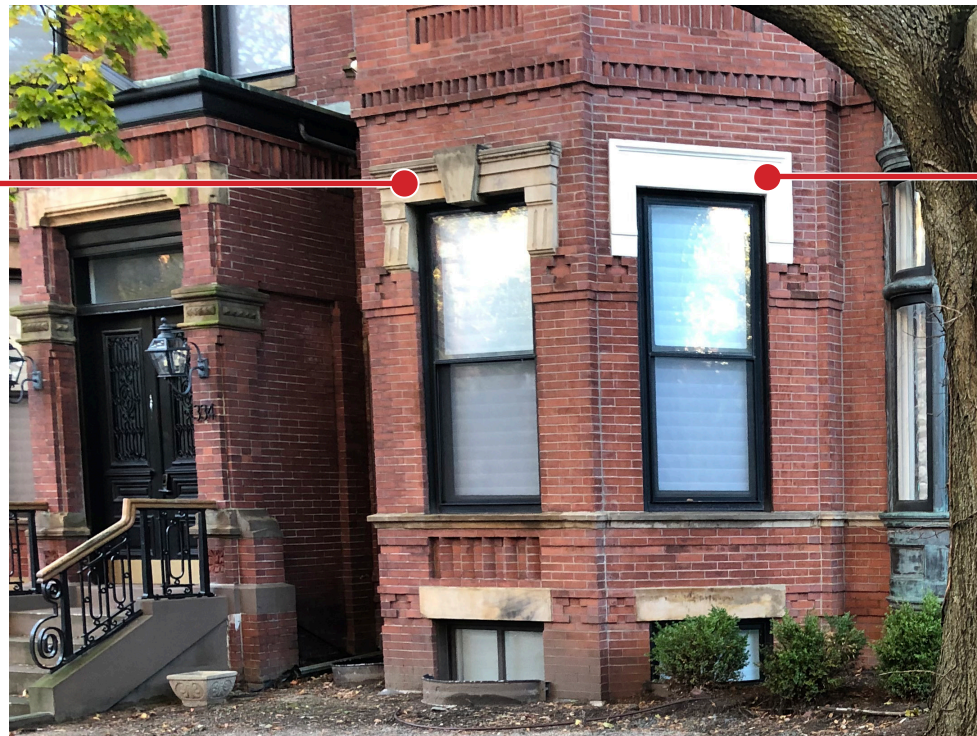
Existing
Unpainted
Architrave

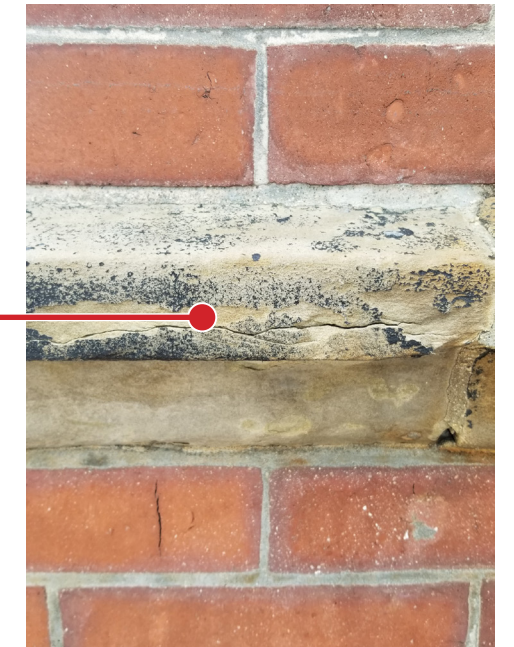
Existing
Painted
Architrave

Paint stone architraves
and trim to consolidate
stone and restore historic
appearance.
Color to match stone.
Color to be submitted for
review and approval.
