**Massachusetts Department of Environmental Protection**  
 Bureau of Resource Protection - Wetlands  
**WPA Form 8A – Request for Certificate of Compliance**  
 Massachusetts Wetlands Protection Act M.G.L. c. 131, §40

In 2016, the National Park Service at Boston Harbor Islands National Recreation Area (a.k.a. Boston Harbor Islands National and State Park) began a habitat restoration project on a 6-acre site on Thompson Island, in partnership with Thompson Island Outward Bound Education Center. This project area, which was selected due to its high ecological value that was being actively degraded by highly invasive non-native plants, contains 2.4 acres of freshwater wetland, separated into 3 hydrologically connected cells. The project area also contains upland meadow and upland forest habitats. Our restoration efforts primarily consisted of invasive plant removal, native plant revegetation, and environmental monitoring.

The National Park Service (Michael Creasy, superintendent of National Parks of Boston) is requesting a Certificate of Compliance for the Ecological Restoration Order of Conditions (006-1459) on Thompson Island. The COC materials submitted as part of this request a

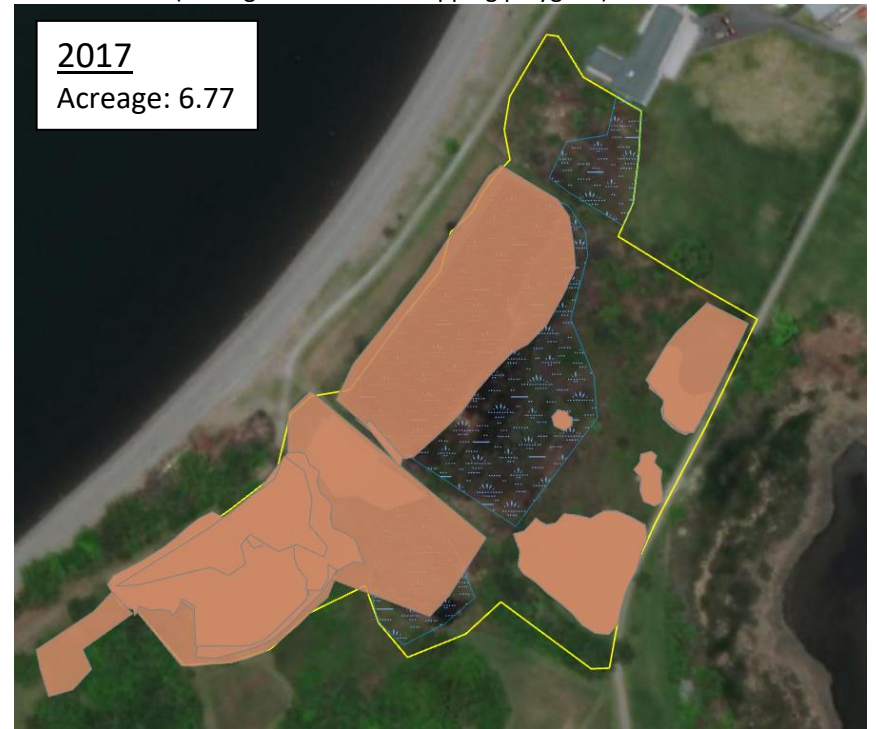
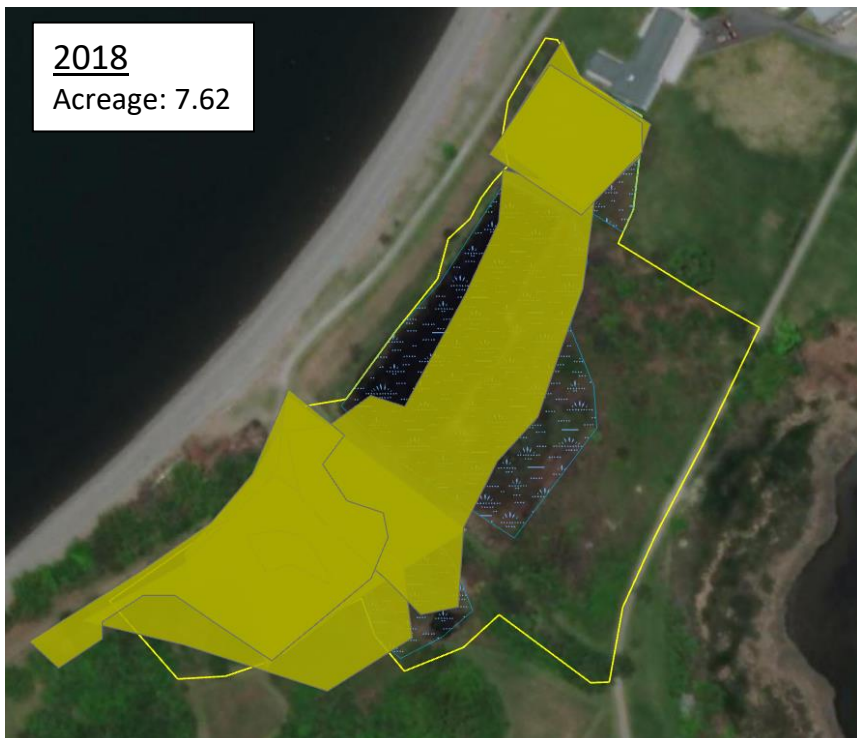
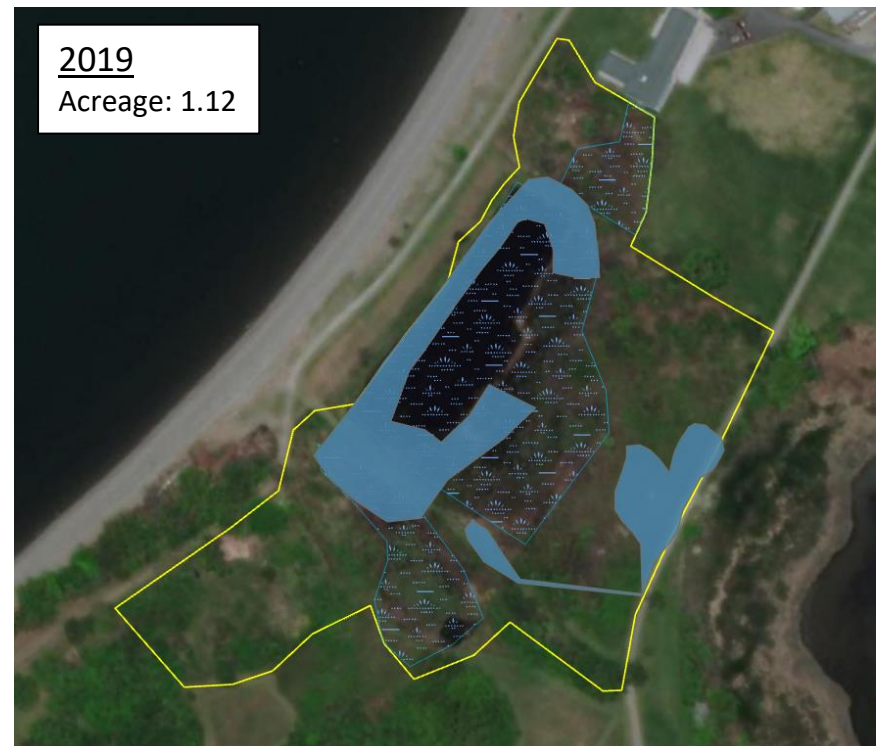
Ecological restoration of nearshore freshwater wetlands and buffer zones, Thompson Island, Boston (DEP #006-1459). Invasive Plant Treatment Summary 2016-2019 (Acreage includes overlapping polygons).

Ecological restoration of nearshore freshwater wetlands and buffer zones, Thompson Island, Boston (DEP #006-1459). Invasive Plant Treatment Summary 2016-2019 (Acreage includes overlapping polygons) .

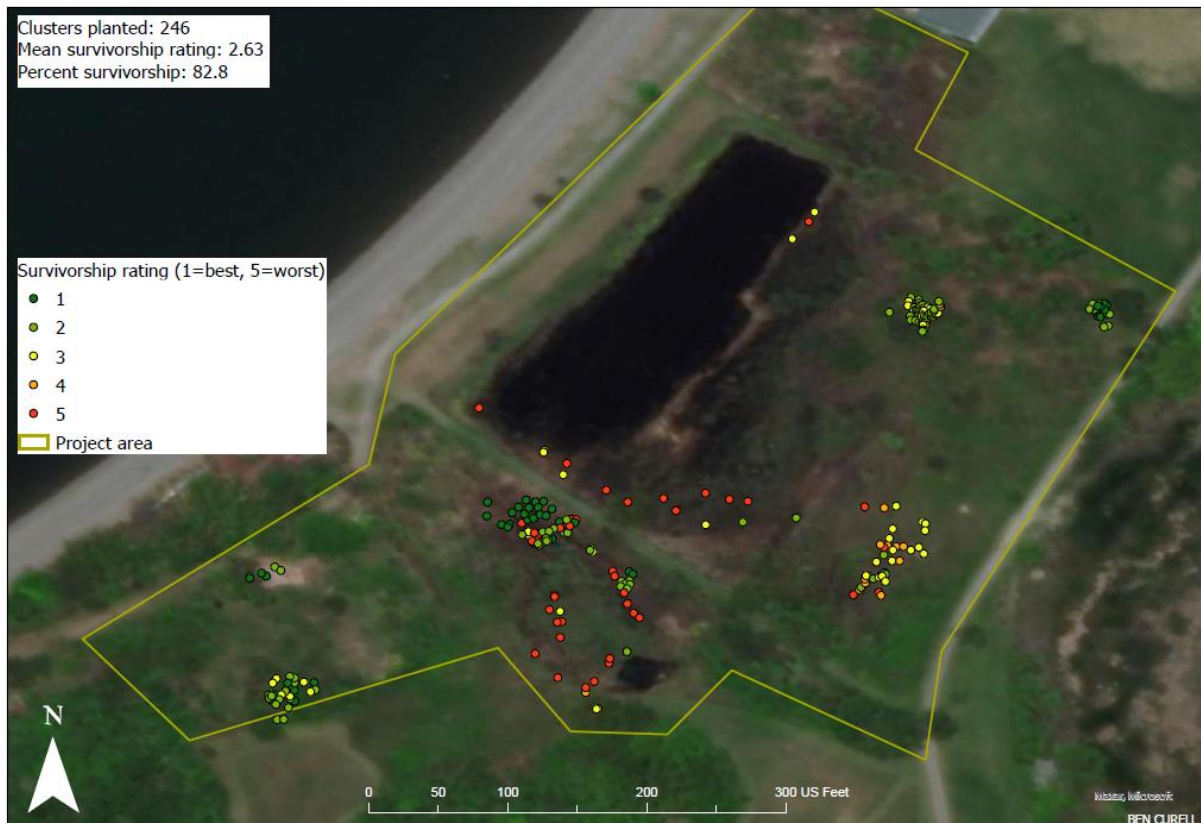
End-season survivorship map for Year 3 (all species). Survivorship rating key on the next page. Each point represents a planting cluster, each of which consists of 3 to 7 plants of a single species.

Positive Rating __1—2	Neutral Rating __ 3	Negative Rating __4—5
<ul style="list-style-type: none"> <li>• <u>Visible growth</u>: plants were taller, fuller and more visibly established</li> <li>• <u>First Season Flowering</u>: plants produced flowers in their first growth year</li> <li>• <u>Seed Production</u>: plants produced seed in their first growth year</li> </ul>	<ul style="list-style-type: none"> <li>• <u>Visible growth</u>: plants made little to no visible growth in their first growth year</li> <li>• <u>First Season Flowering</u>: plants produced few or no flowers in their first growth year</li> <li>• <u>Seed Production</u>: plants produced little to no seed in their first growth year</li> </ul>	<ul style="list-style-type: none"> <li>• <u>Visible growth</u>: plants visibly deteriorated and senesced in their first growth year</li> <li>• <u>First Season Flowering</u>: plants produced no flowers at all in their first growth year</li> <li>• <u>Seed Production</u>: plants produced no seeds at all in their first growth year</li> </ul>

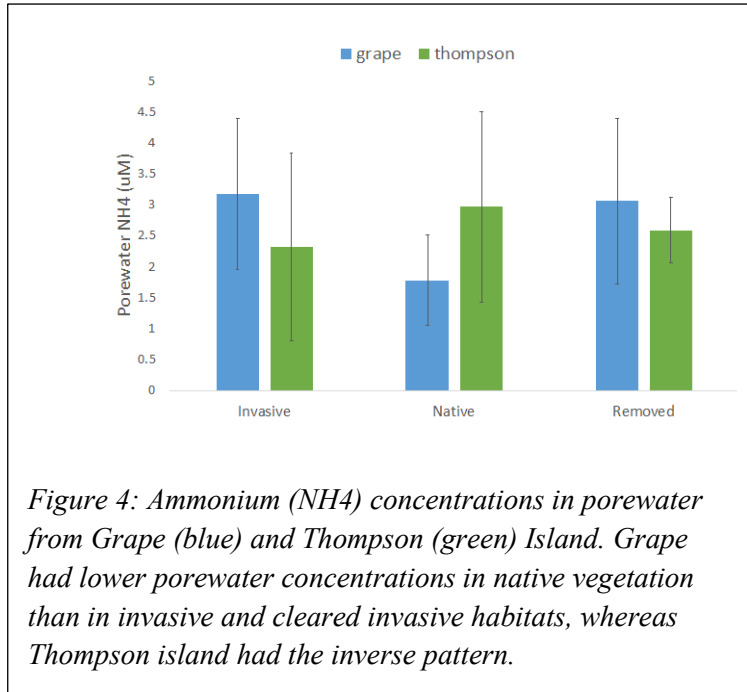
*Figure 4: Ammonium (NH<sub>4</sub>) concentrations in porewater from Grape (blue) and Thompson (green) Island. Grape had lower porewater concentrations in native vegetation than in invasive and cleared invasive habitats, whereas Thompson island had the inverse pattern.*

N in the porewater underlying the vegetation. We found that the concentration of ammonium (NH<sub>4</sub>) in the pore water underlying each vegetation differed both by location and habitat (Fig. 4). The porewater ammonium concentrations demonstrated opposite patterns on the two islands, which could be a reflection of the different local soil types. In Grape, the native vegetation had considerably lower ammonium concentrations in the porewater compared to the areas with invasive vegetation and areas where invasive vegetation had been removed. This result could be a feature of the type and biomass of vegetation present in the native stands (eg higher demand for ammonium from the native vegetation). Further, these results suggest that revegetating Grape Island with native

vegetation may help reduce excess bioavailable N being exported from the land and into the coastal ocean. On Thompson Island, however, the opposite pattern was observed. There, the native vegetation had higher concentrations of ammonium in the pore water, compared to the invasive and recently cleared habitats, indicating that in that system, local geological features may play a more important role than vegetation history in determining the flux of ammonium through the system.

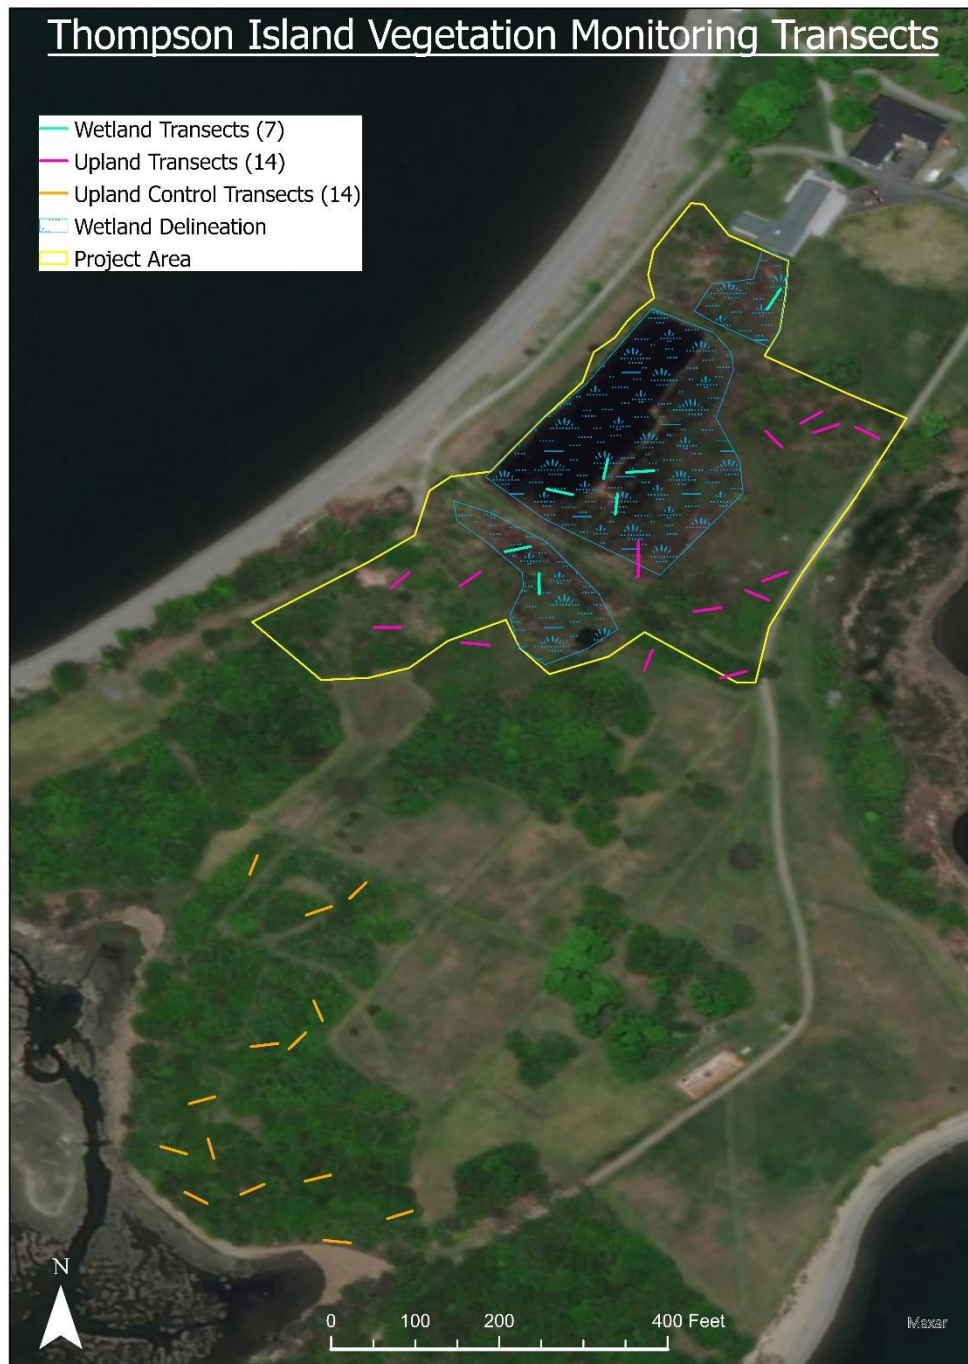
The initial phase of vegetation monitoring protocol was the establishment of randomly distributed 10-meter transects throughout the project area and in a control plot outside of the project area (see map below). The transects were randomly distributed within project zones through a restricted random sampling design, in order to ensure a balanced sampling design among wetland, upland and control zones. In total, 35 transects were established on the island (7 wetland, 14 upland, and 14 upland control).

During each monitoring year, staff and volunteers collected data from within twenty (20) 0.5m x 0.5m quadrats along each transect, recording the presence or absence, cover, and number of stems of each woody and herbaceous plant species. These data result in frequency and percent cover statistics for each transect and thus can be combined to provide summary statistics for each zone (upland, wetland, control), or for the entire project area (wetland and upland zones). In addition, photos were taken from the origin point of each transect (see photo monitoring document for year-to-year comparisons).

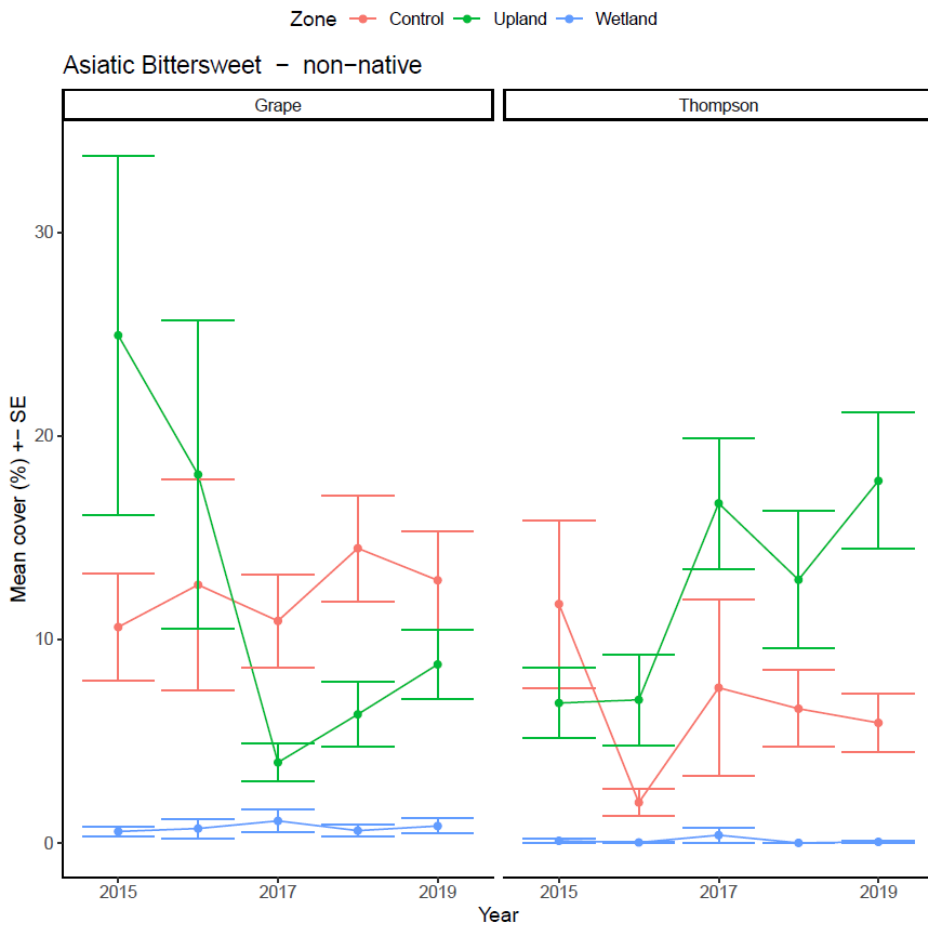
Percent Cover Charts

x-axis unit=mean percent cover

Zone Control Upland Wetland

The final output was a series of charts that summarize the changes in individual species' percent cover and frequency across all years for each transect group (wetland, upland, upland control). From these charts, we can extrapolate how species dynamics shifted throughout the entire project area and control area. This analysis was done for several priority native and invasive plant species (below are some example charts). This data acts as a mechanism that allows us to quantitatively measure the success/failure of our habitat restoration efforts on a species-specific basis.
