# Boston Landmarks Commission

## 280 Summer Street // Façade Restoration

PROJECT:  
**280 SUMMER STREET FACADE RESTORATION**  
 280 SUMMER ST.  
 BOSTON, MA 02210

EXISTING EXTERIOR WOOD TRIM DETAIL  
**SK-001**

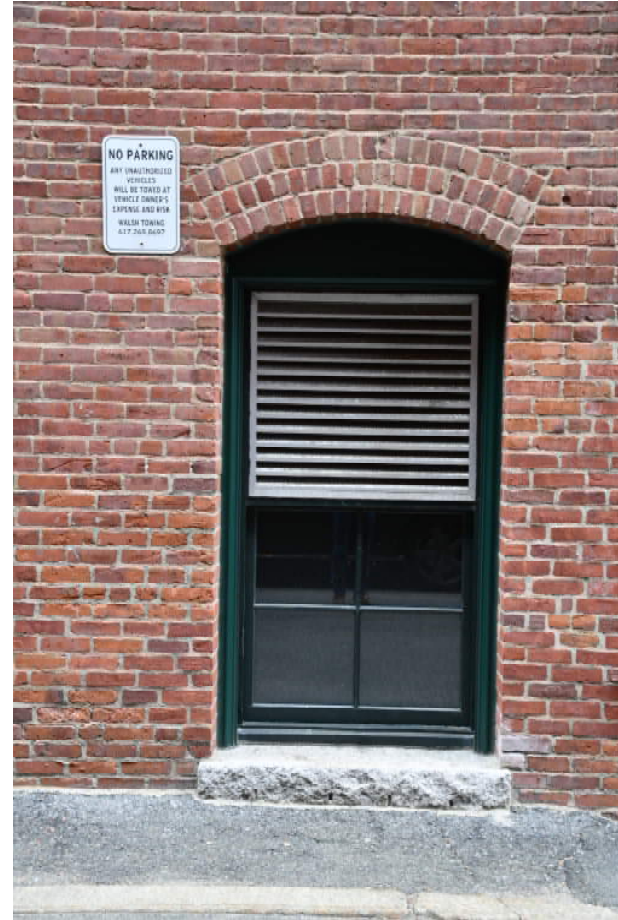
Existing wood trim surrounding the aluminum window systems.

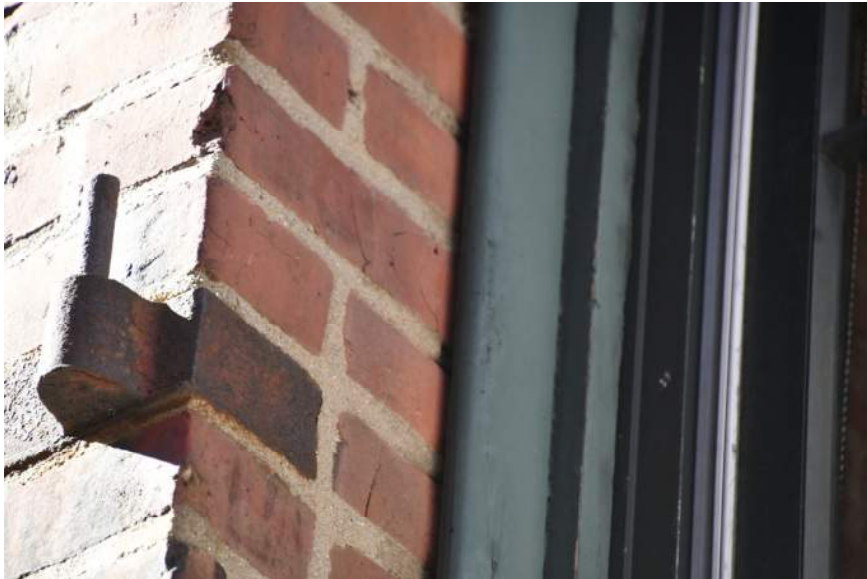
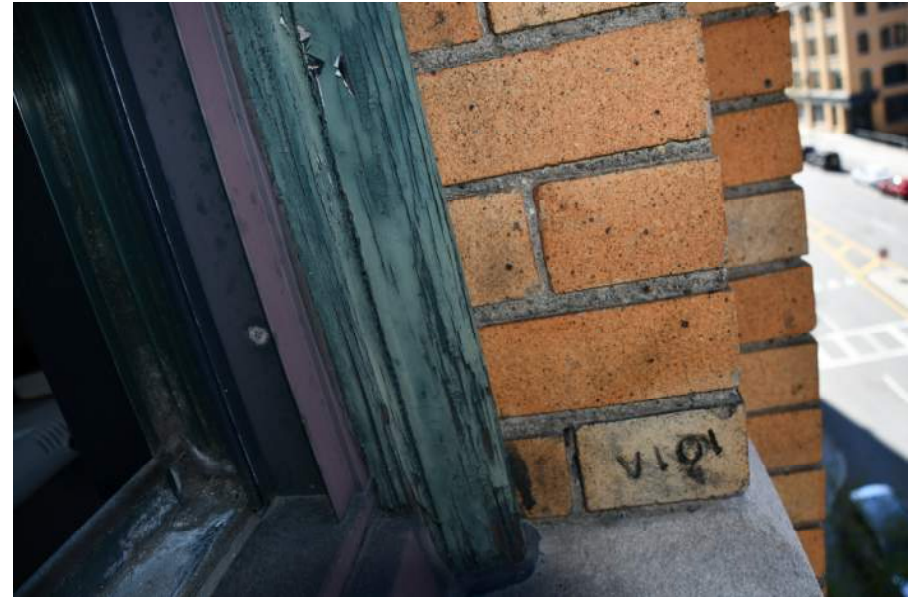
**Aluminum window panning trim installed over original wood trim; Window mockup later Rejected and determined that custom trim needs to be made.**

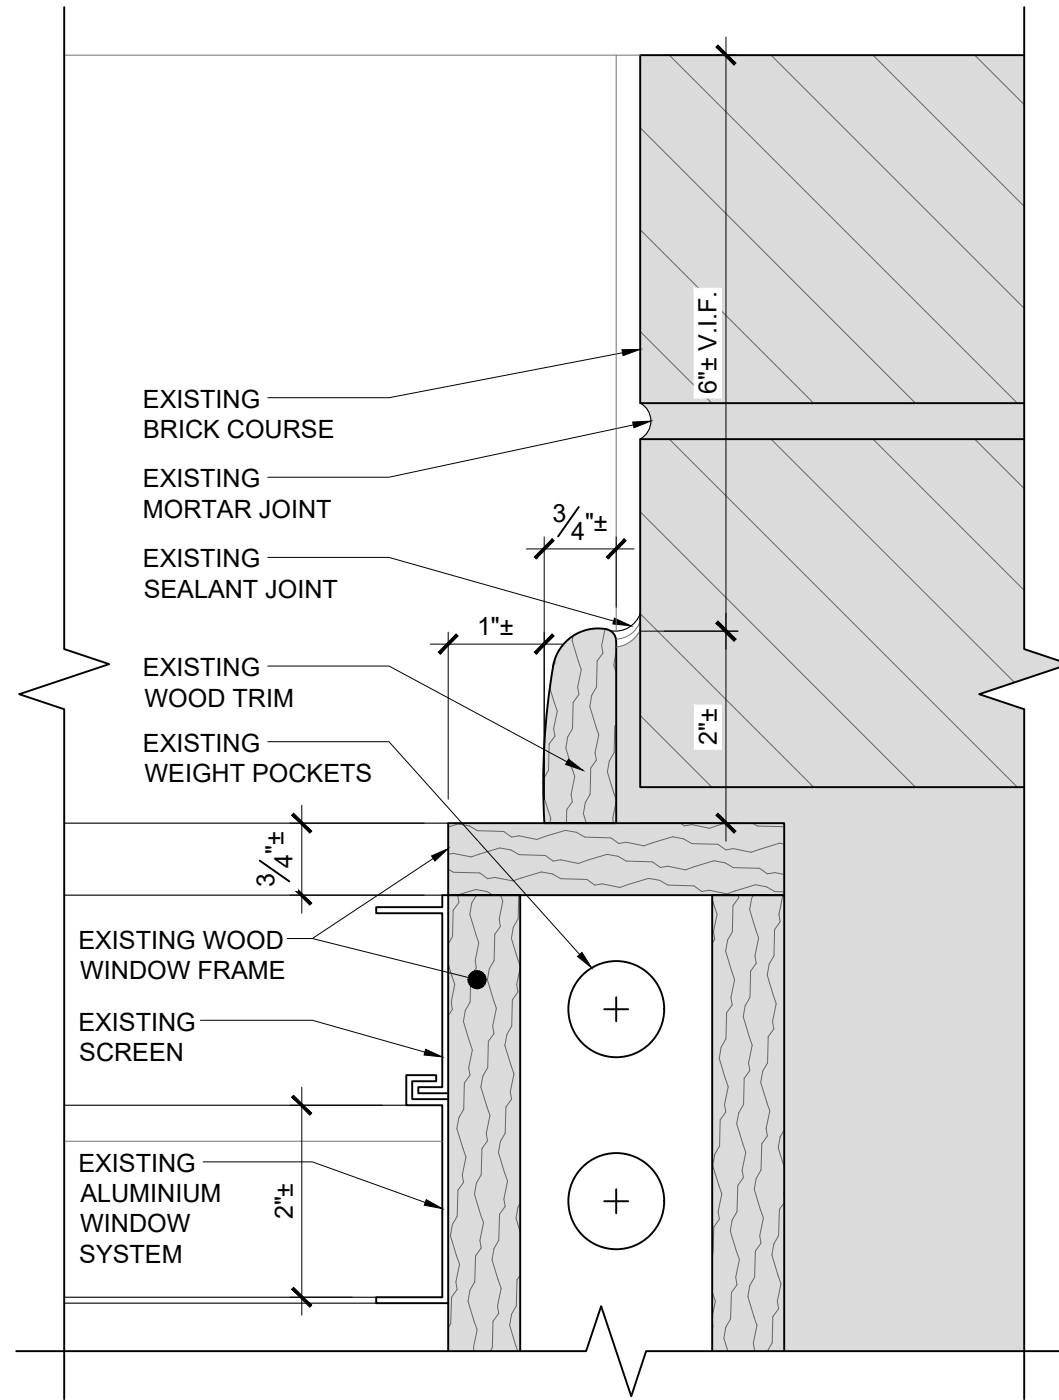
1 WOOD TRIM AT WINDOW DETAIL  
 6"=1'-0"

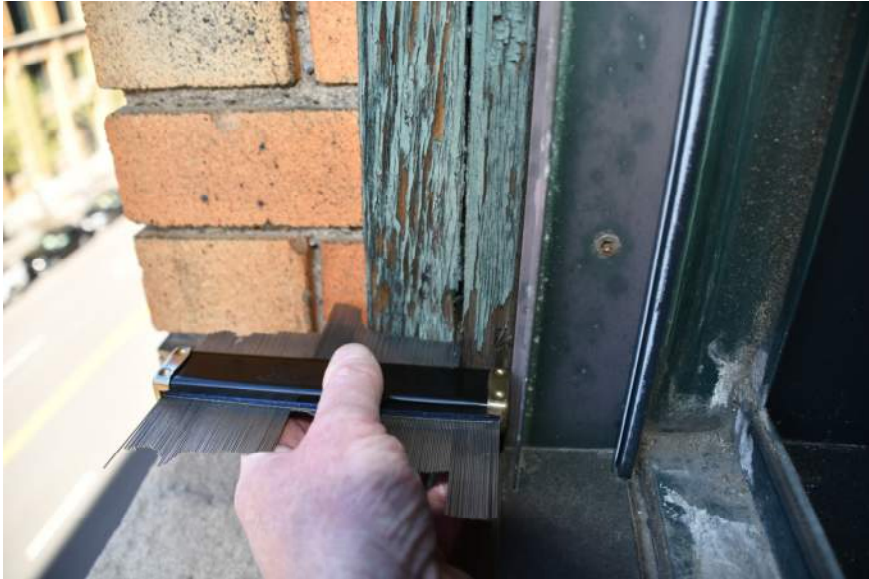
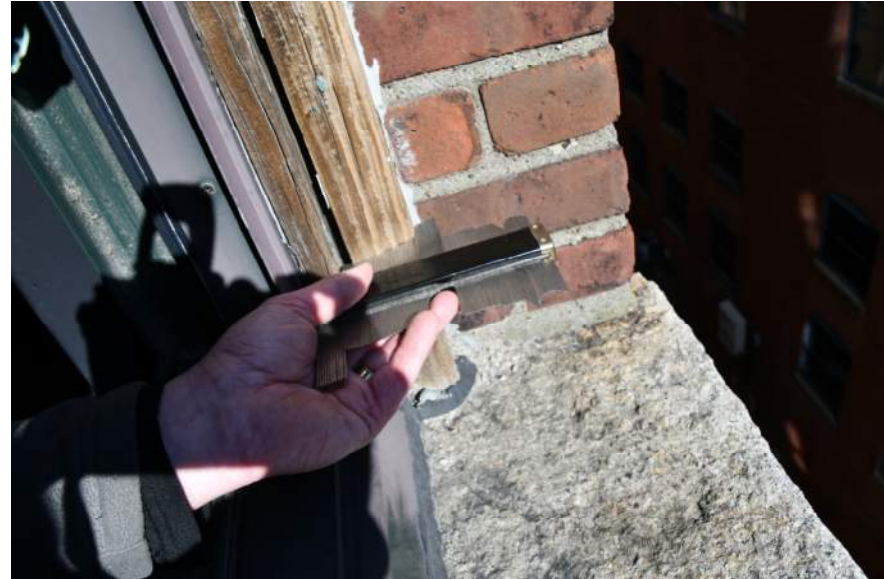
On-site profile confirmation took place on 4/19/2023; both front (left) and rear (right) elevations. Slight dimensional variations between multiple locations profiled (+/- 1/8") likely due to wood deterioration and/or aluminum window installation differences. The contractor intends to fabricate one profile that matches the average existing original profile and install that panning trim at all window surrounds with this trim profile.

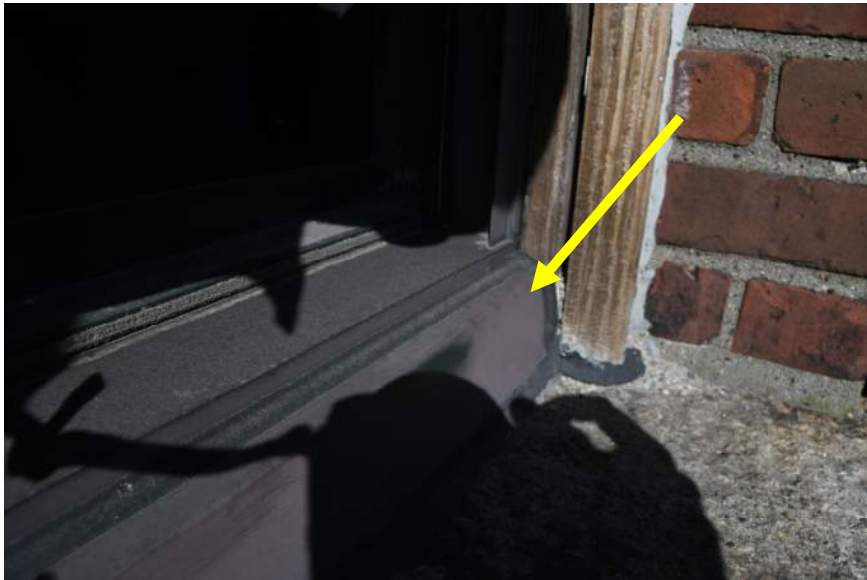
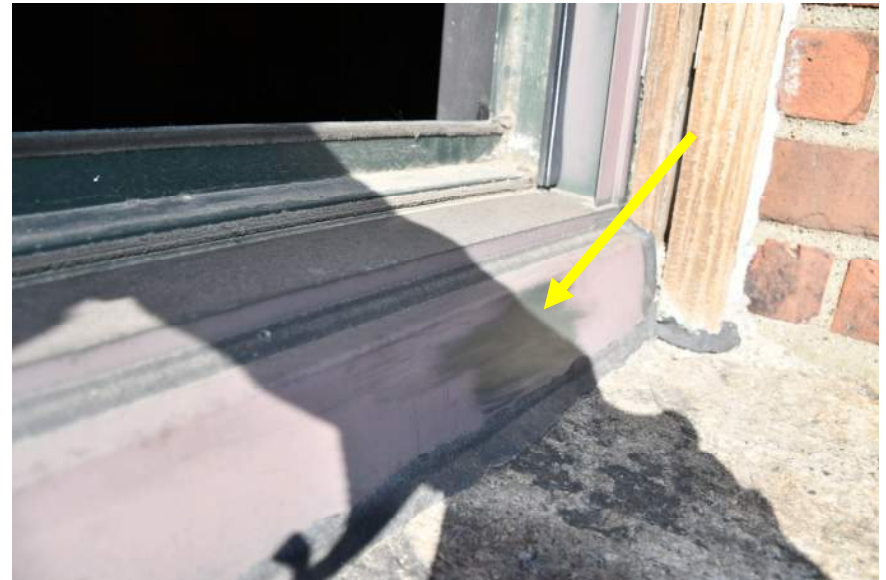
The existing aluminum windows were determined to be green in color after confirmation site visit on 4/19/2023. The lack of cleaning has left a heavy build up and all window frames will be washed to bring back the green finish. Left existing condition and right spot cleaned area on sill.  
Note, you can see the green on the interior portions of the window frame.
