BOSTON MEDICAL CENTER

South End Landmark District Commission

Vose Hall Demolition Design Review

August 14, 2023

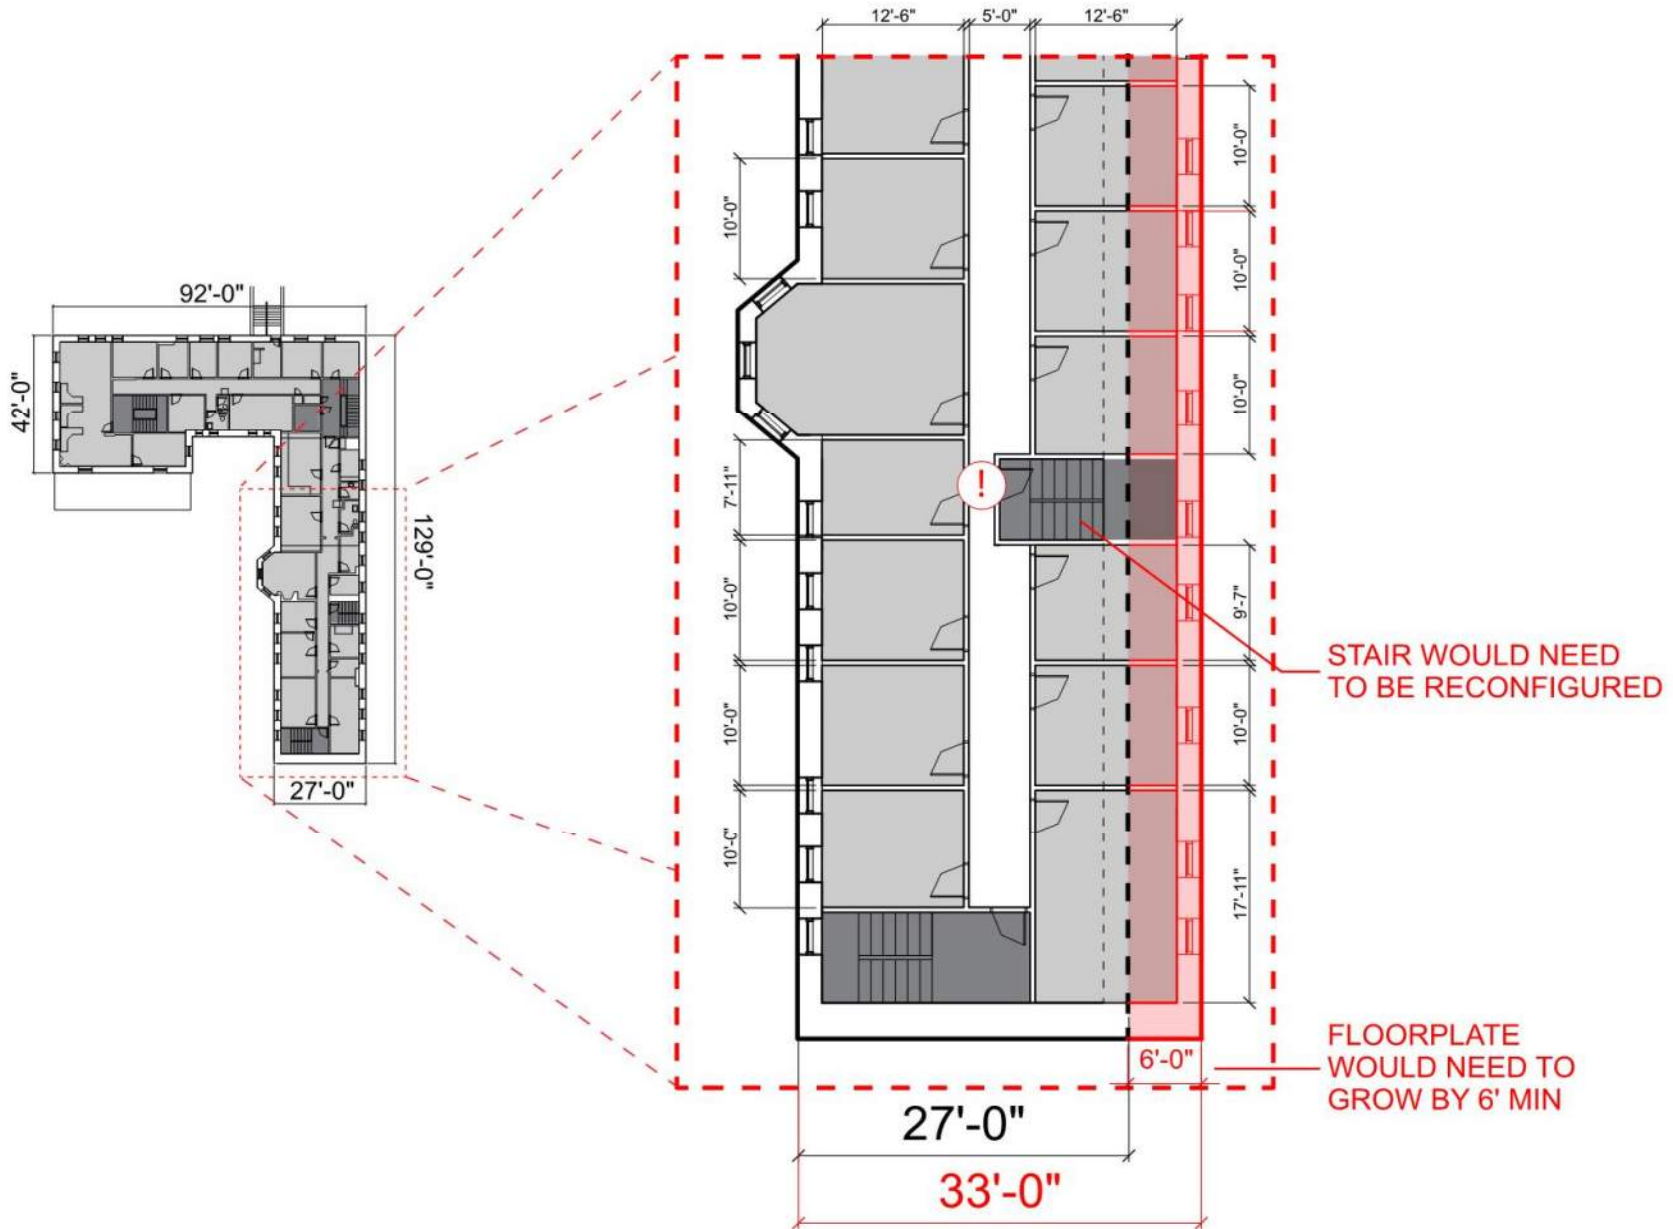
Reuse Study for Administrative Use

- A number of architectural and infrastructure deficiencies exist, the most significant include:
 - heating and ventilation systems are poor or non-existent

- corridors are narrow
 - wood frame structure does not meet current building codes
 - small bay space limits the number of required offices that can be accommodated and limit the space being able to handle modern office technology requirements

- Renovating the existing structure to incorporate all required code and infrastructure upgrades would result in **less than 30% of the required administrative office program accommodated** within the existing building footprint.

- In order to rehabilitate the building and bring Vose Hall into full compliance with Massachusetts State Building Code, Mechanical, Electrical, Plumbing and Life Safety Codes, the estimated Total Cost in today's dollars is approximately **\$21.9M, without meeting the required administrative office space program need.**

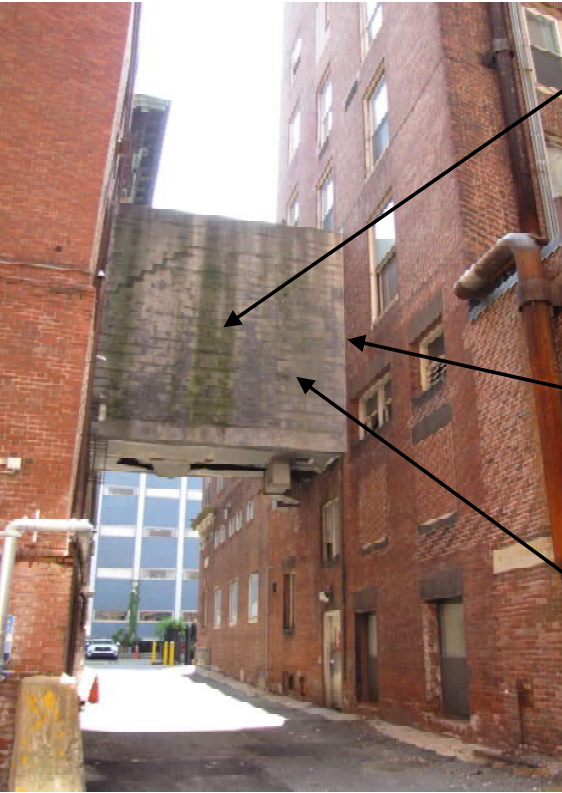
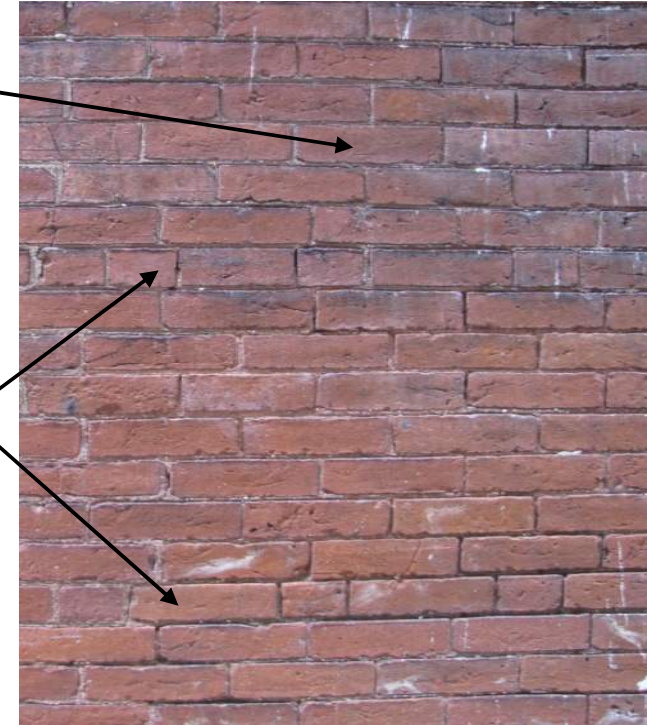
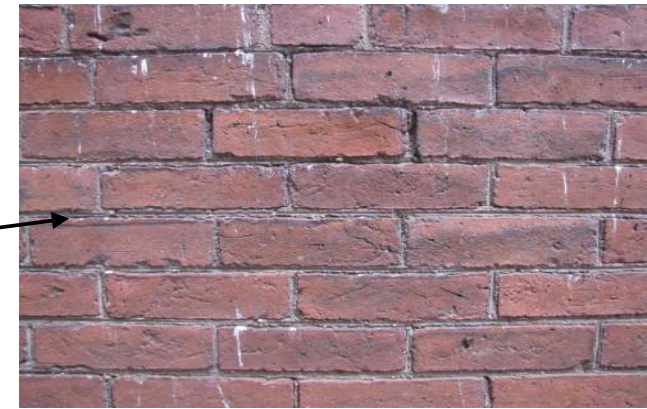
Restoration of Robinson Building

Carefully demolish concrete bridge to protect existing brick wall

After bridge removal, clean all concrete from face of existing brick

Infill opening where bridge removed, tooth brick into existing wall

Match existing brick in color, size, texture and composition

Replicate brick bond – header/stretcher course every 8th course

Match existing mortar in color, texture, composition and grapevine joint profile

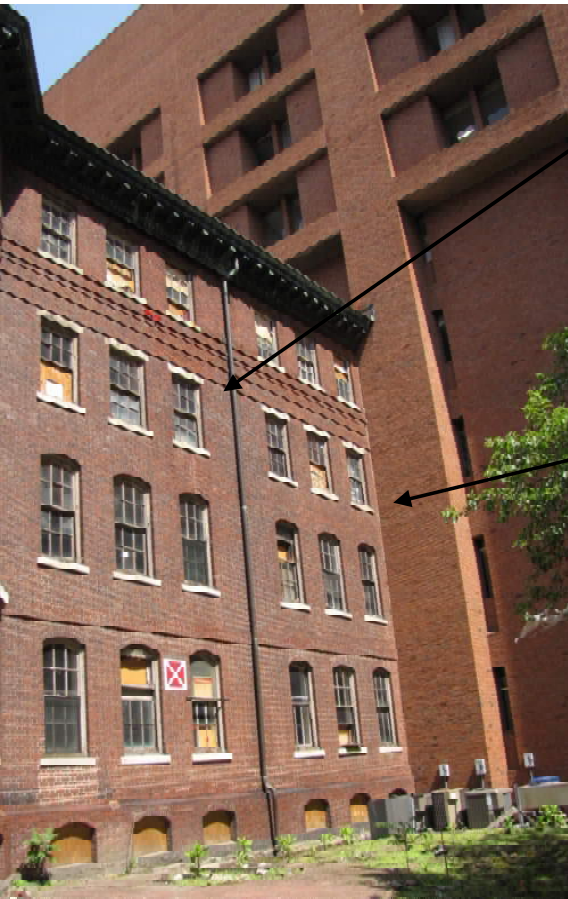
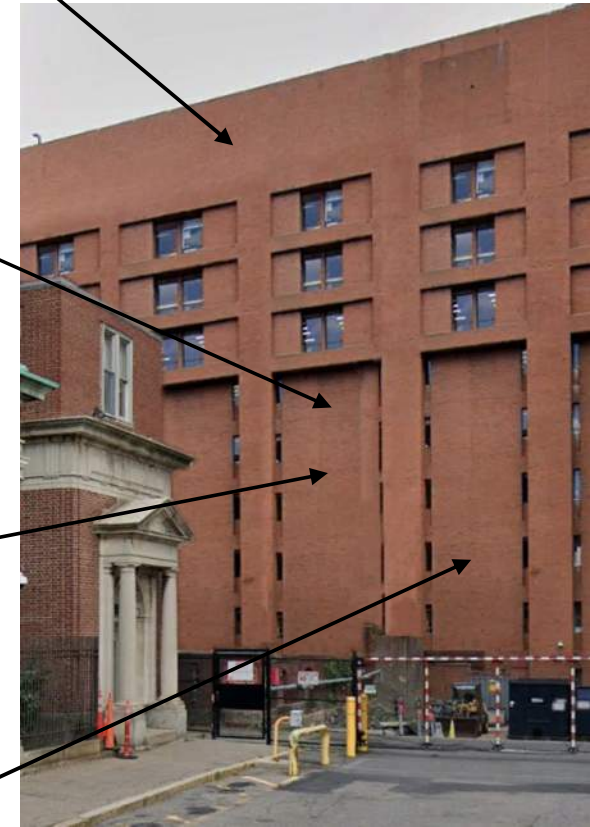
Restoration of Evans Building

Carefully demolish Vose Hall to protect existing brick wall

After Vose removal, clean all debris from face of existing brick

Match existing brick in color, color range, size, texture and composition

Replicate brick bond – header/stretcher course every 8th course

Infill opening where bridge removed, tooth brick into existing wall

Match existing mortar in color, texture, composition and joint profile
