THE COPLEY PLAZA HOTEL

138 St. James Avenue (205 Dartmouth Street), Boston

BOSTON LANDMARKS COMMISSION STUDY REPORT

Petition # 147.89

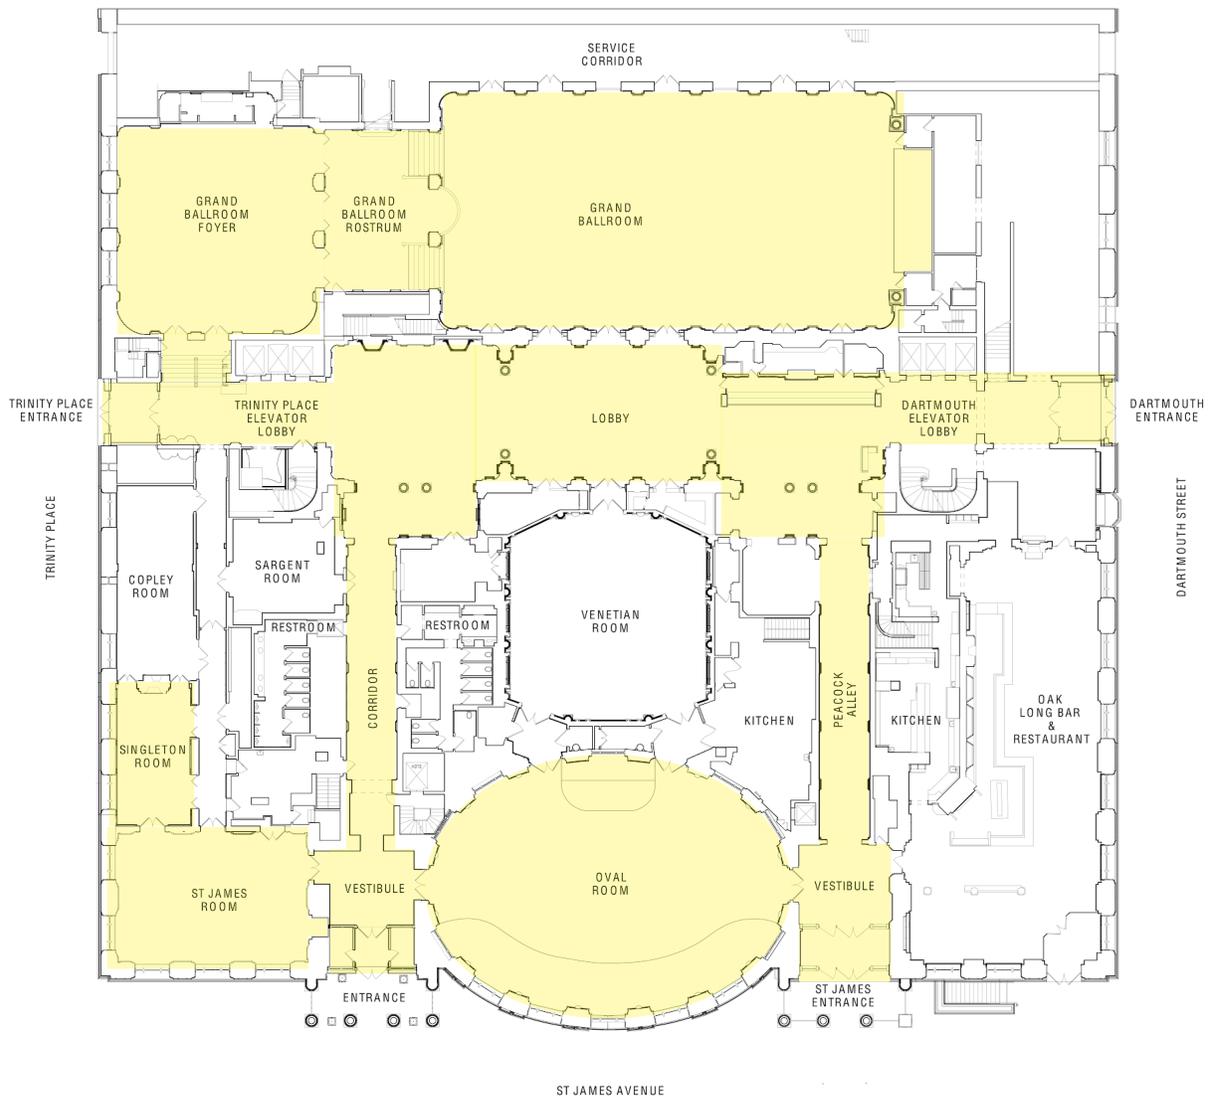
Figure 1. Ground floor plan of the Copley Plaza Hotel. Areas that are highlighted in yellow are included in the proposed designation.

- The exterior envelope of the building.
- Certain interior character-defining features in the following spaces on the lobby level (see section 7.3 for List of Character-Defining Features):
 - Lobby and connecting concourses (such as Peacock Alley) and foyers
 - Grand Ballroom, including Grand Ballroom Foyer and Rostrum
 - Oval Room
 - St. James Room
 - Singleton Room

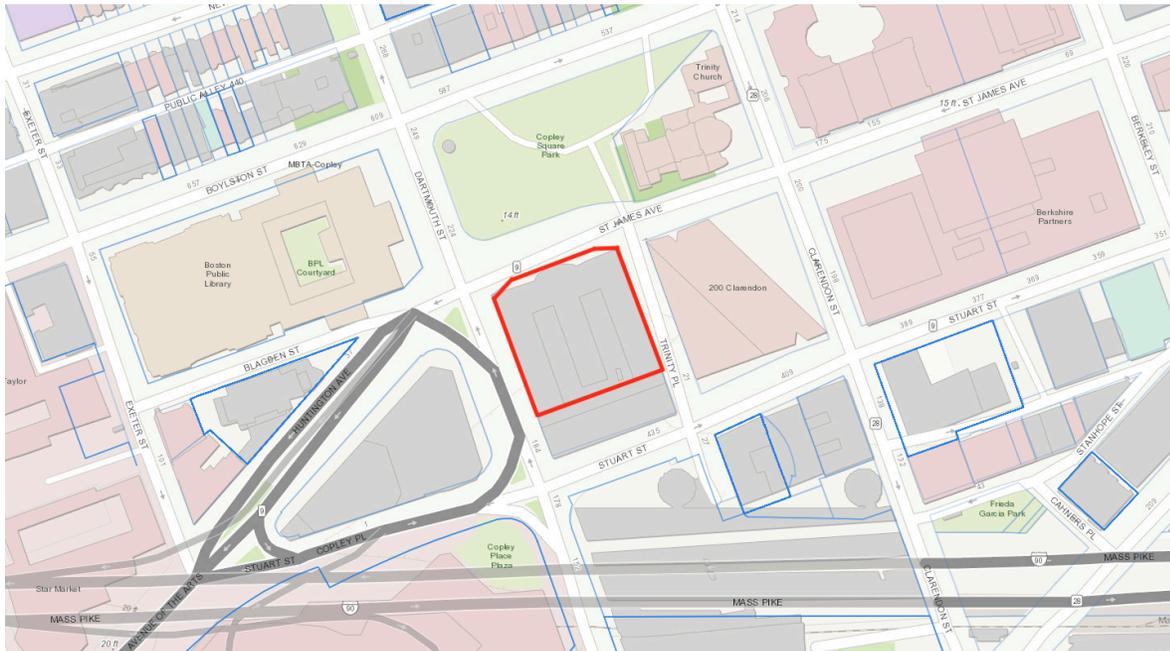
Figure 2. Map showing the proposed boundary of the designation which corresponds to the boundary of parcel #0401087000.

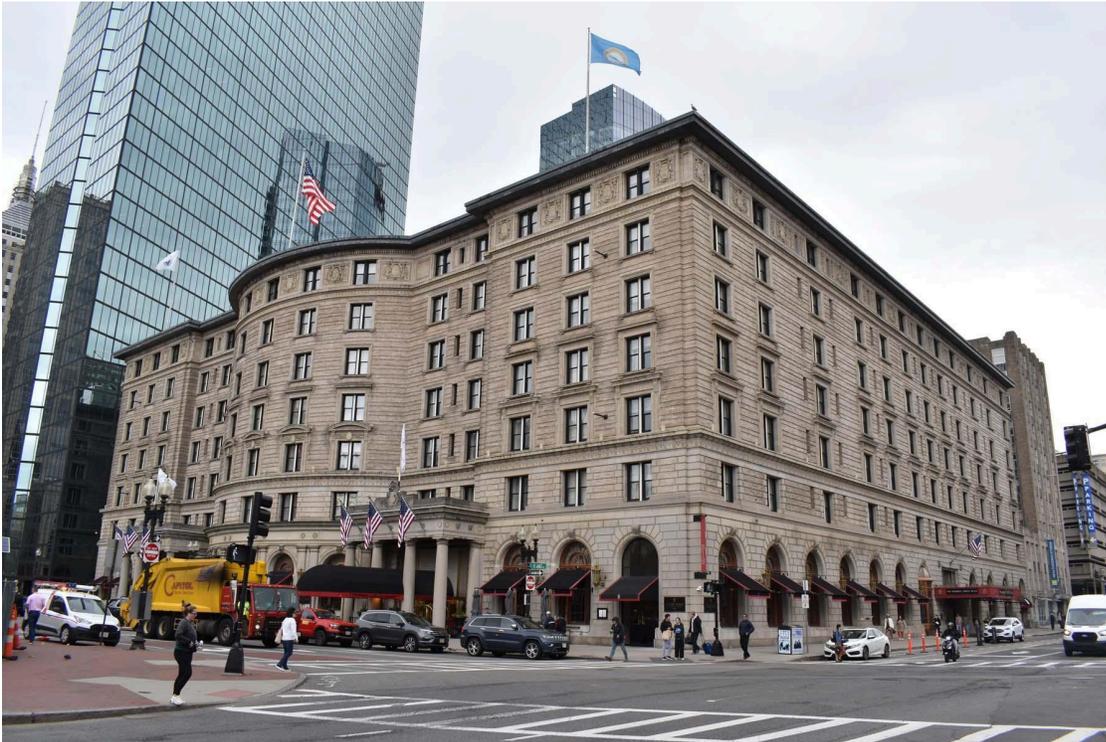
Figure 3. Copley Plaza Hotel, north facade and west elevation, looking southeast (G. Pineo, PAL, photographer, May 2024).

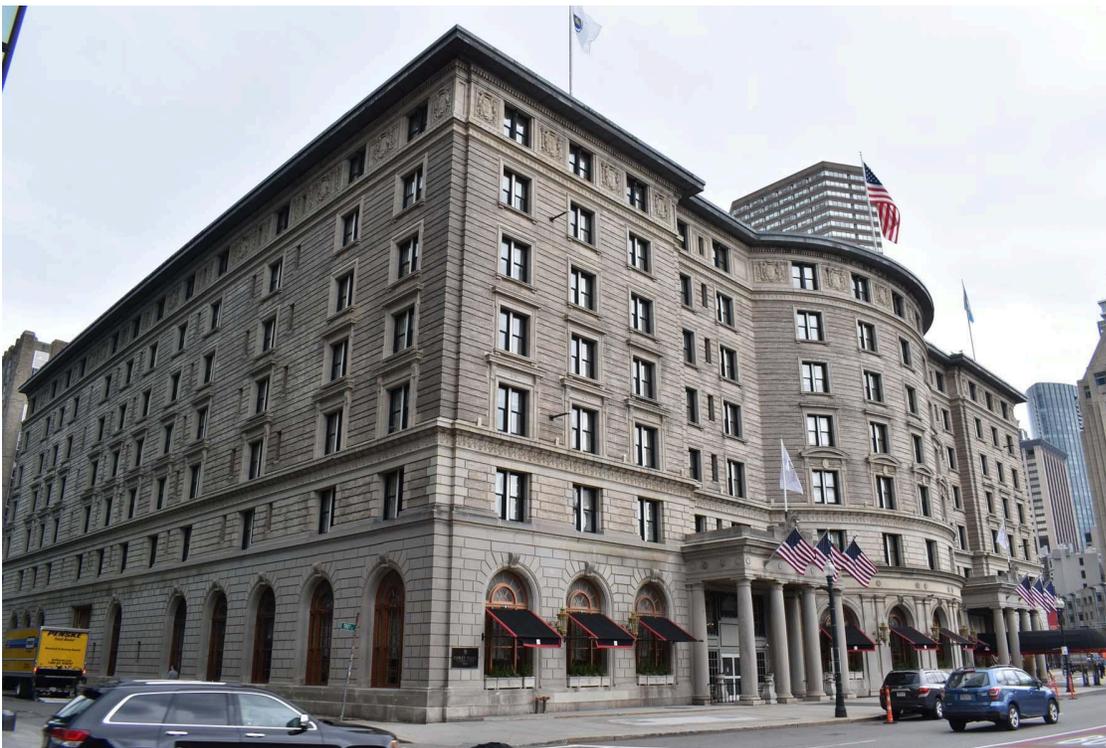
Figure 4. Copley Plaza Hotel, east elevation and north facade, looking southwest (G. Pineo, PAL, photographer, May 2024).

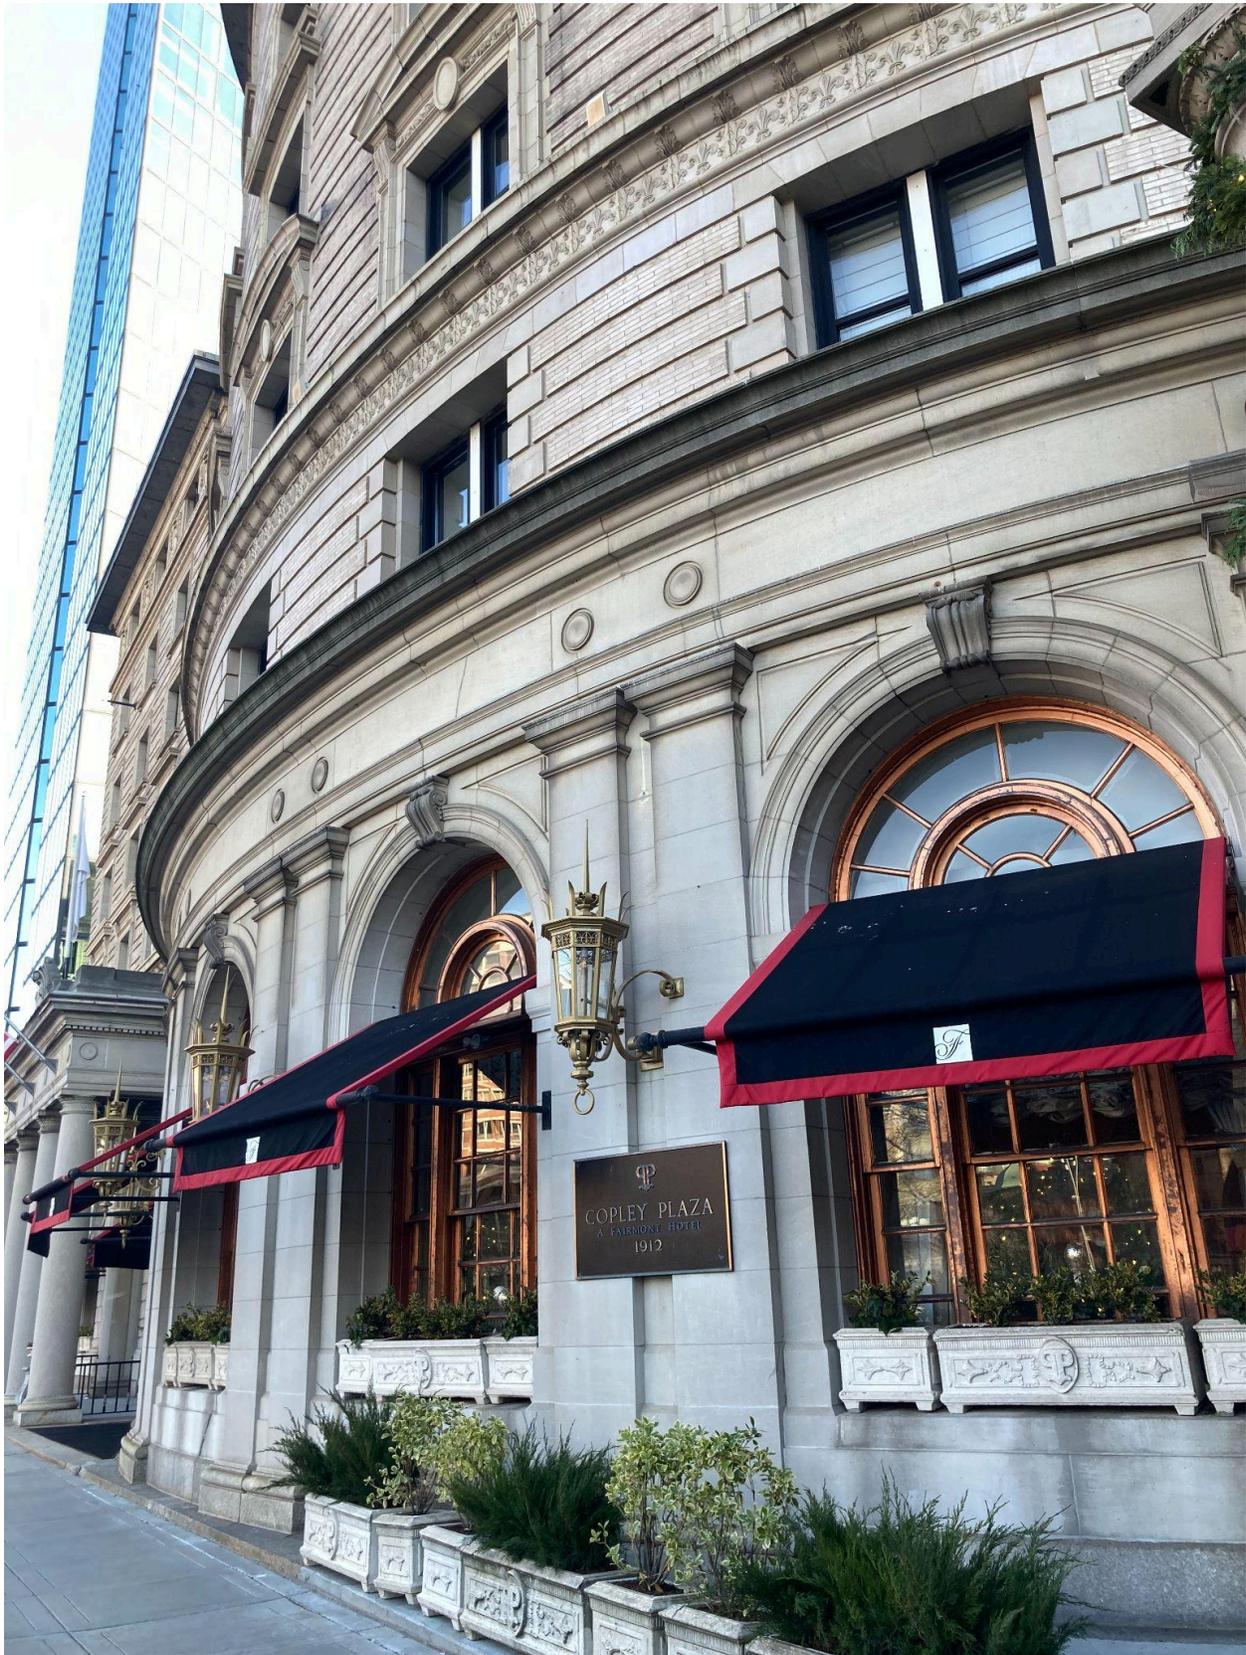
Figure 5. Detail of the St. James Avenue facade (J. Gaugler, Boston Landmarks Commission staff, photographer, December 2025).

The hotel sits on a stone foundation and has a two-story base of rusticated regular coursed ashlar limestone at the first story and brick at the second story, topped by a fleur-de-lis cornice. Along all three street facades of the building, large arched windows in the first story are set into stone surrounds with volute keystones. The window frames are clad in copper.

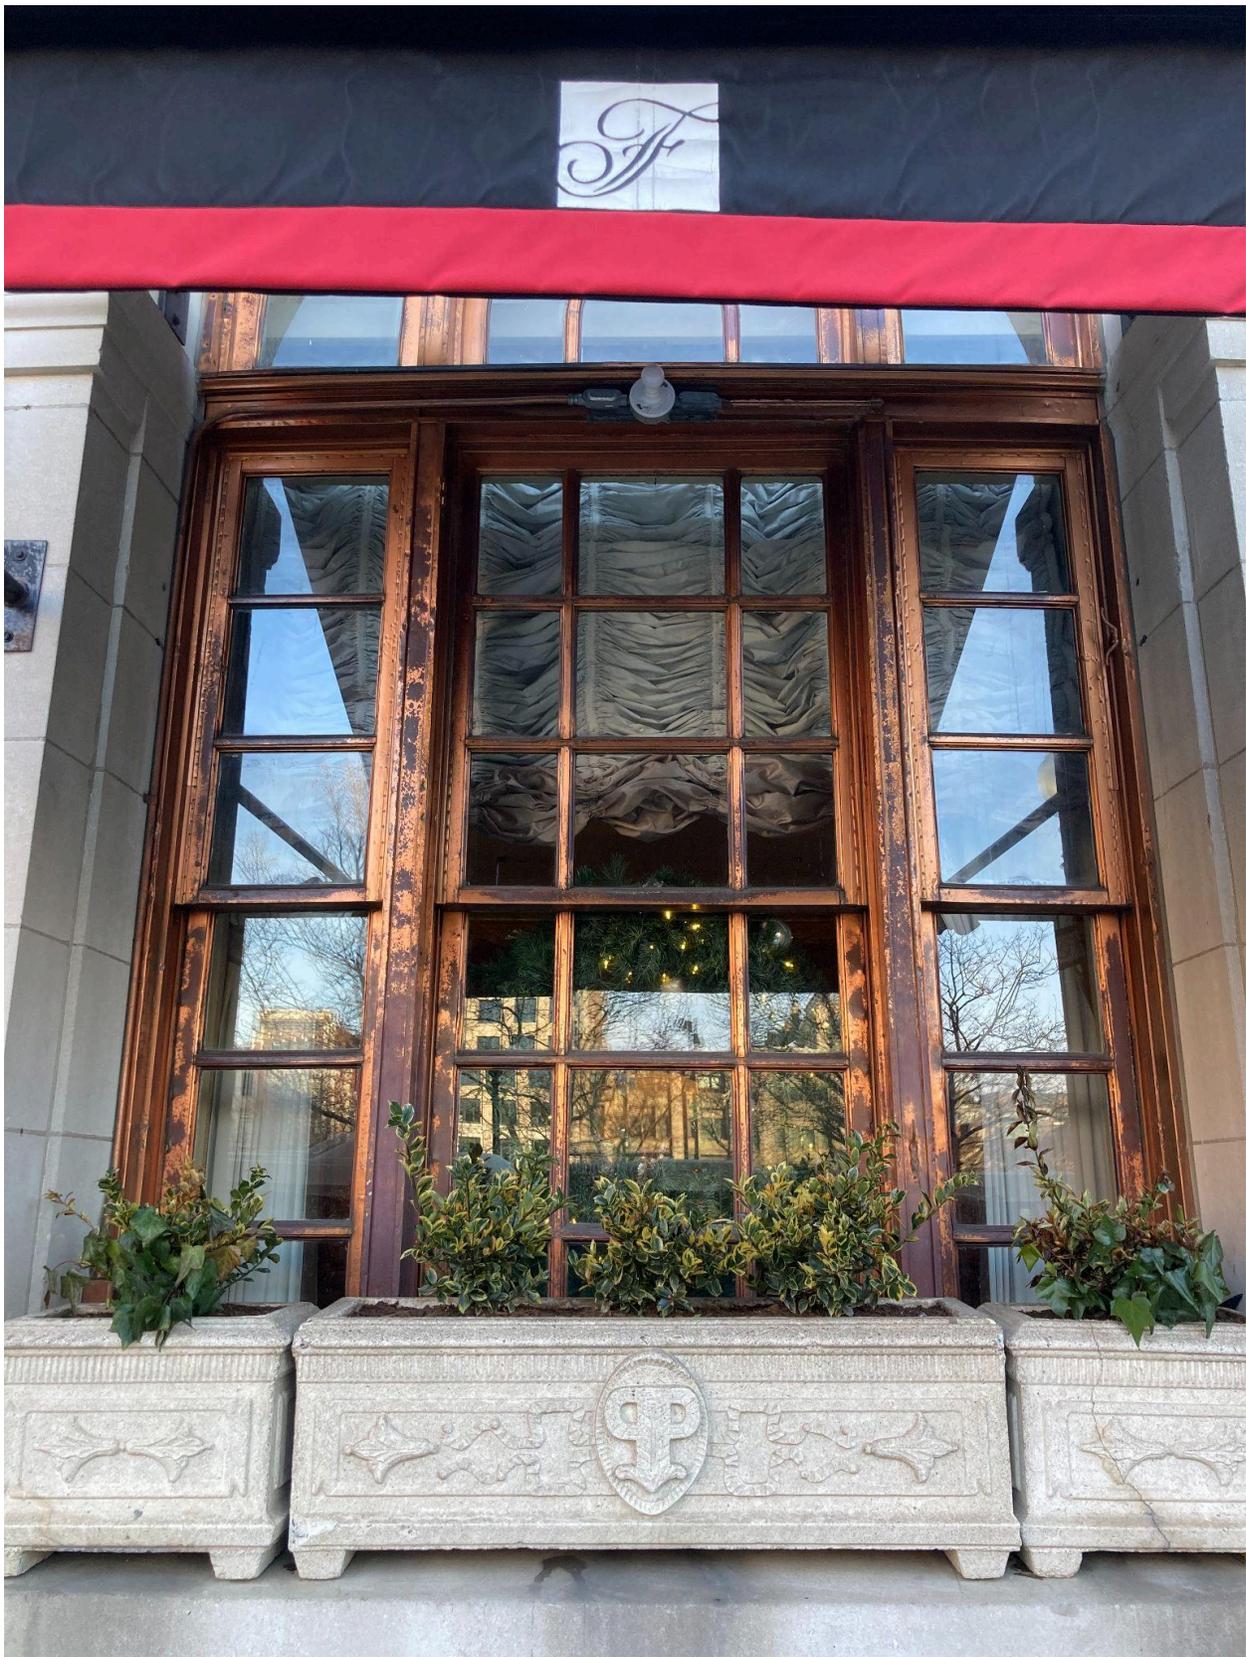
Figure 6. Detail of a St. James Avenue window (J. Gaugler, Boston Landmarks Commission staff, photographer, December 2025).

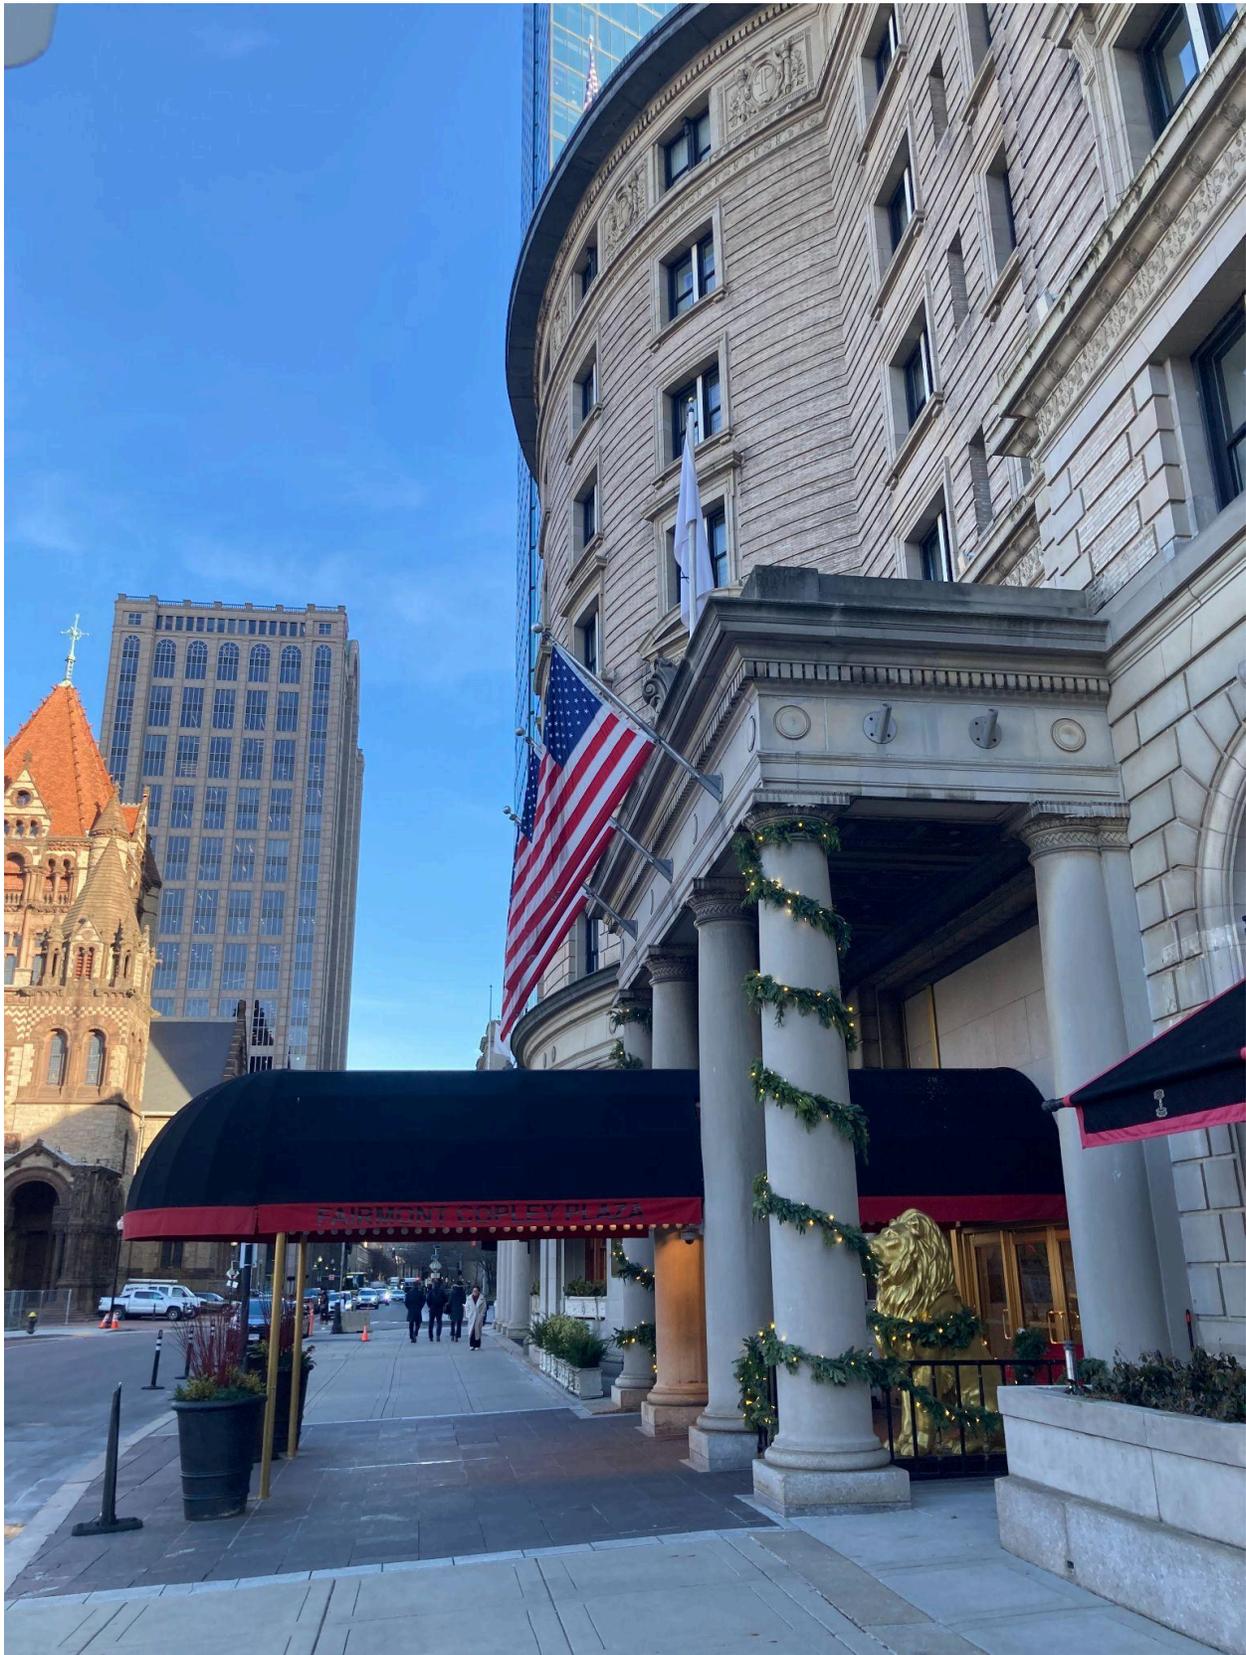
Figure 7. Primary entrance on St. James Avenue (J. Gaugler, Boston Landmarks Commission staff, photographer, December 2025).

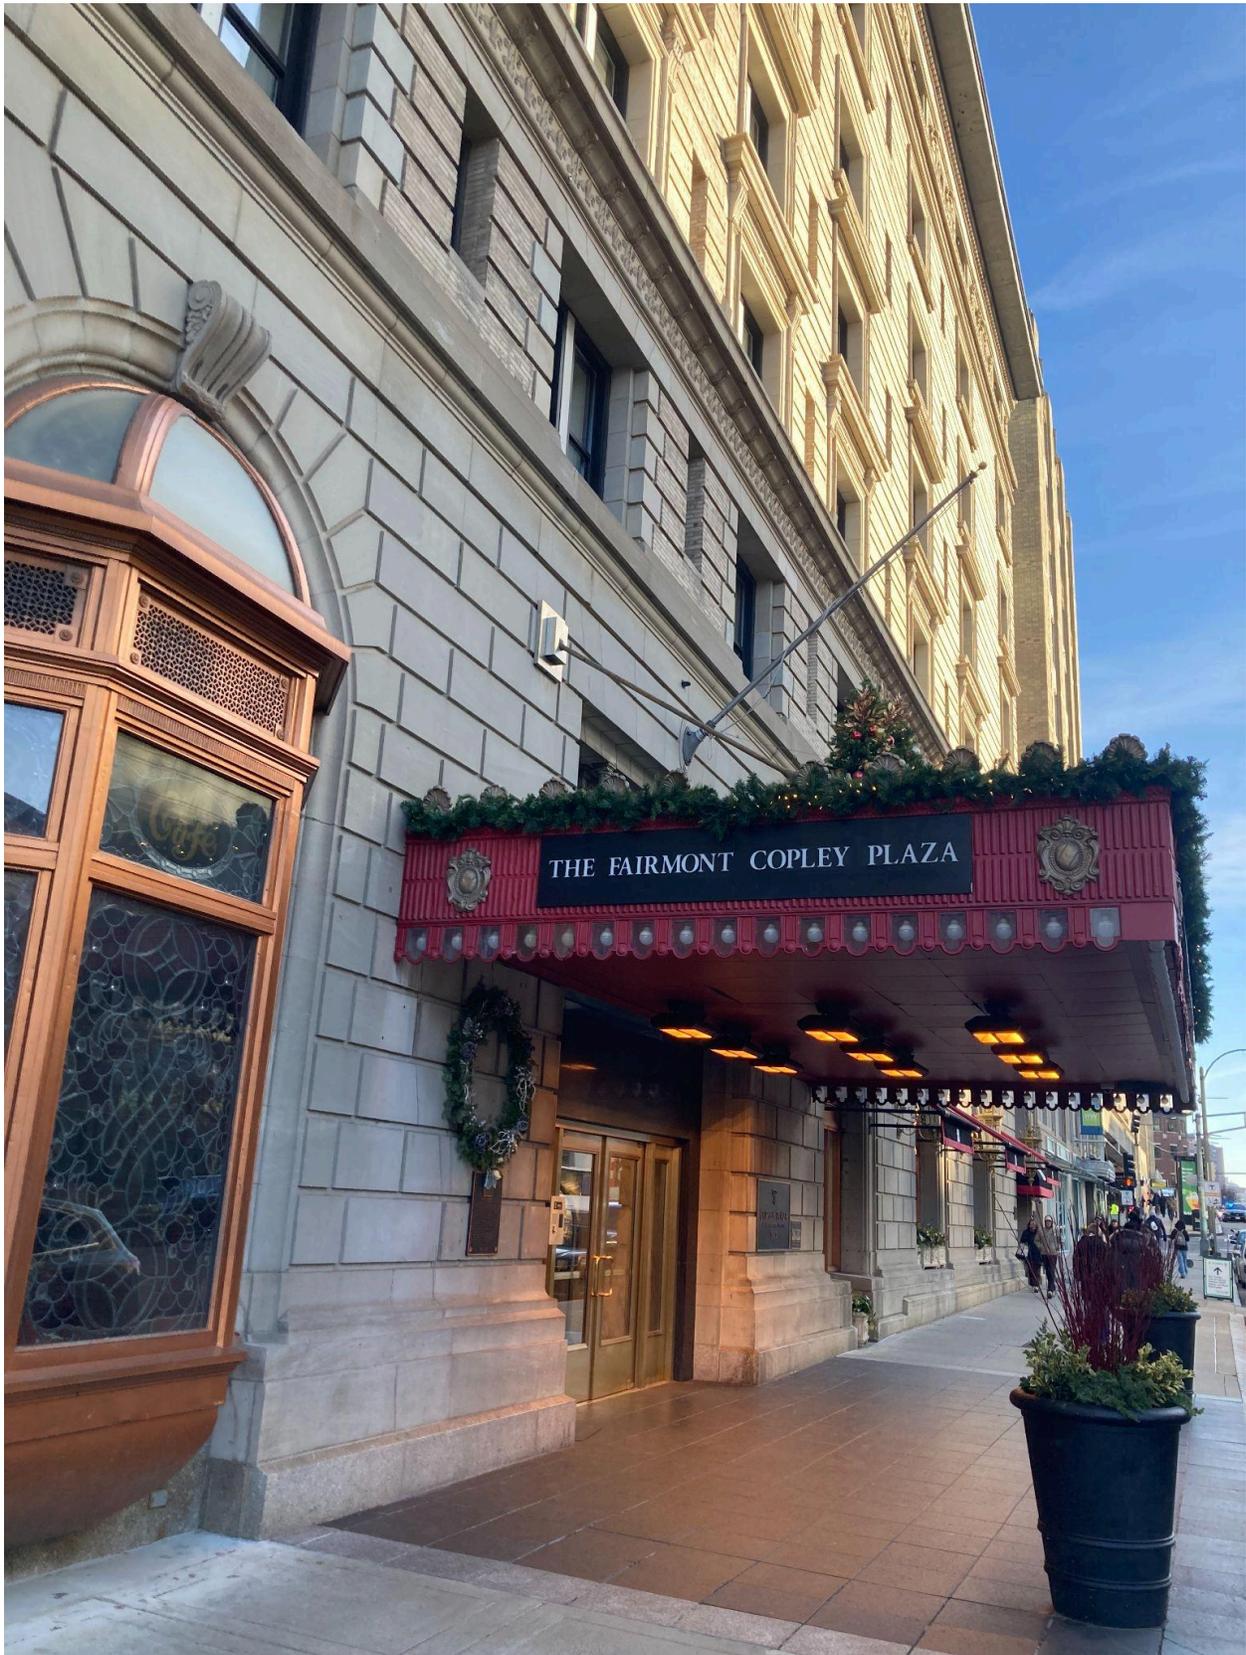
Figure 9. Entrance and non-original marquee on Dartmouth Street (J. Gaugler, Boston Landmarks Commission staff, photographer, December 2025).

On the Dartmouth side of the building, there is a non-original projecting marquee with decorative molded medallions, palmettes, and integrated lighting, which replaced the original marquee visible in historic photographs. There was a marquee in this location historically, but the current marquee is thicker than the original due to the installation of outdoor heating panels. It is also narrower, as it no longer crosses the window on either side of the entrance. To the left of the entrance there is a non-original projecting oriel window with a domed hood and ornamental grilles.

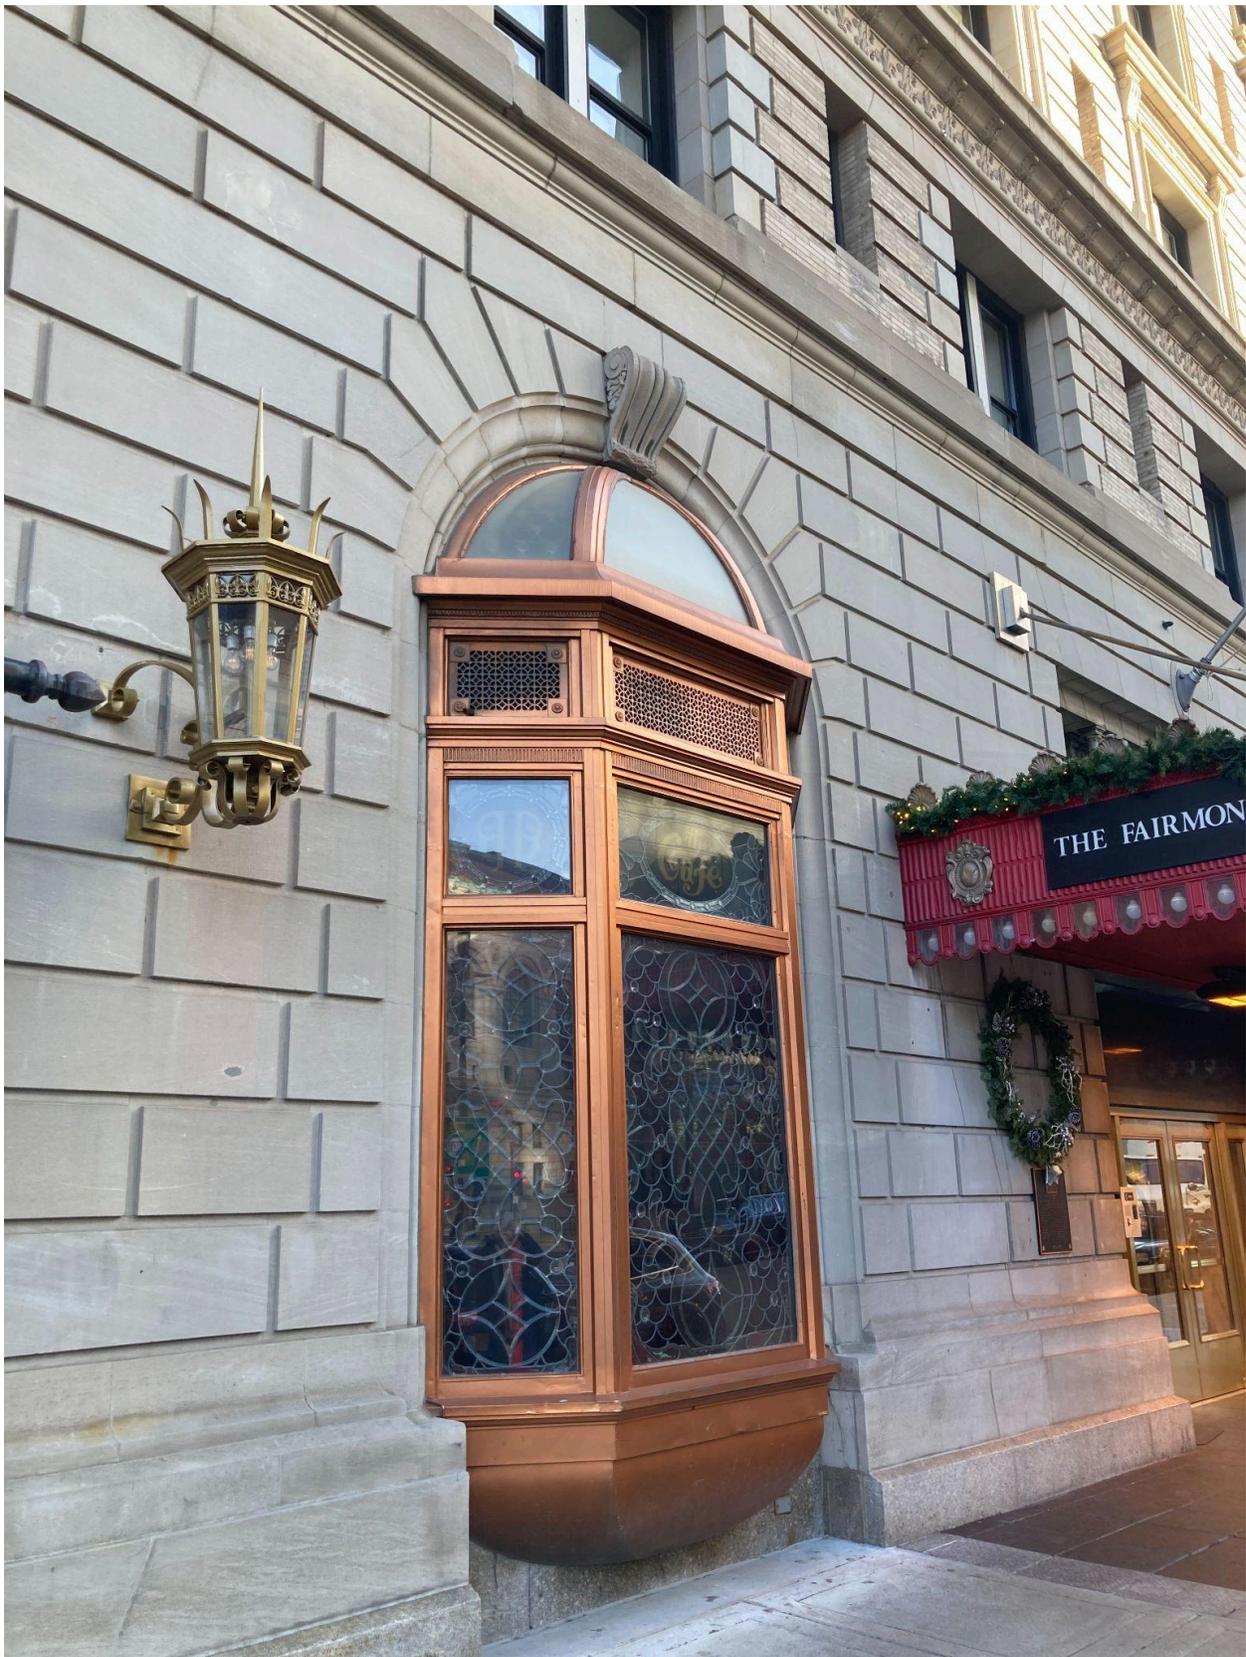
Figure 10. Non-original projecting oriel window on Dartmouth Street (J. Gaugler, Boston Landmarks Commission staff, photographer, December 2025).

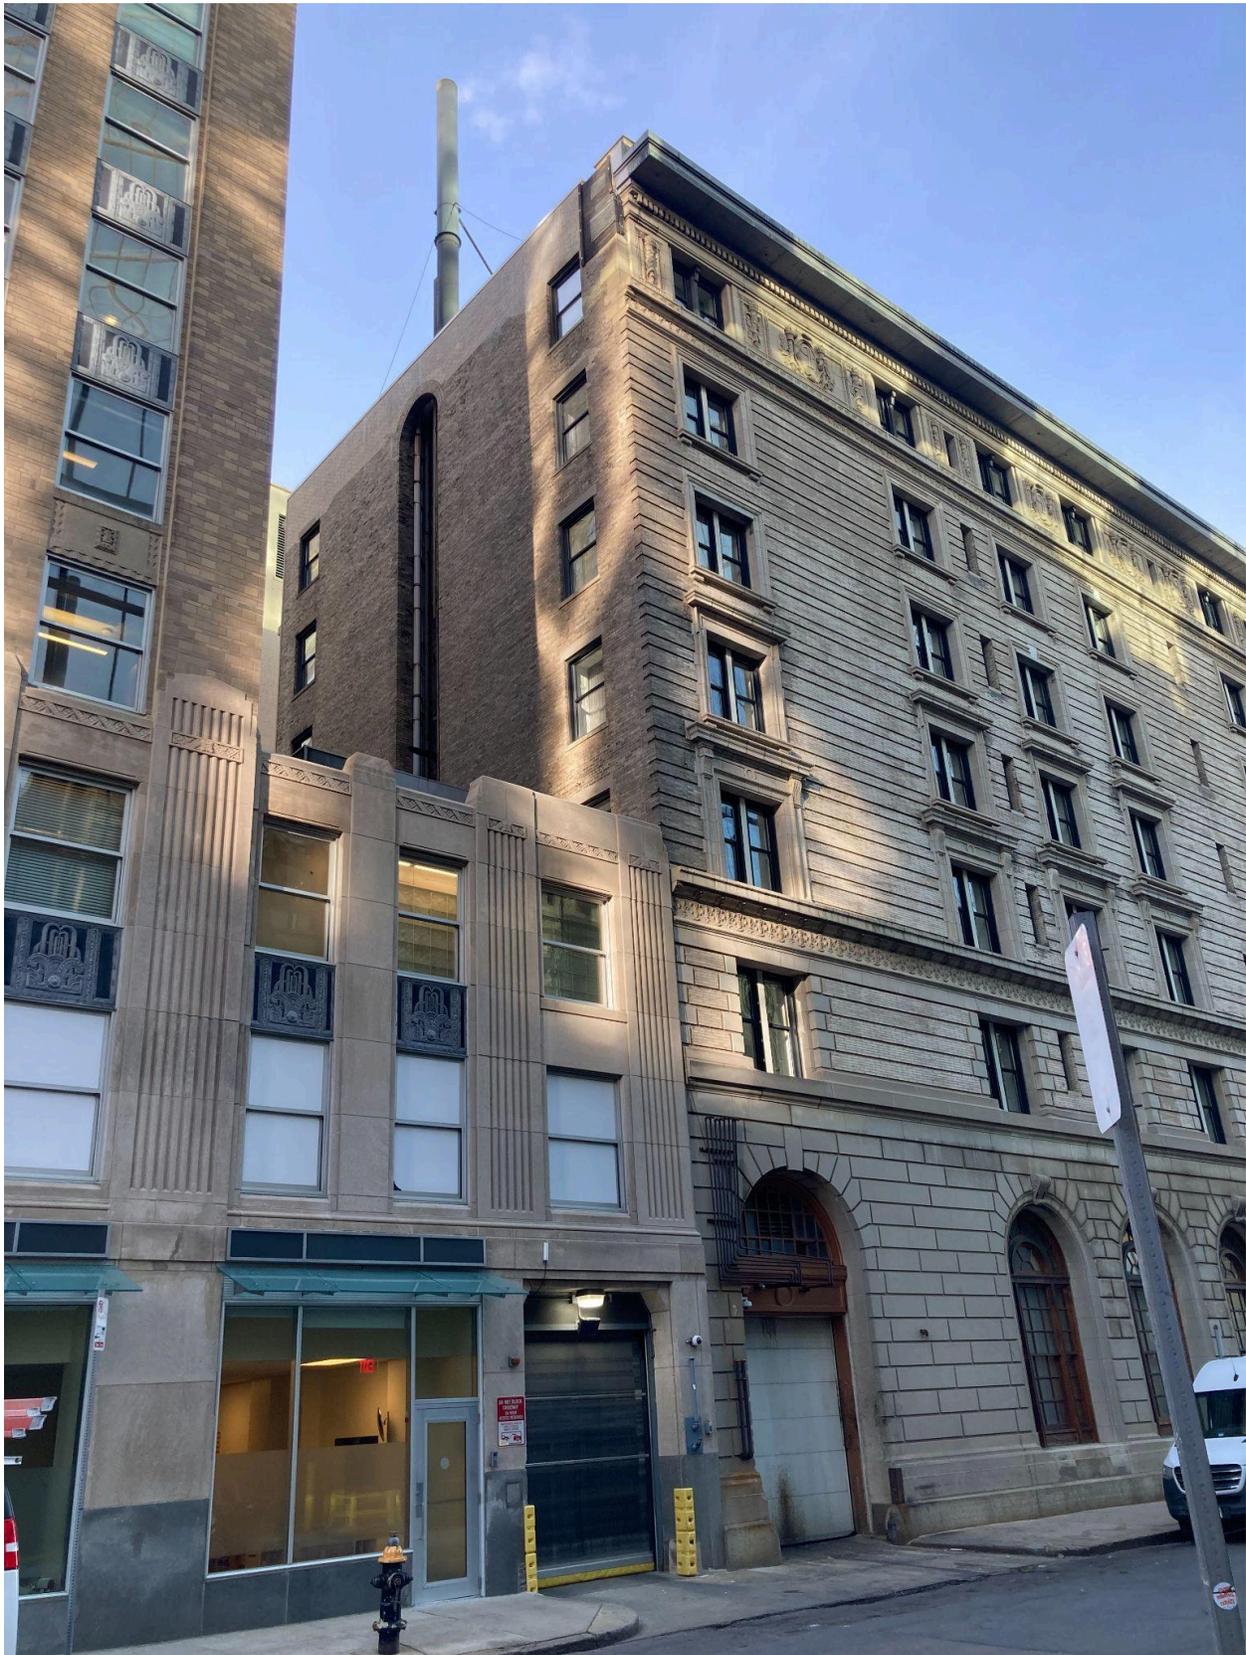
Figure 11. Photo taken from Trinity Place showing the rear (south) facade of the hotel in the unadorned brick (J. Gaugler, Boston Landmarks Commission staff, photographer, December 2025).

The Copley Plaza Hotel is a monumental Renaissance Revival building of rusticated limestone and tan brick with a 15-bay-wide front facade along St. James Avenue and 12-bay side facades along Dartmouth Avenue and Trinity Place. The rear of the building is flush with the adjacent building for the lower two stories, but above that the building becomes E-shaped in plan, with deep lightwells providing light and air to the rooms in the interior of the footprint.

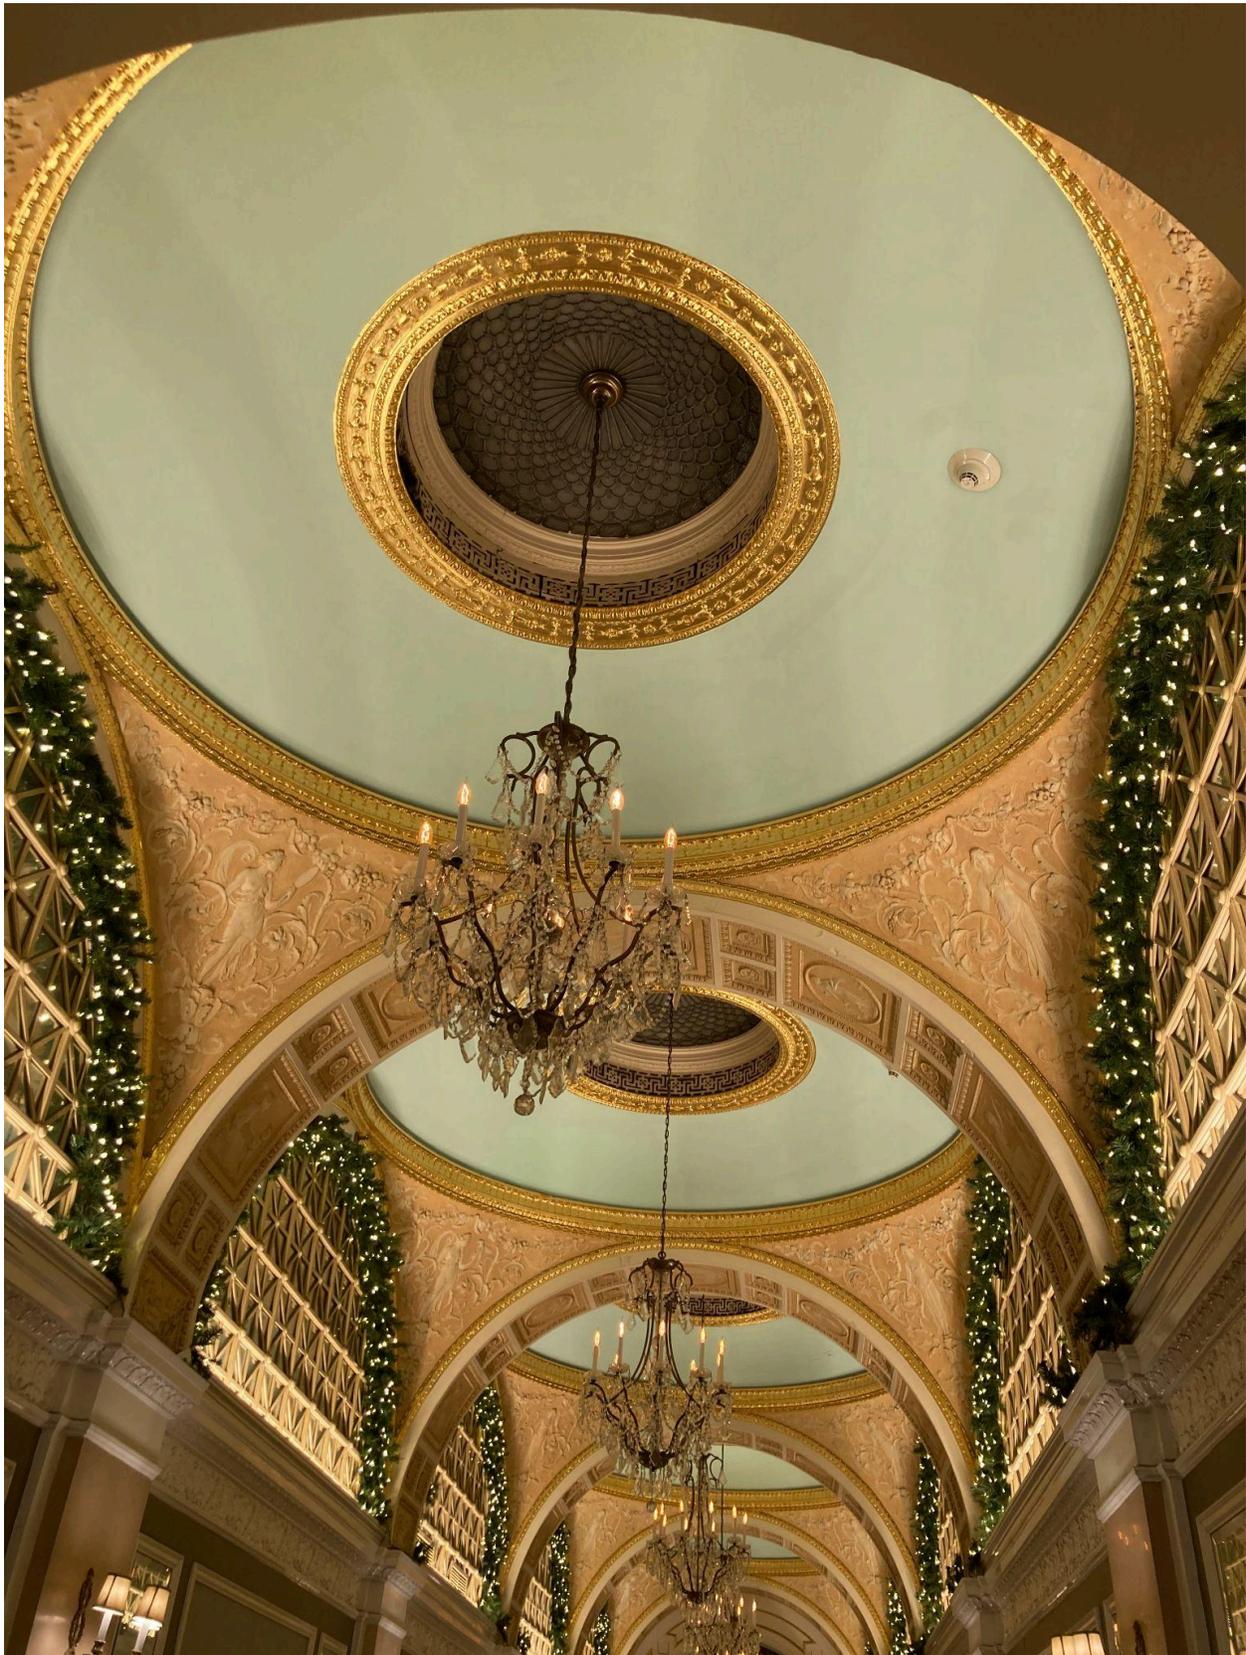
Figure 13. The ceiling of Peacock Alley (J. Gaugler, Boston Landmarks Commission staff, photographer, December 2025). Note that the chandeliers are not original.

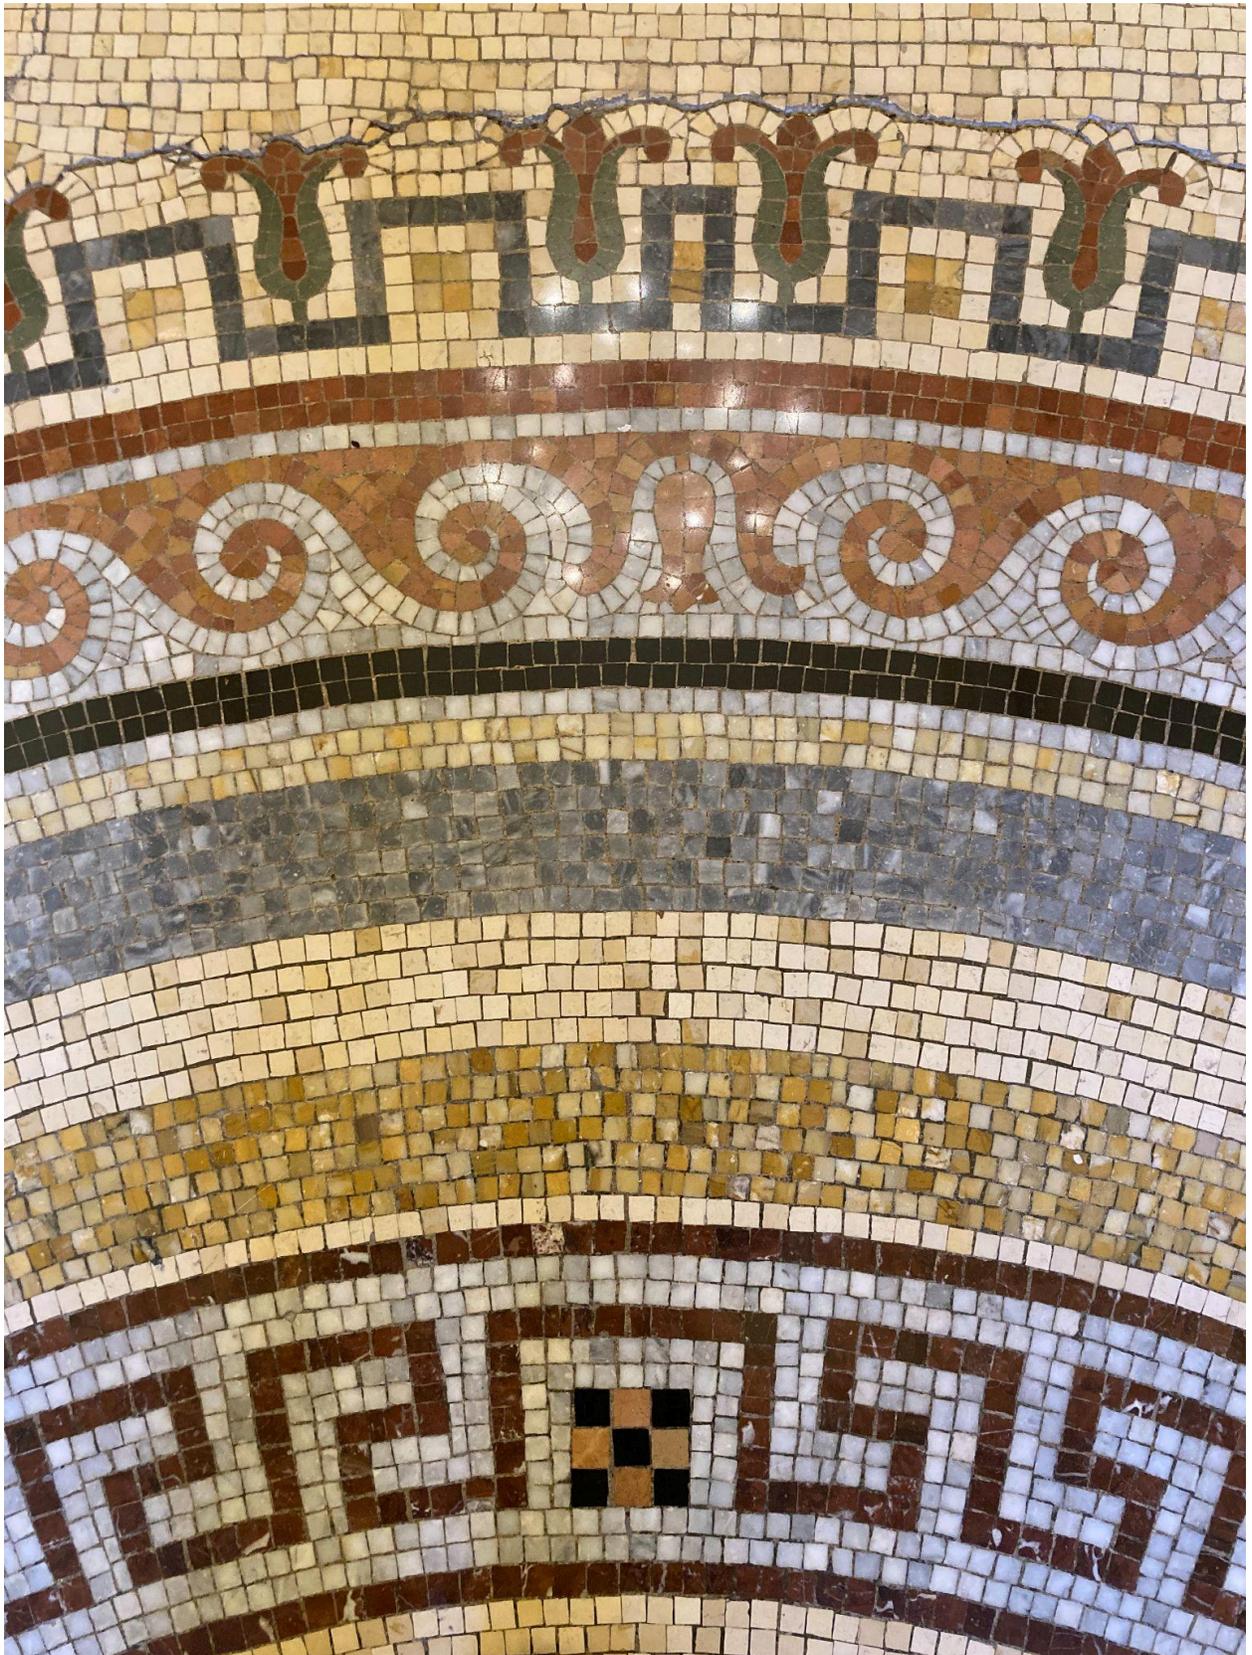
Figure 16. Detail of mosaic tile floor in the foyer of the secondary entrance on St. James Avenue (J. Gaugler, Boston Landmarks Commission staff, photographer, December 2025).

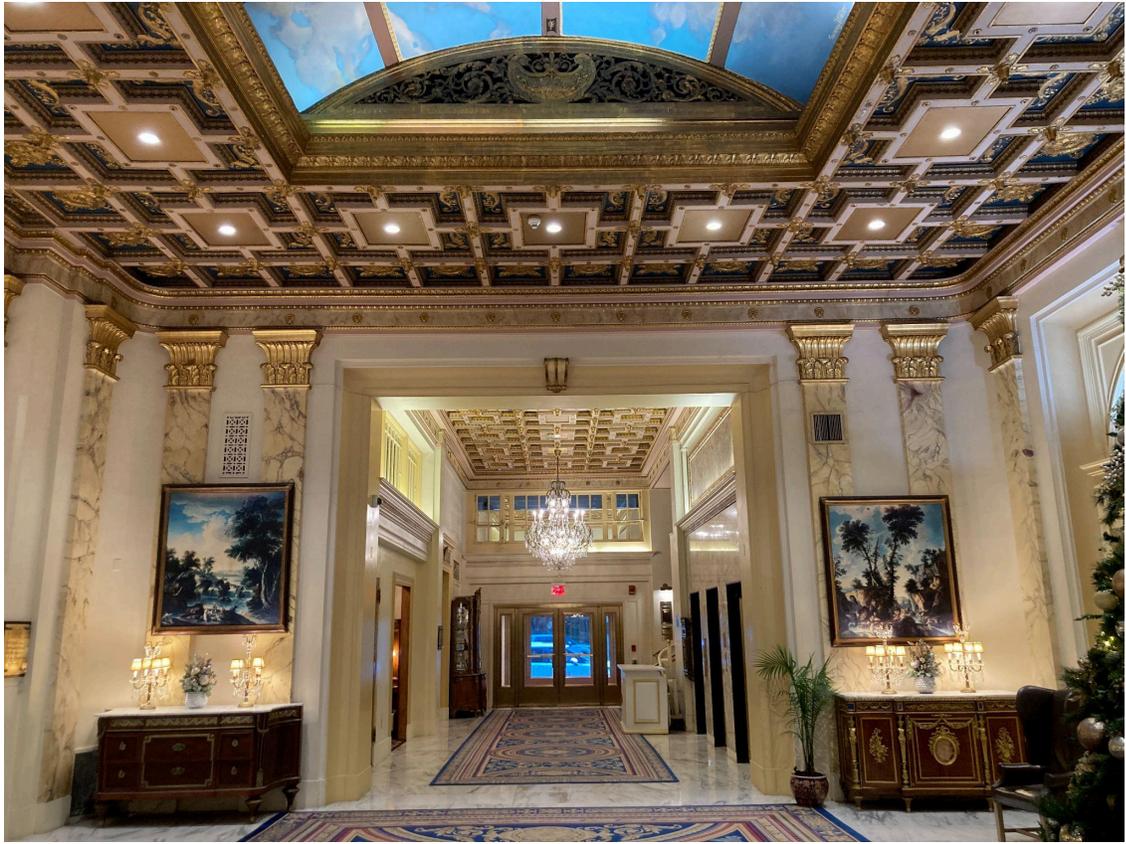
Figure 19. Lobby looking east toward Trinity Place exit (J. Gaugler, BLC staff, photographer, December 2025). Note the different placement of grilles on the left and the right.

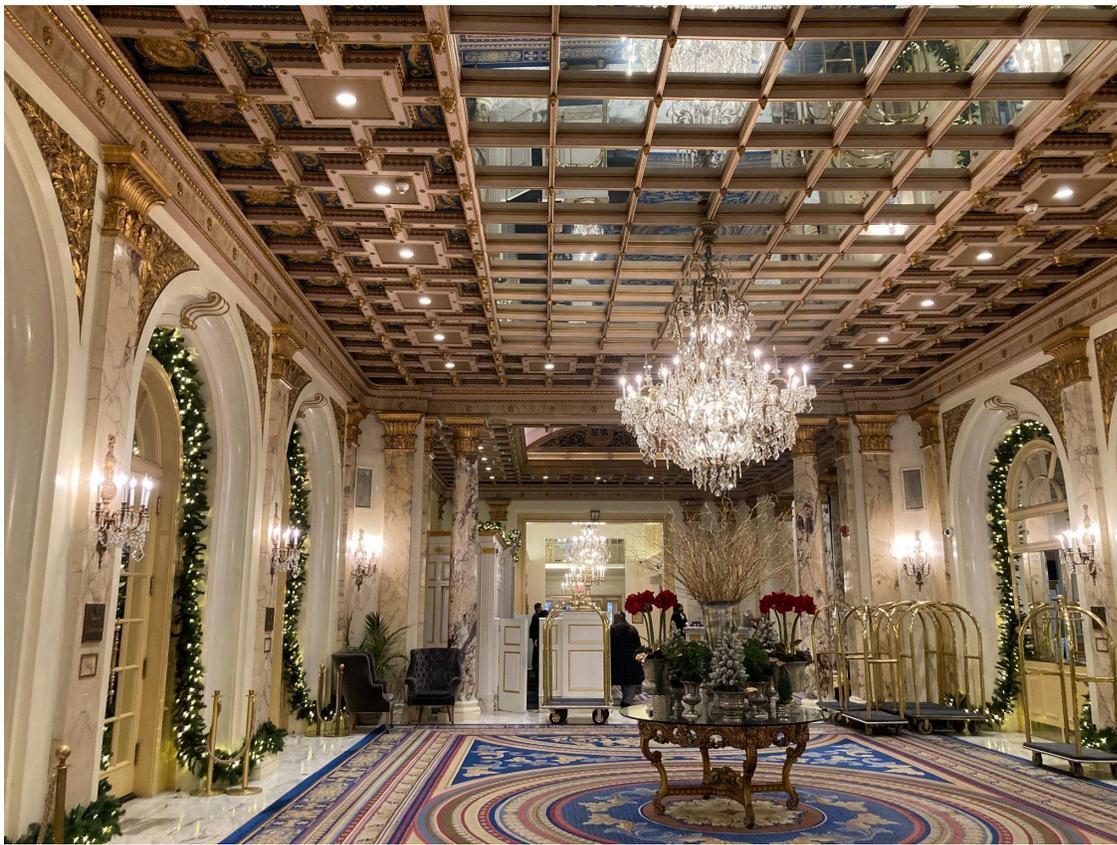
Figure 21. Lobby interior looking west (J. Gaugler, BLC staff, photographer, December 2025). Front desk is visible.

Alterations identified in this space include: marbling added to the wall pilasters; gilded finishes; marble flooring instead of mosaic; and the front desk, which has been replaced and relocated several times (see next page).
