THE COPLEY PLAZA HOTEL

138 St. James Avenue (205 Dartmouth Street), Boston

BOSTON LANDMARKS COMMISSION STUDY REPORT

Petition # 147.89

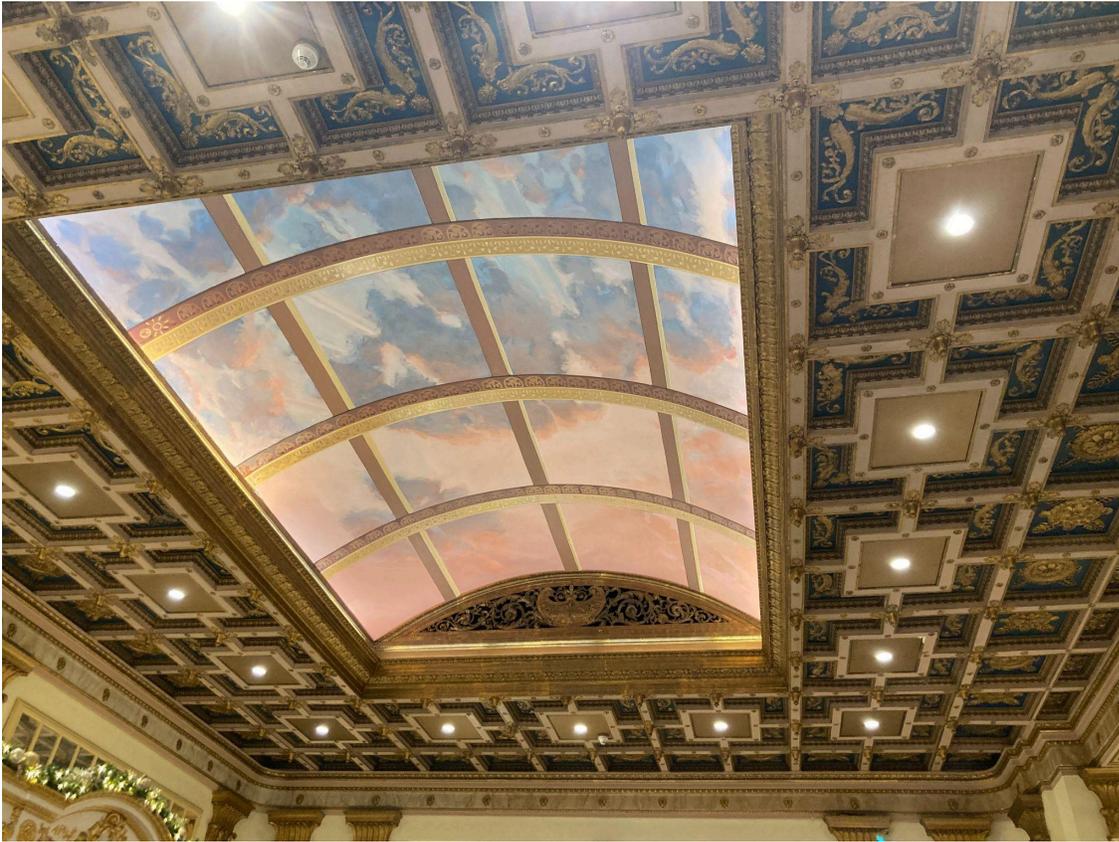
Figure 23. Detail of lobby ceiling (J. Gaugler, BLC staff, photographer, December 2025).

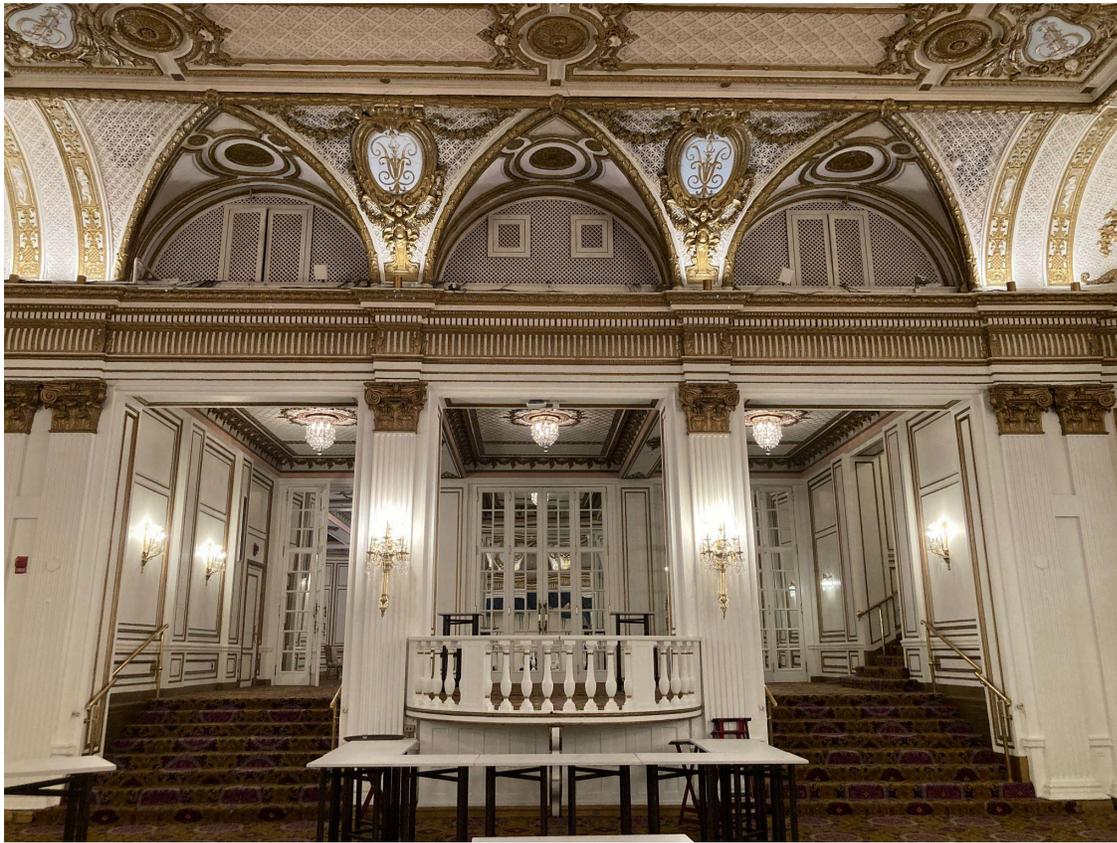
Figure 24. Grand Ballroom looking into the rostrum (J. Gaugler, BLC staff, photographer, December 2025).

The Grand Ballroom is the most magnificent room in the hotel, and also one of the least altered. The ballroom is sumptuously decorated with decorative molding and plasterwork on the walls and ceiling. On the south side there is a mezzanine with service space below. At the west end there is a raised stage, while on the opposite end of the room, stairs lead to the rostrum.

Alterations identified in this space include: one bay below the mezzanine converted from door to window; central bay of the stairs to the rostrum converted from stairs to balcony (see next page).

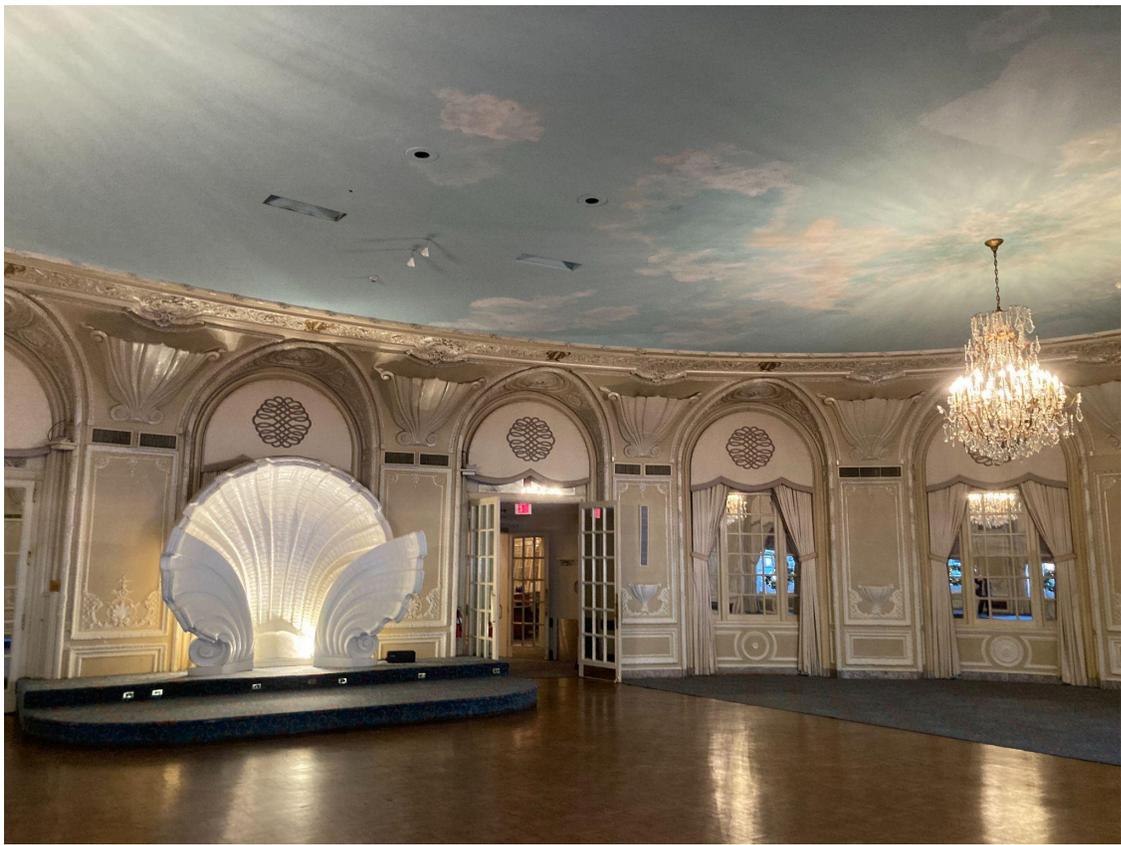
Figure 26. Oval Room (J. Gaugler, BLC staff, photographer, December 2025). See Section 5 for a discussion of alterations to this room.

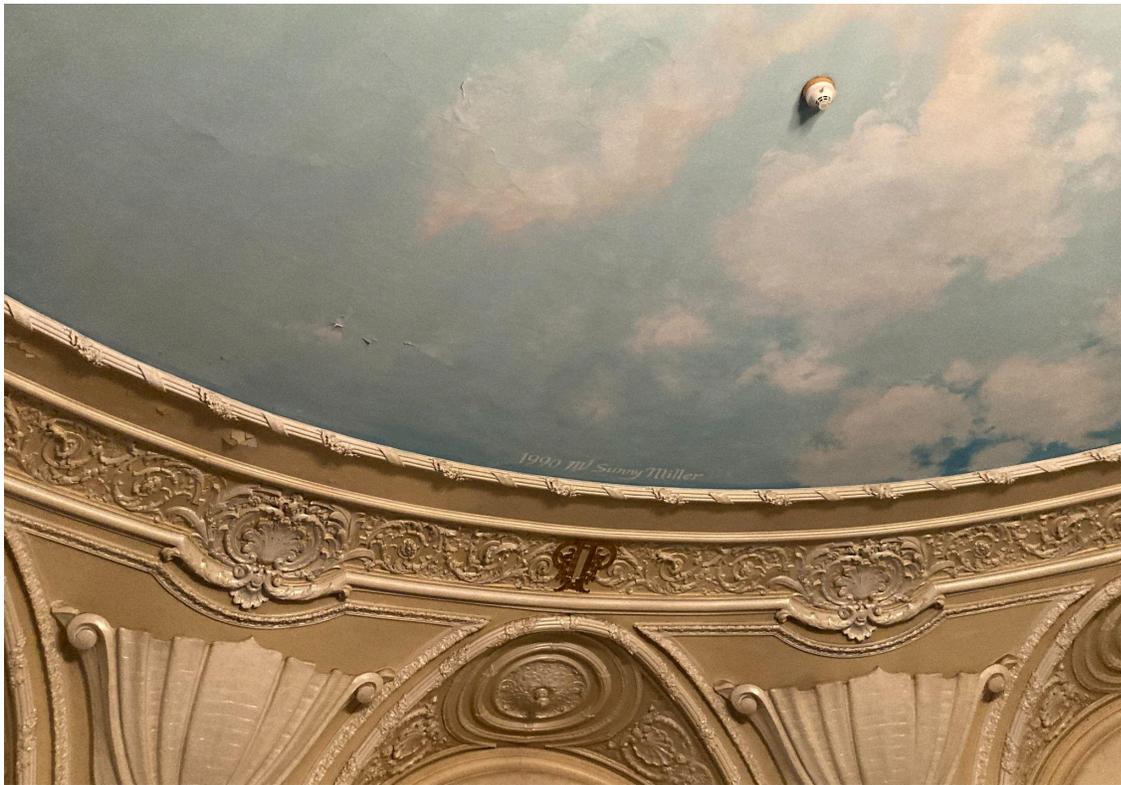
Figure 27. Oval Room ceiling detail (J. Gaugler, BLC staff, photographer, December 2025).

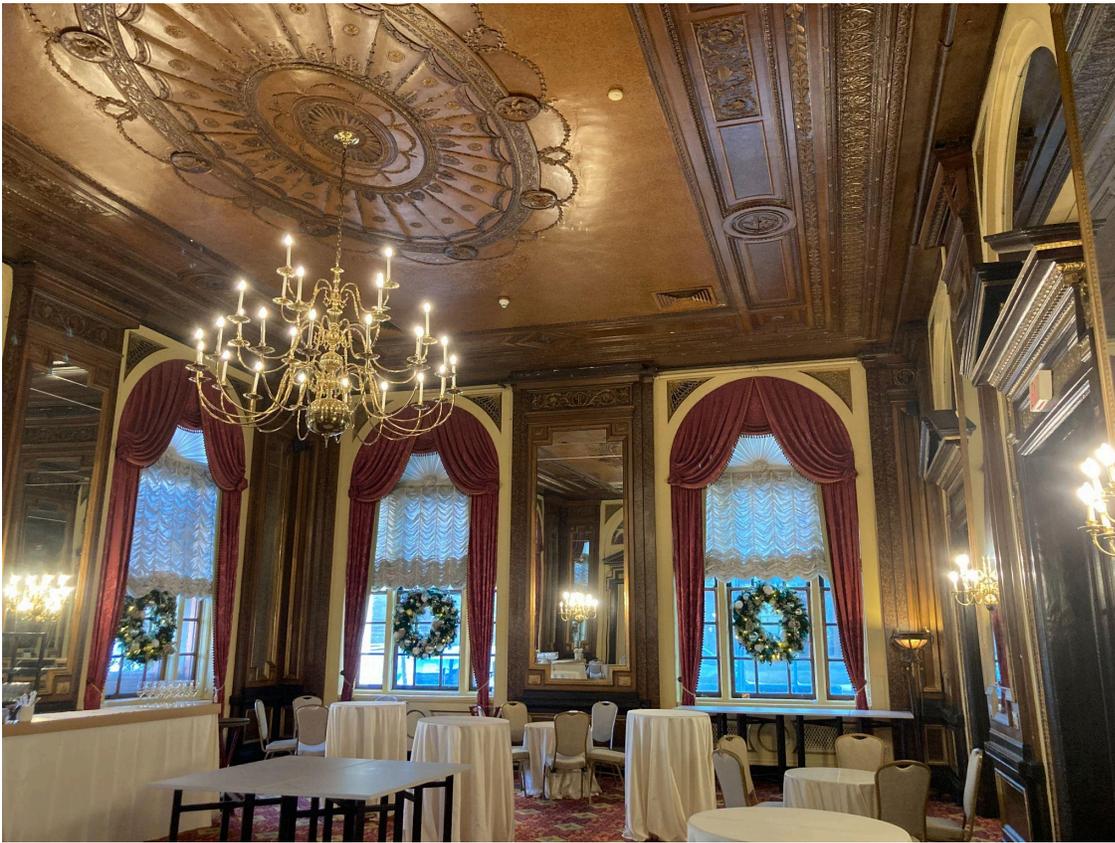
Figure 28. St. James Room (J. Gaugler, BLC staff, photographer, December 2025).

The St. James Room is particularly notable for its decorative ceiling, including border molding and a large, elaborate center medallion. The room also has raised wall panels and doorways with prominent entablatures surmounted by broken pediments. The room has been little altered from its original appearance.

Alterations identified in this space include: lighting fixtures; color treatment (the historic photo depicts light-colored walls, trim, and ceiling, whereas today much of the room is dark brown); the original multi-pane mirrors over the broken pediments are now single-pane mirrors. (Also see **Figure 56.**)

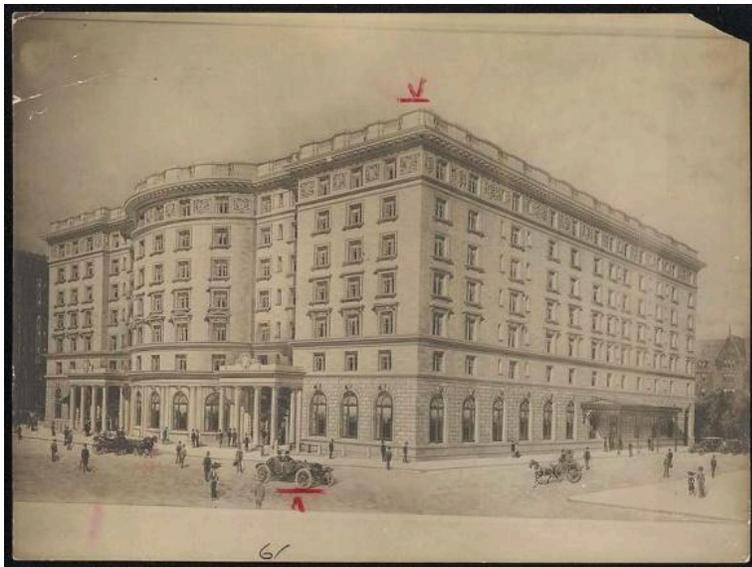
Figure 31. Architect Henry Janeway Hardenbergh's annotated work drawing of the Copley Plaza Hotel, north façade and west elevations, looking southeast, 1911.²

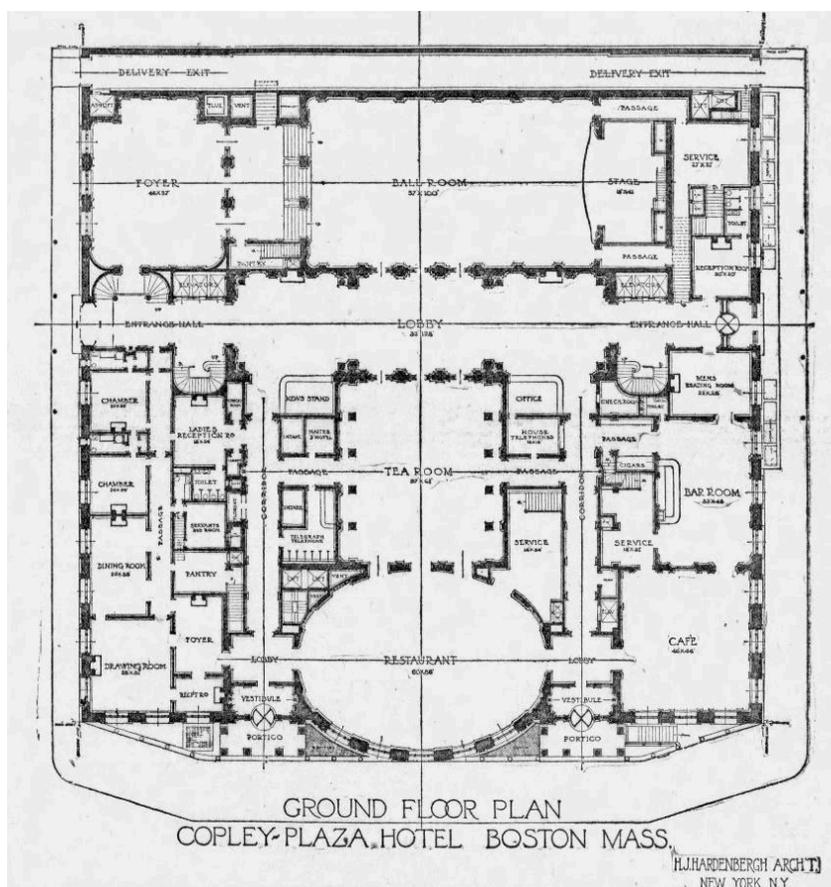
Figure 32. Architect Henry Janeway Hardenbergh's Ground Floor Plan drawing of the Copley Plaza Hotel, 1911.³

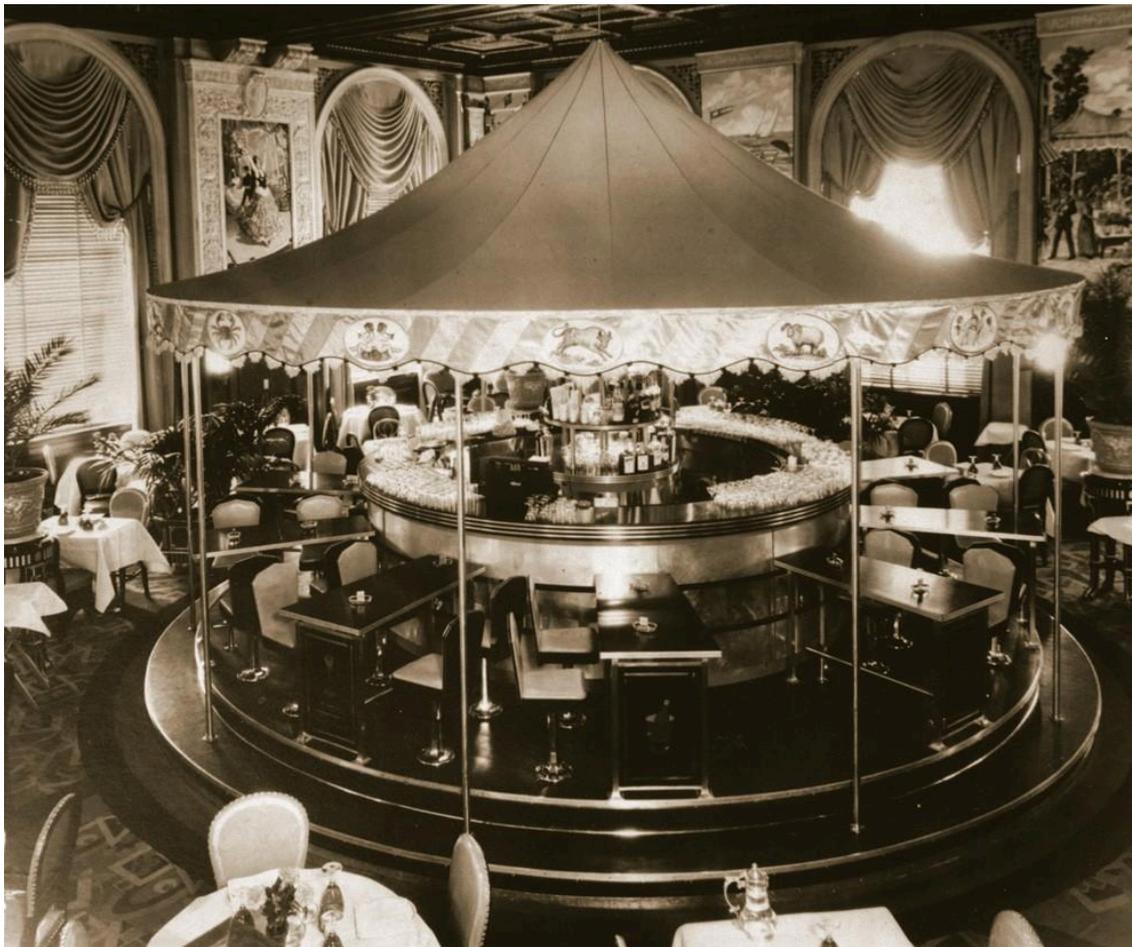
Figure 37. Carousel in the Merry-Go-Round Bar, which is now the Oak Long Bar + Kitchen, Copley Plaza Hotel (photographer unknown, ca. 1934-1978).

The Copley Plaza's dining room has seen many modifications and identity shifts over the years, and today reflects the combining of the originally distinct cafe and bar rooms into one open space. Original features in the space include the elaborate ceiling, which is coffered wood in one part and bas-relief plaster in the other part, with decorated cross beams. Molded swags still festoon the walls. There is also a metal rail embedded in the floor which indicates the former location of the mid-20th century carousel from the time the cafe functioned as the Merry Go Round Bar (see **Figure 37**).

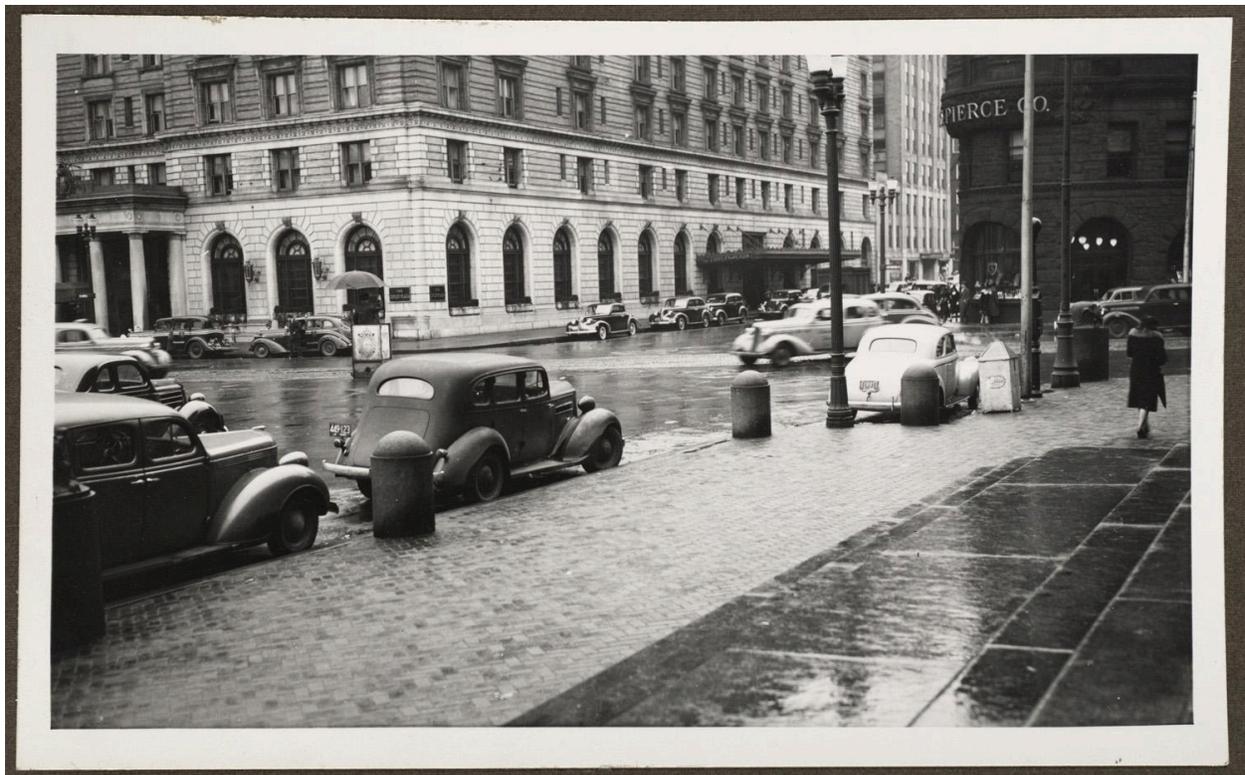
Figure 38. Copley Plaza Hotel taken from the opposite side of Dartmouth Street (photographer and date unknown). Note the width of the marquee.

On the Dartmouth side of the building, there is a non-original projecting marquee with decorative molded medallions, palmettes, and integrated lighting, which replaced the original marquee visible in historic photographs. There was a marquee in this location historically, but the current marquee is thicker than the original due to the installation of outdoor heating panels. It is also narrower, as it no longer crosses the window on either side of the entrance. To the left of the entrance there is a non-original projecting oriel window with a domed hood and ornamental grilles.

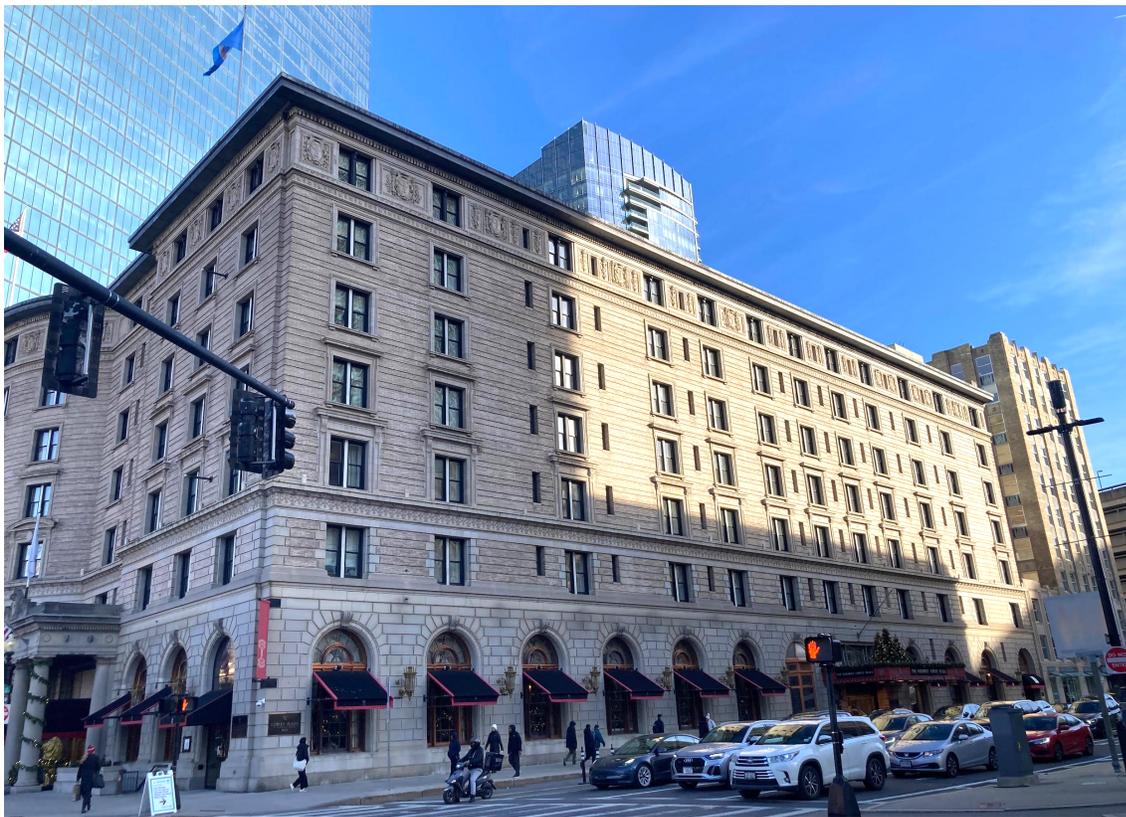
Figure 39. Dartmouth Street facade showing narrower marquee (J. Gaugler, Boston Landmarks Commission staff, photographer, December 2025).

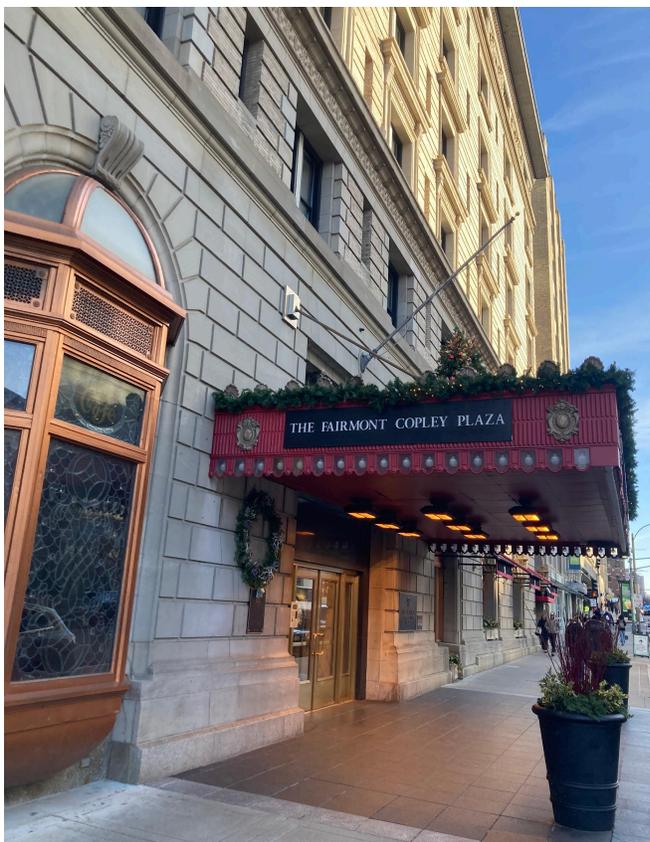
Figure 40. Note the altered marquee and the non-original oriel window (J. Gaugler, Boston Landmarks Commission staff, photographer, December 2025).

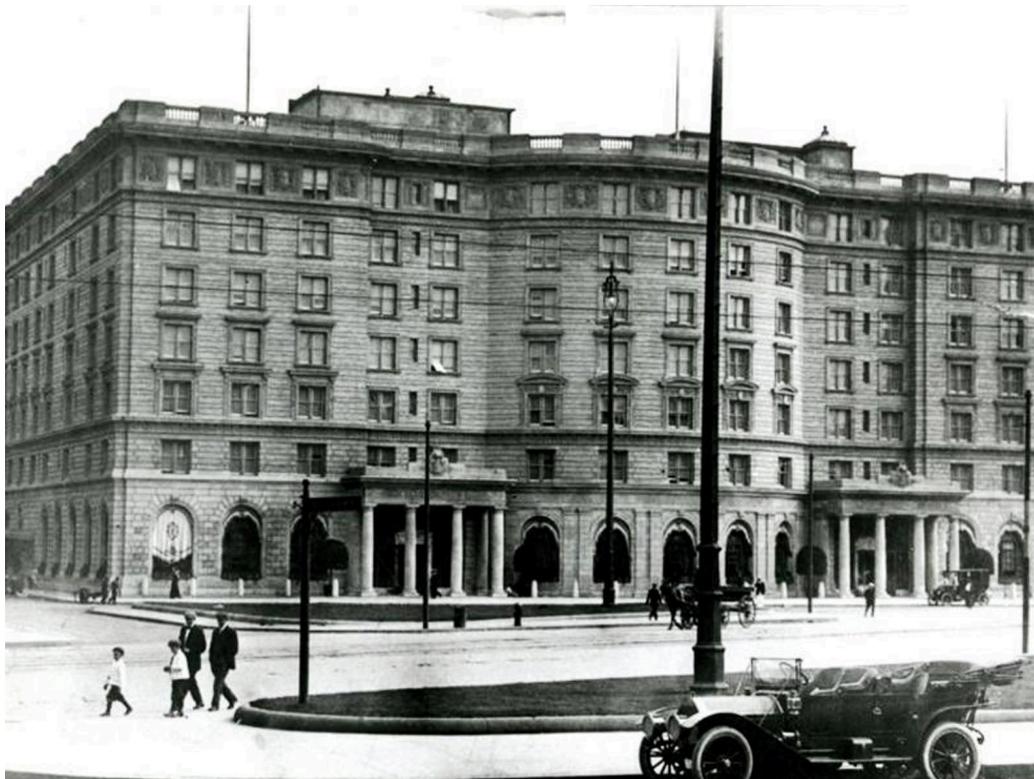
Figure 41. St. James facade showing the original balustrade (photographer unknown, 1912).

At the top of the building there is a non-original metal-wrapped cornice above dentil molding. Historically there was a balustrade that was later removed (see **Figure 41**). The roof of the building contains various headhouses that have been constructed at various points in time that do not contribute to the architectural significance of the building. The roof also features a wide assortment of late-20th century mechanical equipment and duct work.

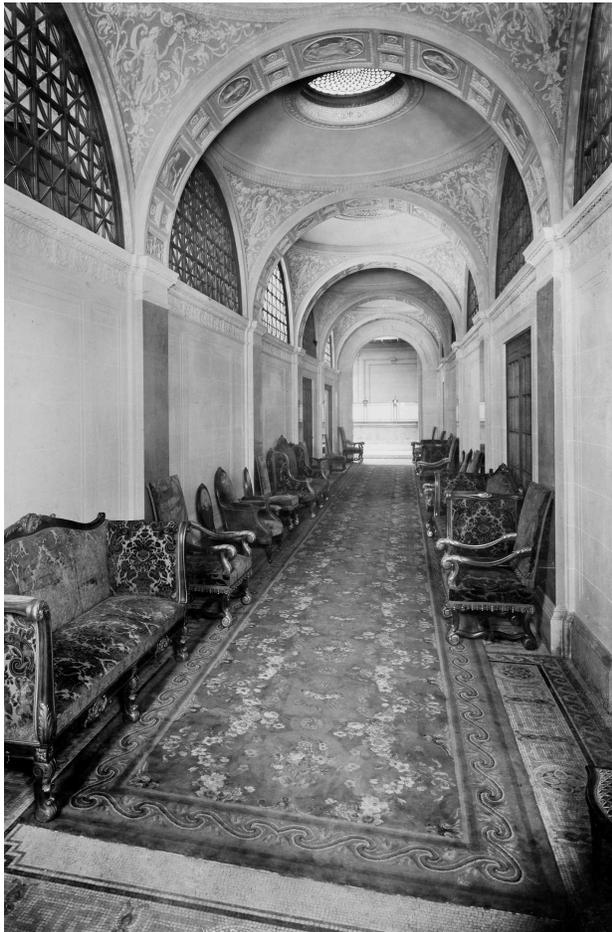
Figure 42. Historic photo of Peacock Alley (photographer unknown, 1912).

Alterations identified in this space include: the addition of wall sconces and chandeliers; changes to the wall surface treatment; changes to paint colors; the addition of mirrored panels.

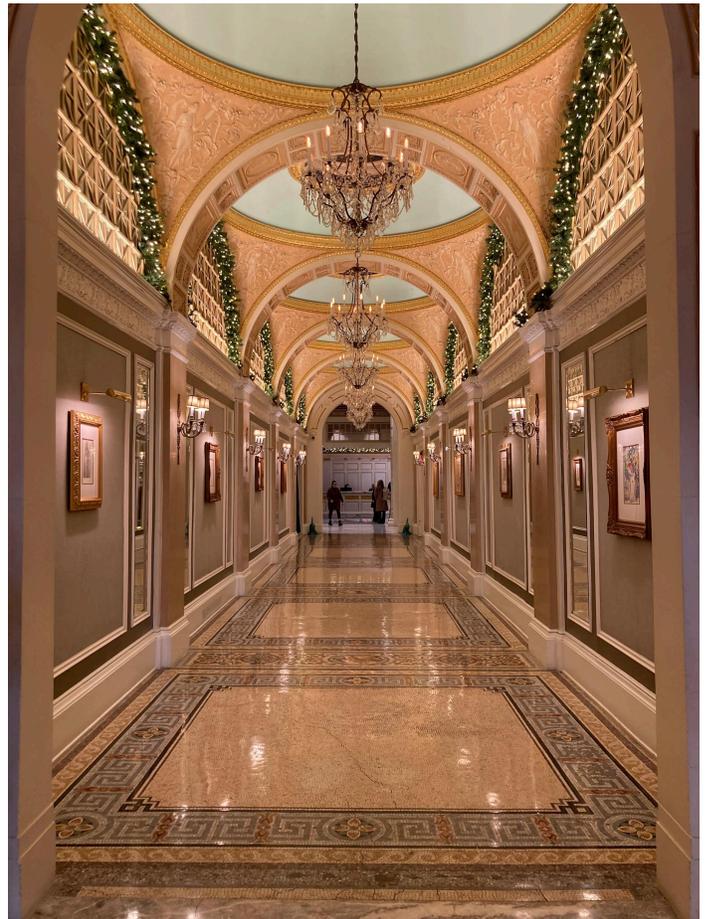
Figure 43. Contemporary photo of Peacock Alley including temporary garlands for the Christmas season (J. Gaugler, Dec. 2025). Note that the chandeliers are not original.

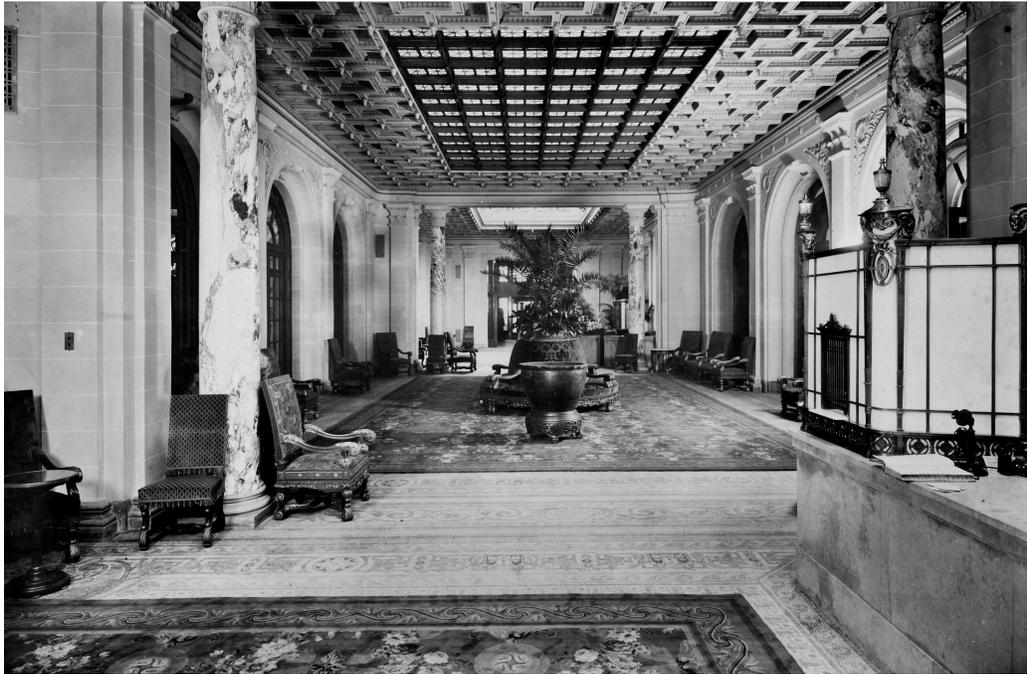
Figure 44. Historic photo of the lobby (photographer unknown, 1912).

Alterations identified in this space include: marbling added to the wall pilasters; gilded finishes; marble flooring instead of mosaic; and the front desk, which has been replaced and relocated several times (see next page).

The current design and configuration of the front desk in the lobby is not original. An older version can also be seen in **Figure 44** on the previous page.

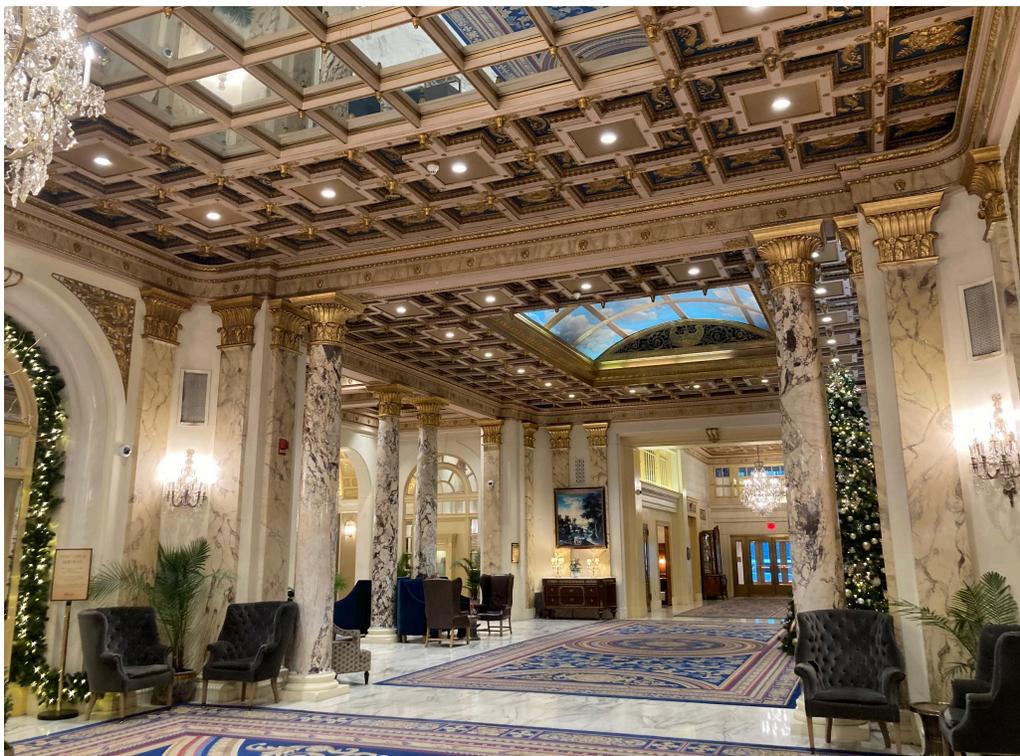
Figure 45. Contemporary photo of the lobby (J. Gaugler, December 2025).

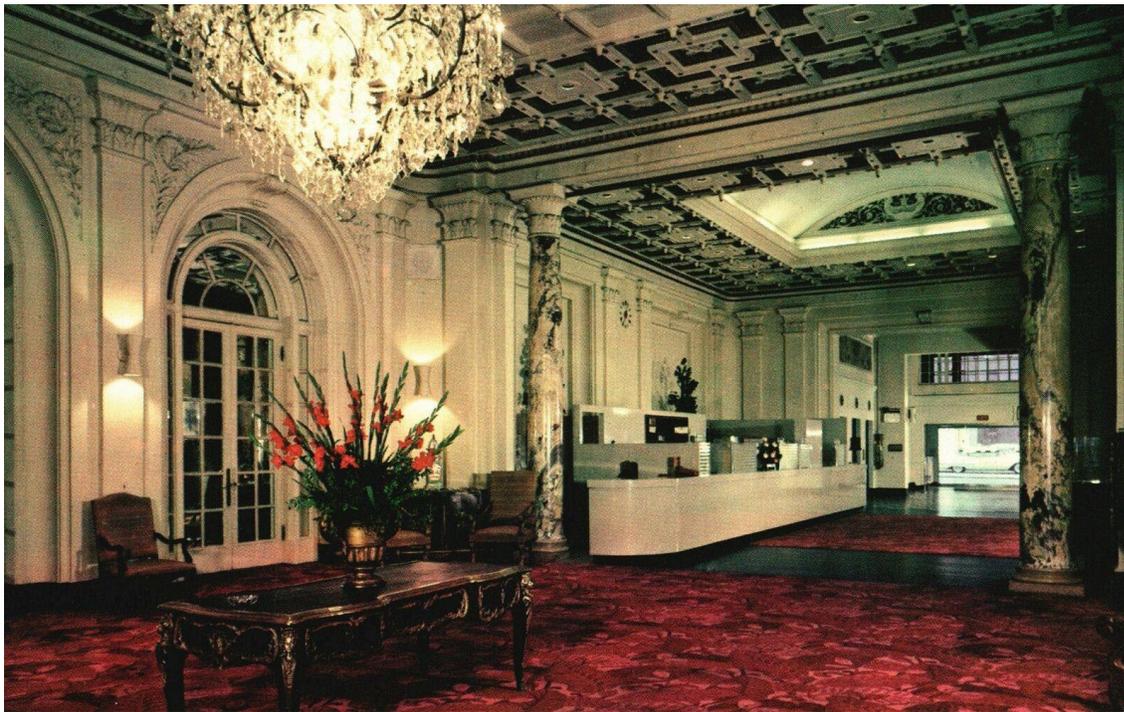
Figure 46. Historic photo of the mid-20th century front desk (photographer and date unknown).

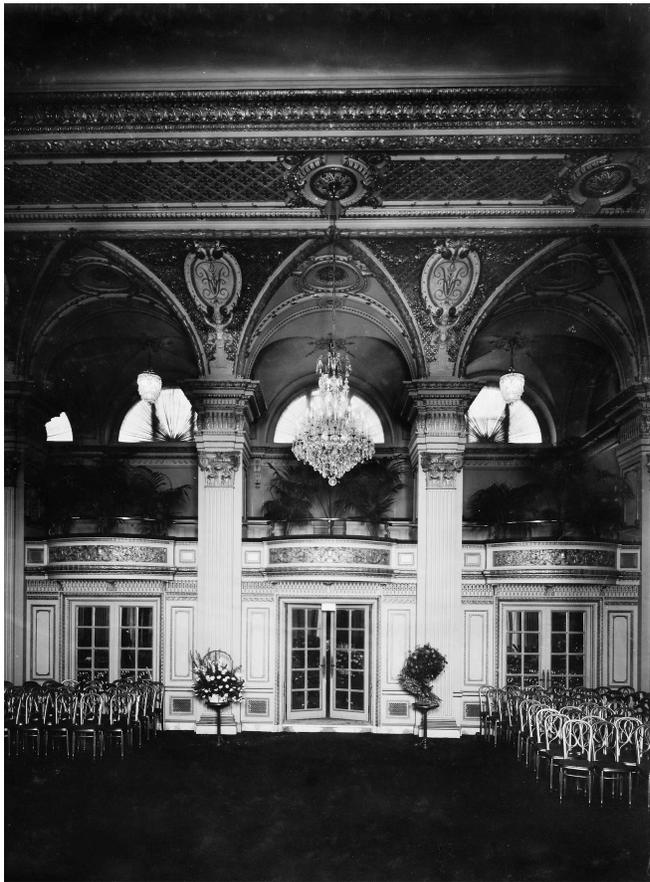
Figure 48. Historic photo of Grand Ballroom (photographer and date unknown).

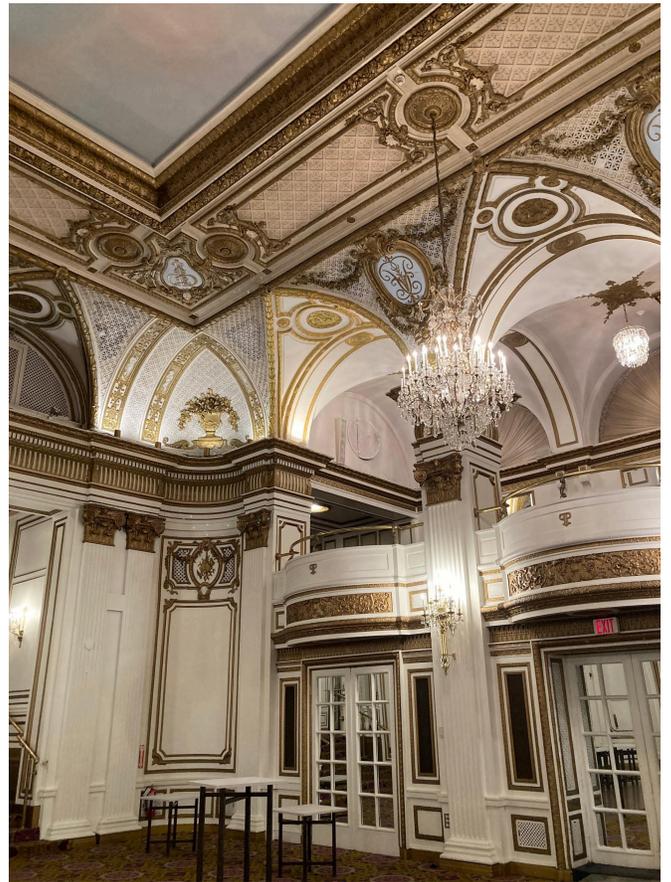
Figure 49. Contemporary photo of Grand Ballroom (J. Gaugler, Dec. 2025).

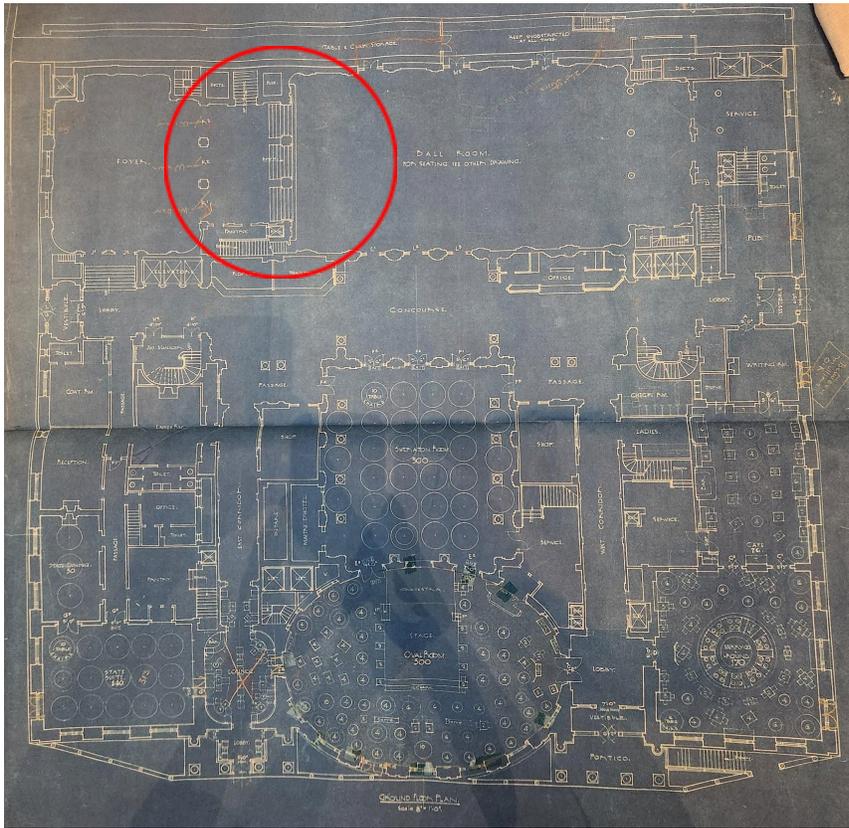
Figure 50. Plan of the Grand Ballroom showing stairs in red circle (Perry Shaw and Hepburn Architects, 1944).

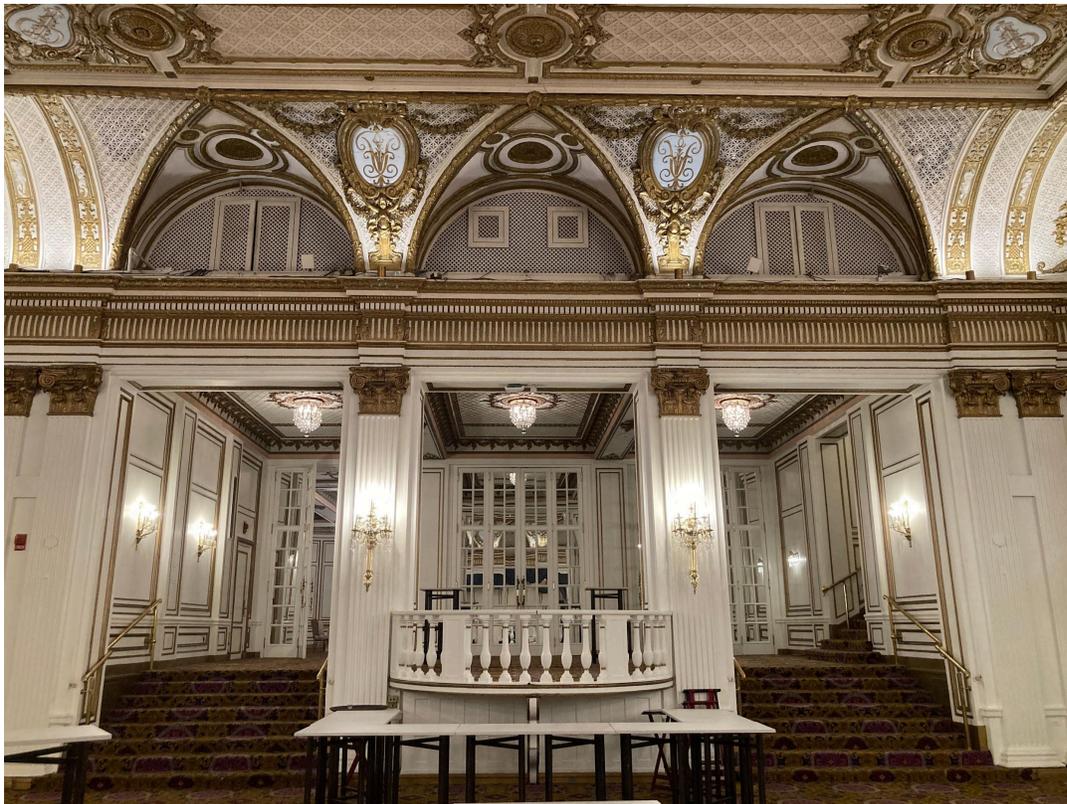
Figure 51. Contemporary photo of the stairs from Grand Ballroom to Rostrum showing the central bay converted to a balcony (J. Gaugler, December 2025).

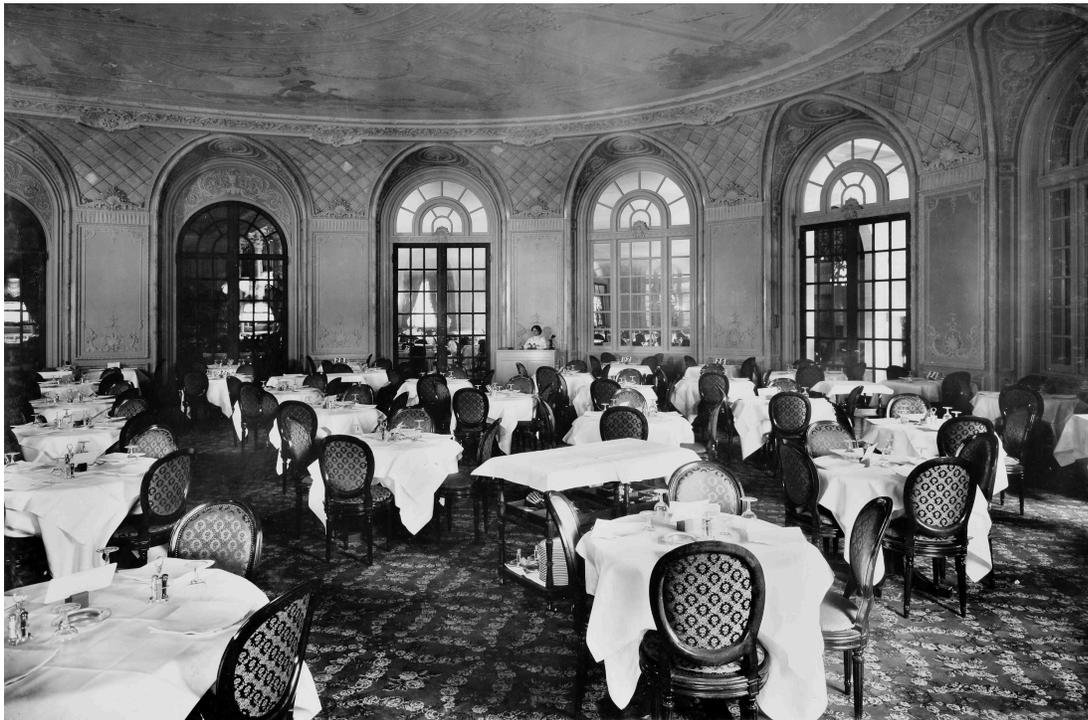
Figure 52. Historic photo of the Oval Room (photographer unknown, 1912).

Alterations identified in this space include: raised floors on the north and south sides of the room; large seashell on the stage; sculptural shells at top and bottom of wall panels; scalloped infill panels within the upper portions of the arches; and ceiling mural.

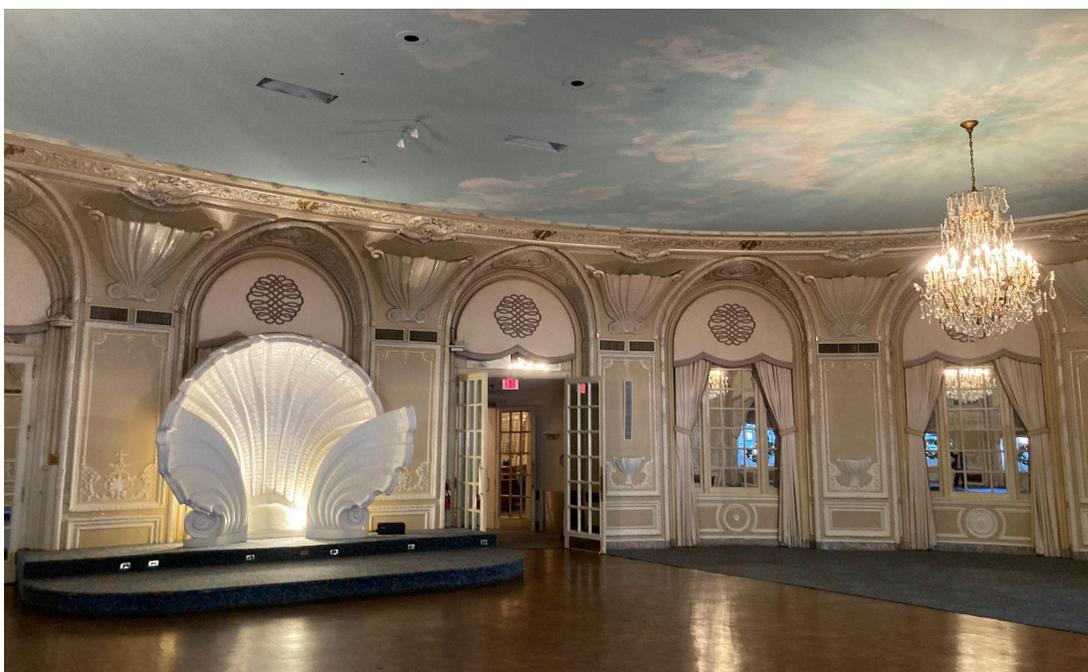
Figure 53. Contemporary photo of the Oval Room (J. Gaugler, December 2025).

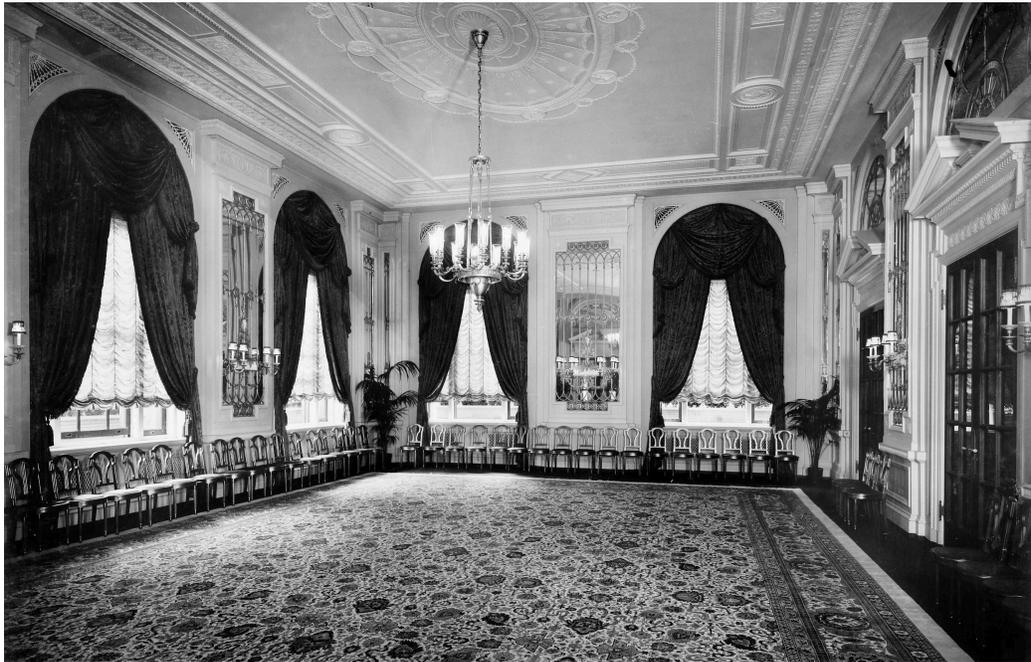
Figure 54. Historic photo of the St. James Room (photographer unknown, 1912).

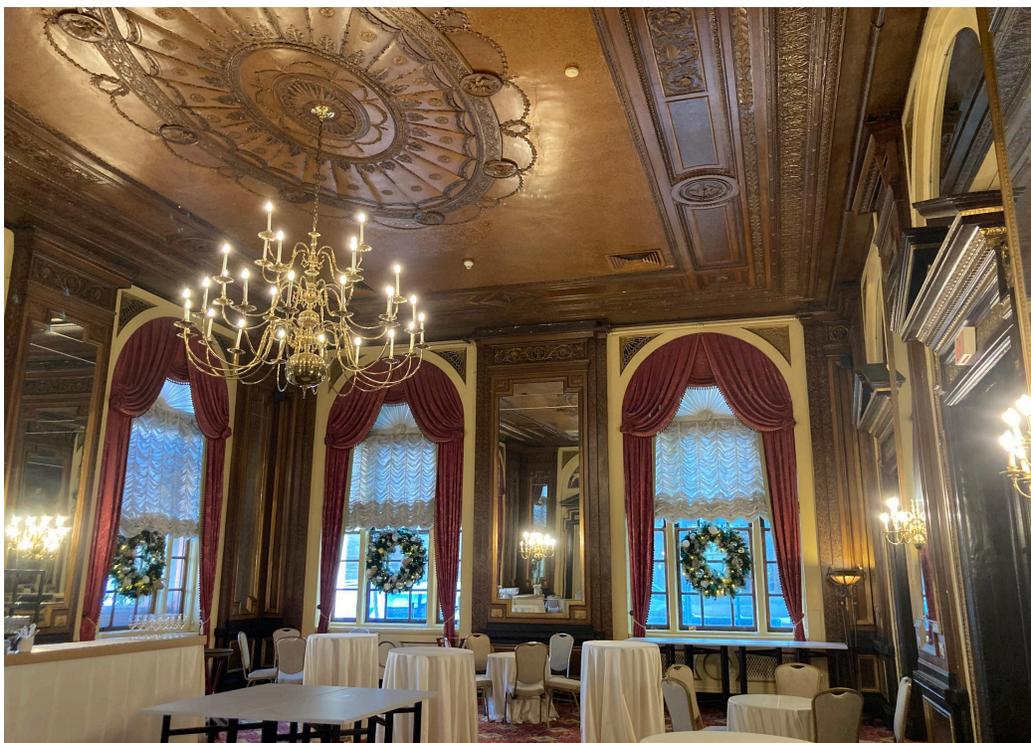
Figure 55. Contemporary photo of the St. James Room (J. Gaugler, December 2025).

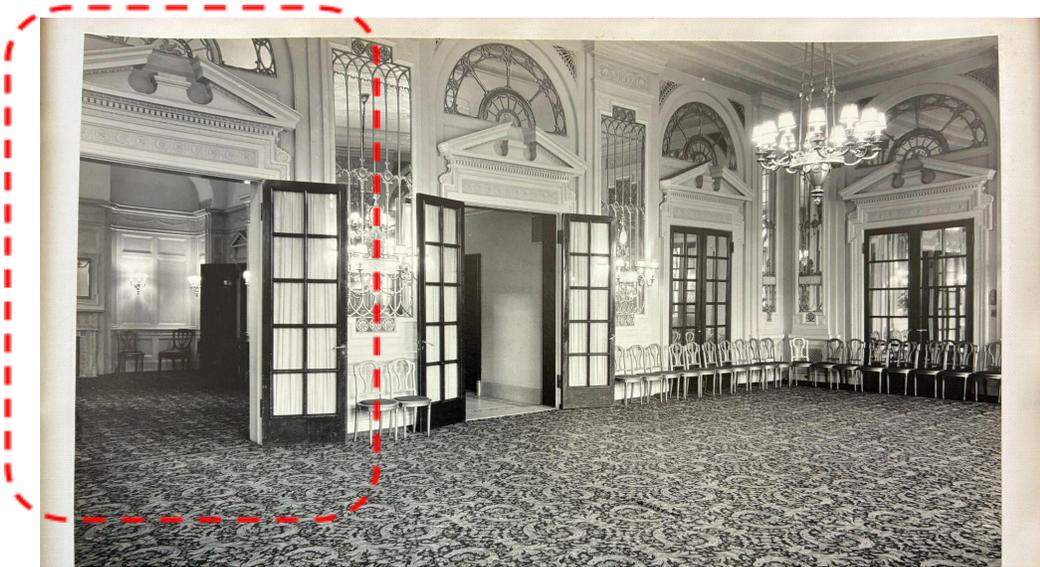
Figure 56. Historic photo of the St. James Room looking into the Singleton Room through the opening on the left (photographer and date unknown). Courtesy of Historic New England.

Alterations identified in this space include: the wall on either side of the fireplace has been opened up to create two doorways; doorways on the corridor side of the room have been altered (removal of pediment).

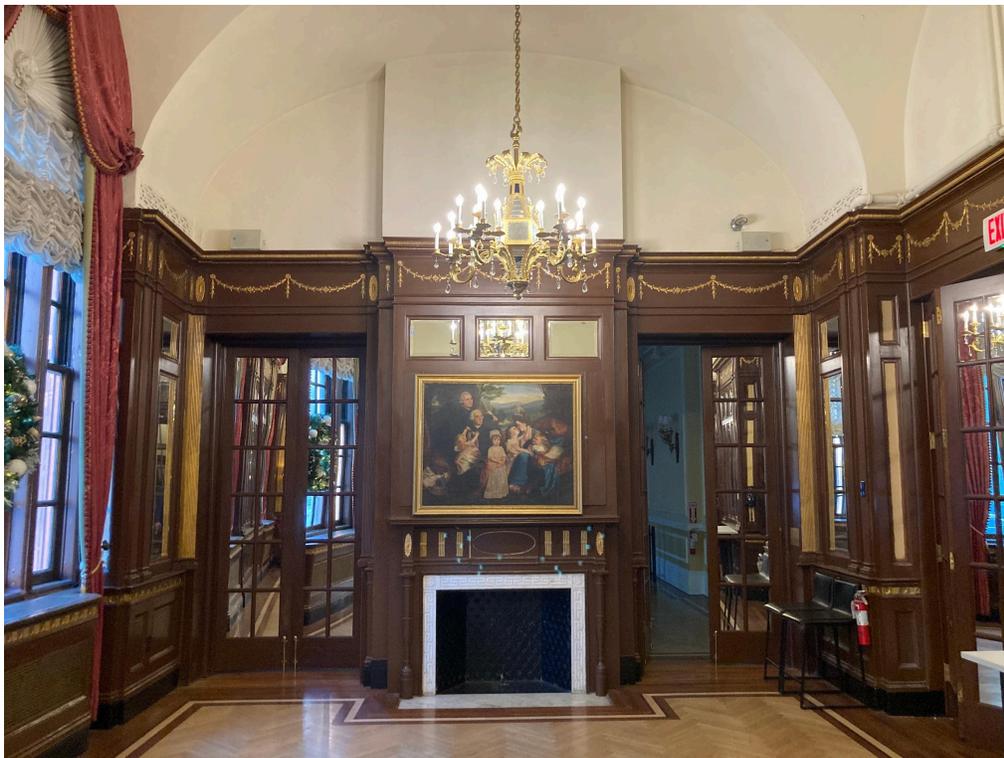
Figure 57. Contemporary photo of the Singleton Room (J. Gaugler, December 2025).
