THE COPLEY PLAZA HOTEL

138 St. James Avenue (205 Dartmouth Street), Boston

BOSTON LANDMARKS COMMISSION STUDY REPORT

Petition # 147.89

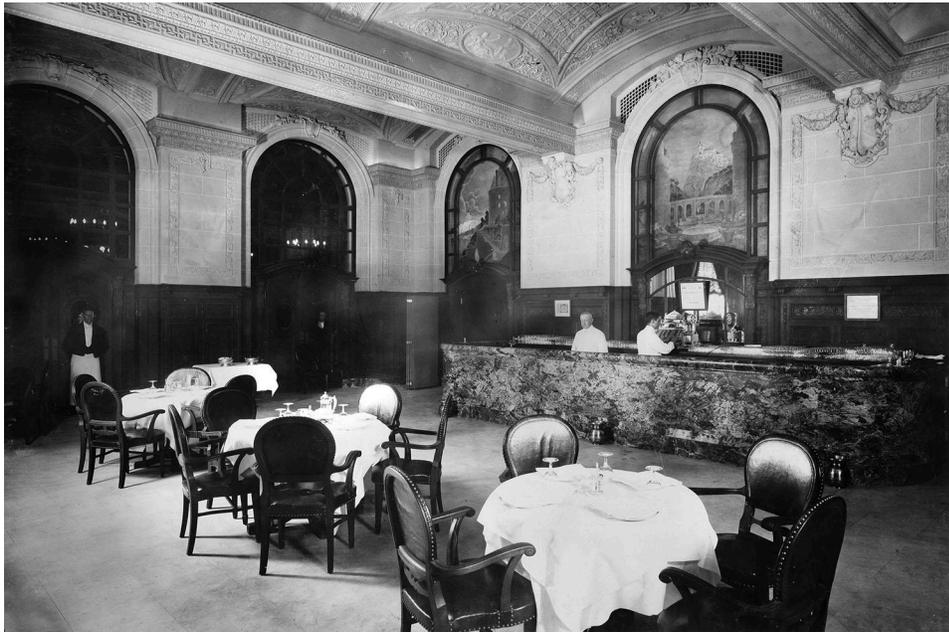
Figure 59 (left). Historic photo of the original bar room (photographer unknown, ca. 1912-1934).

Alterations identified in this space include: the removal of a wall to combine the former bar and dining space into one room; the entire bar itself; the fireplace and shelving behind the bar; flooring; and many wall surface treatments. As a result of the various modifications previously made to the finishes and configuration of these spaces, the Oak Long Bar + Kitchen are excluded from the designation.

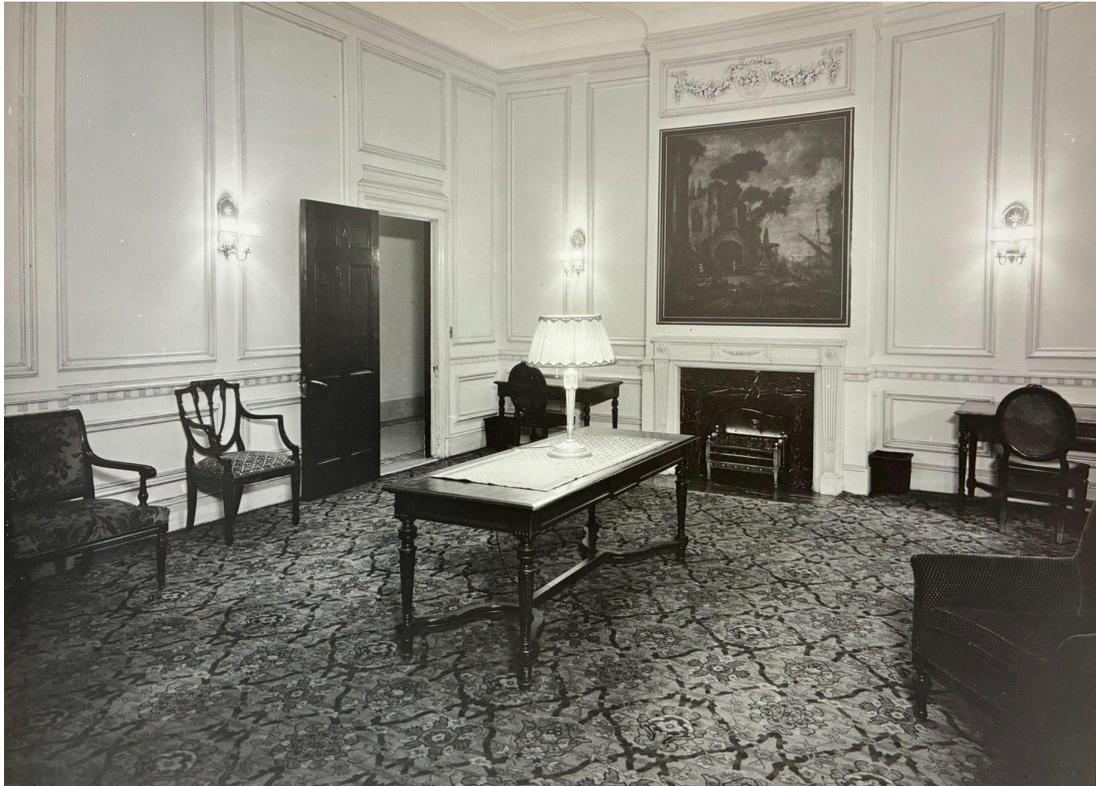
Figure 61. Historic photo of the Copley Room (photographer and date unknown). Courtesy of Historic New England.

The Copley Room is not recommended for inclusion in the designation due to relatively substantial alterations, including the combination of two rooms into one, the removal and alteration of original wall panels/molding, the installation of new doorways on either side of the fireplace, and the removal of a decorative swagged panel above the fireplace mirror. However, some historic architectural features remain, including historic fireplace, ceiling medallions and plasterwork.

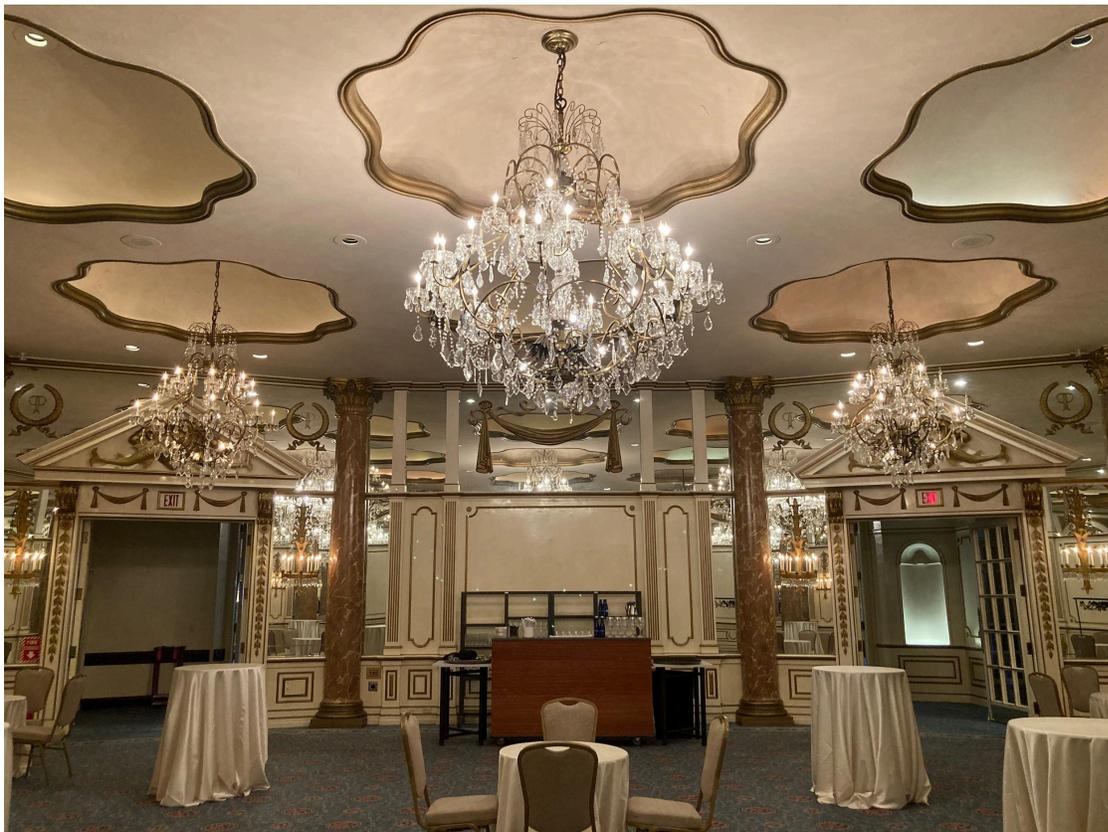
Figure 64. Contemporary photo of the Venetian Room (J. Gaugler, December 2025).

The Venetian Room is not recommended for inclusion in the designation due to the fact that it has been completely altered from its original form, as shown below.

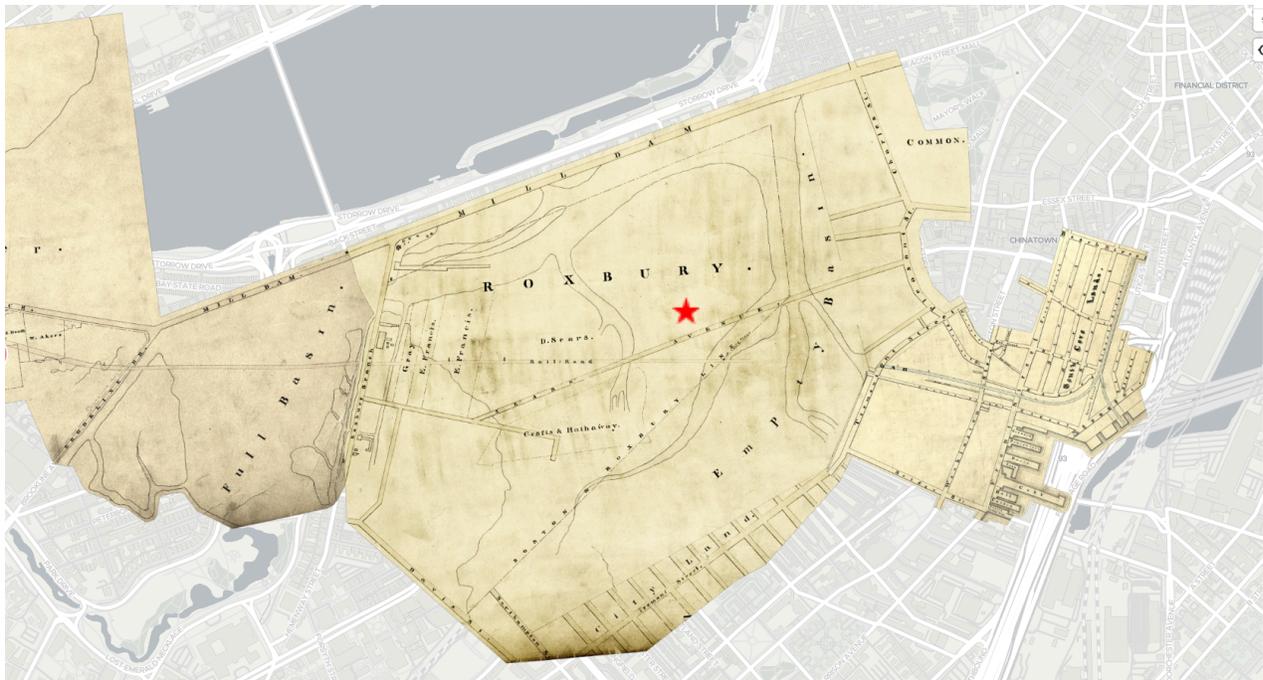
Figure 65. Future location of the Copley Plaza Hotel indicated on the 1835 Boston and Worcester Railroad Atlas (MapJunction).

The site of the Copley Plaza Hotel has an estimated fill depth of approximately 20 feet. Both the first Museum of Fine Arts (constructed in 1872) and the Copley Plaza Hotel that replaced it in 1912 were built on thousands of wood piles pounded 70 feet through fill and organic soils to sand and gravel outwash and clay.³⁵
