REPAIR AND RESTORATION OF THE MOTHER CHURCH

BLC PRESENTATION
28 FEBRUARY 2017

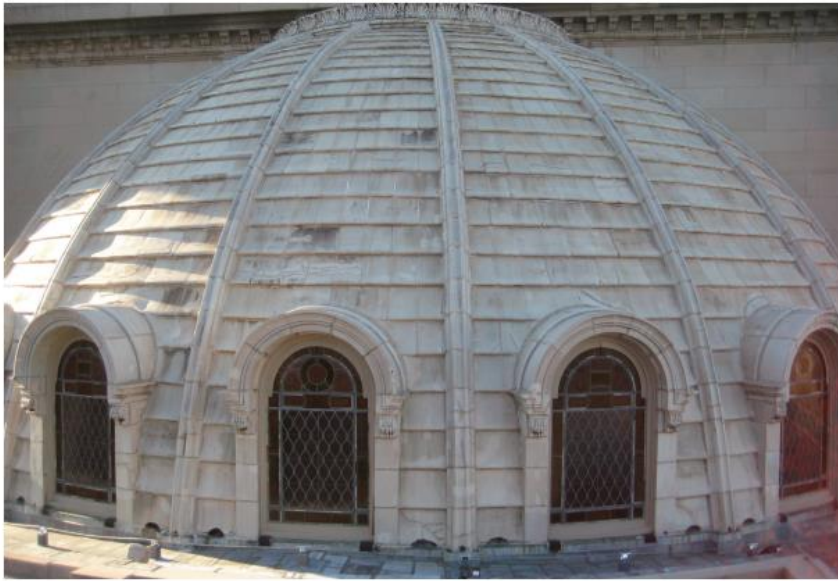
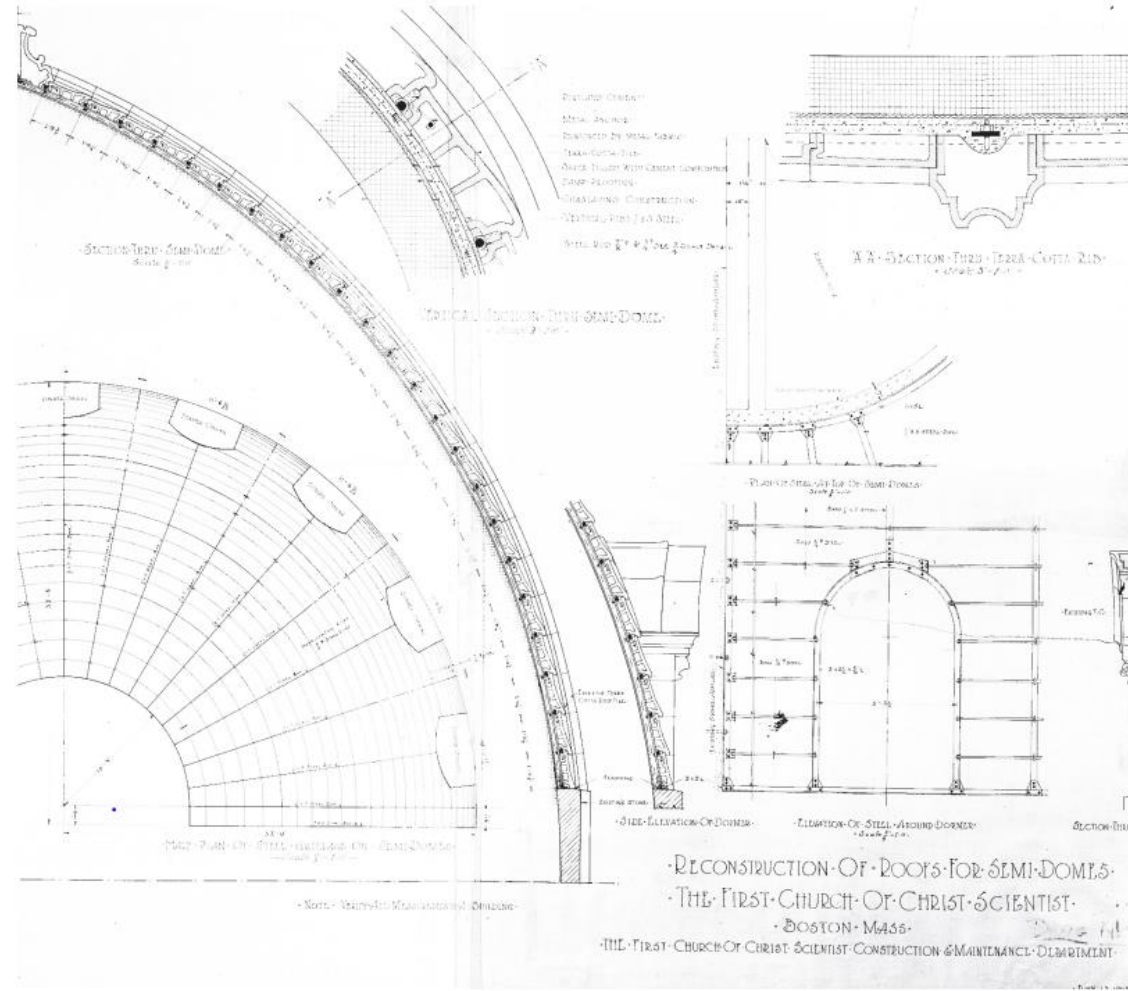
1918 TMCX Semi-Dome Restoration

- Significant leaks developed at both North and South Semi-Domes
- All terracotta on both semi-domes was removed and replaced

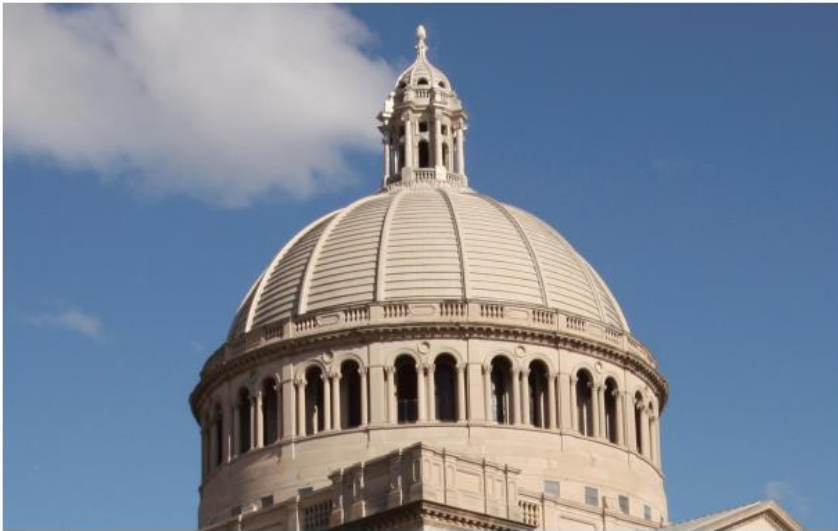
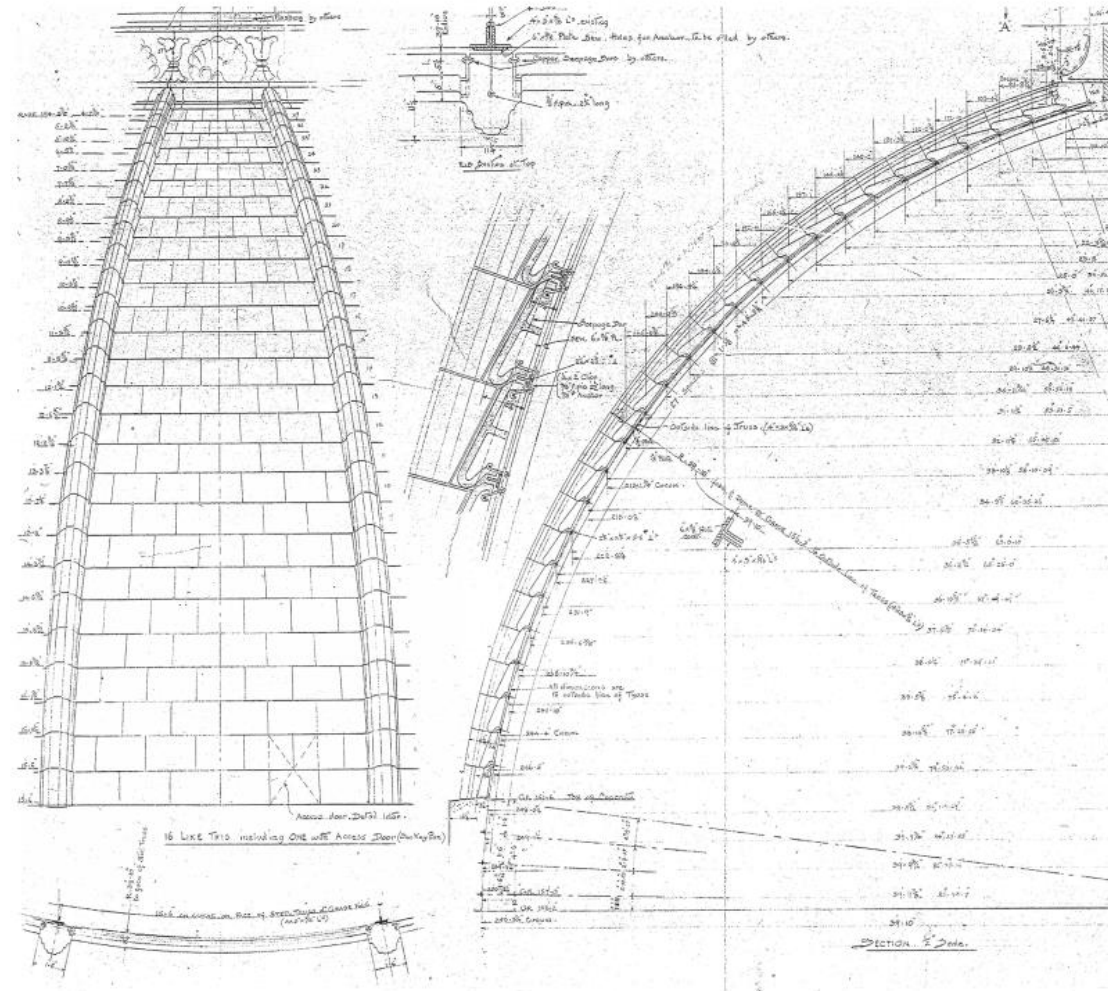
1950 TMCX Dome Restoration

- The material of the terracotta cladding on the central TMCX dome systemically failed
- The cupola and all terracotta on the main dome were removed and replaced

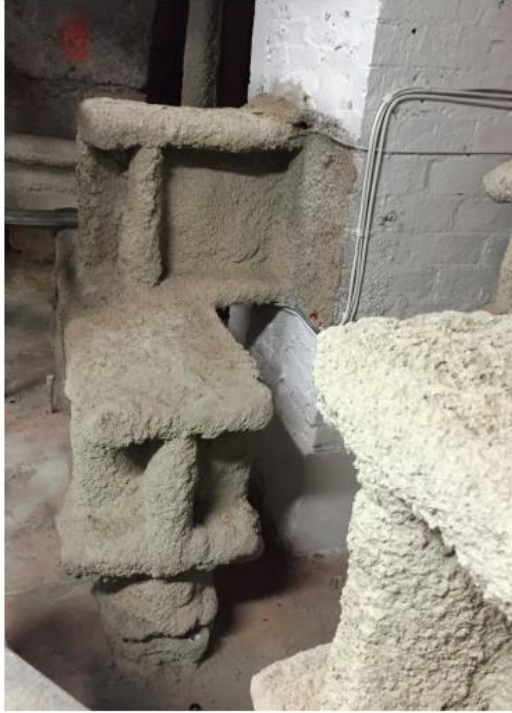
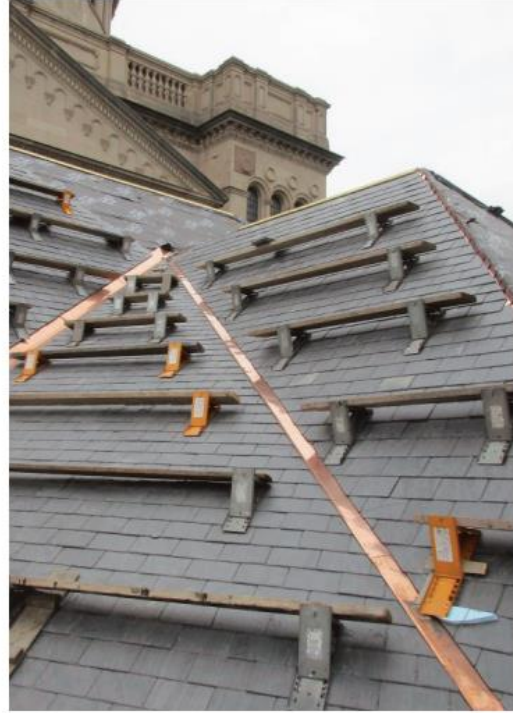
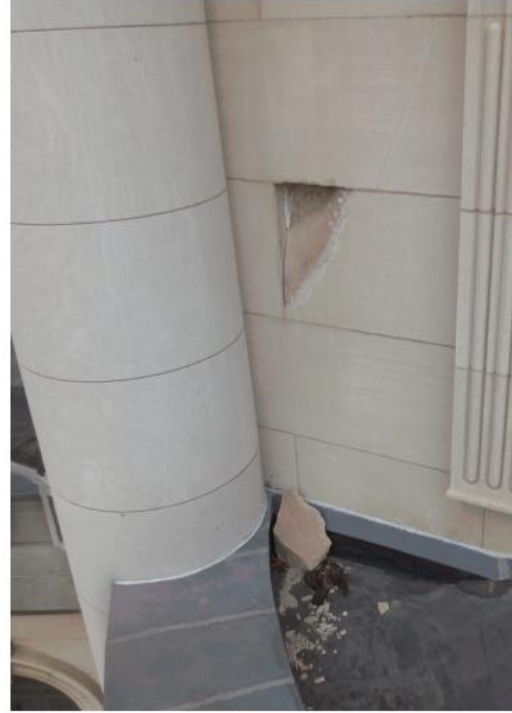
Example Projects Completed Since 2010

- Underpinning of TMCO Tower foundations

- Replacement of TMCO slate roof

- Yearly inspection and ongoing spall removal

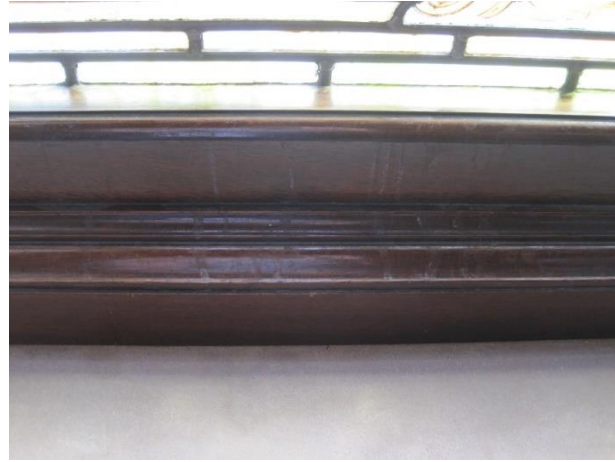
Split Caming

Evidence of Leaks

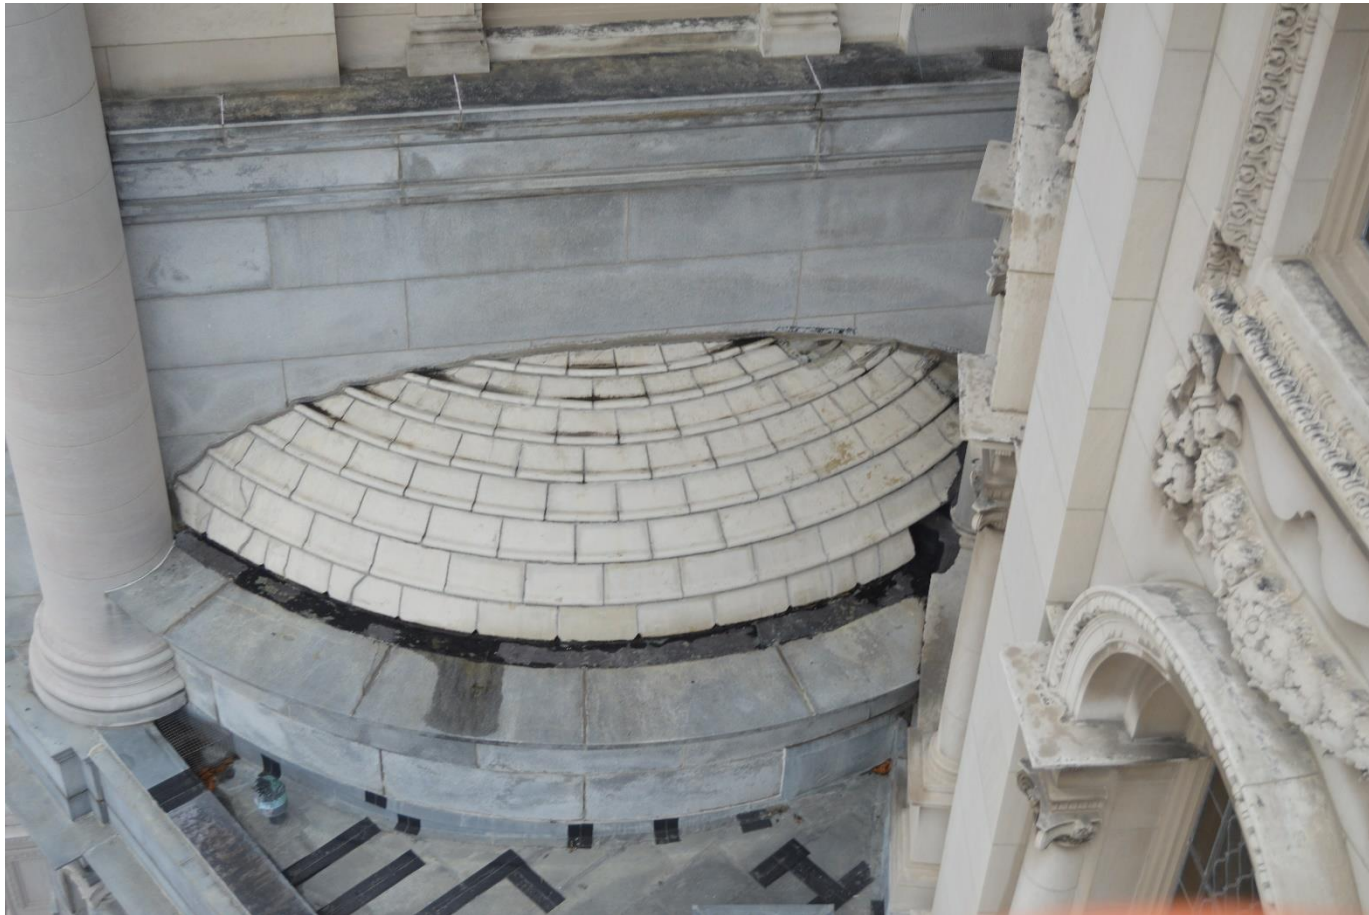
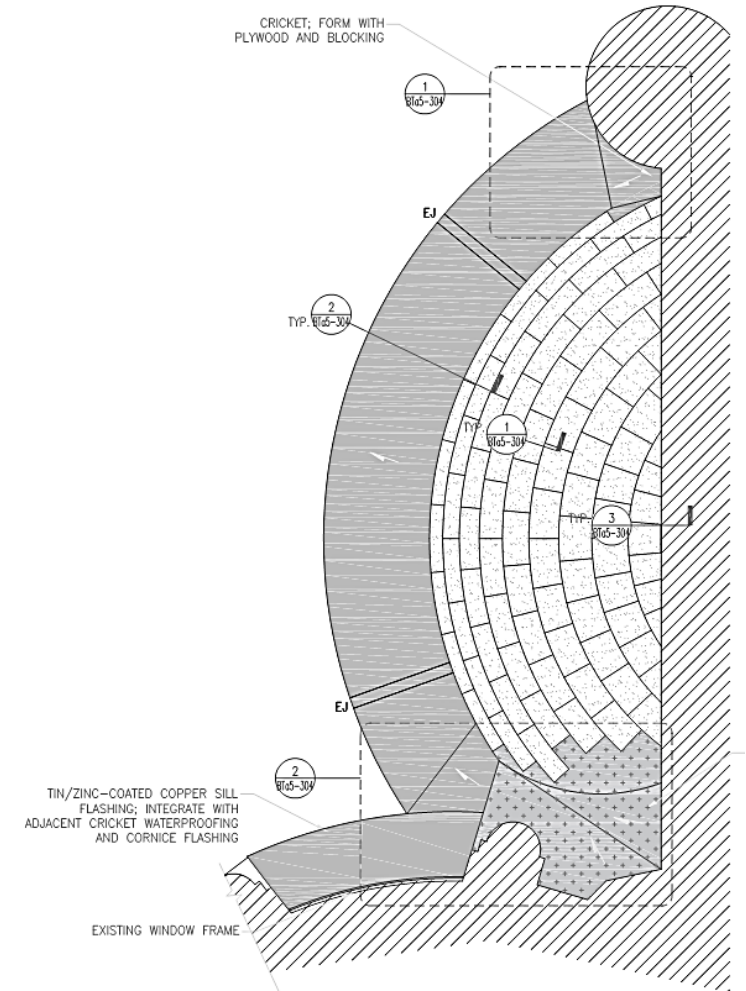
SOUTH PARTIAL DOME

PORTICO DAMAGE
