23 UPTON STREET RESTORATION

12-10-20

PREPARED FOR SOUTH END LANDMARK DISTRICT COMMISSION

WINDOW REPLACEMENT

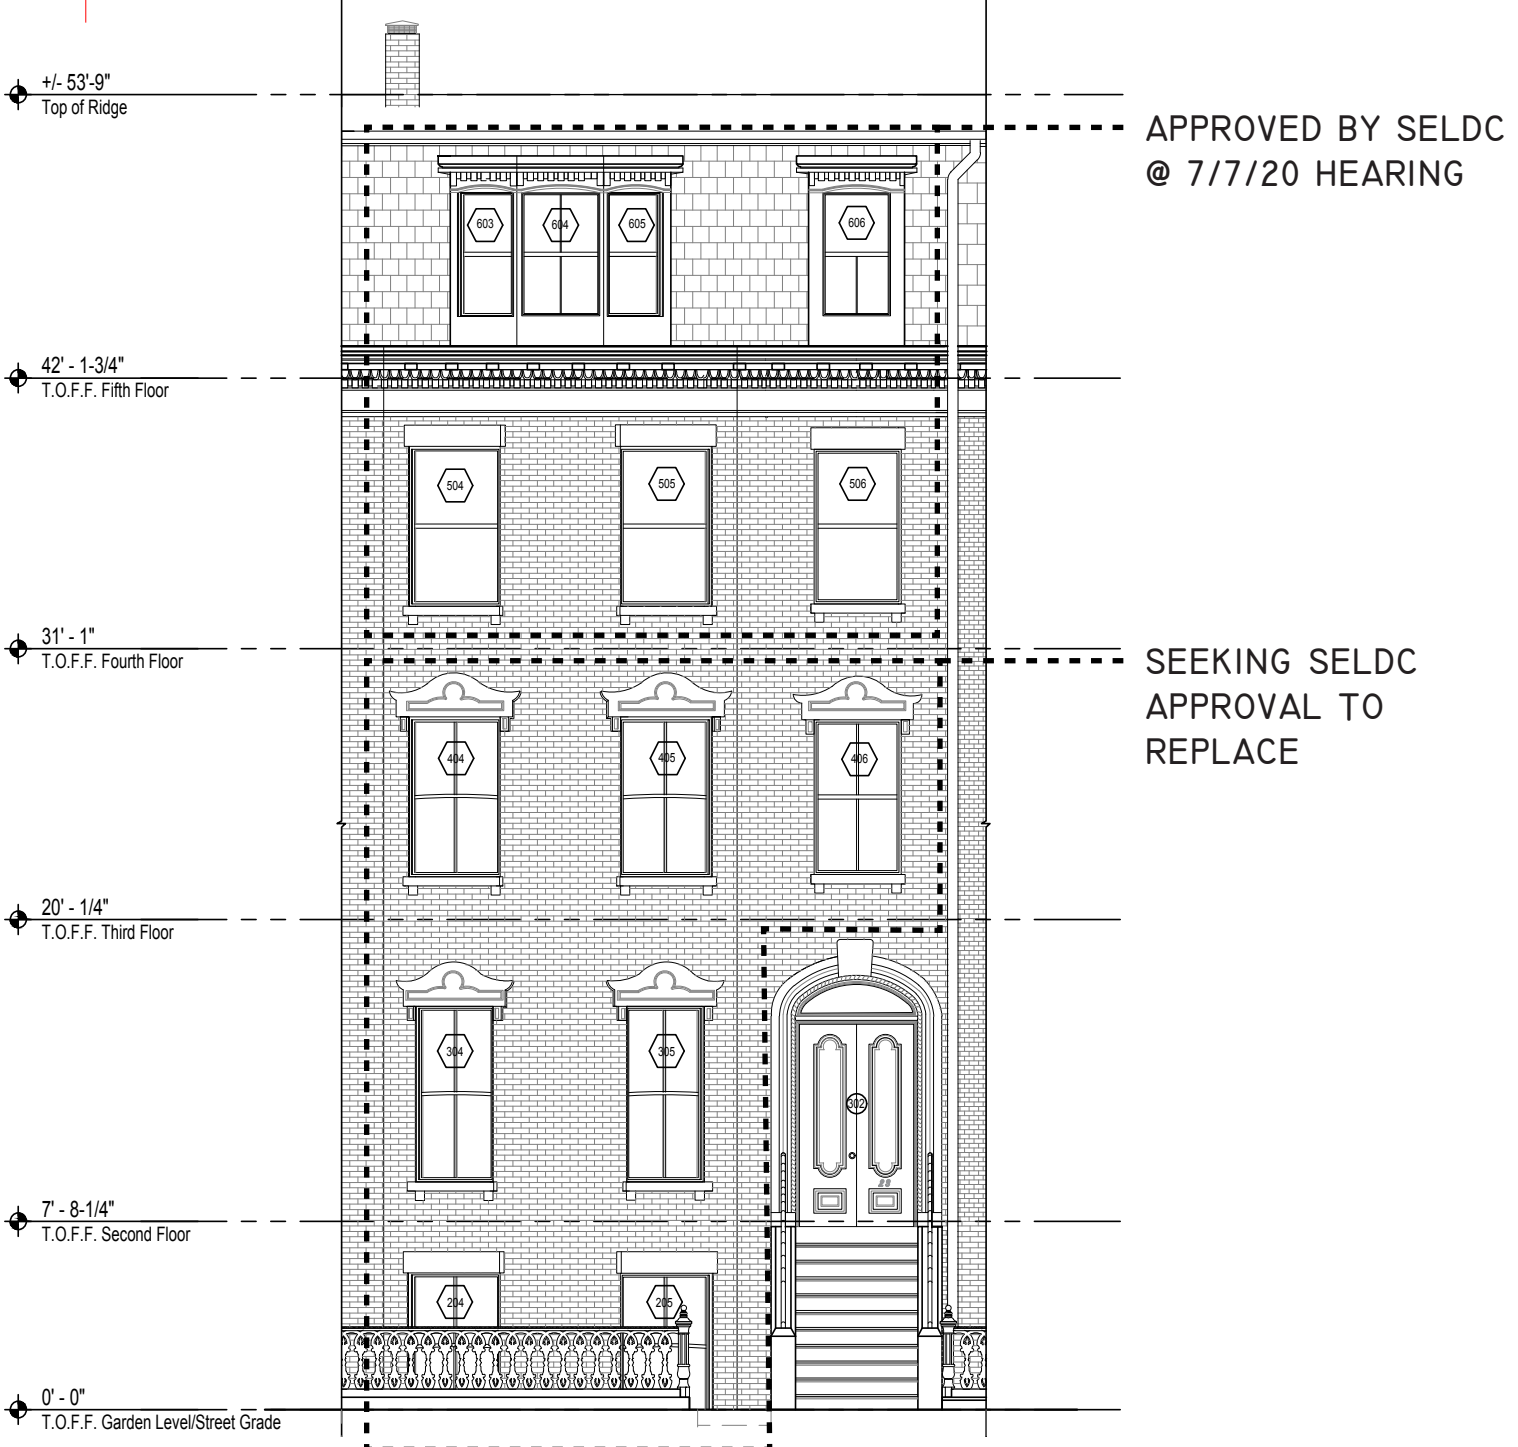
This letter is to attest that I have performed an evaluation of the windows at 23 Upton Street in Boston and that in my professional opinion, they are prime candidates for replacement. There is extensive damage present at every window, the windows on the third floor are missing entirely and nearly every opening, including jambs, sills and framing are in advance states of disrepair.

- 1) Sash are collapsing with glass missing or falling out.
- 2) Sash missing altogether
- 3) Exterior sills collapsing or heavily weathered
- 4) Exterior casing and brickmould damaged or weathered

Based upon my observations, I believe the windows are beyond repair and they have reached the end of their serviceable life.
