# 16-18 & 22 GARDNER ST.

# REASONS FOR DEMOLITION

# Structural Investigation Report

16-18 Gardner St, Boston, MA 02119

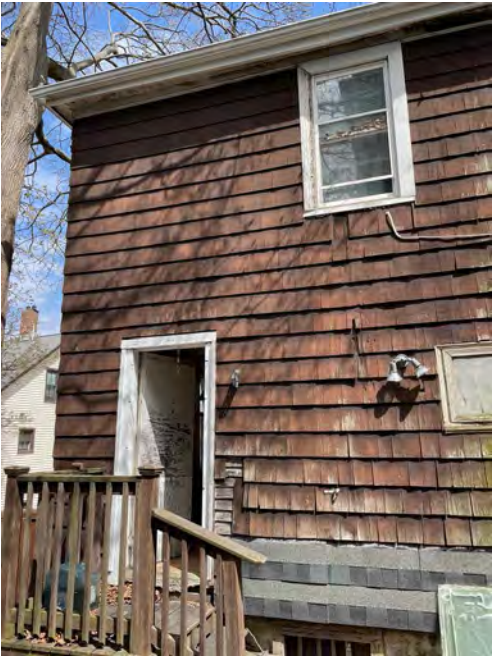
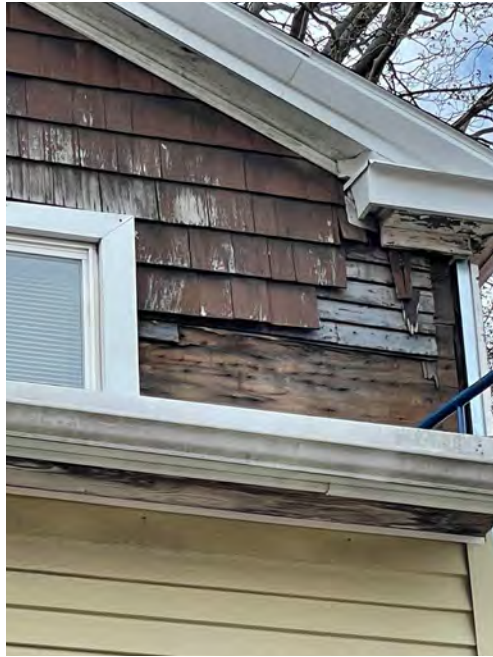
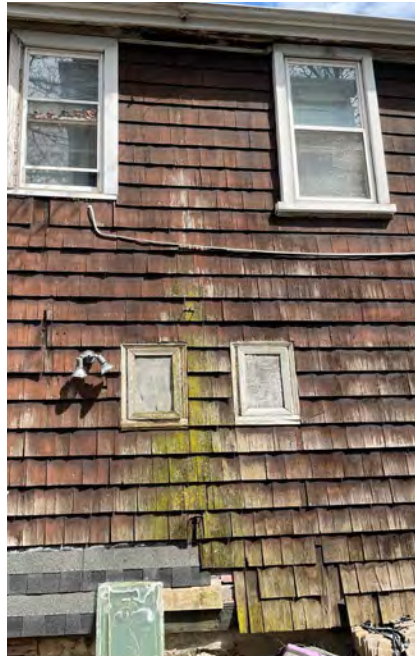
## Exterior

The building's exterior conditions exhibit failing materials. The wood deck, soffits, and trims are damaged, and the masonry shows signs of water leakage.
