139 W Canton Street, Boston, Massachusetts
02118

SELDC - Window Repair & Replacement

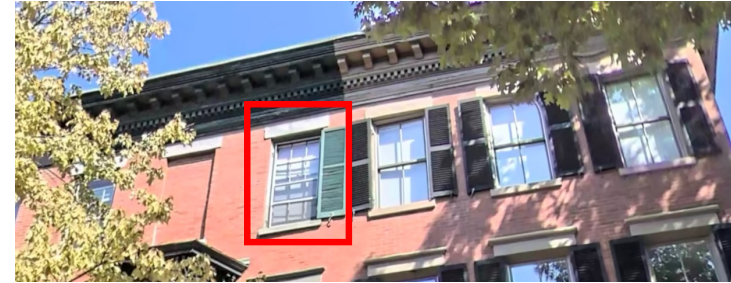
A Replace non-original 6 over 6 with historically accurate 2 over 2 wood windows, with simulated divided lite with filler. To match the neighborhood.

B Windows to be Restored by Olde Bostonian. New storm windows.

C Remove iron grills. Windows non-restorable. Historically accurate 2 over 2 wood windows, with simulated divided lite with filler
