# THE FIRST CHURCH OF CHRIST, SCIENCE

## **Proposed Accessible Entry BLC Hearing**

September 28, 2021

**FINE GOLD  
ALEXANDER**  
ARCHITECTS

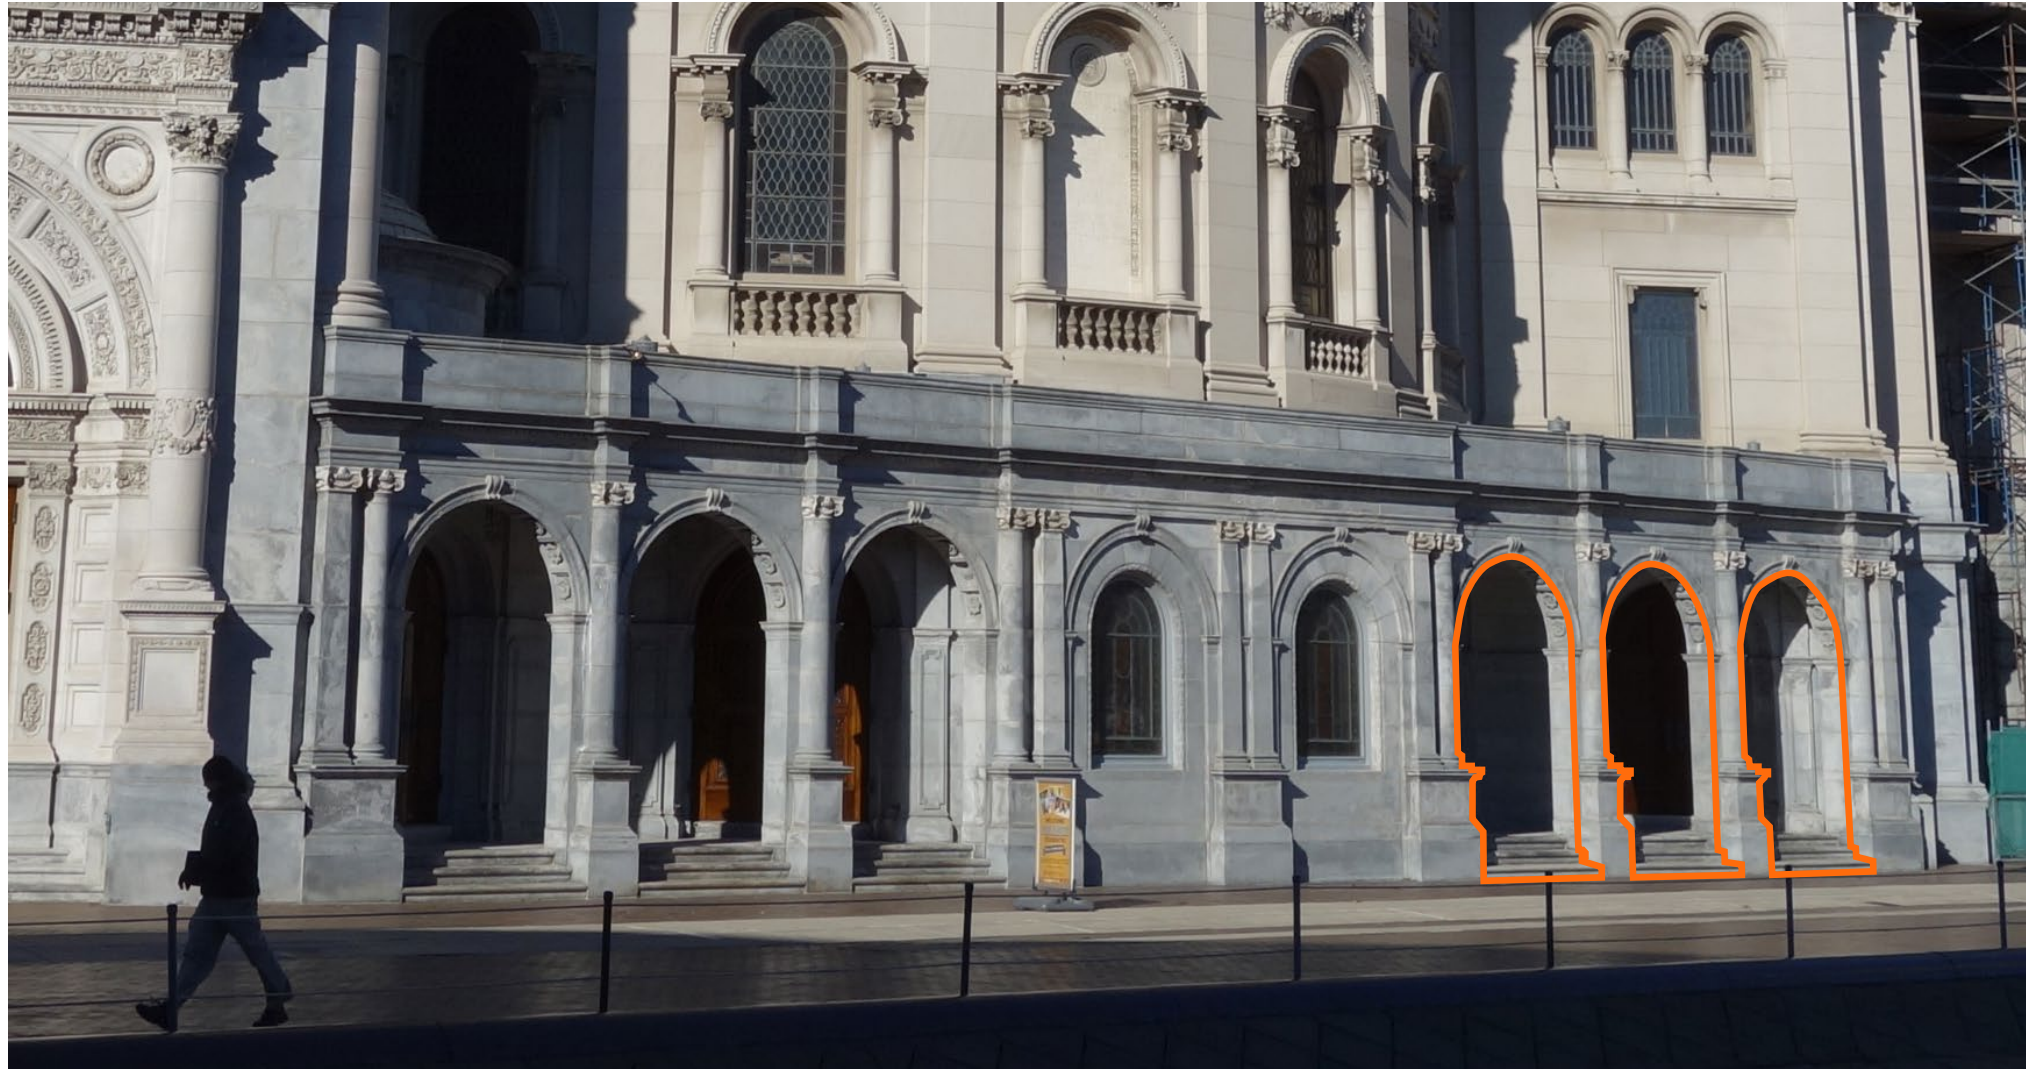
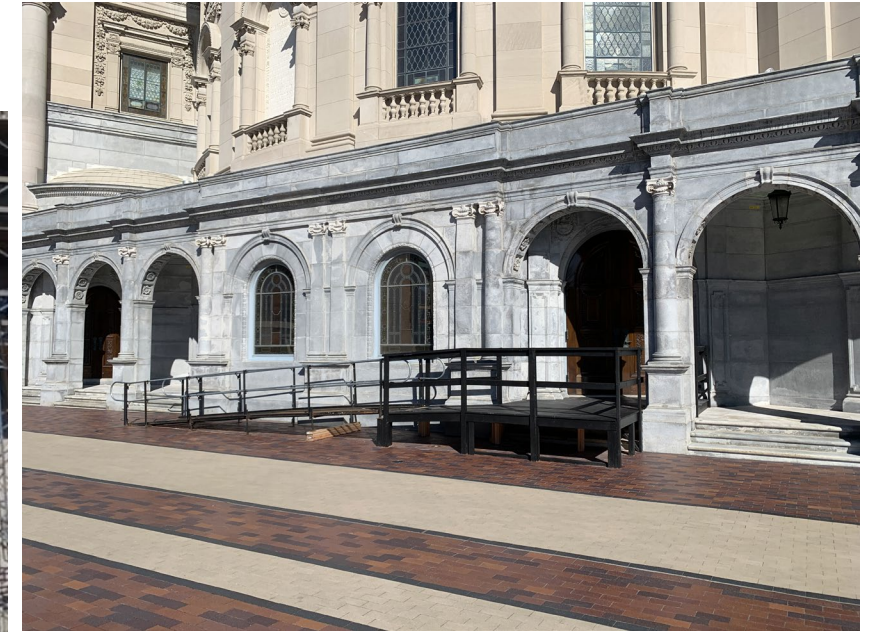
Existing Conditions with Temporary Ramp

- 2'-0" elevation difference between the plaza level and the interior lobby.
- Pinchpoints at the north and south end arches of the portico.
- Arched Guastavino tiled ceiling to remain as existing.
- Decorative, detailed wall profiles at the base, imposts and tiled ceiling.
- Existing intricately carved wood doors at vestibule and future elevator openings.

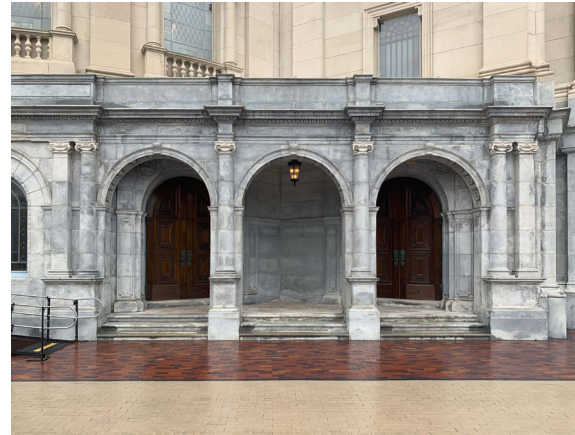
Proposed Elevator – left,  
Existing Vestibule – right

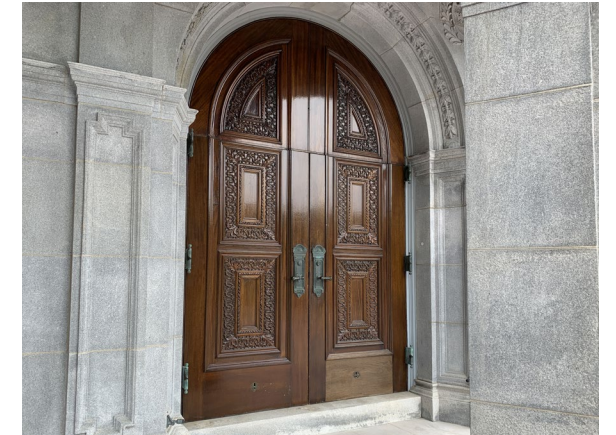
Existing Wood Doors at Vestibule

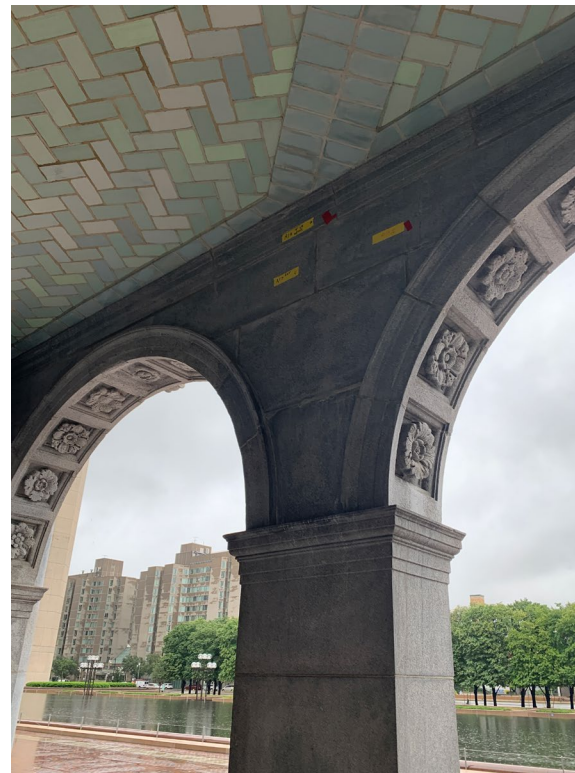
Stone Detail and  
Guastavino Tiled Ceiling

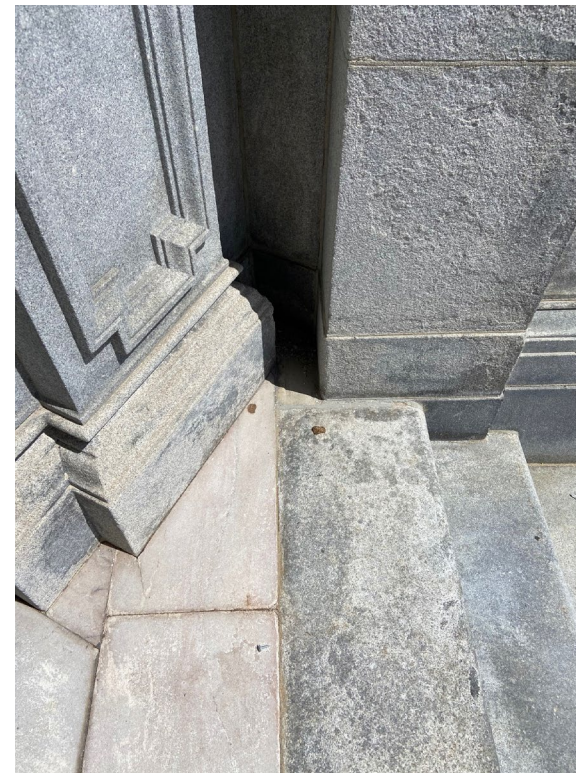
Stone Pinchpoint at Base

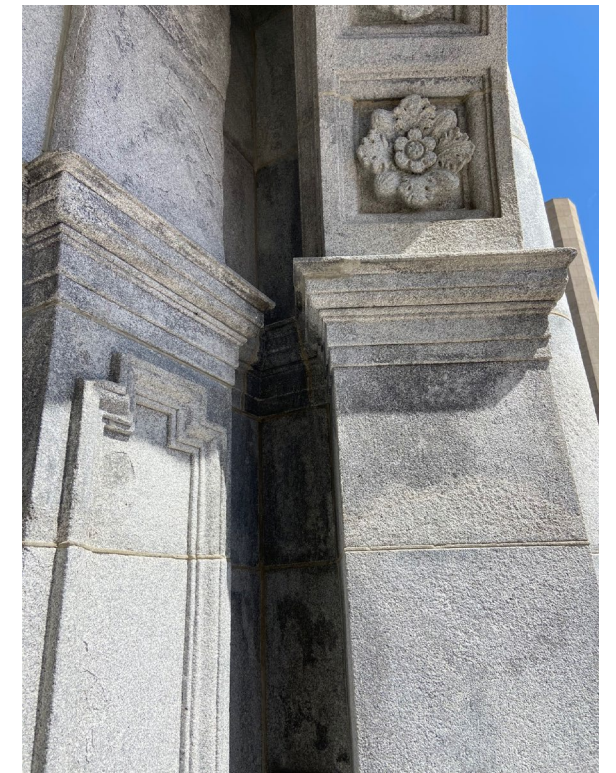
Stone Pinchpoint at Impost

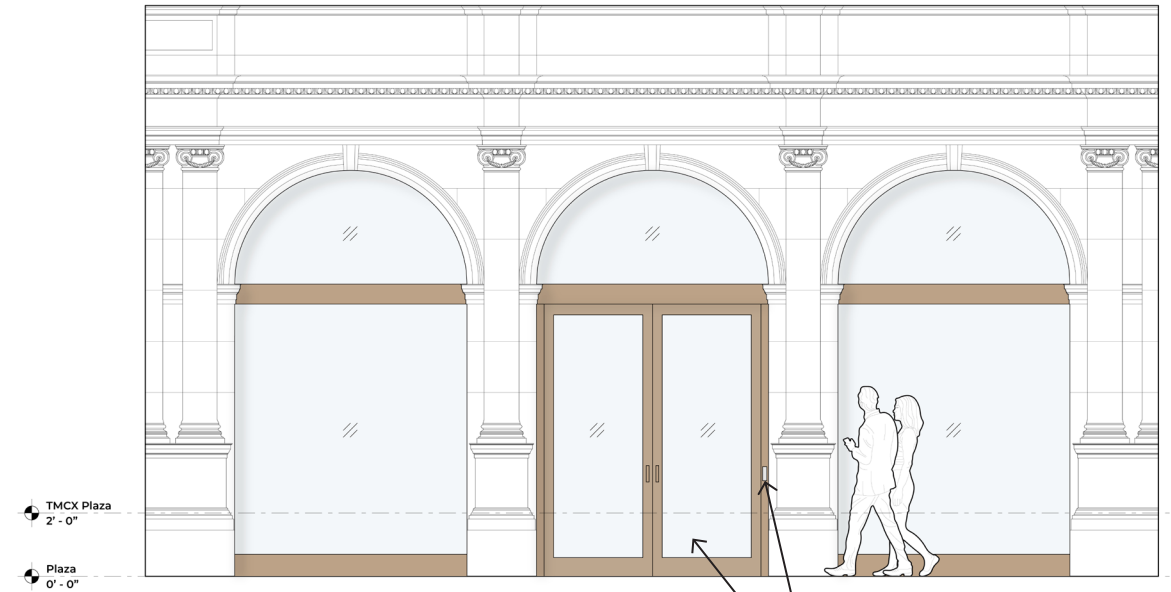
**Exterior Elevation – Proposed**

Frame Mounted ADA Push Button Operator  
Bronze Double Doors

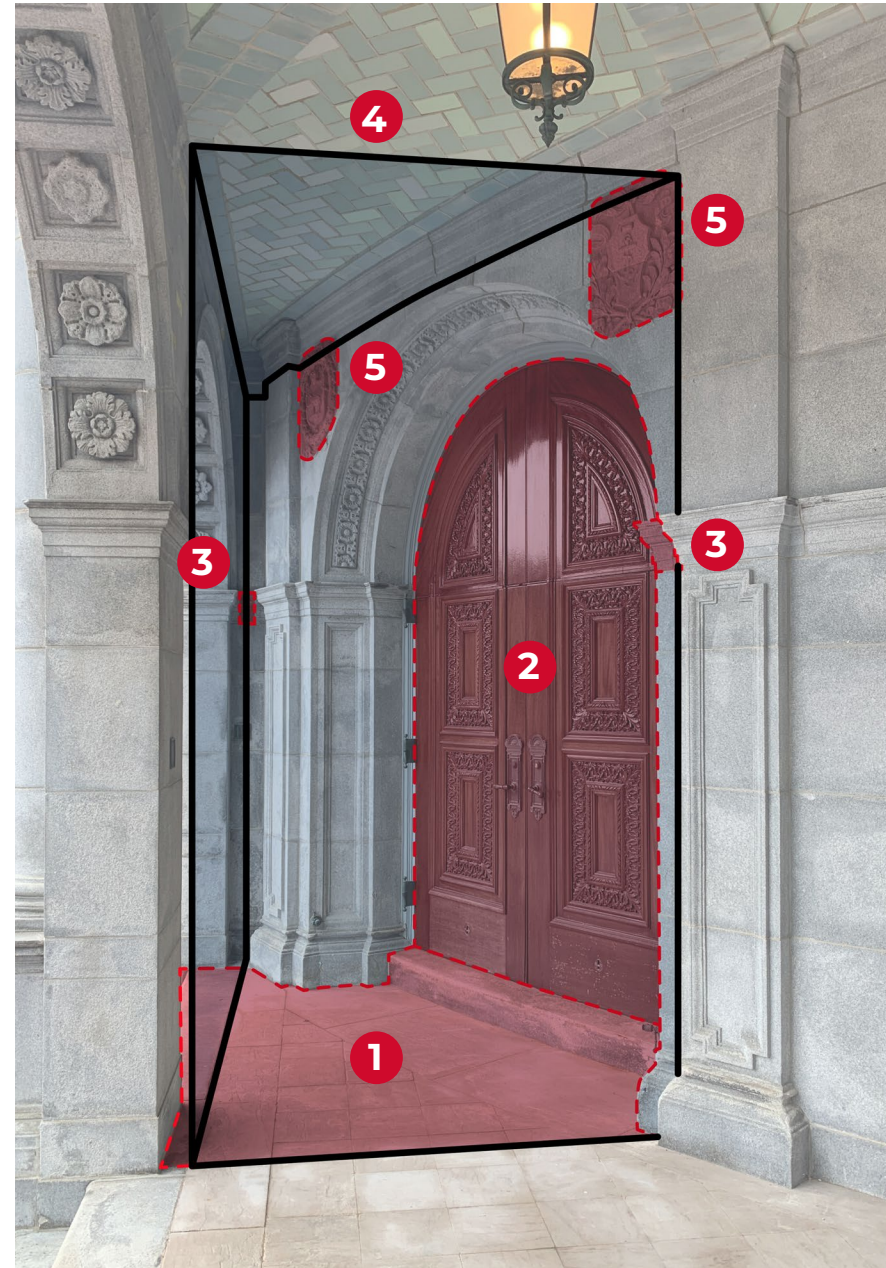
Frame Attachments to Existing Stone  
Required Adjustments

- 1 Portico landing to be lowered to match the elevation of the plaza.
- 2 Existing wood doors to be removed and stored.
- 3 Section of capital would need to be removed for vestibule attachment.
- 4 Arched Guastavino tiled ceiling to remain as existing.
- 5 Medallions carved into the stone would need to be removed.

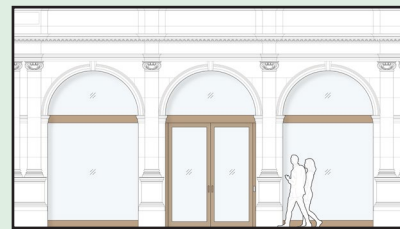
**Modified Option**

- + Provides a symmetrical design solution for this portico.
- + Provides a 24/7 weather controlled accessible entry from plaza.
- + Minimal attachment points from glass storefront to back of arched openings.
- + New interventions are reversible.

- Two sets of existing wood doors would need to be removed and stored.
- Introduces new material (glass) to the architectural vocabulary of this area of the church.
- Lowers portico/vestibule floor and requires new stone veneer to match existing facade.

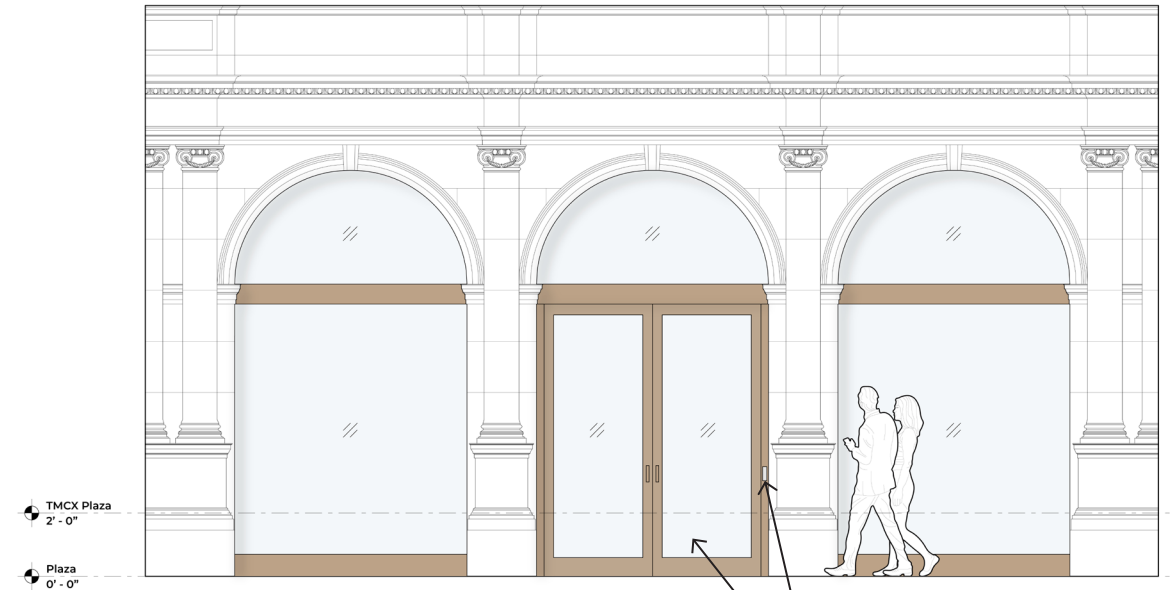
**Exterior Elevation – Proposed**

Frame Mounted ADA Push Button Operator  
Bronze Double Doors
