RESIDENCE AT 40 UNION PARK

40 UNION PARK
BOSTON, MASSACHUSETTS 02118

Submission For Review by South End Landmark District Commission: May 16, 2022
Public Hearing: June 7, 2022

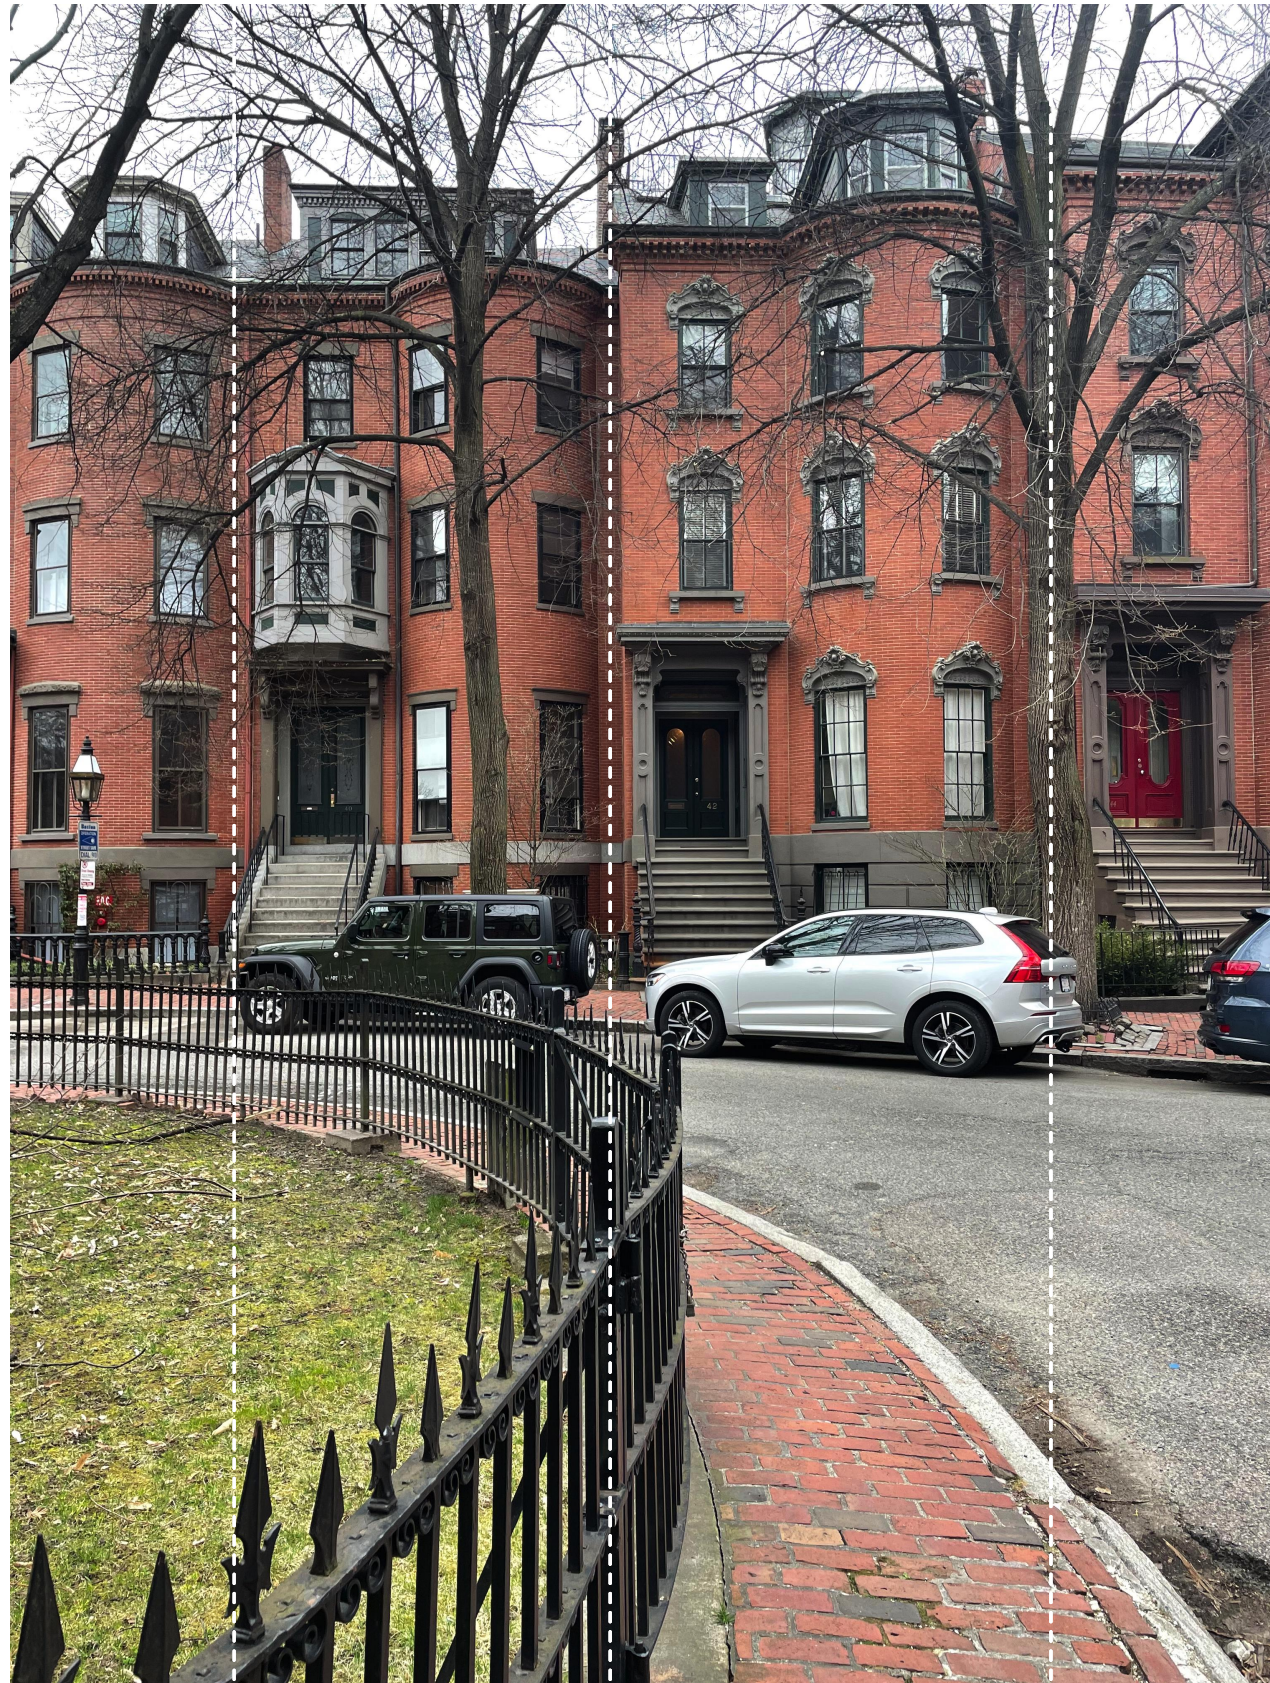
VIEW LOOKING WEST FROM UNION PARK (FRONT ELEVATION)

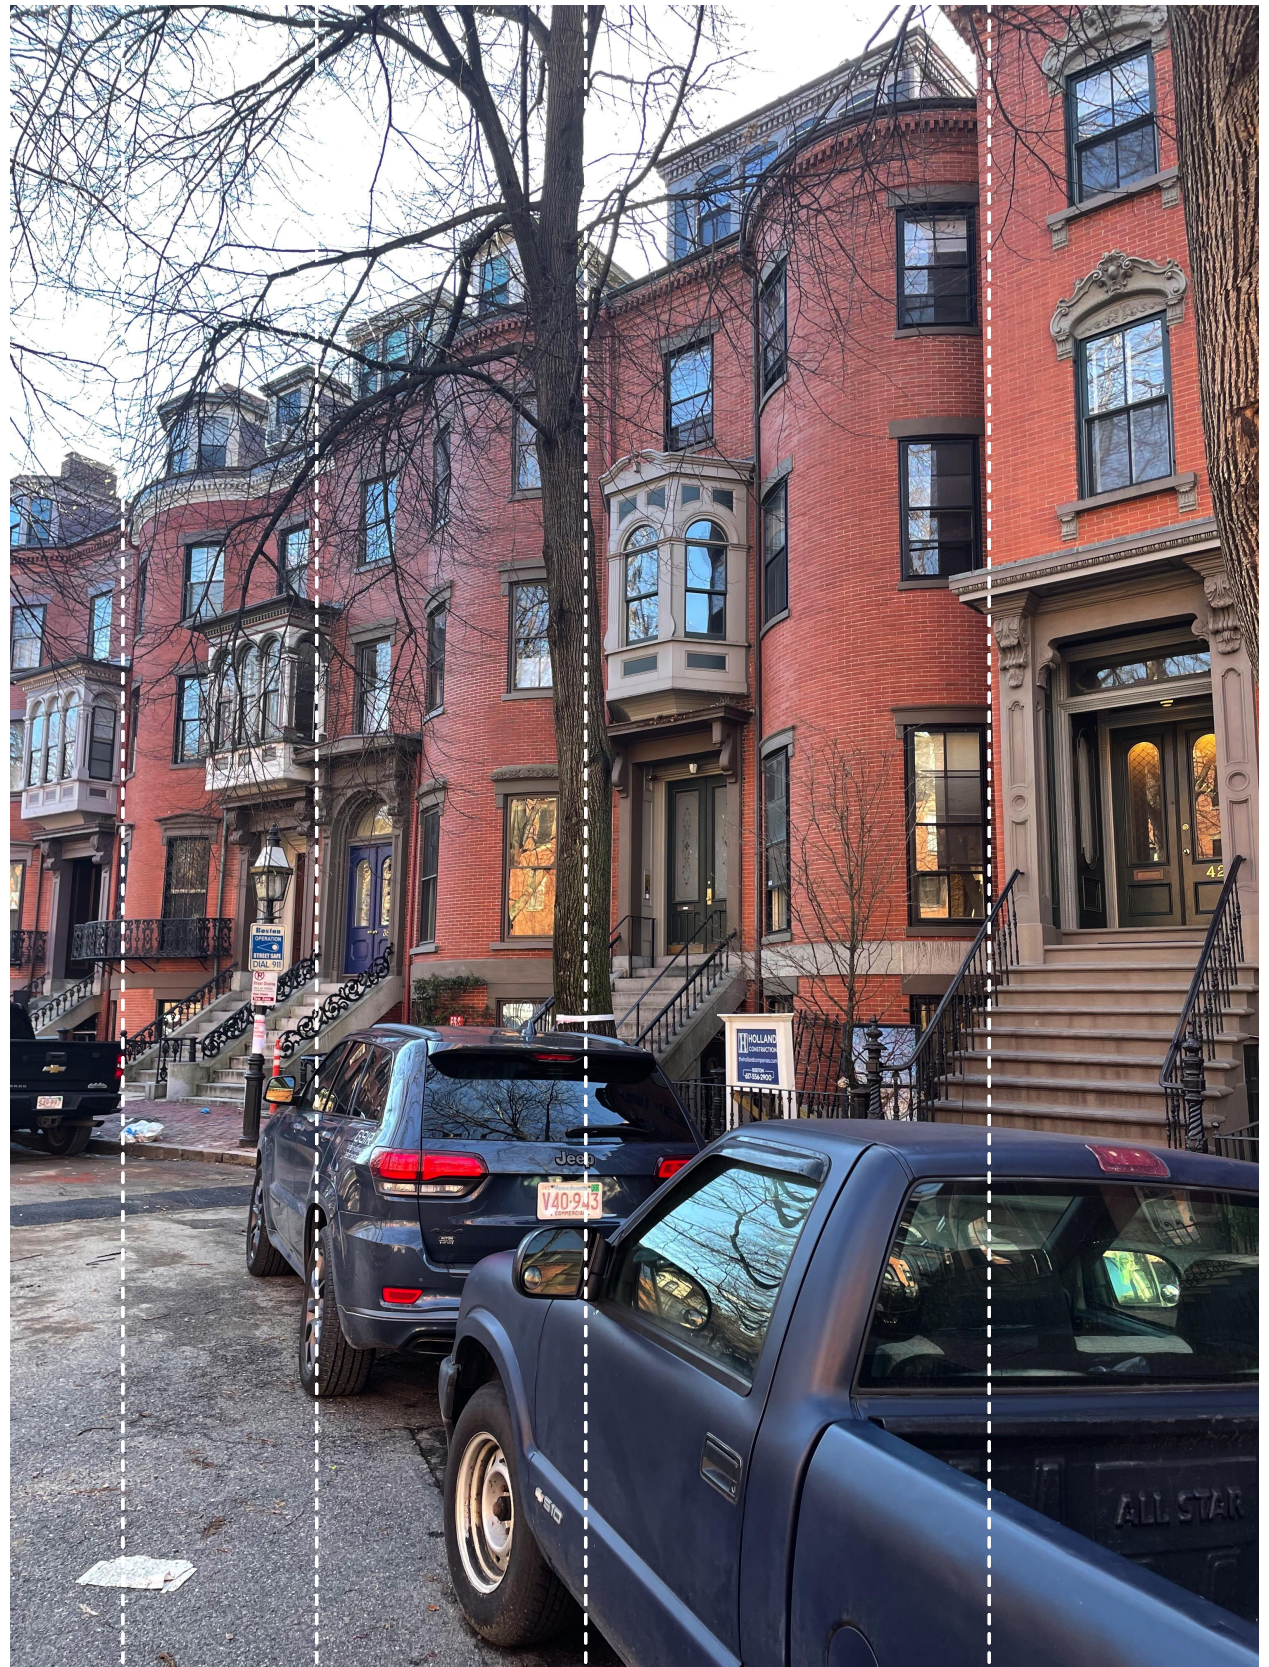
VIEW LOOKING SOUTH FROM UNION PARK (FRONT ELEVATION)

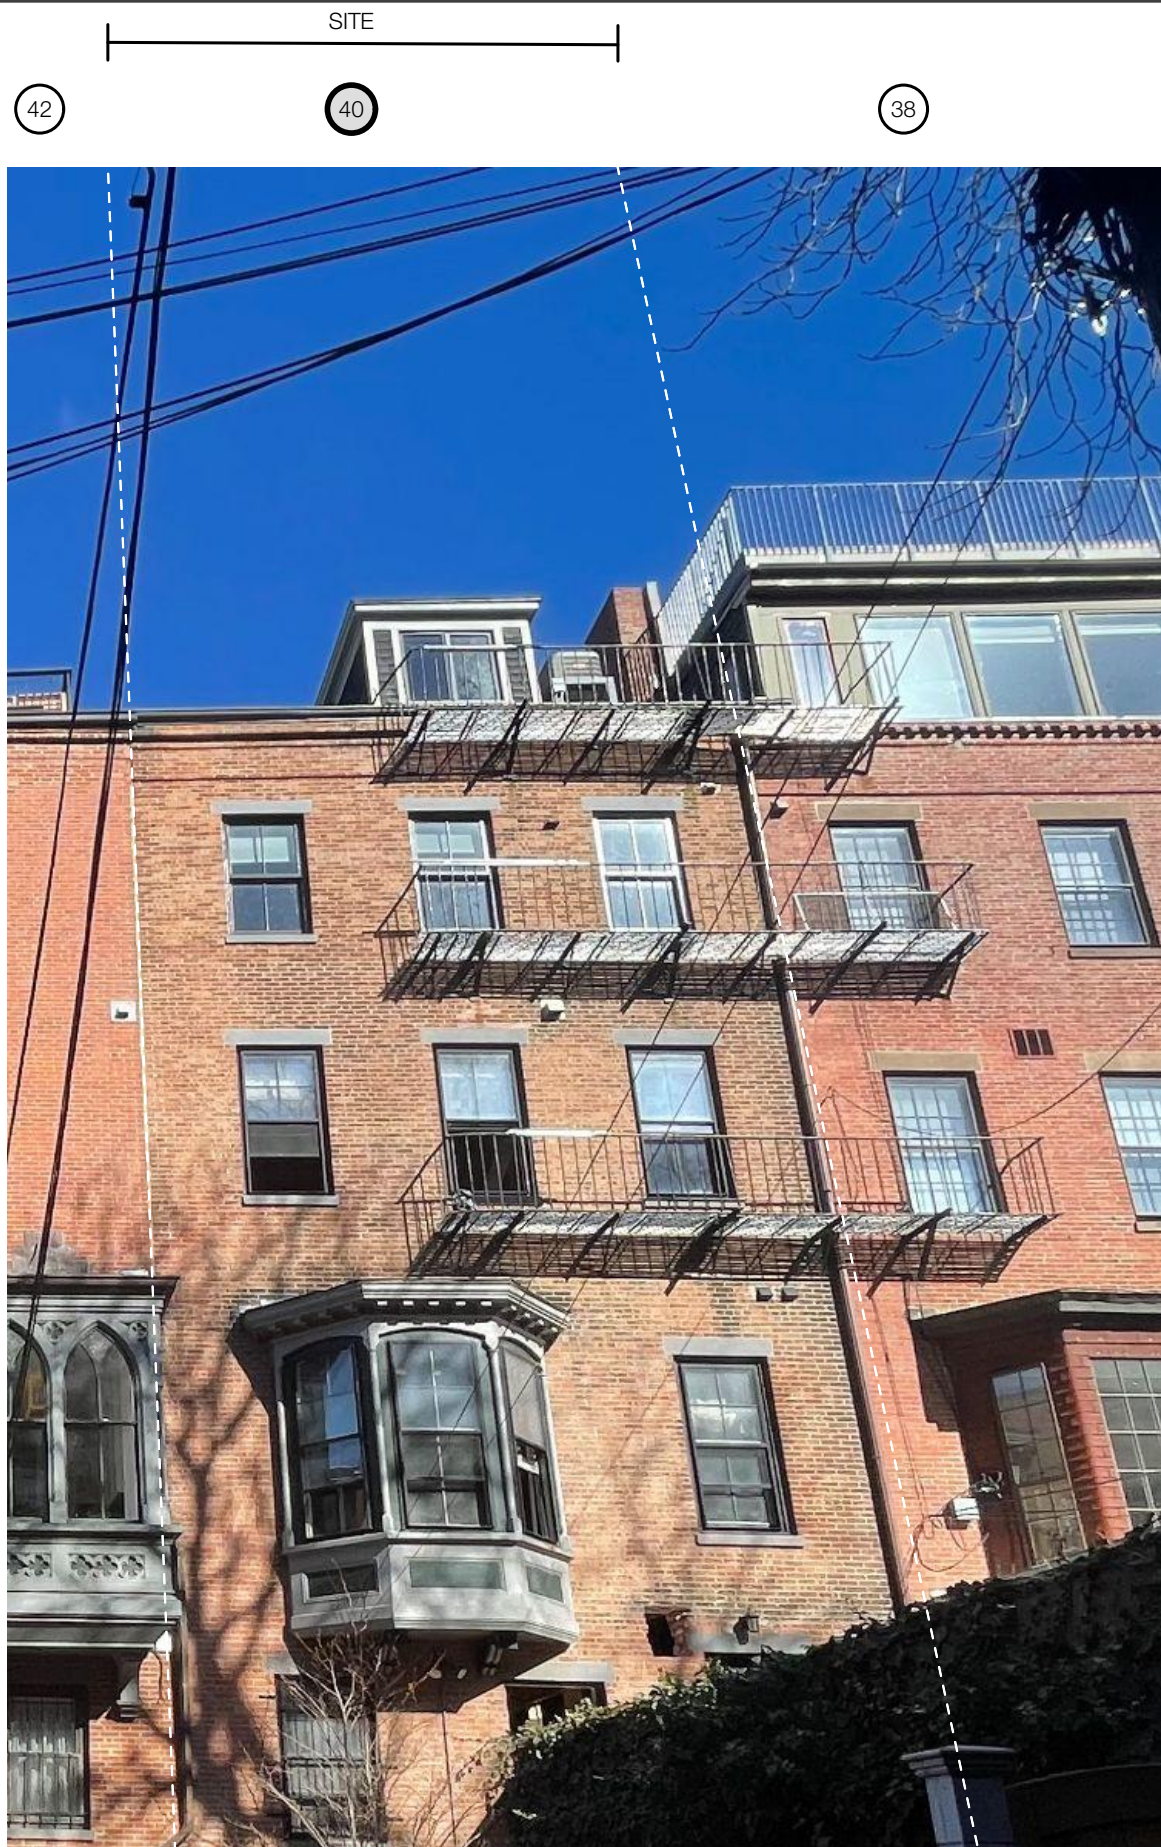
VIEW LOOKING EAST FROM PUBLIC ALLEY 701 (REAR ELEVATION)

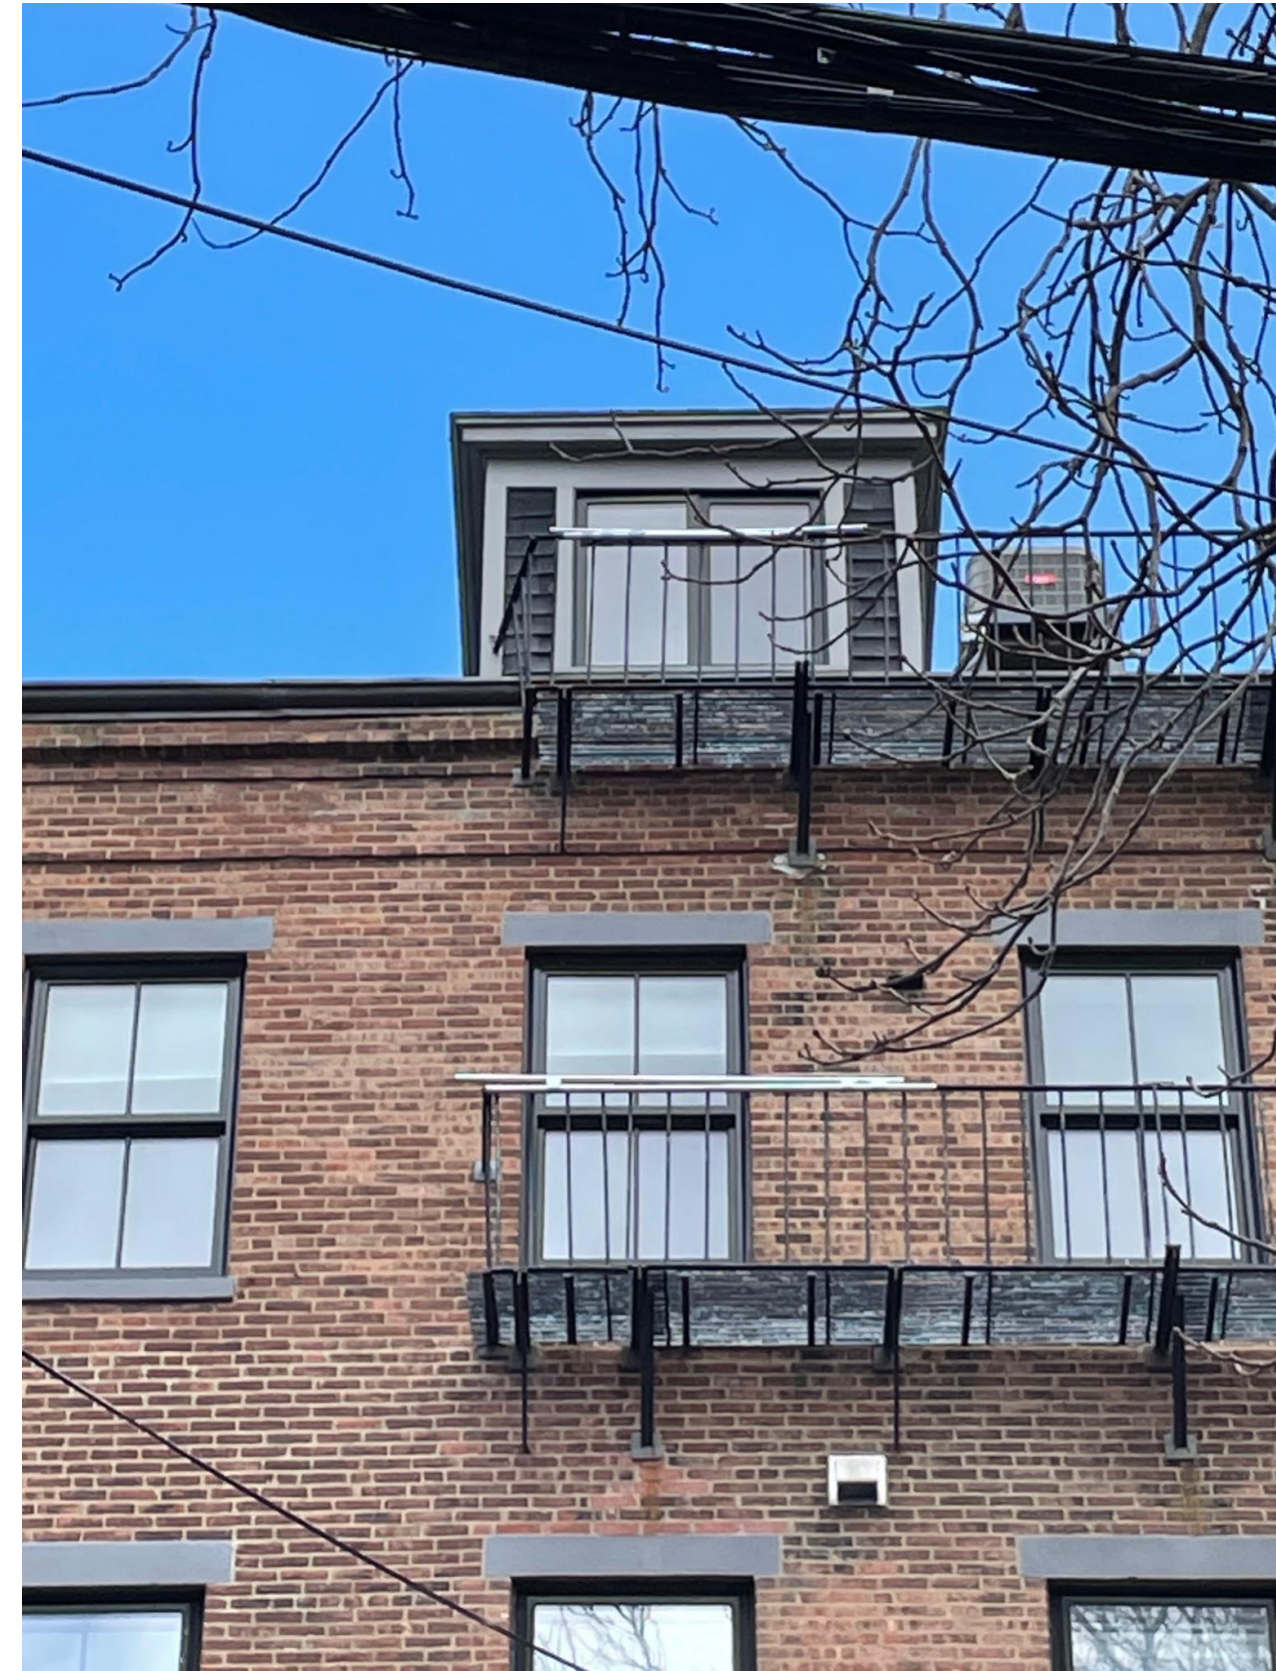
DETAIL VIEW - CORNICE LINE & REAR DORMER (REAR ELEVATION)

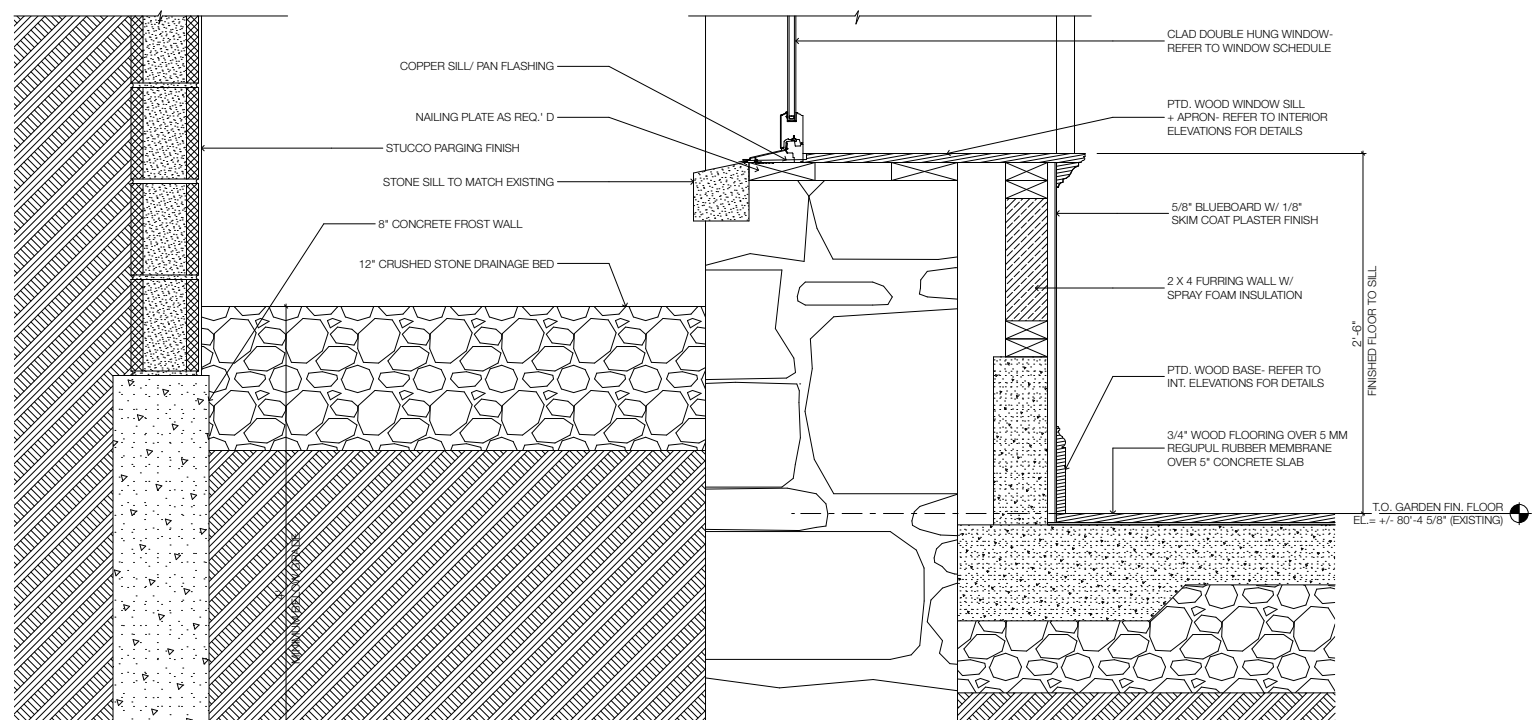
3 PROPOSED WINDOW WELL - WALL SECTION DETAIL
1/8" = 1'-0"

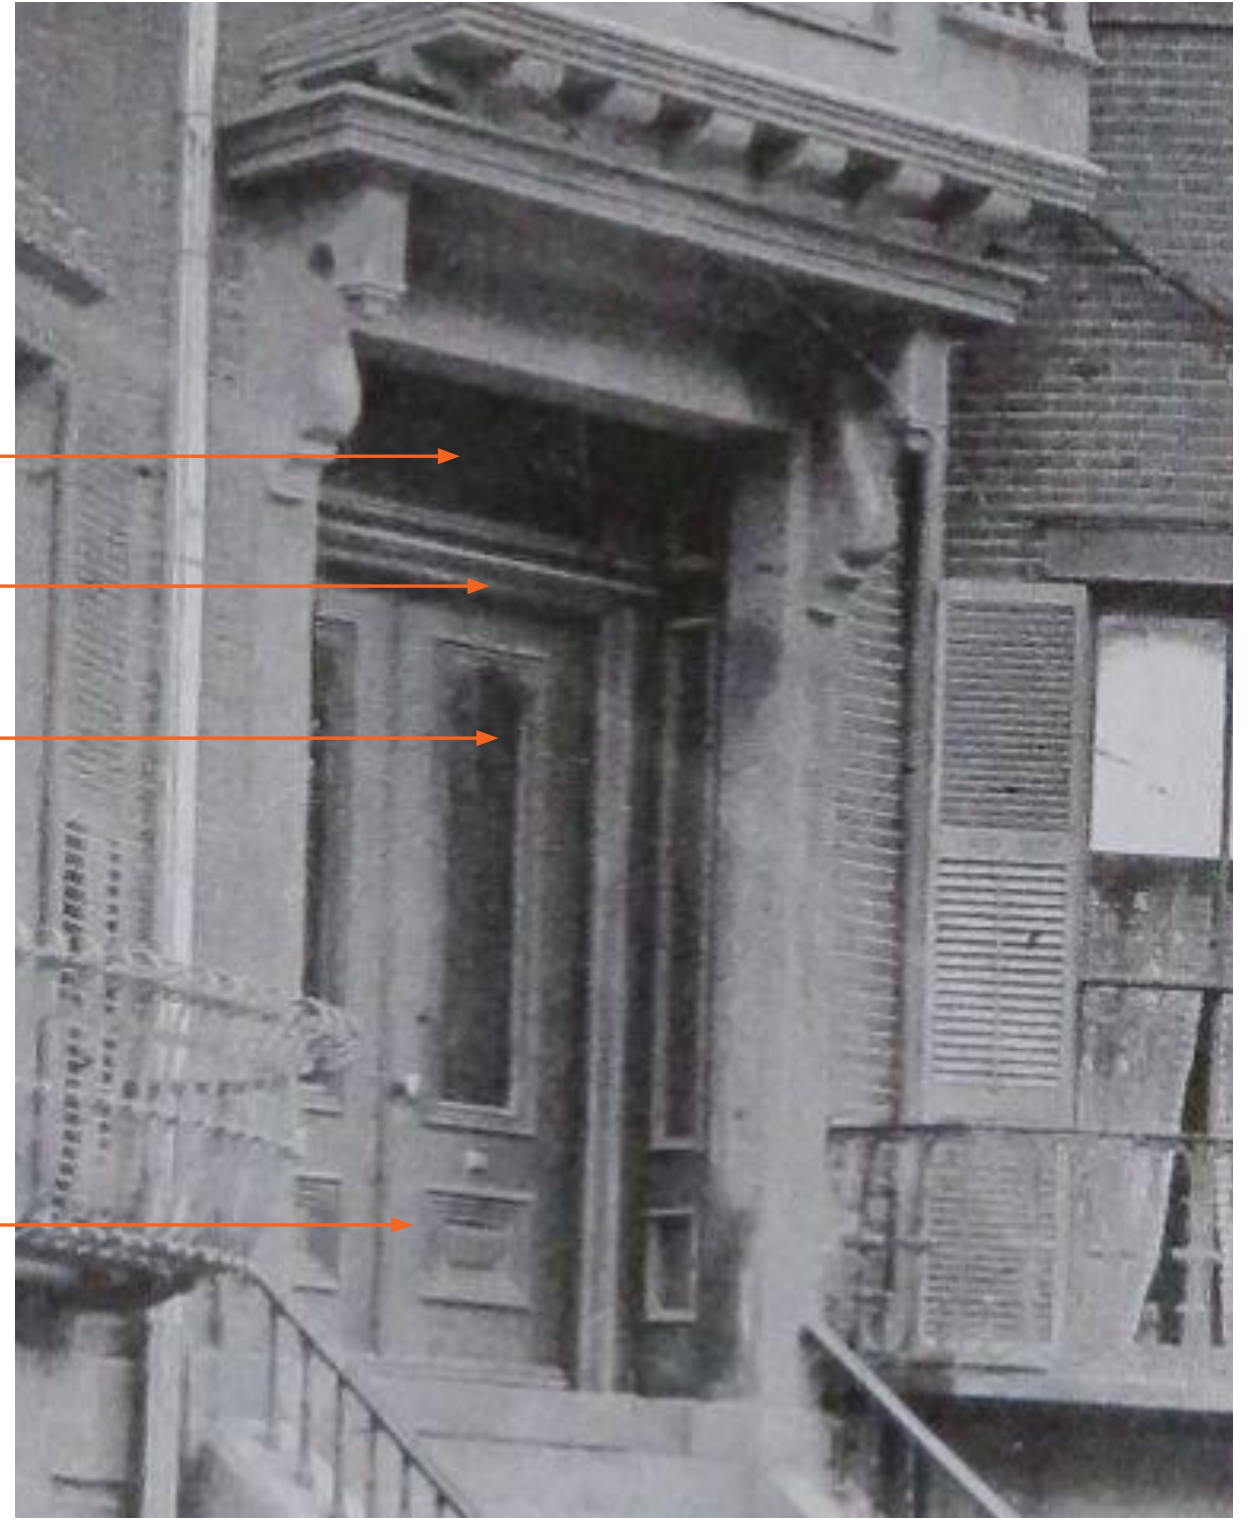
RECTANGULAR TRANSOM

T.O. DOOR ALIGNS WITH
T.O. SIDE PANEL

RECTANGULAR LITE
W/ INSET ARCHED DETAIL

SINGLE RAISED PANEL
W/ PROFILE DETAILING

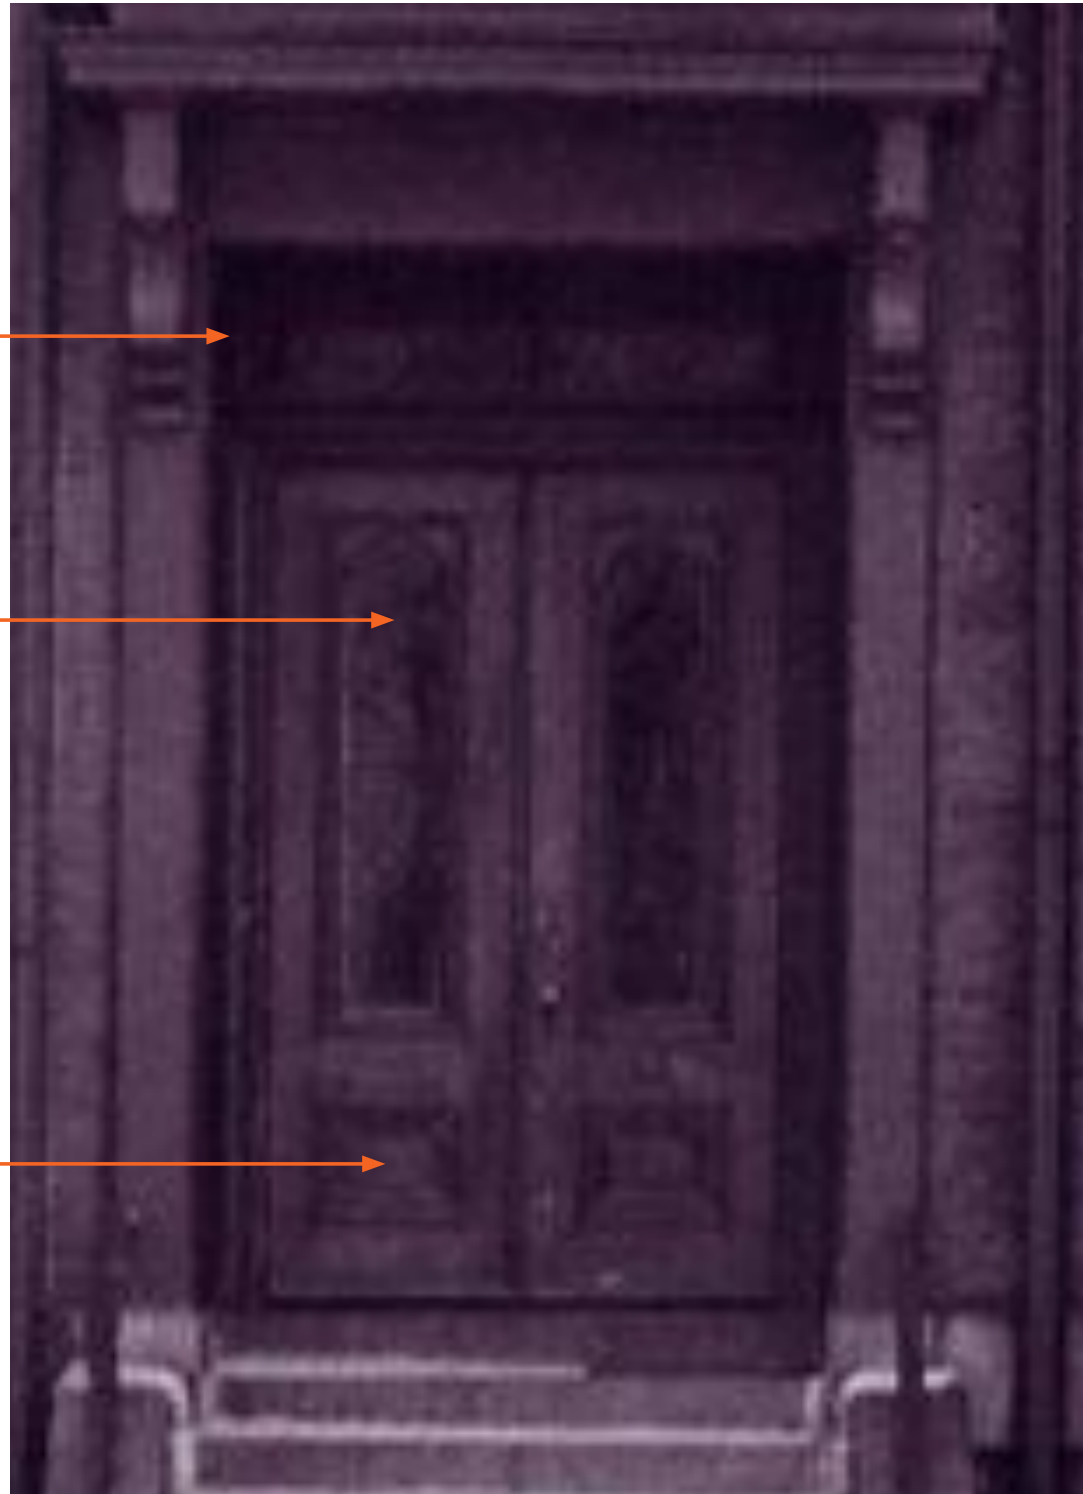
RECTANGULAR LITE
W/ INSET
ARCHED DETAIL
& STEPPED STICKING →

SINGLE
RAISED PANEL →

VIEW OF ENTRY DOOR
South End Streets Survey (1972)

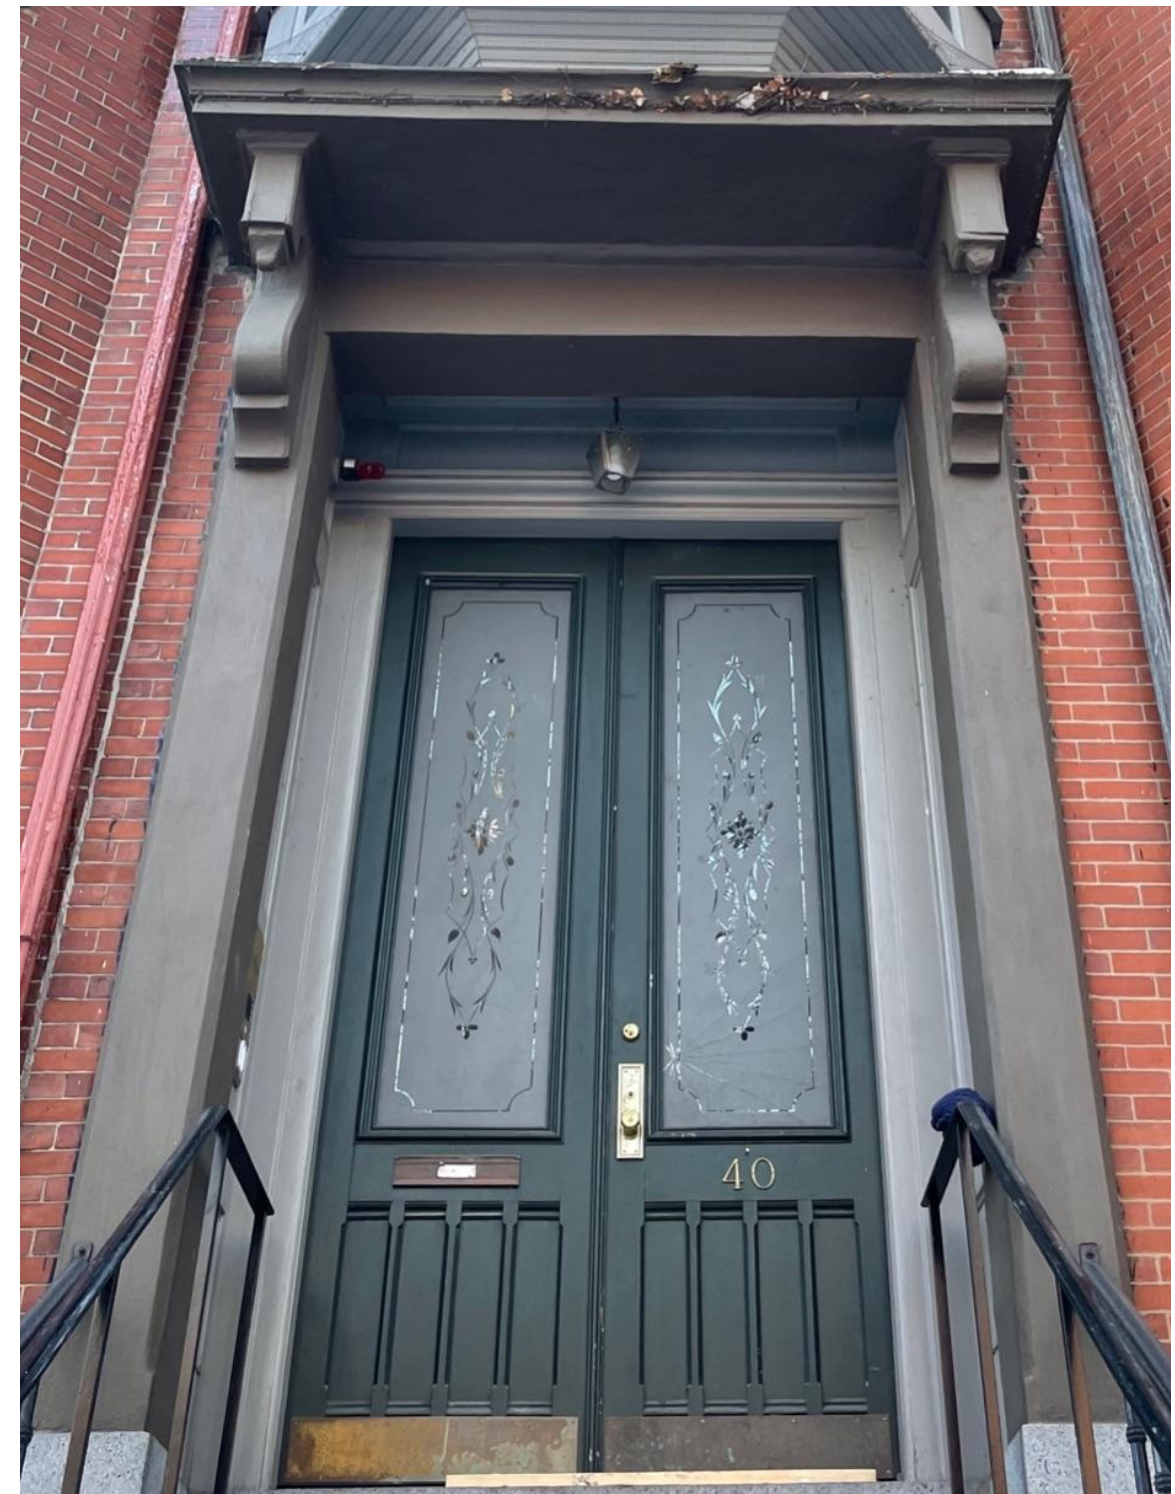
CURRENT ENTRY DOOR (2022)
Modified In 1988 Per ISD Special Permit

Install two (2) new window sashes; relocate entrance door; reframe & new header; close door; install new wood beam; close in transom.

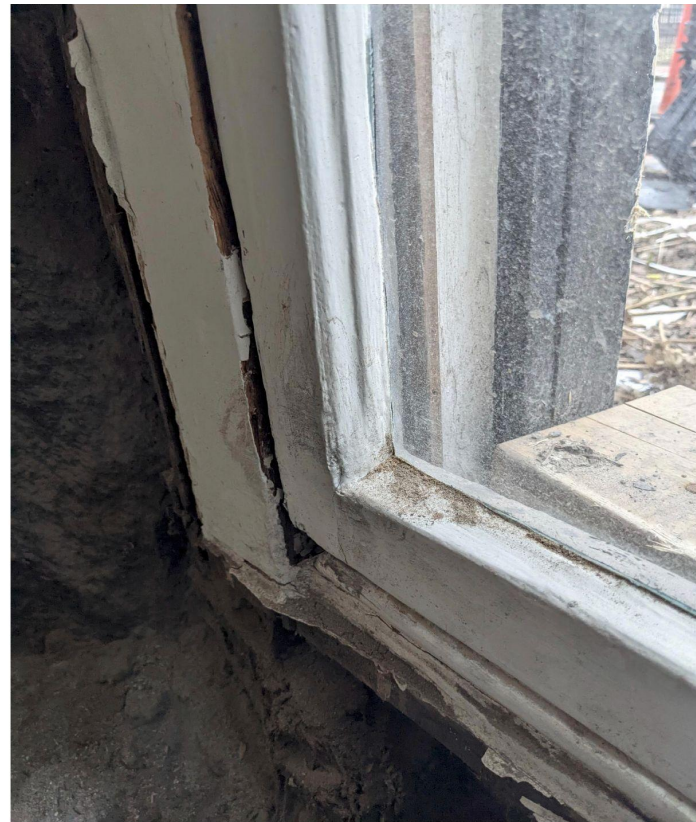
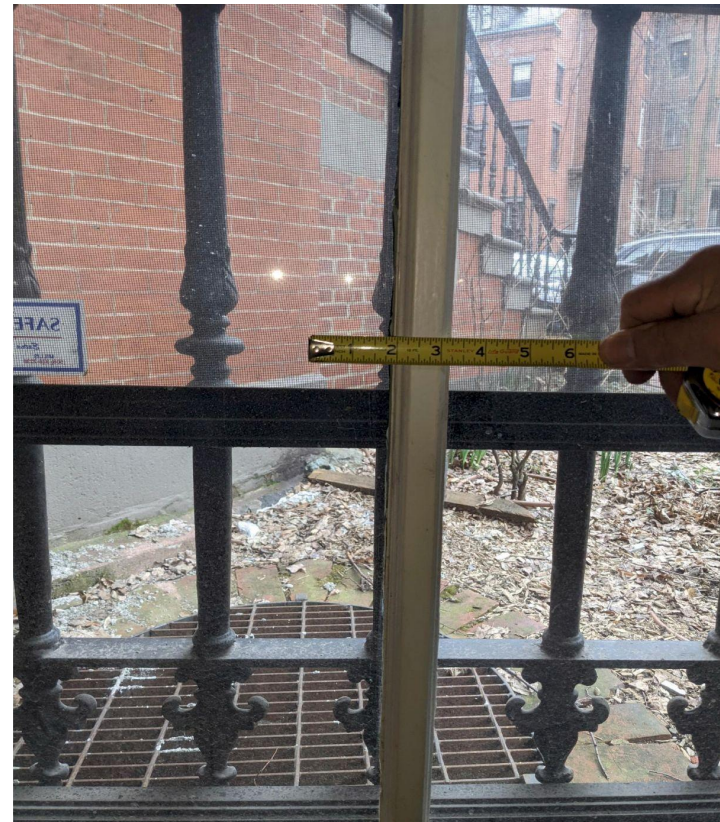
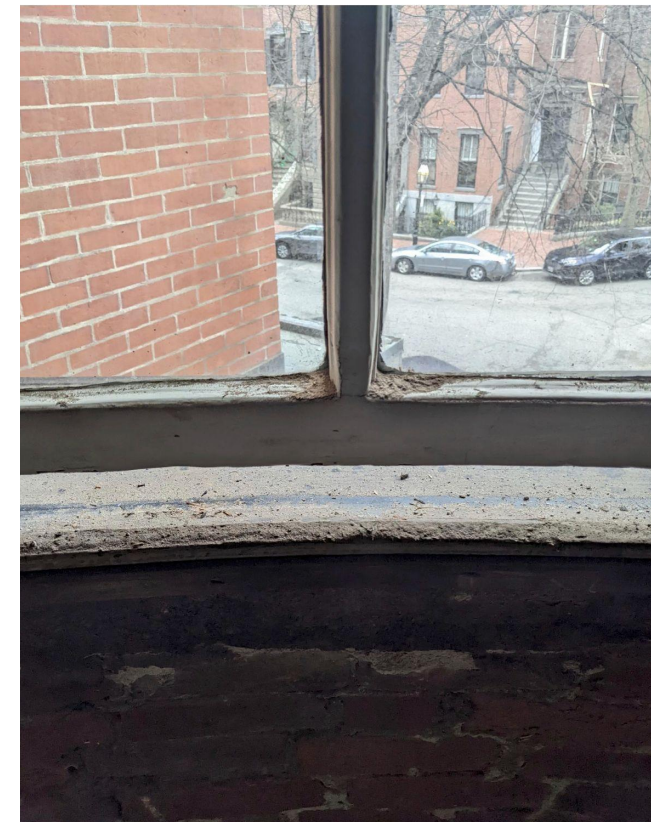
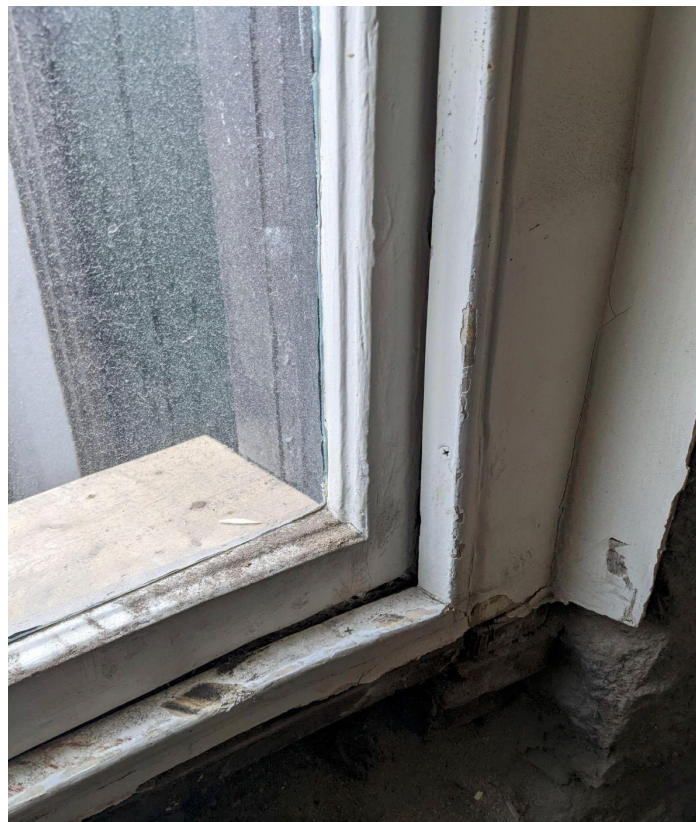
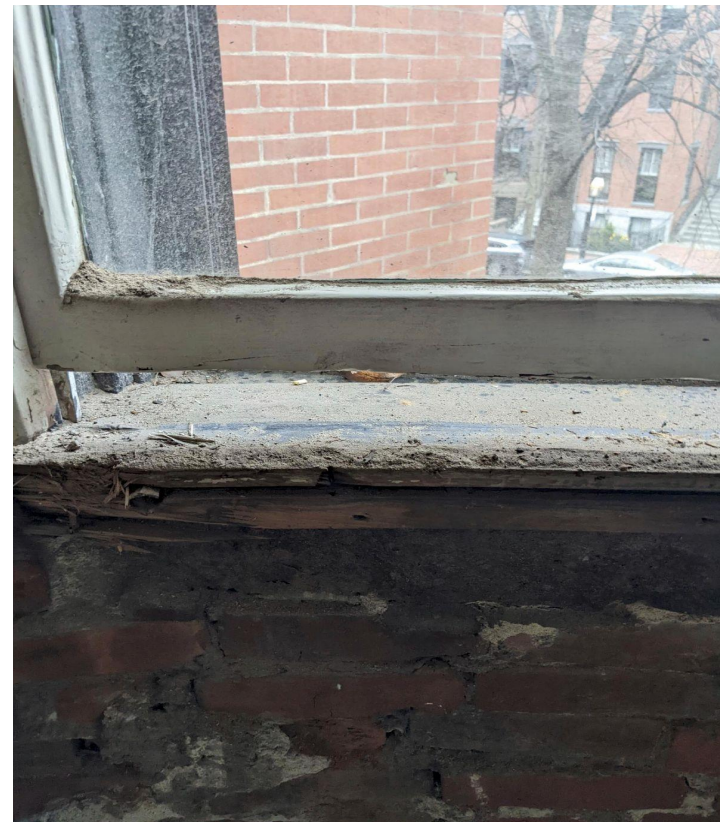
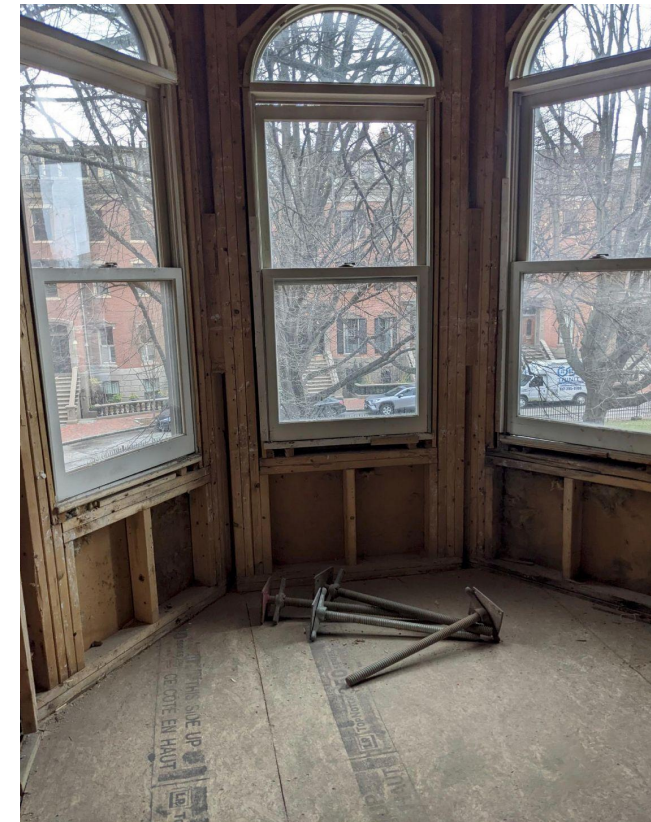
CURVED SASH CONDITION REPORT:

- 6 OF 8 CURVED SASH WINDOWS HAVE 1 ¼" MUNTINS & REPLACEMENT GLASS, WHICH IS WIDER THAN TYPICAL PERIOD WINDOWS
- PROFILES ON INTERIOR GLAZING STOPS HAVE BEEN SANDED AWAY
- SEVERAL WINDOW HAVE BOTTOM RAILS THAT SHOW RAGGED CUTS ALONG FULL WIDTH
- WOOD ROT & NEGLECT AT EXTERIOR OPENINGS (TYPICAL ACROSS ALL CURVED SASH WINDOWS)
- WINDOWS HAVE SLOTS CUT INTO FRAMES FOR INTERLOCKING ZINC WEATHERSTRIPPING
- SURFACE-MOUNTED BOX FRAMES FOR TRIPLE-TRACK STORM WINDOWS ARE INOPERABLE & NO LONGER WEATHERTIGHT
- ALL WINDOWS IN ORIEL ARE RECENT REPLACEMENT WINDOWS.

Evaluation by (2) Independent Window Experts indicates that the curved sash windows are not original to the building.

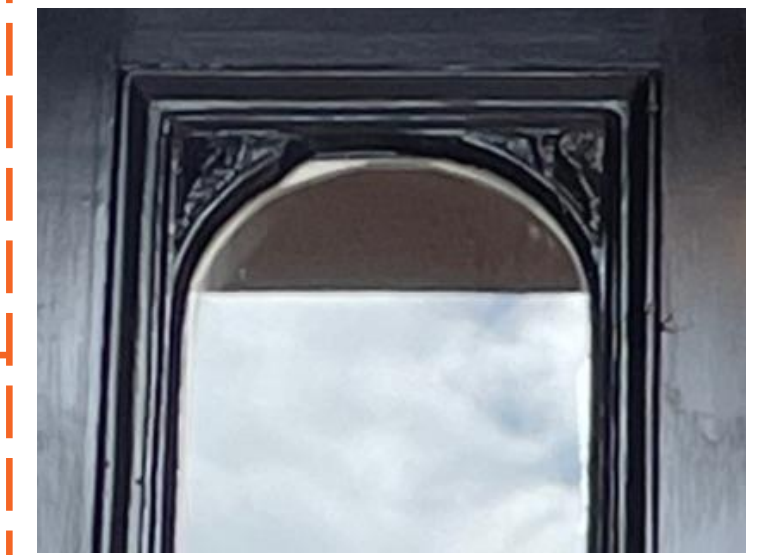
INSET ARCHED LITE DETAIL

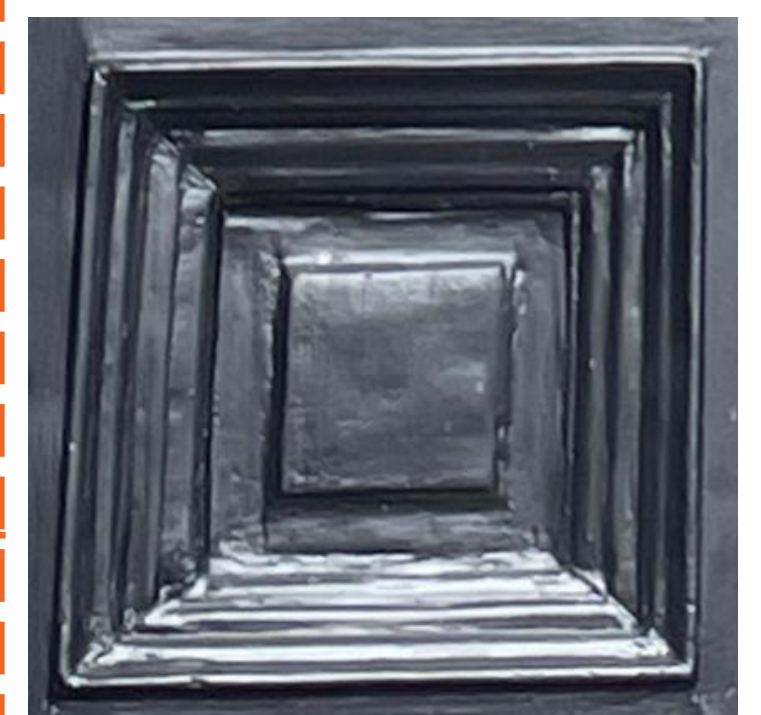
RAISED PANEL DETAIL

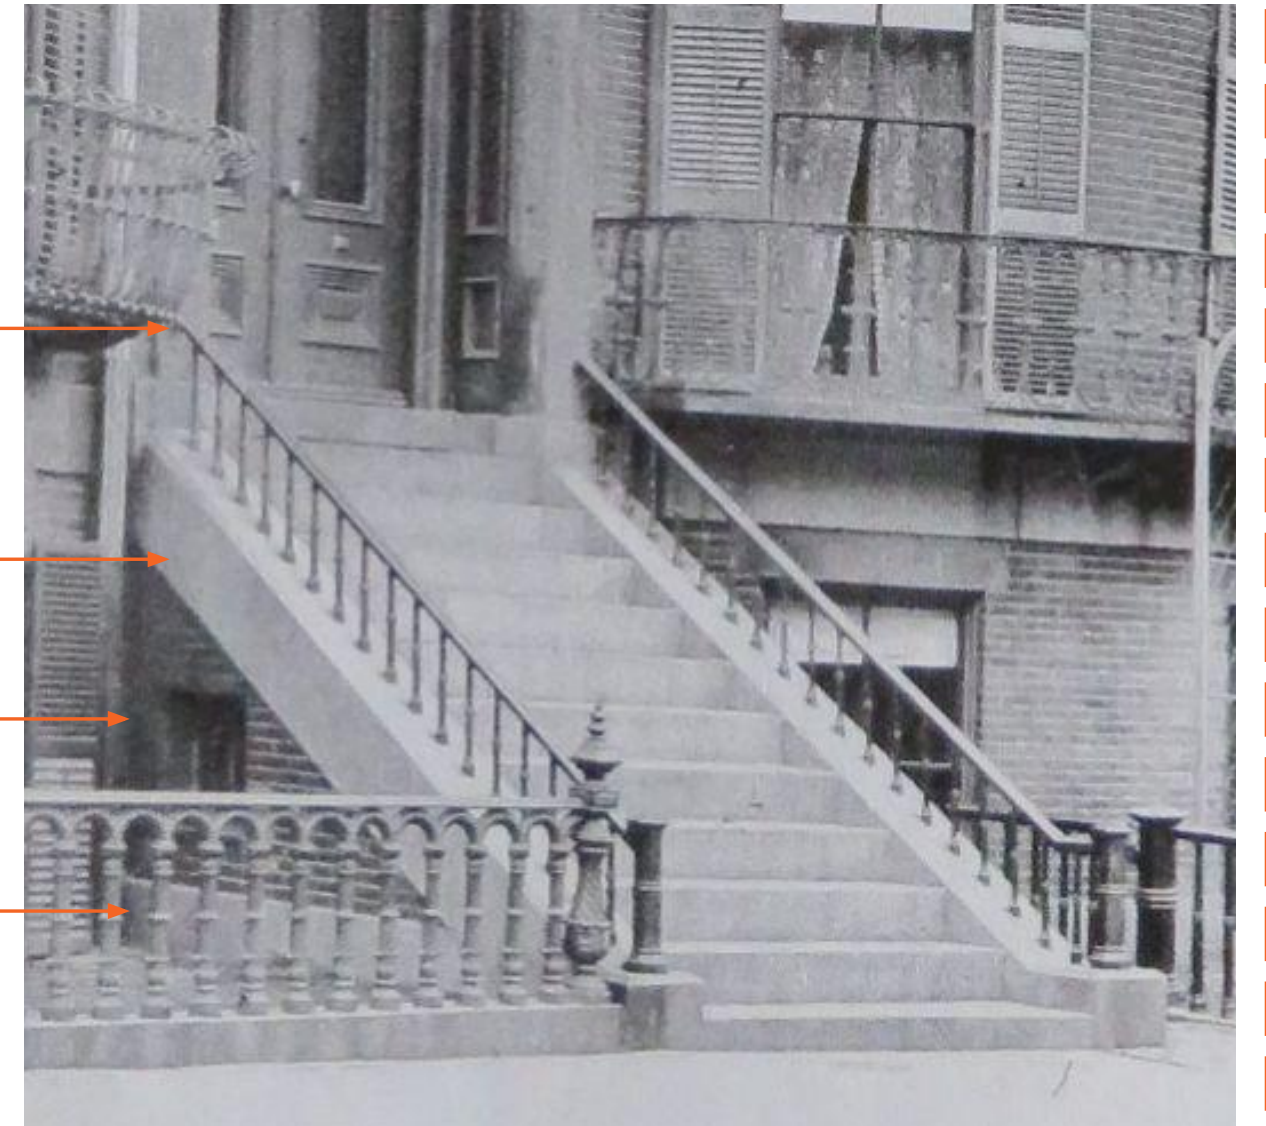
ORIGINAL IRON BALUSTRADE

ORIGINAL GRANITE
STRINGER W/ CHAMFER
