RESIDENCE AT 40 UNION PARK

40 UNION PARK
BOSTON, MASSACHUSETTS 02118

Submission For Review by South End Landmark District Commission: May 16, 2022
Public Hearing: June 7, 2022

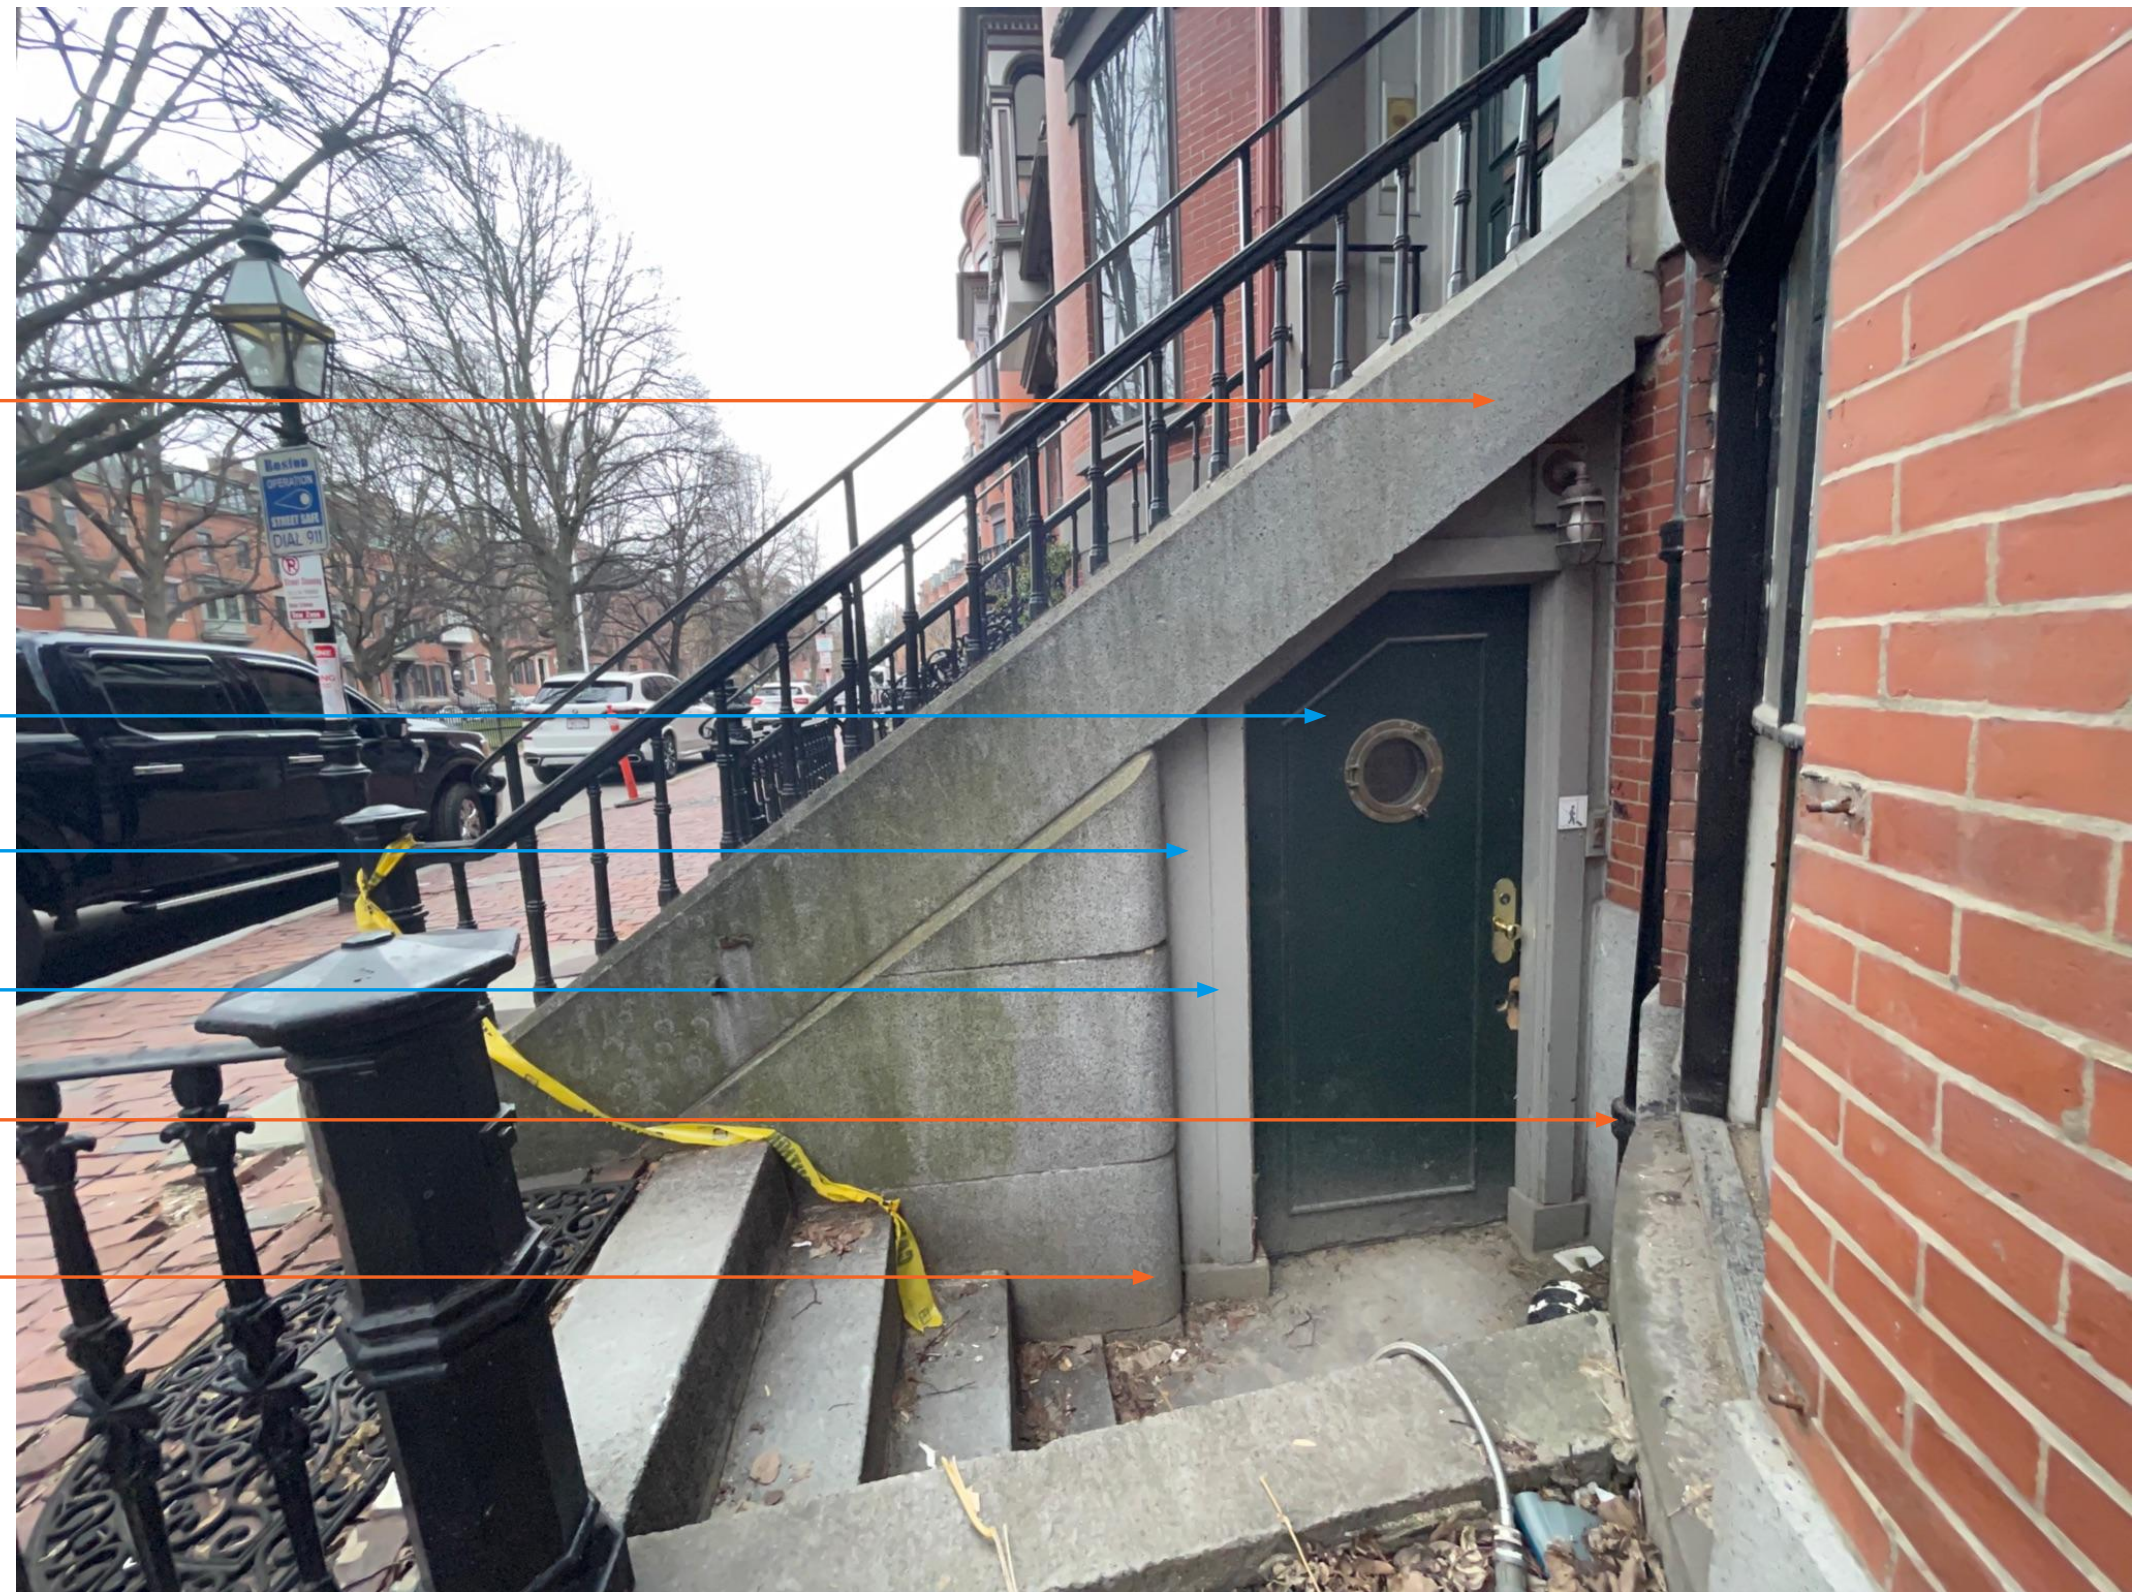
MORTAR RESIDUE
SHOWING ORIGINAL
LOCATION OF BRICK INFILL

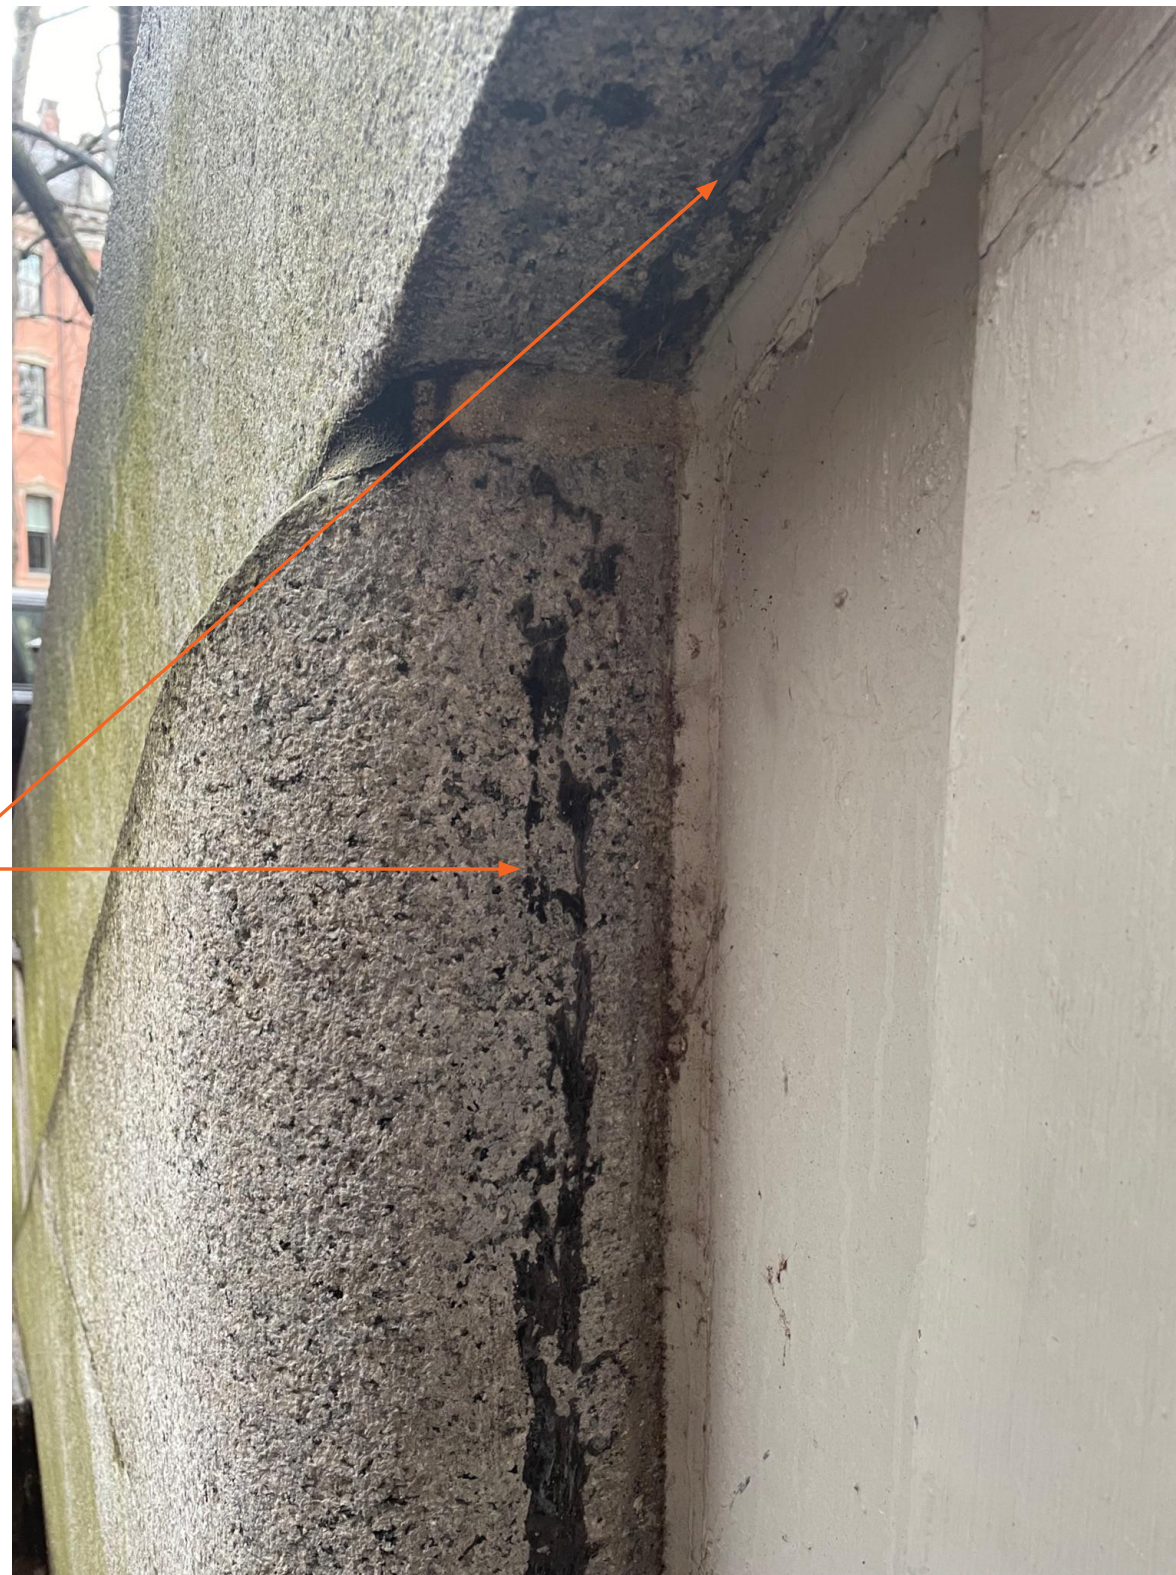
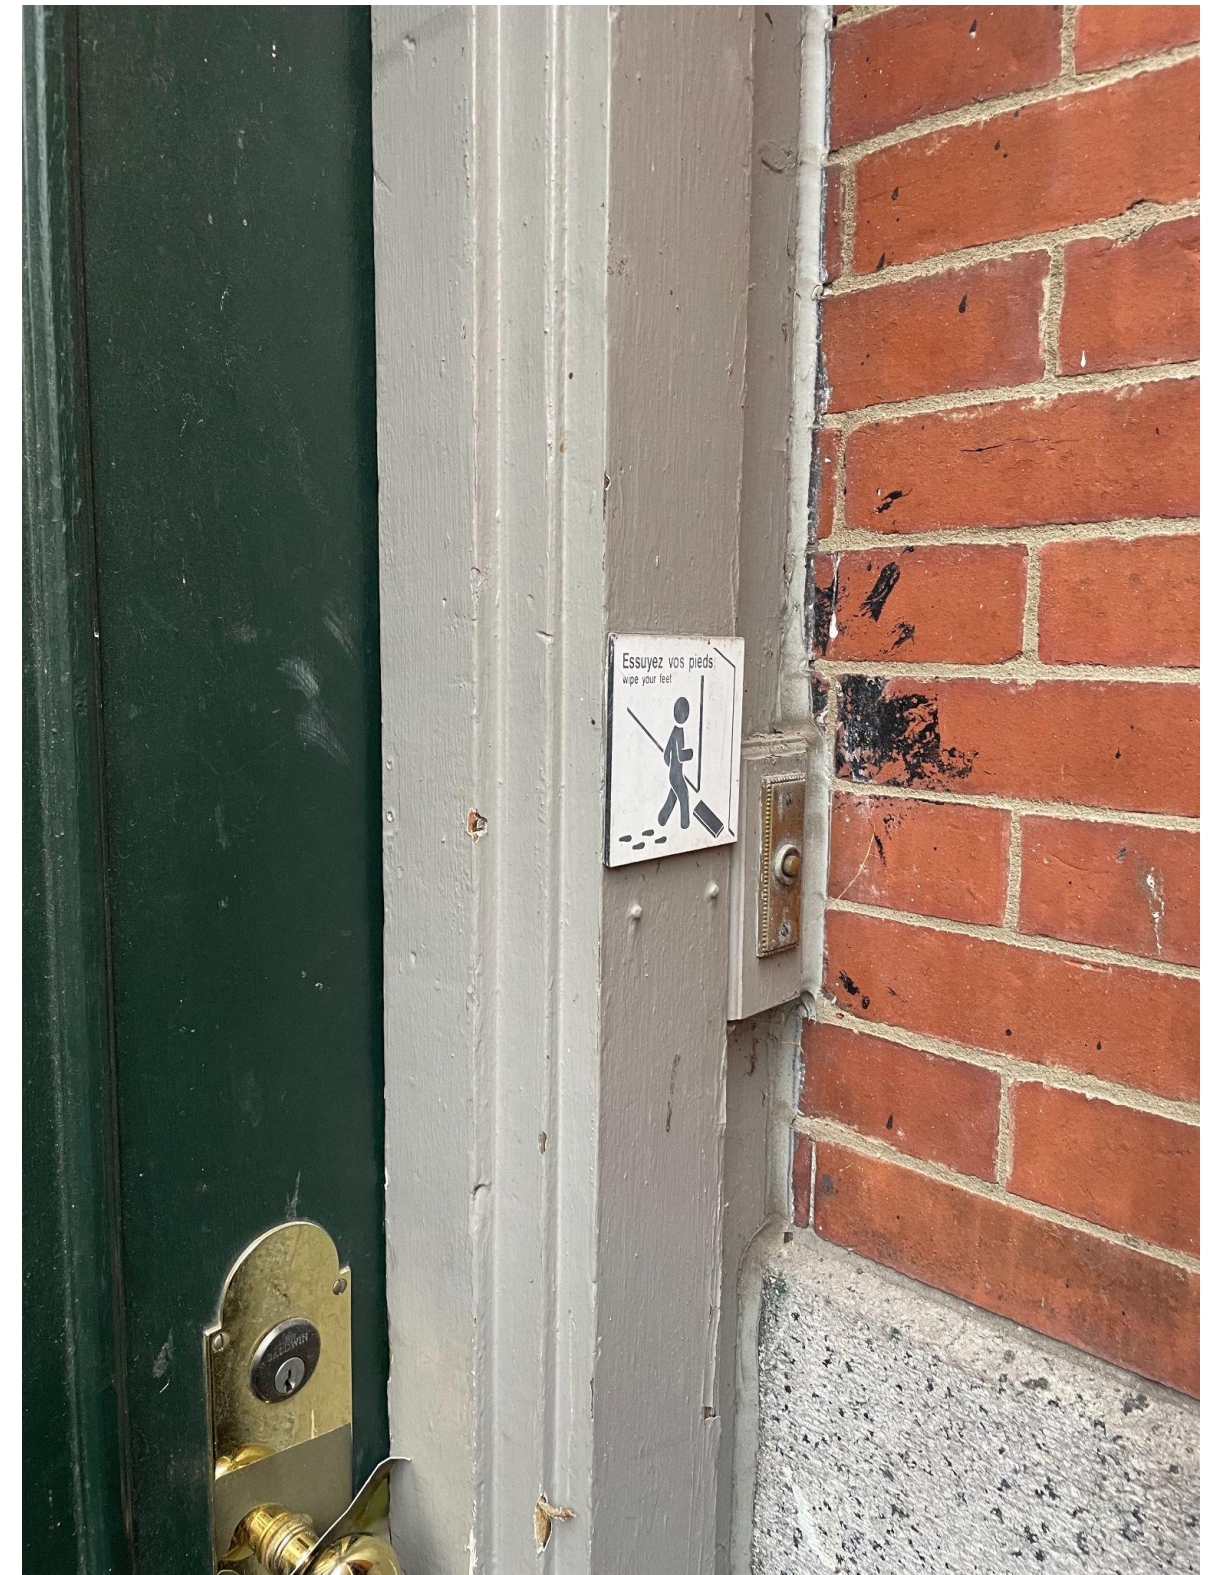
FRONT STOOP - EXISTING CONDITIONS AT DOOR
SCALE: AS INDICATED

SHARED FEATURES

GRANITE STRINGER WITH
DECORATIVE IRON
BALUSTRADE ABOVE

RUNNING BOND
BRICK MASONRY BELOW STRINGER

ARCHED DOORS BELOW THE
STRINGER

BRICK SOLDIER COURSE
ABOVE DOOR

HIGH GRANITE COURSING
EXTENDING AROUND BOW
FRONT, TERMINATING AT DOOR

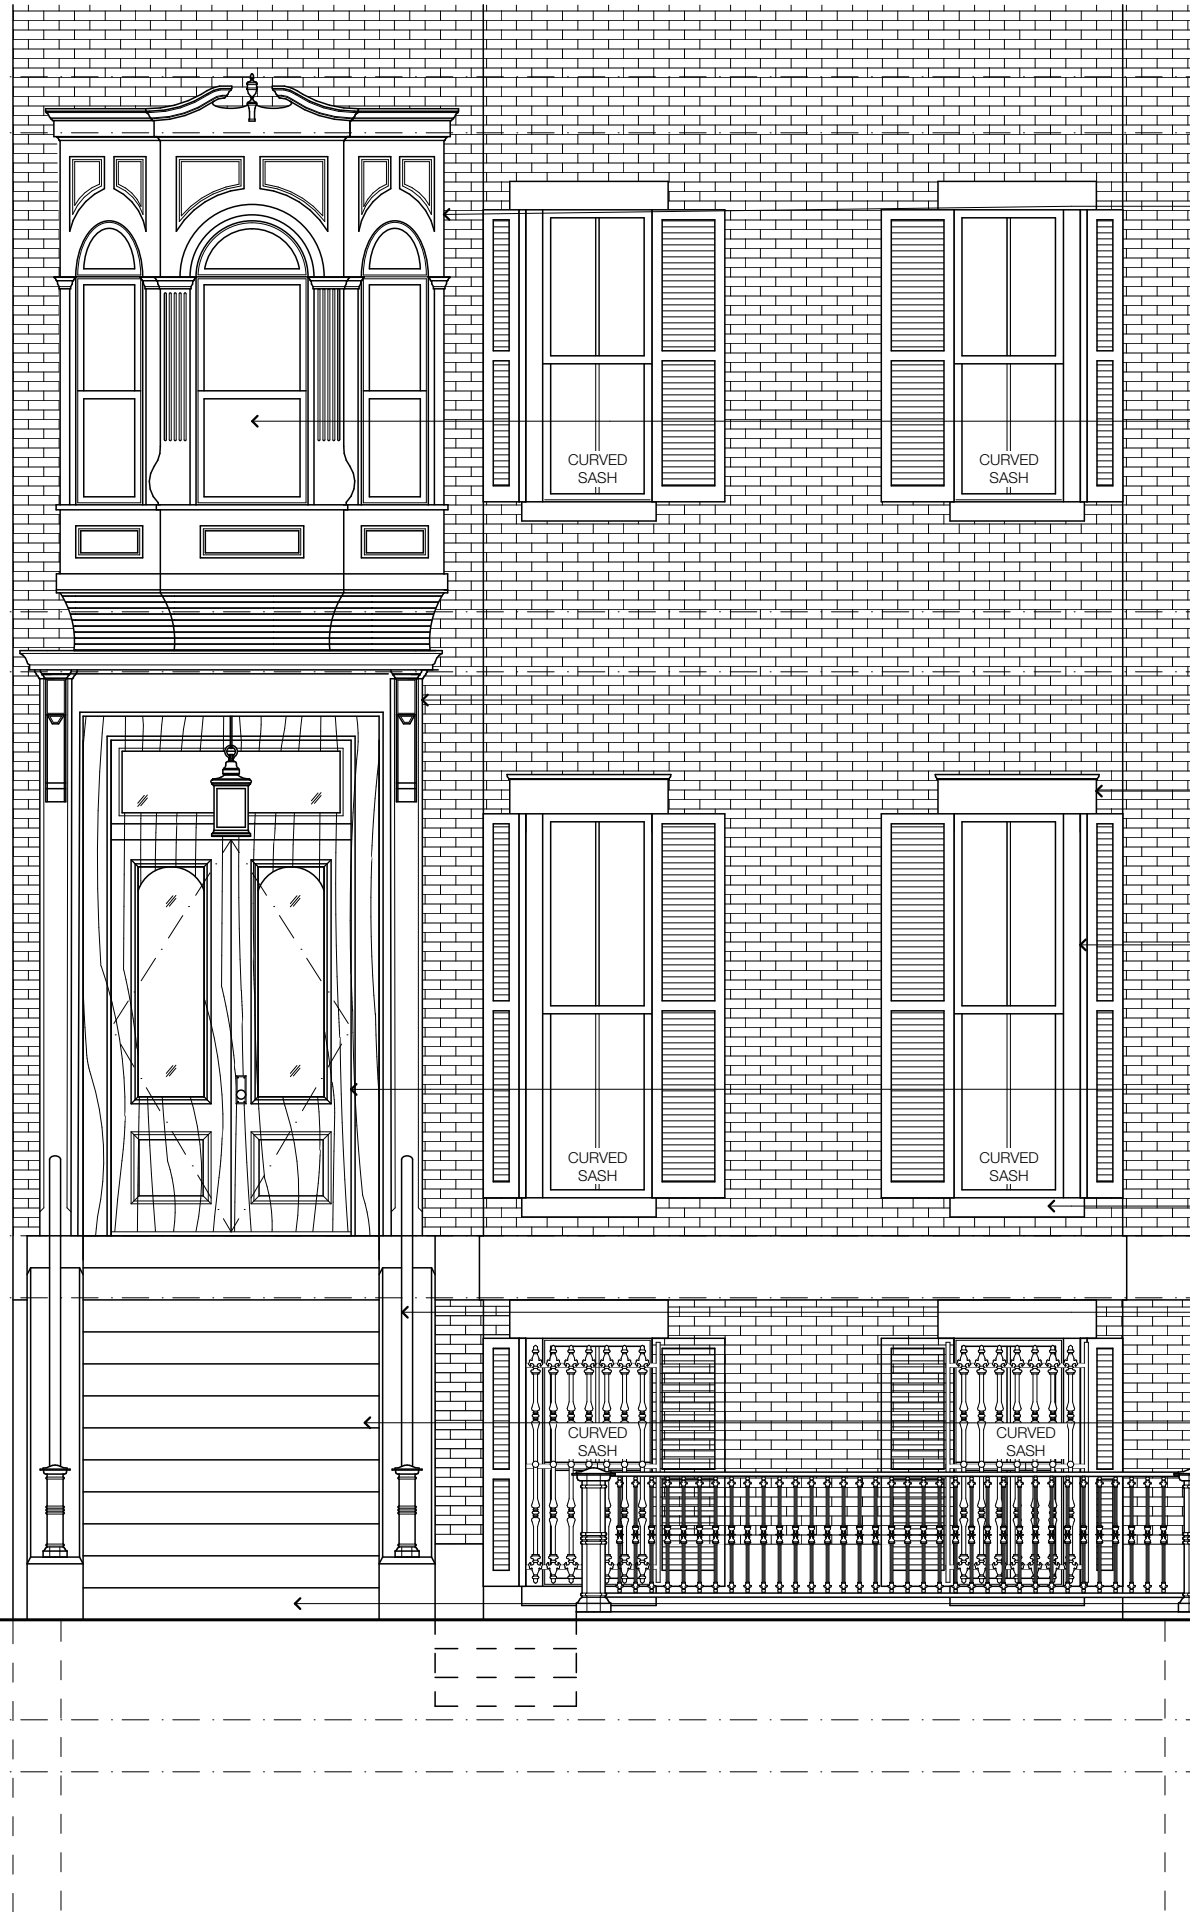
1 FRONT ELEVATION AT FRONT GARDEN
1/4" = 1'-0"

RESTORE WOOD BAY STRUCTURE TO MATCH EXISTING; REPLACE & REPAIR MISSING & DAMAGED PIECES AS REQUIRED.

NEW 1-OVER-1 DOUBLE-HUNG WINDOWS TO BE INSTALLED IN EXISTING OPENINGS.
NEW WINDOWS TO BE HISTORICALLY ACCURATE TO MATCH DESIGN STANDARDS PER SELDC.

EXISTING WOOD PEDIMENT & BRACKETS TO BE REPAIRED AS NECESSARY.
EXISTING STONE LINTELS TO BE REPAIRED AS REQUIRED (TYPICAL THROUGHOUT BUILDING).

NEW 2-OVER-2 DOUBLE-HUNG WOOD WINDOWS TO BE INSTALLED IN EXISTING MASONRY OPENINGS. NEW WINDOWS TO BE HISTORICALLY ACCURATE TO MATCH DESIGN STANDARDS PER SELDC (TYPICAL THROUGHOUT BUILDING).

NEW WOOD ENTRANCE DOORS & GLASS TRANSOM; STAINED MAHOGANY

EXISTING STONE LINTELS TO BE REPAIRED AS REQUIRED (TYPICAL THROUGHOUT BUILDING).

HISTORIC IRON RAILING & BALUSTRADE AT STOOP TO BE REPAIRED AS NECESSARY & PAINTED BLACK.

EXISTING (NON-HISTORIC) IRON RAILING TO BE REMOVED; GRANITE STOOP TO BE PATCHED & REPAIRED AS NECESSARY.

HISTORIC IRON RAILING & BALUSTRADE AT GARDEN TO BE REPAIRED AS NECESSARY & PAINTED BLACK.

EXISTING STONE STOOP TO BE CLEANED & REPAIRED AS NECESSARY.

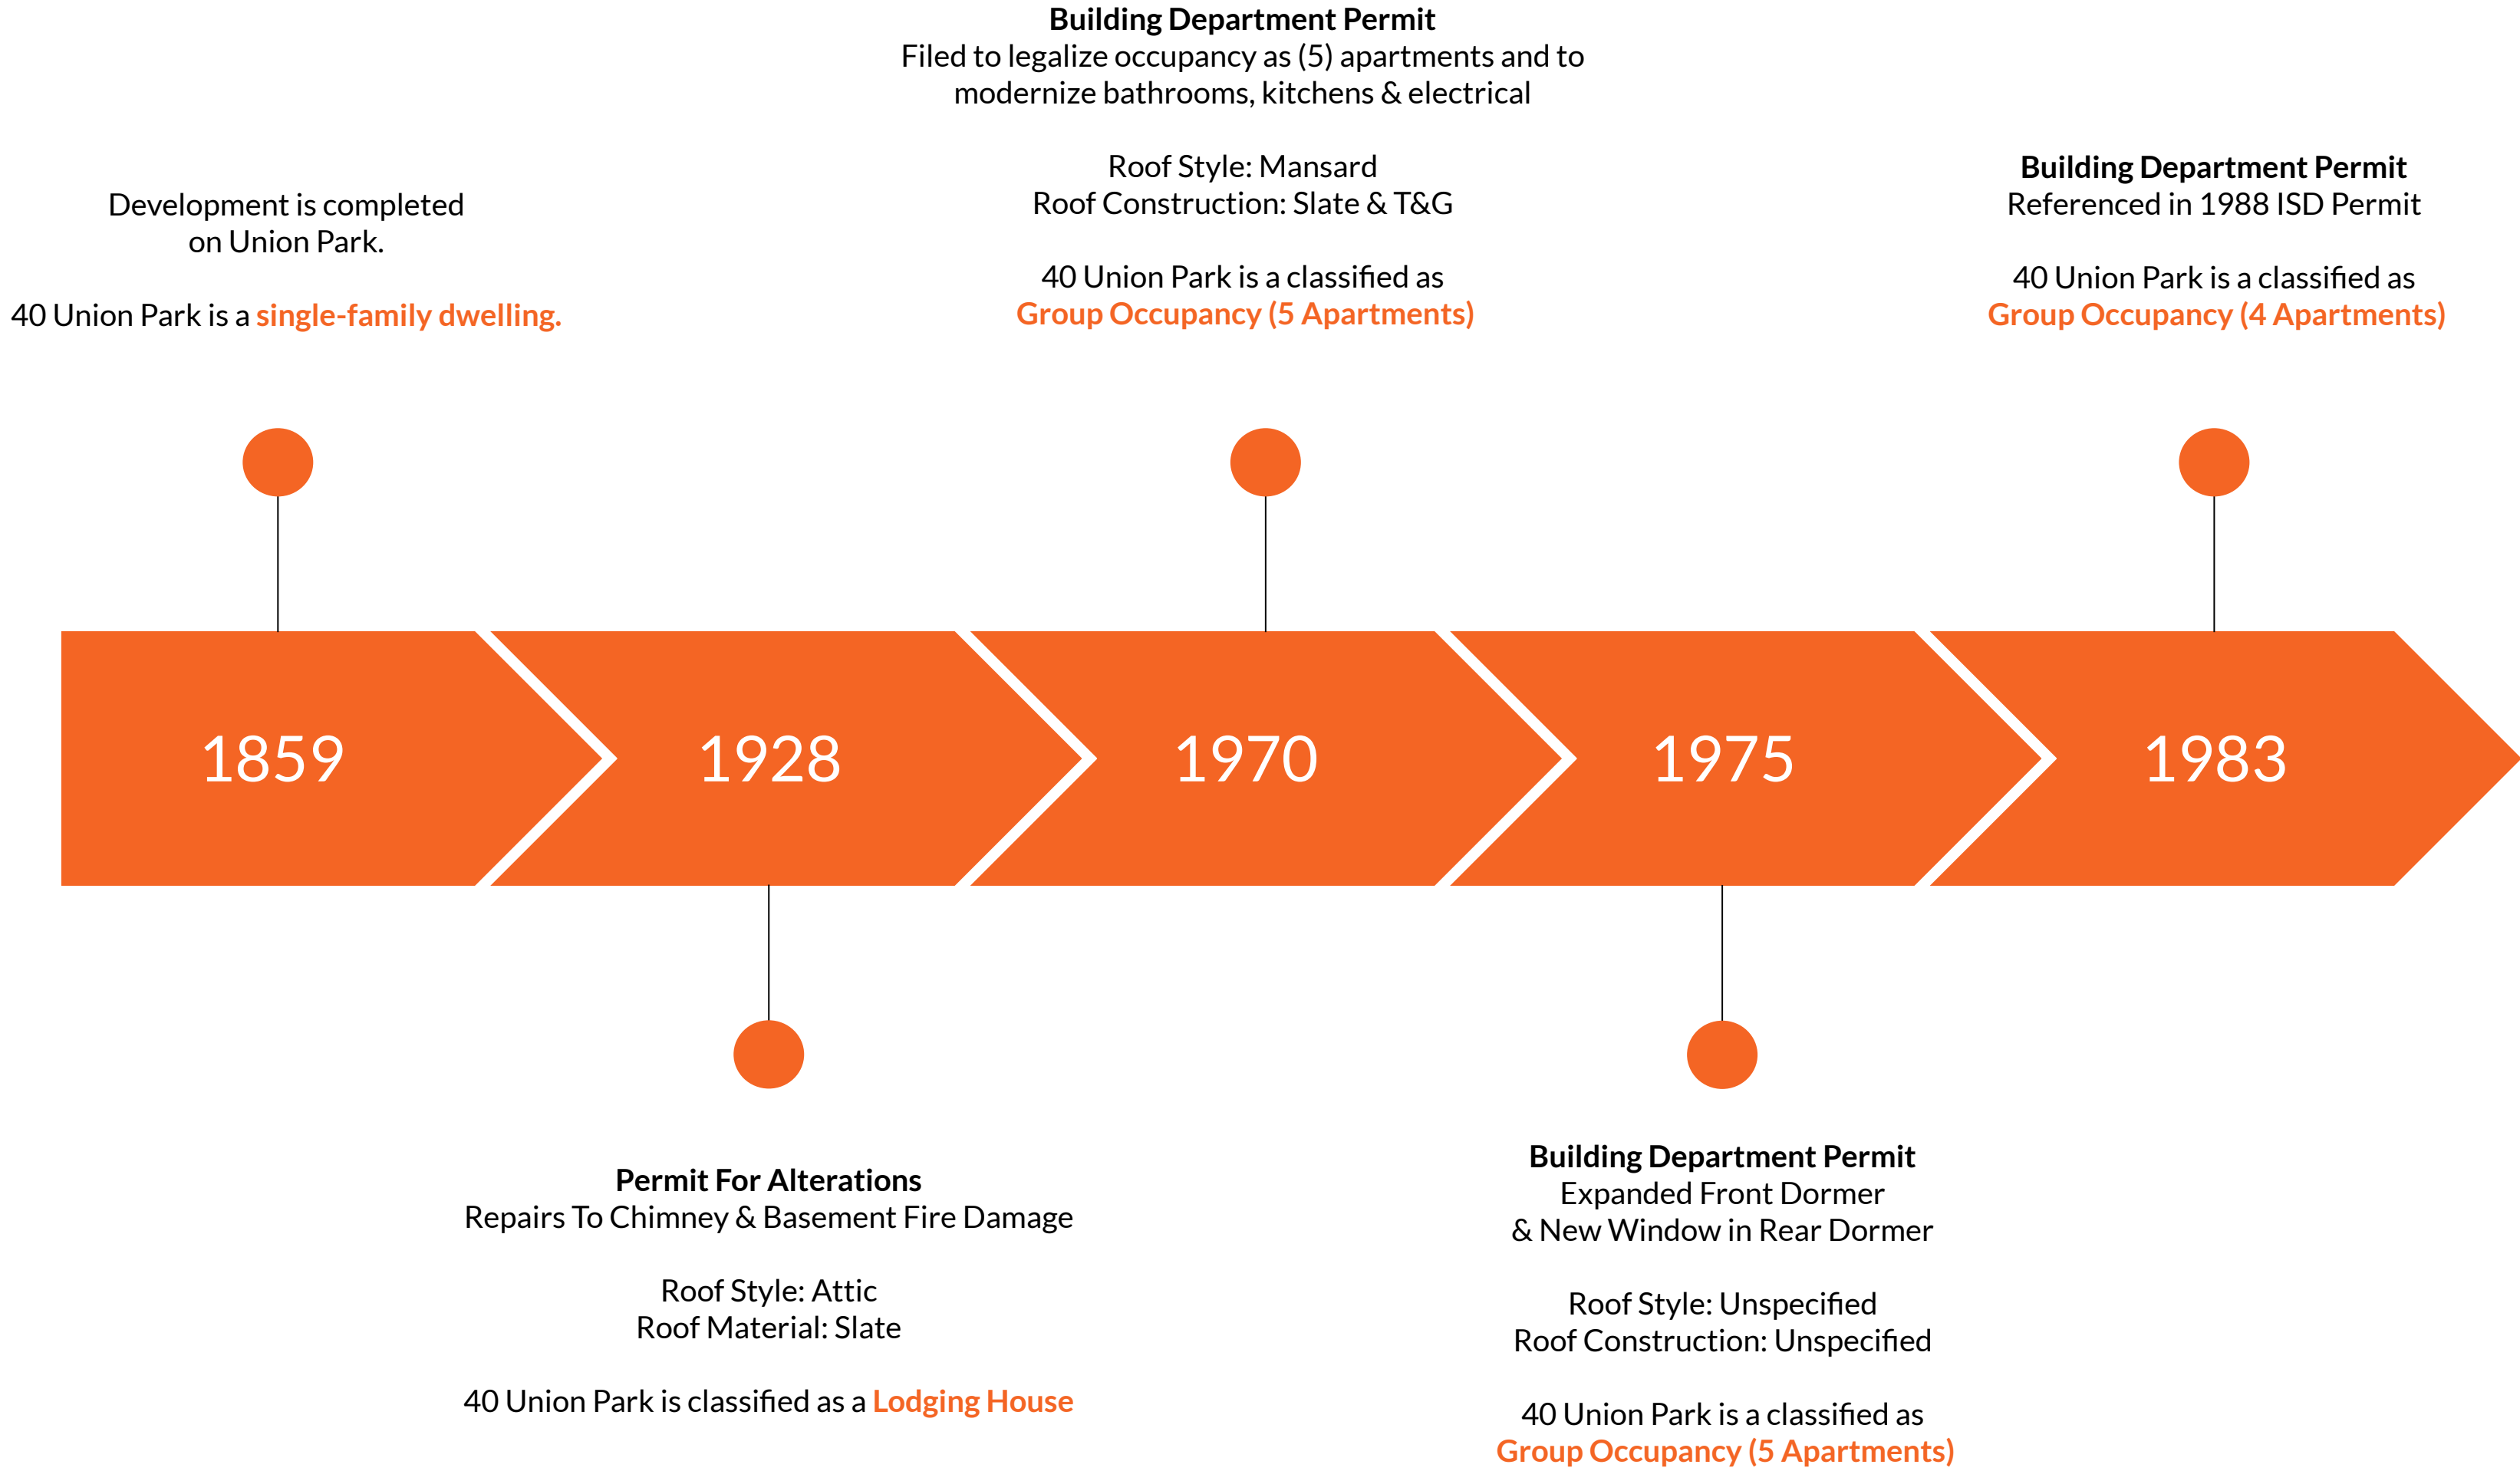
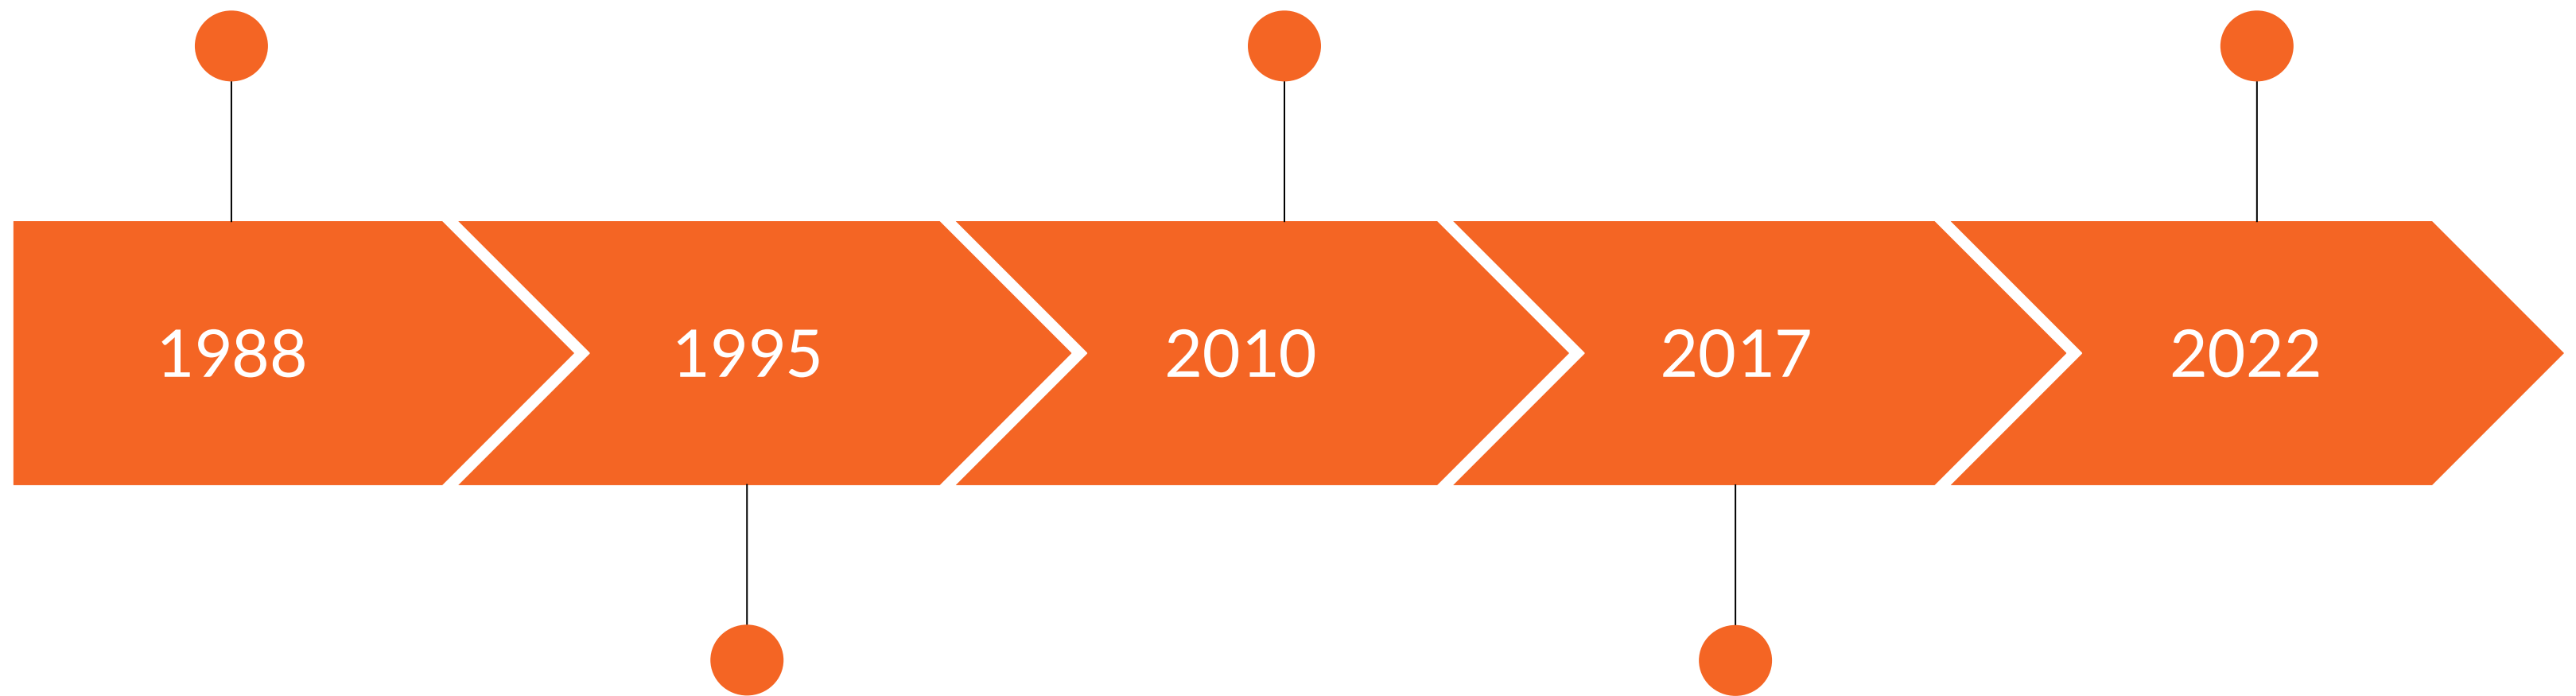
Inspectional Services Department Permit
Interior Renovations &
Exterior Renovations to Front Door & Windows

Roof Style: Unspecified
Roof Construction: Unspecified

40 Union Park is classified as
Group Occupancy (4 Apartments)

Inspectional Services Department Permit
Interior Renovations At
Fourth, Fifth & Sixth Floors

40 Union Park is changed from Group Occupancy (4
Apartments) to **Single-Family Residence.**

SELDC Application
Full Building Restoration with a
Proposal For Expanded Rear Dormer & Roof Deck

Roof Style: Gable
Roof Construction: Slate

40 Union Park is a **Single-Family Residence.**

Inspectional Services Department Permit
Interior Renovations

Roof Style: Mansard
Roof Construction: Slate

Inspectional Services Department Permit
Exterior Renovation To Construct
New Rear Deck & Patio

40 Union Park is classified as
Single-Family Residence.

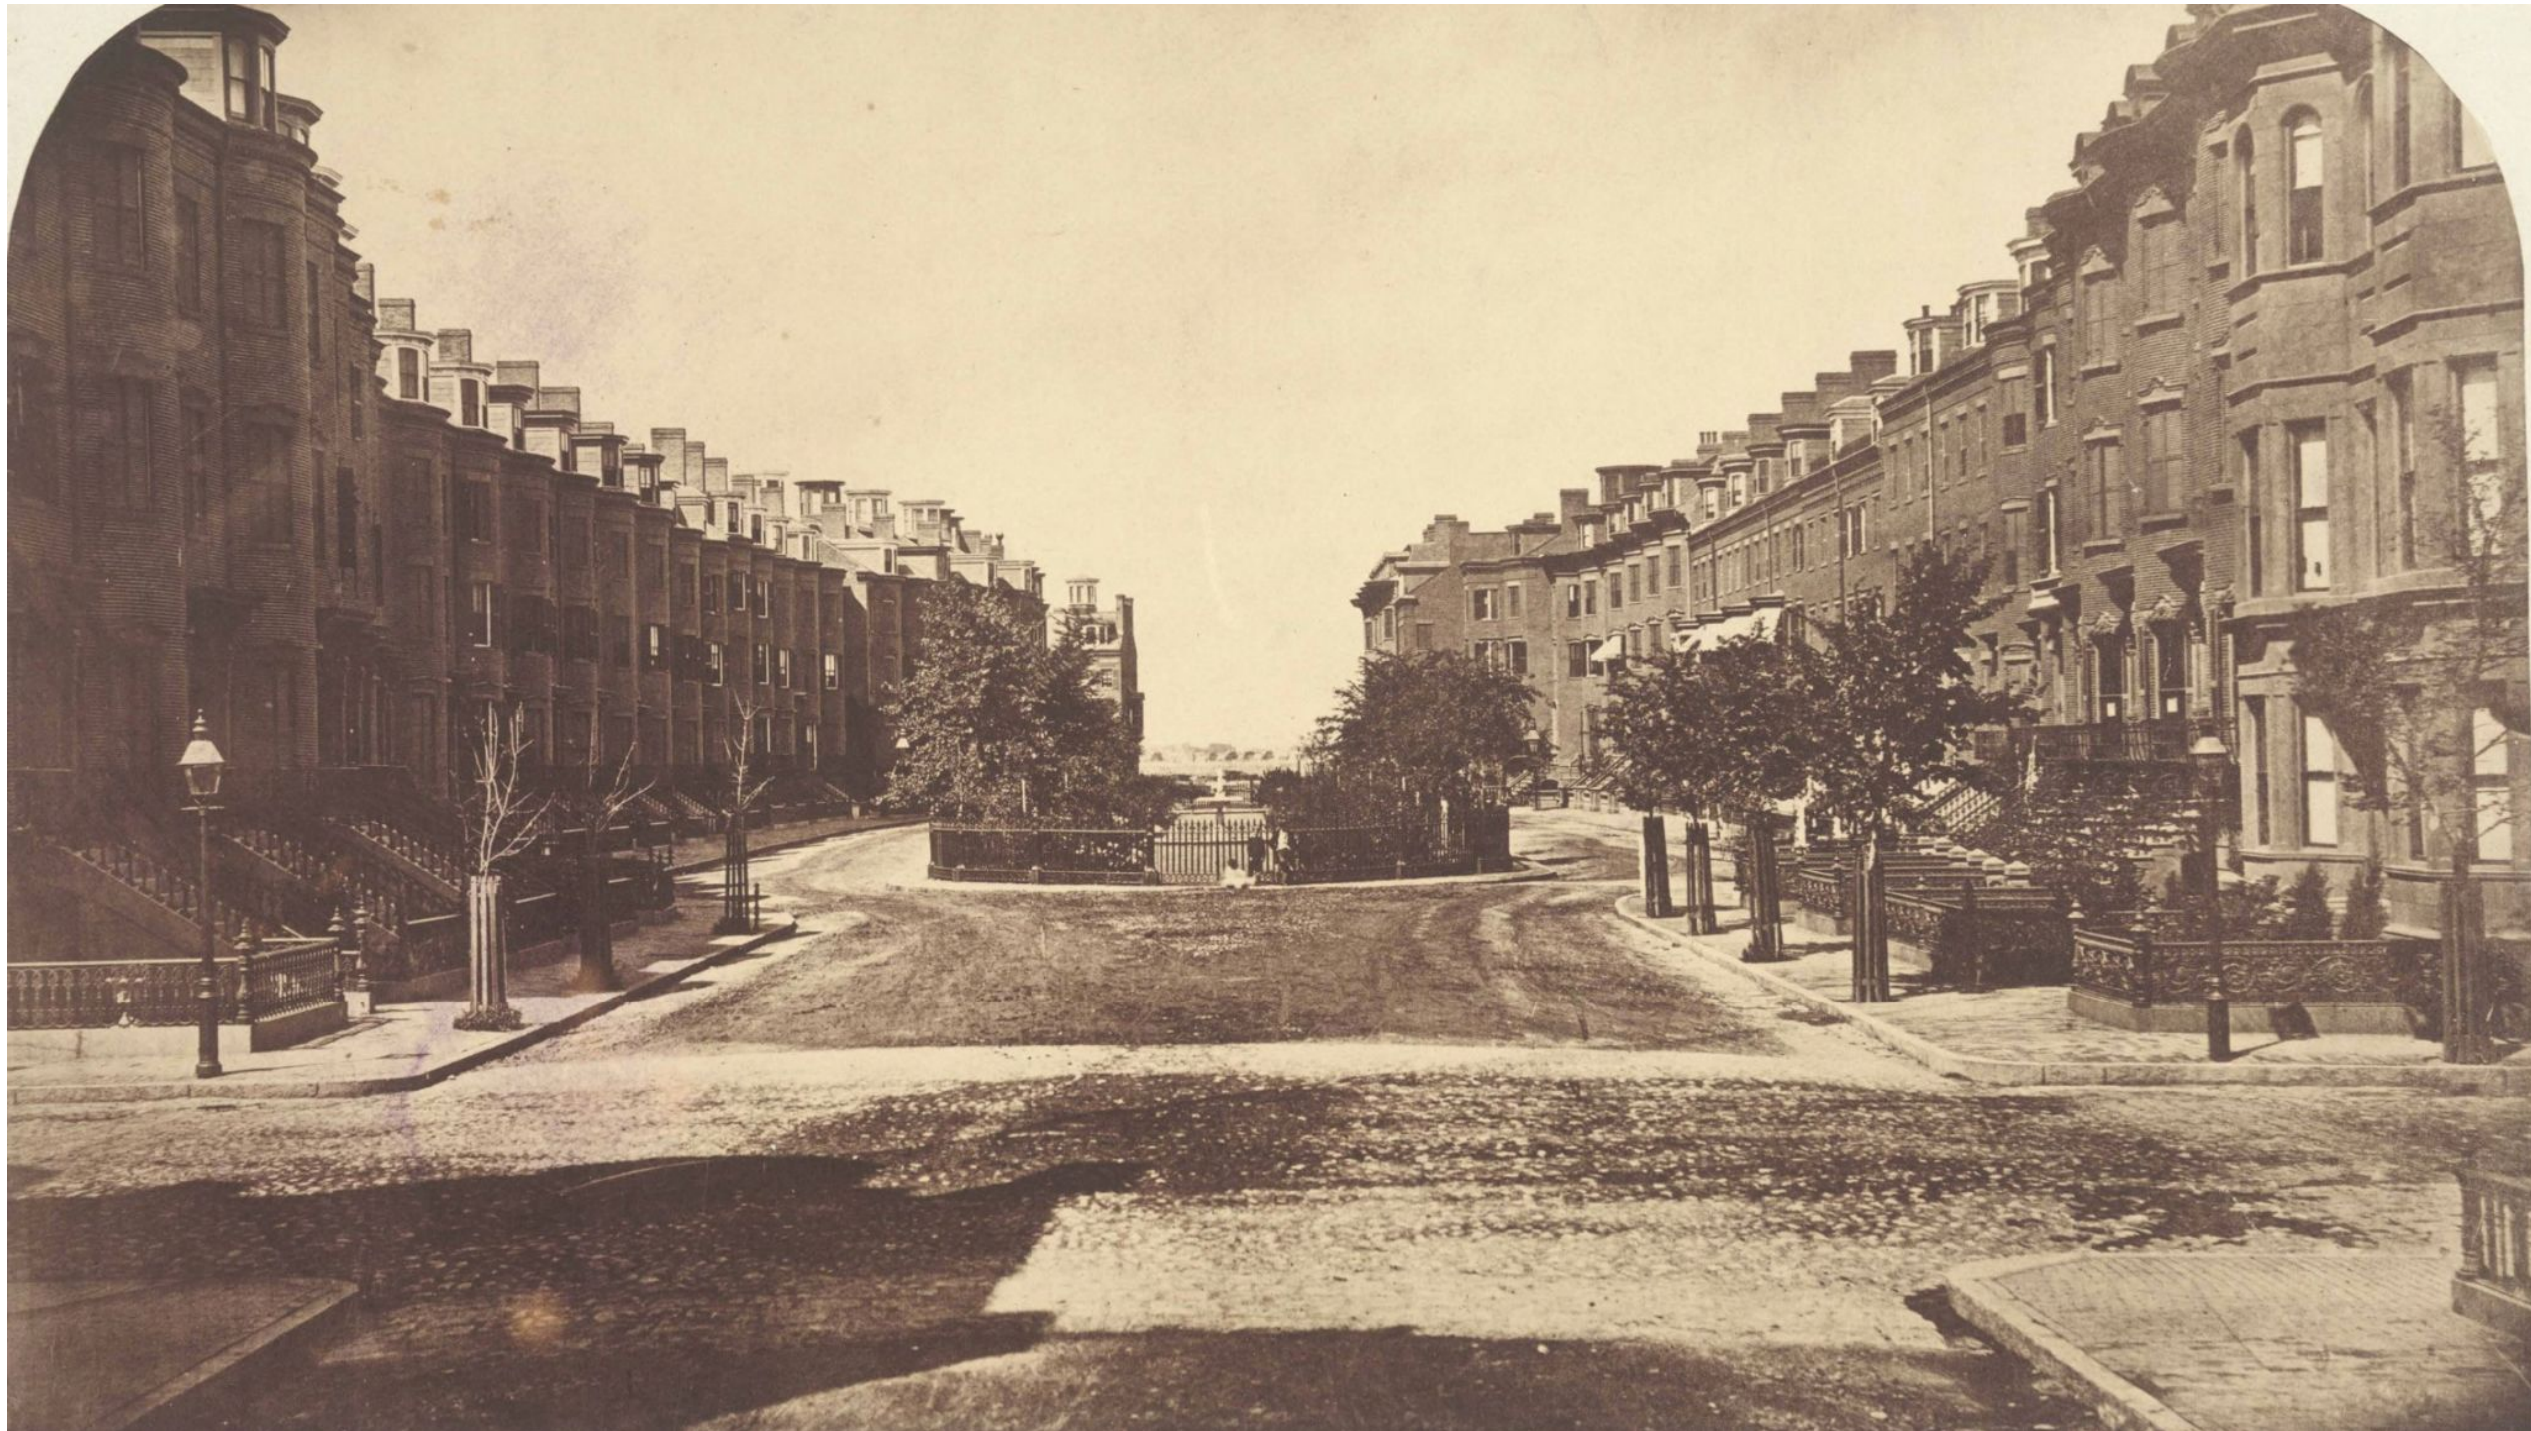
UNION PARK CONTEXTUAL VIEW (ca. 1860)
View looking north towards Tremont Street from Shawmut Avenue

THIS PHOTO IS DATED AROUND THE TIME OF COMPLETION
OF THE DEVELOPMENT OF UNION PARK.
NOTE THE PROMINENT FRONT DORMERS ON MOST OF THE BROWNSTONES, WHICH WERE CENTERED OVER THE BOW FRONT FACADES.
THESE LARGE THREE-FACETED DORMERS ARE COMMONLY KNOWN AS “BALLOON BAY DORMERS”,
AND EACH FACET (SIDE) FEATURES A CURVED-TOP WINDOW SASH.

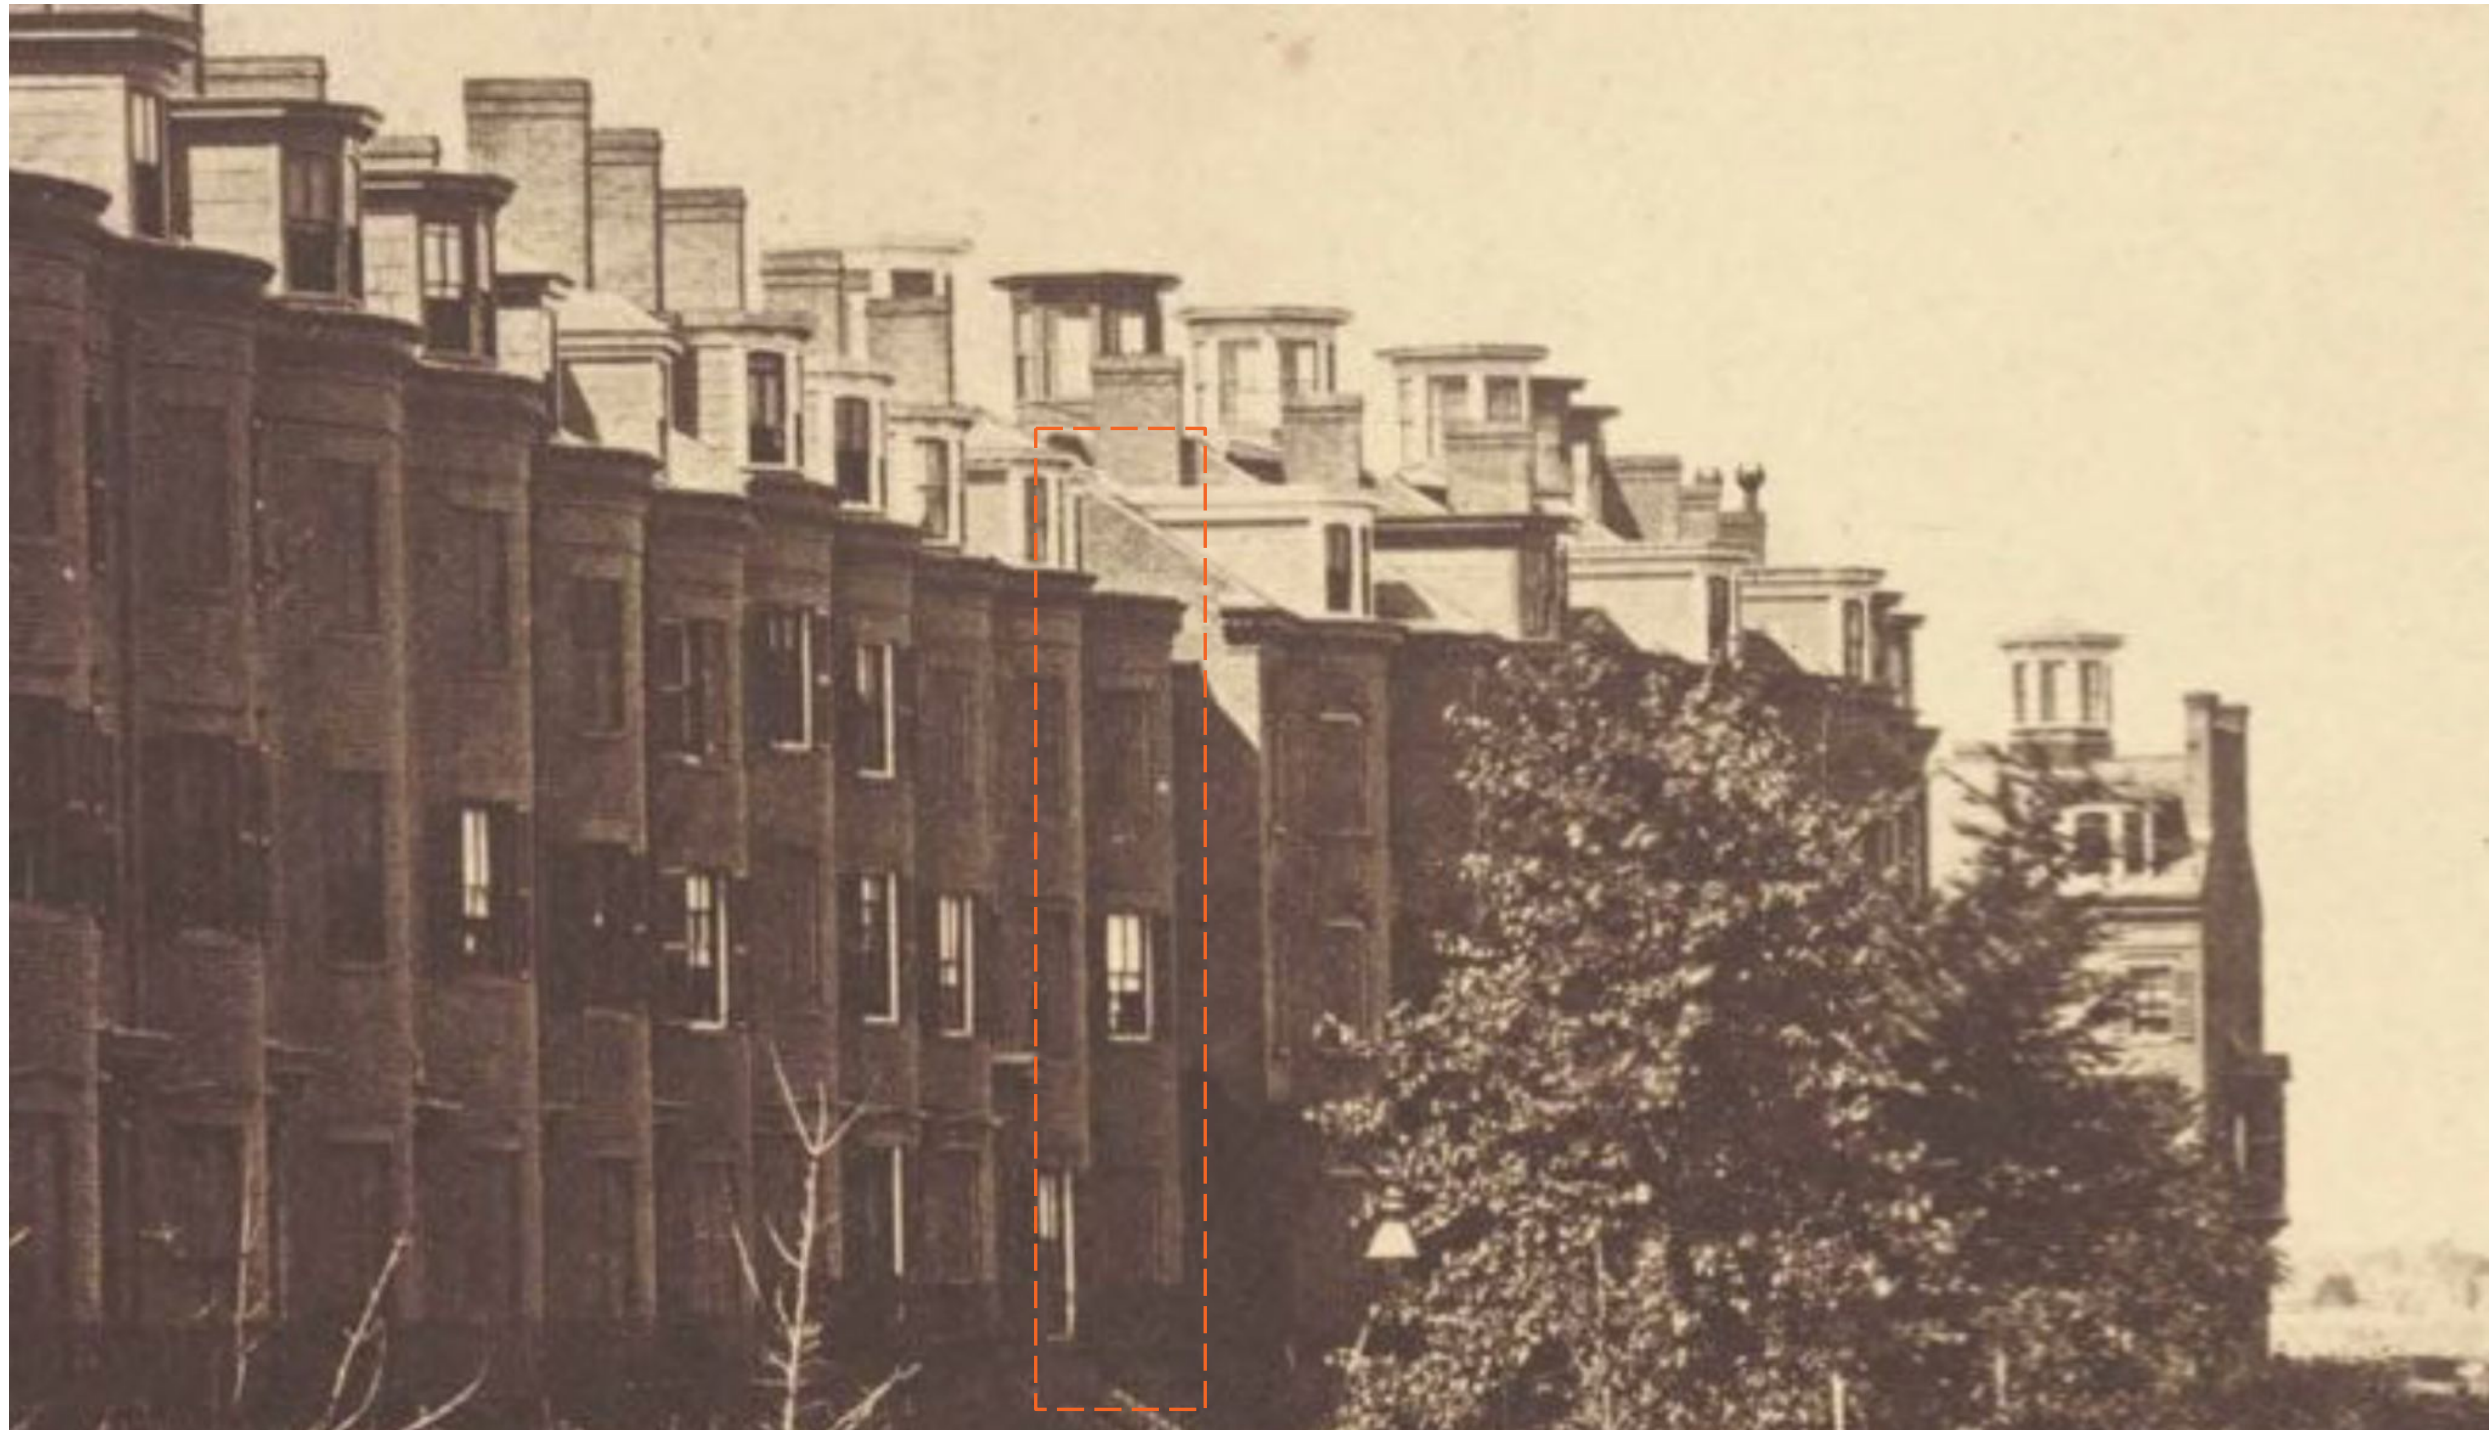
UNION PARK CONTEXTUAL VIEW (ca. 1860)

THE DASHED LINE HIGHLIGHTS THE LOCATION OF 40 UNION PARK IN THIS PHOTOGRAPH.

40 UNION PARK DID NOT FEATURE A BALLOON BAY DORMER ABOVE THE BOW FRONT.
RATHER, IT HAD TWO SINGLE DORMERS SET FURTHER BACK ON THE GABLE ROOF.
