RESIDENCE AT 40 UNION PARK

40 UNION PARK
BOSTON, MASSACHUSETTS 02118

Submission For Review by South End Landmark District Commission: May 16, 2022
Public Hearing: June 7, 2022

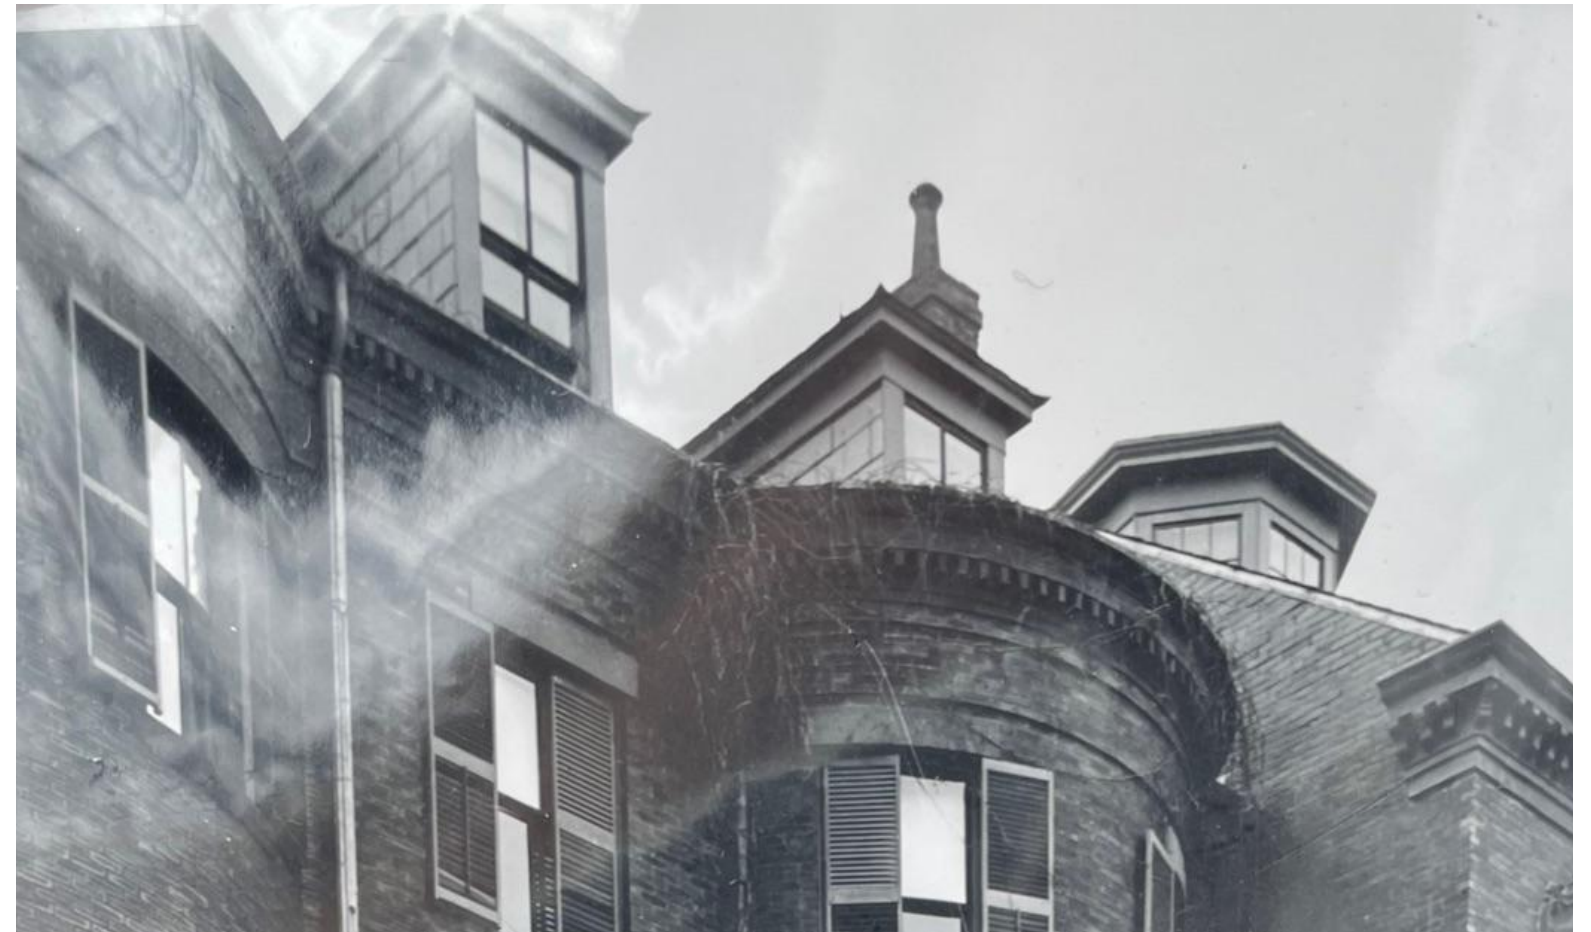
VIEW OF FRONT ELEVATION

- PLAIN RECTILINEAR FOOTPRINT WITH SHED ROOF
- SQUARE WINDOW SASHES, PAINTED BLACK
- NO CURVED TOPS ON UPPER SASHES
- DORMER CHEEKS FINISHED WITH RECTANGULAR SLATE (LIKELY CLASSIC GREY COLOR)

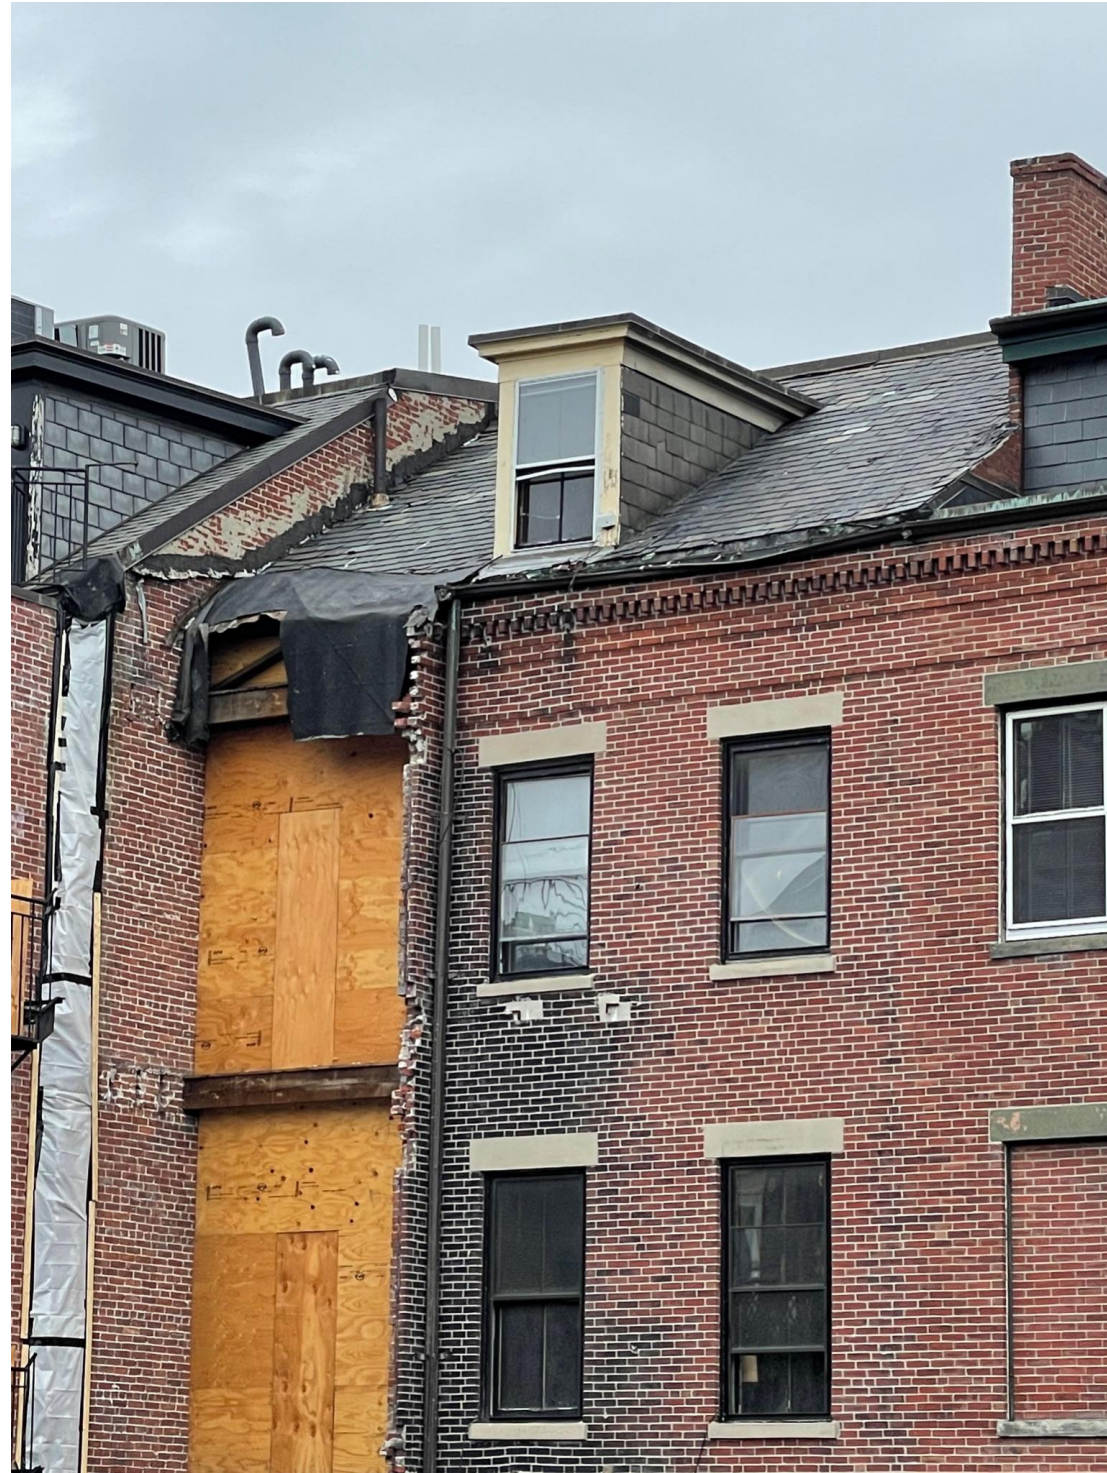
REAR DORMER AT 10 UNION PARK
(ORIGINAL DORMER)

- COMMON FEATURES:**
- PLAIN RECTILINEAR FOOTPRINT WITH SHED ROOF
 - SQUARE WINDOW SASHES
 - NO CURVED TOPS ON UPPER SASHES
 - DORMER CHEEKS FINISHED WITH RECTANGULAR SLATE (LIKELY CLASSIC GREY COLOR)

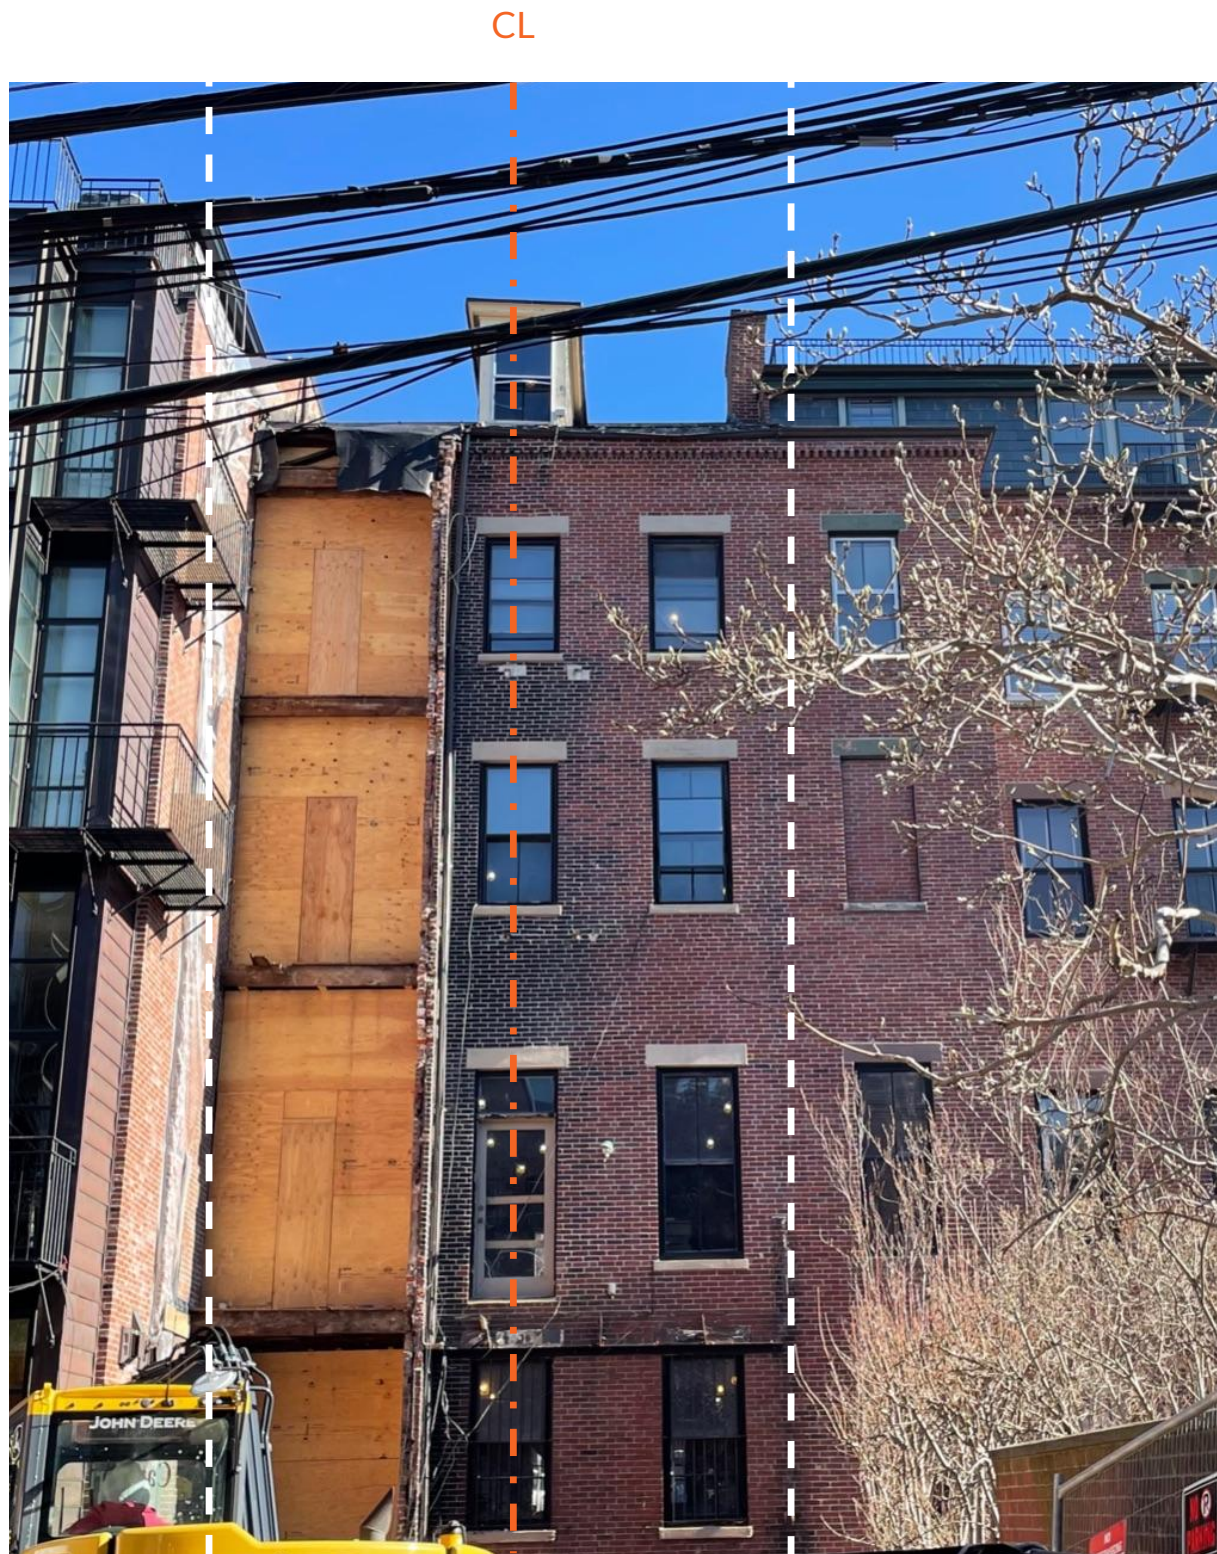
10 UNION PARK

OFF-CENTER
PLACEMENT
MISALIGNED W/
REAR WINDOWS

LARGER FOOTPRINT
& HIPPED ROOFLINE,
COMPARED TO
ORIGINAL FRONT
DORMERS W/
NARROW
FOOTPRINT,
SINGLE WINDOWS &
SHED ROOFS

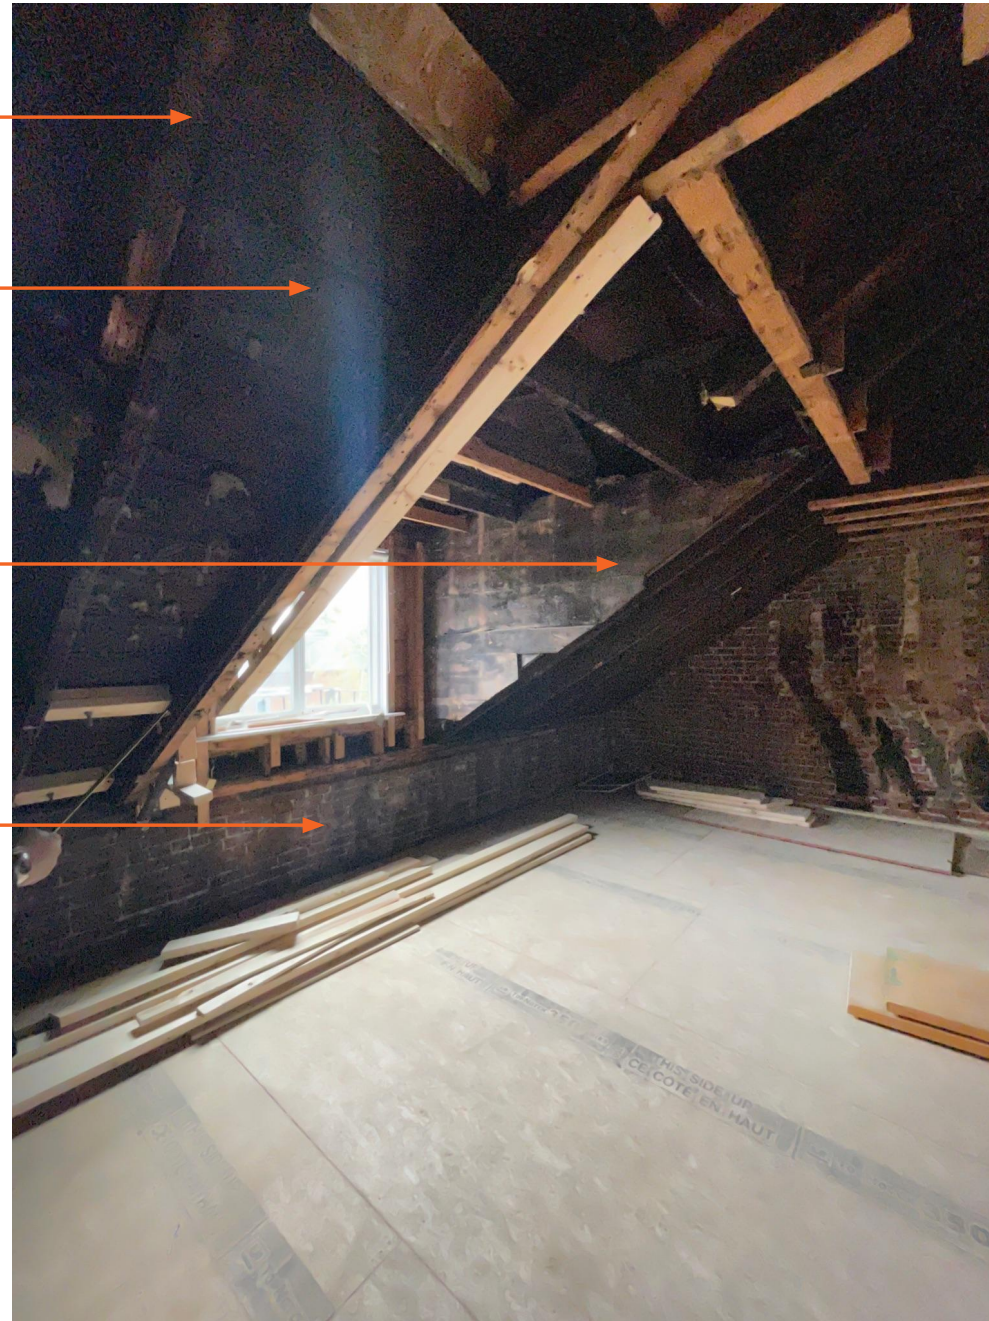
ROUGH SAWN ACTUAL DIM.
ROOF RAFTER

ROUGH SAWN ROOF SHEATHING

ROUGH SAWN WALL
SHEATHING

MASONRY
KNEE WALL

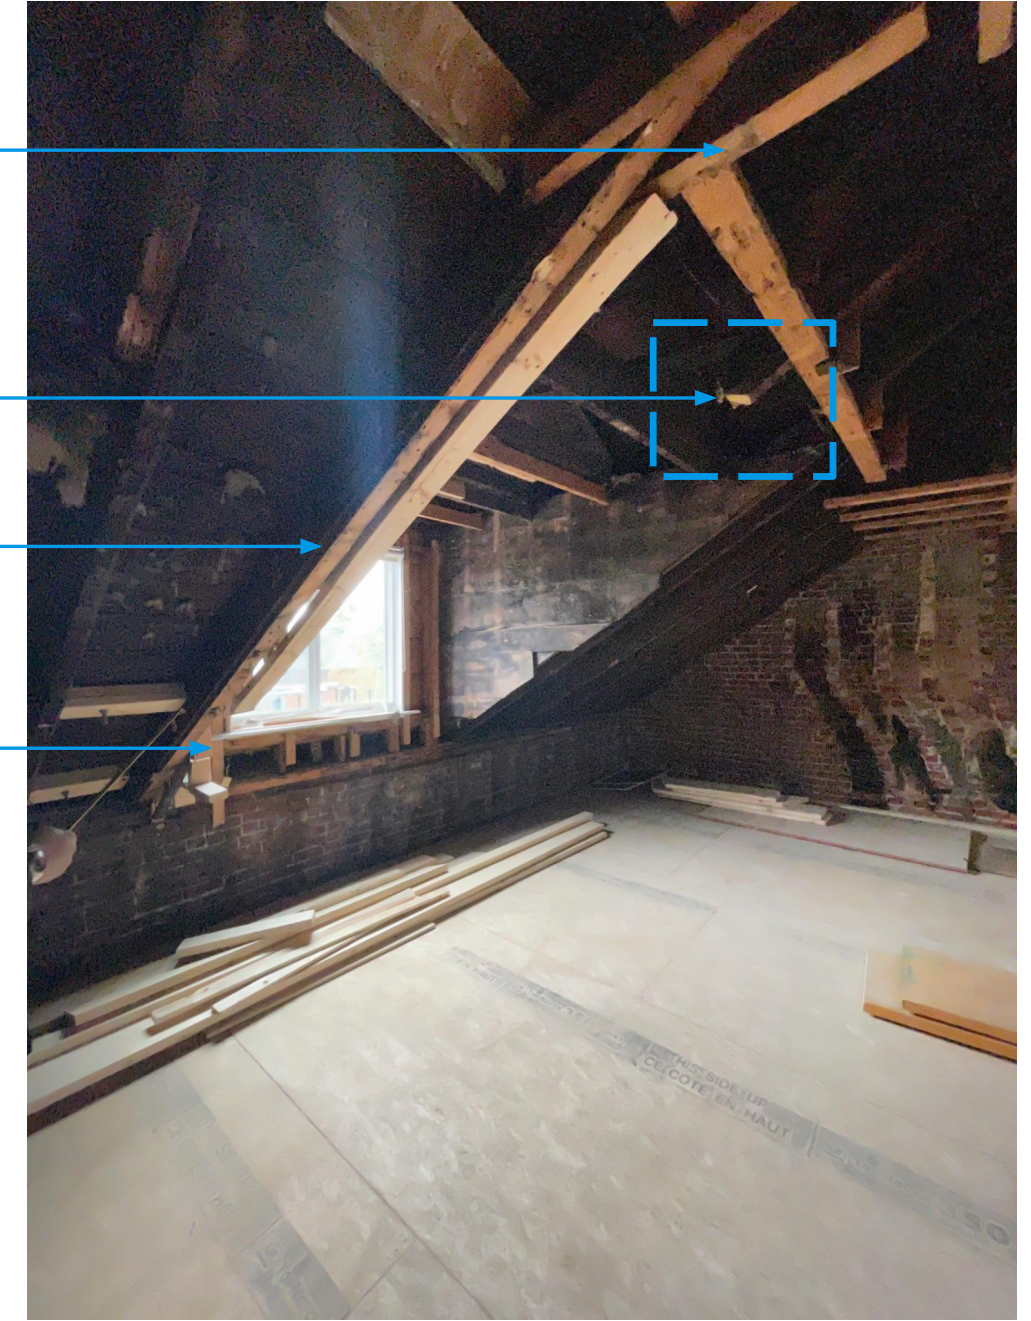
2X4 NOMINAL TIMBER
HEADER AT
DORMER OPENING

CHOPPED ROOF RAFTER

2X4 NOMINAL TIMBER
CHEEK WALL

2X4 NOMINAL TIMBER
FRAMING AT
ROUGH OPENING

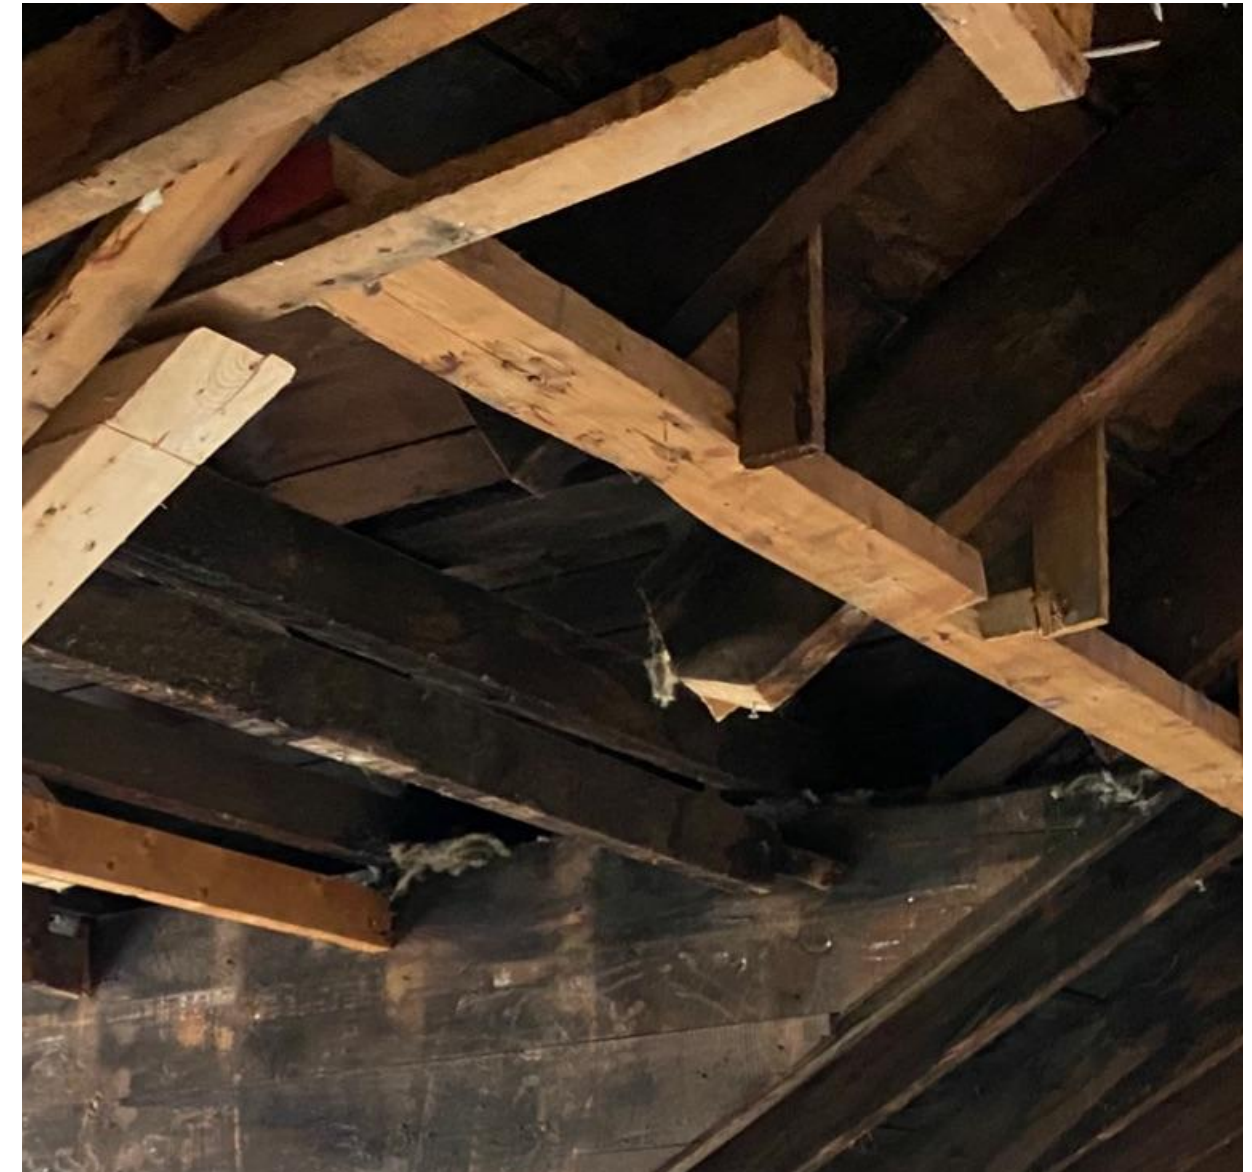
ROUGH SAWN ROOF RAFTER

DOUBLE RAFTER
SHOWS LIKELY
LOCATION WHERE
DORMER WAS CUT INTO
ROOF FRAMING

CONTINUOUS
MASONRY SILL PLATE

MASONRY KNEE WALL

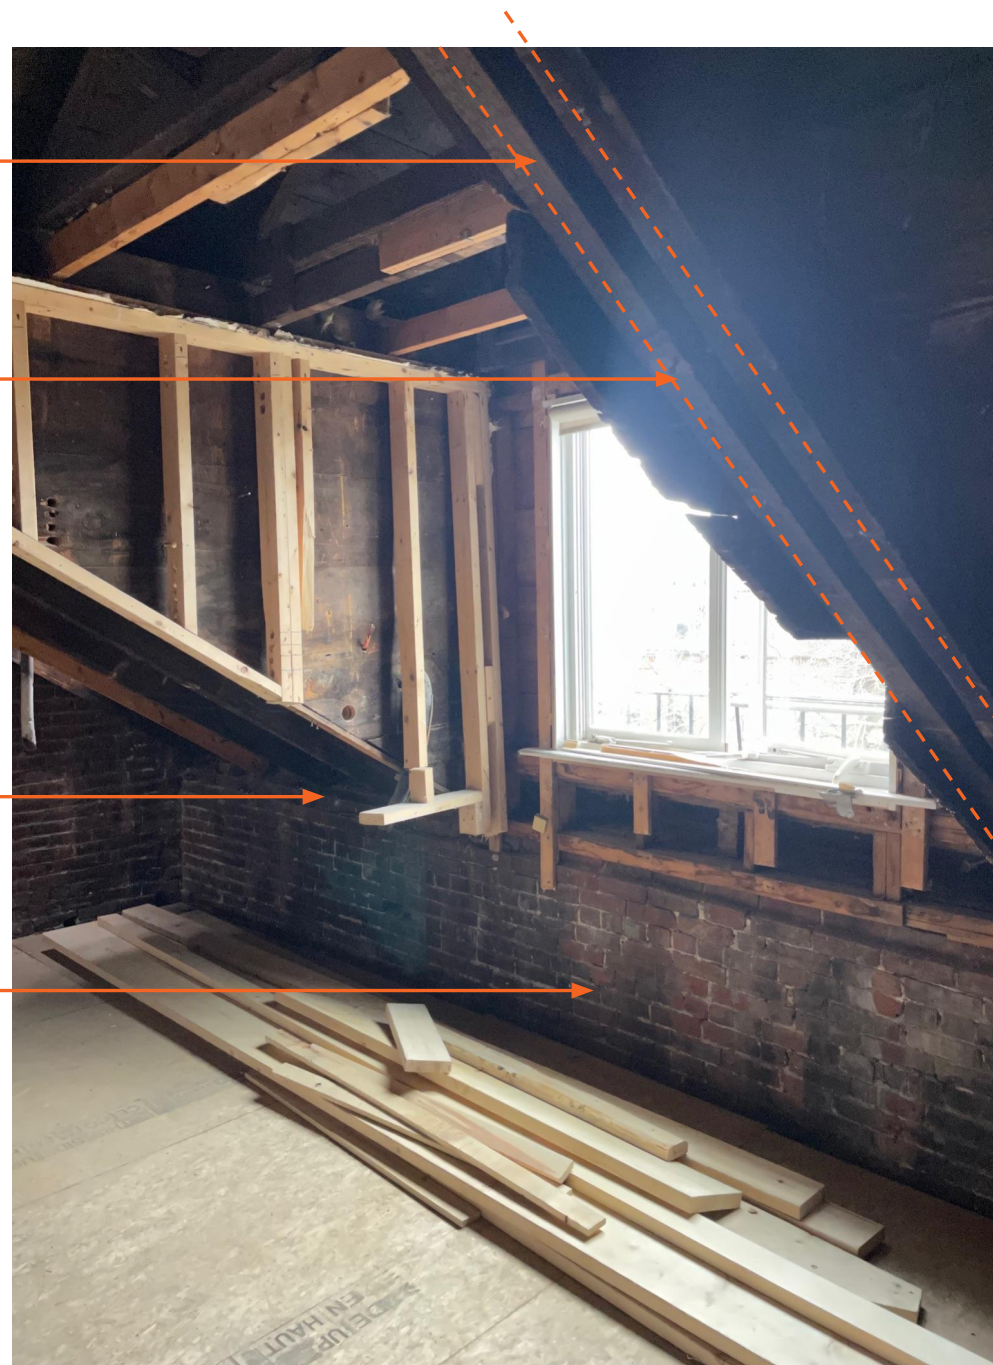
2X4 TIMBER
COLLAR TIES
& BRACING

2X4 TIMBER
CHEEK WALL

VINYL CASEMENT
WINDOW

2X4 TIMBER
FRAMING AT
ROUGH OPENING

2X4 TIMBER
DOUBLE SILL PLATE AT
DORMER OPENING

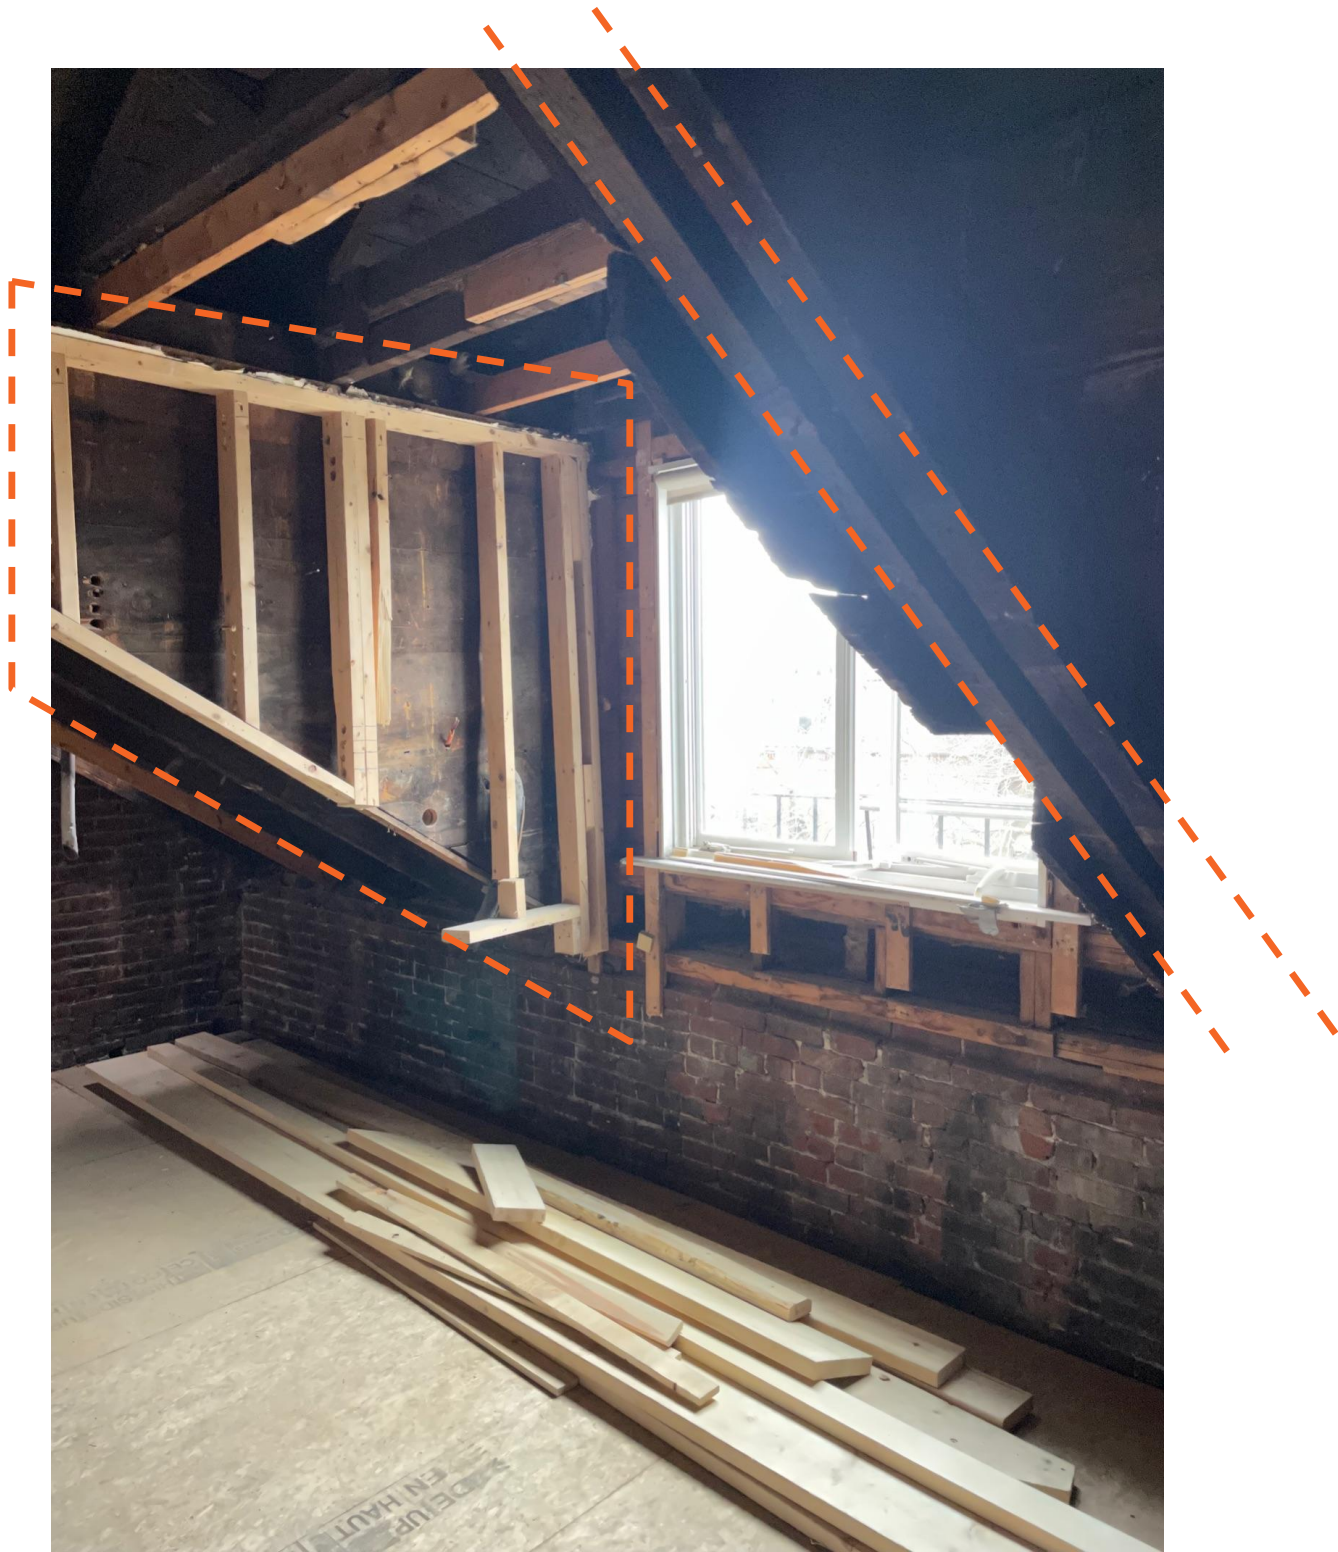
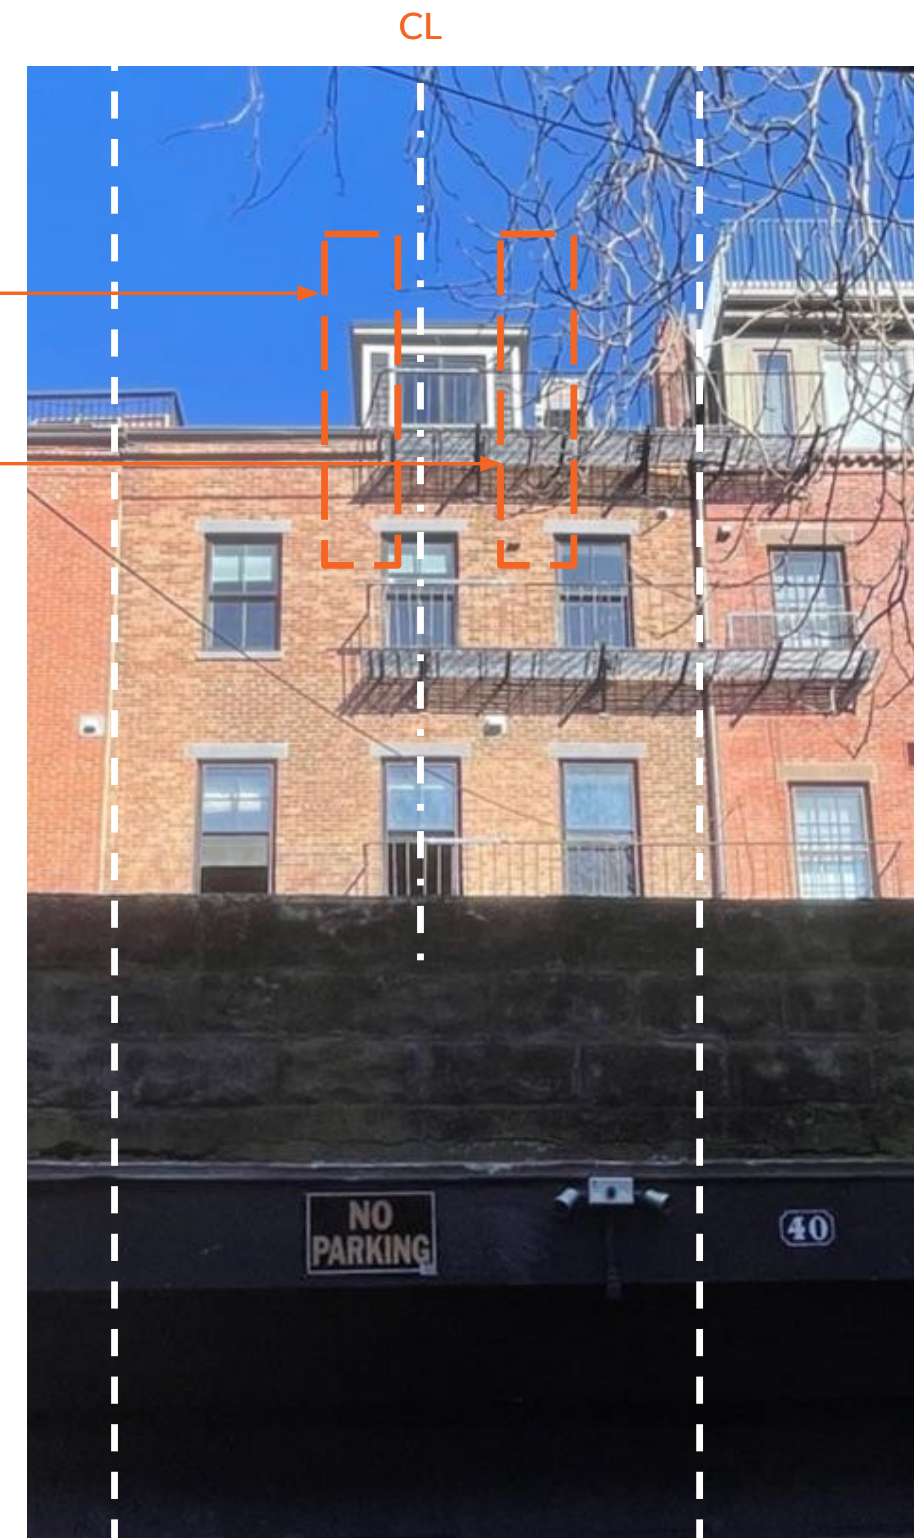
LIKELY LOCATION
SINGLE DORMER WALL

LOCATION OF WIDER
DORMER WALL,
RESULTING IN
OFF-CENTER
DORMER
FOOTPRINT

The date of the original dormer is unknown, but it has changed form & footprint over the years. Its original form likely echoed the forms of the narrow single dormers on the front of the building.

As occupancy changed, the upper floors (previously attic space) were converted to habitable space. We contend that the rear dormer footprint has been expanded from its original form - likely between 1928 and 1970 - to create more habitable space under the eaves on the top floor of the building. This is reflective of the change of occupancy from a lodging house with attic space to a 5-apartment building during this period.

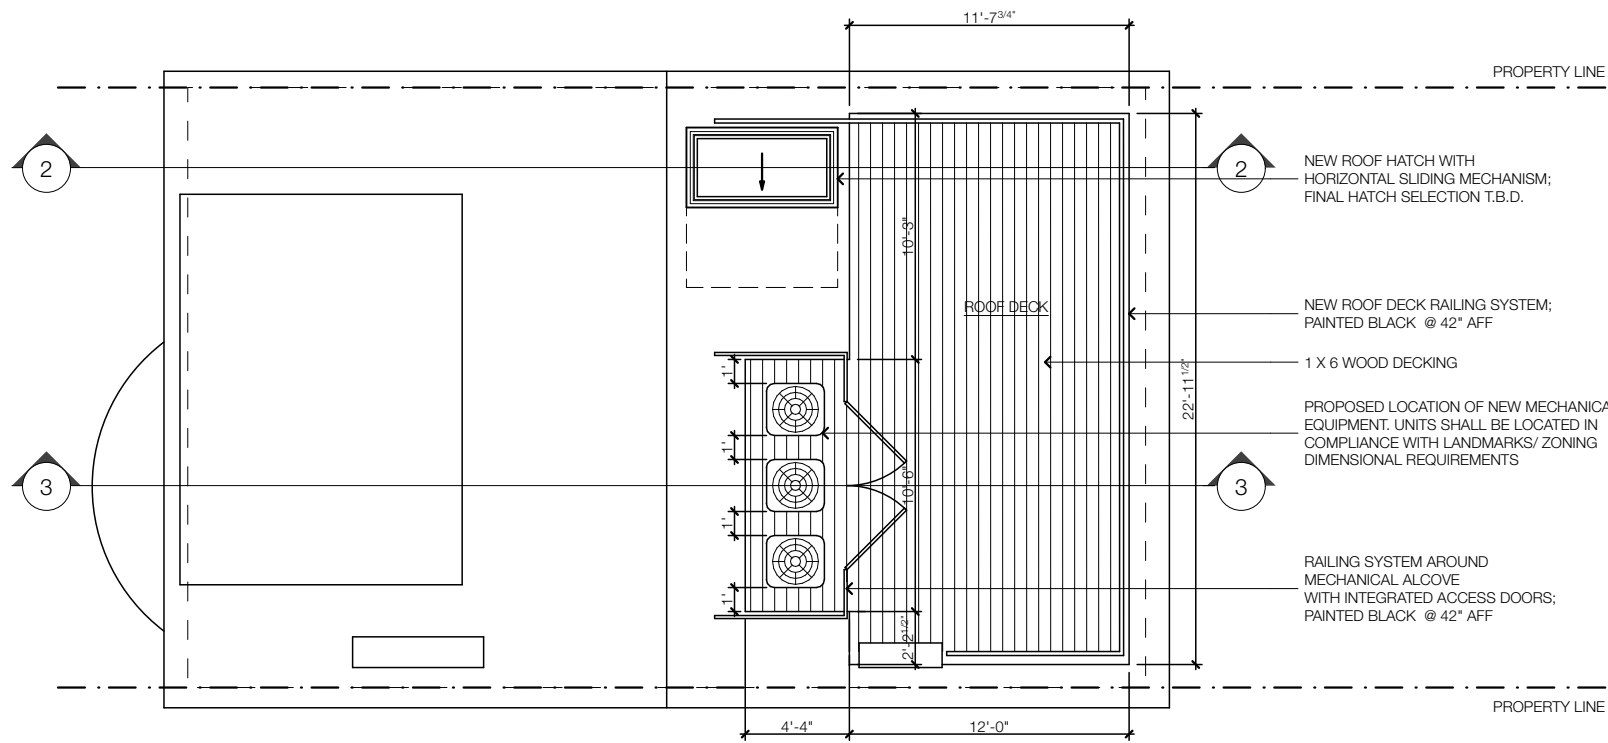
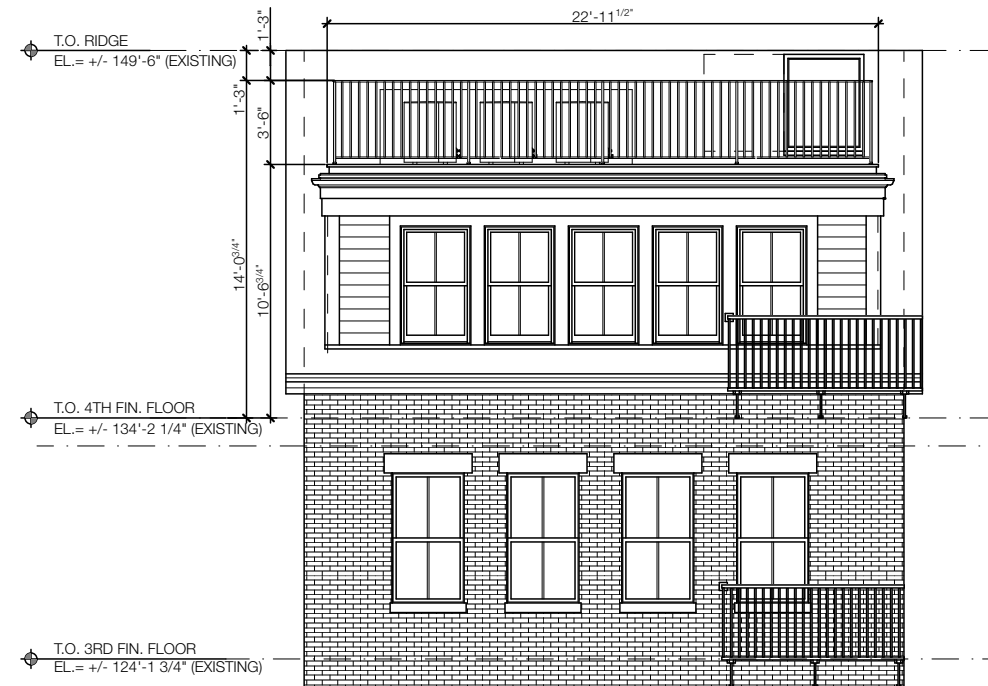
1 PROPOSED ROOF PLAN
1/8" = 1'-0"

4 PARTIAL REAR ELEVATION
1/8" = 1'-0"

Return dormer footprint to single-dormer footprint, centered on building and roof.

Add shed dormers on both sides of single dormer, set back from single dormer, to highlight historic dormer form.

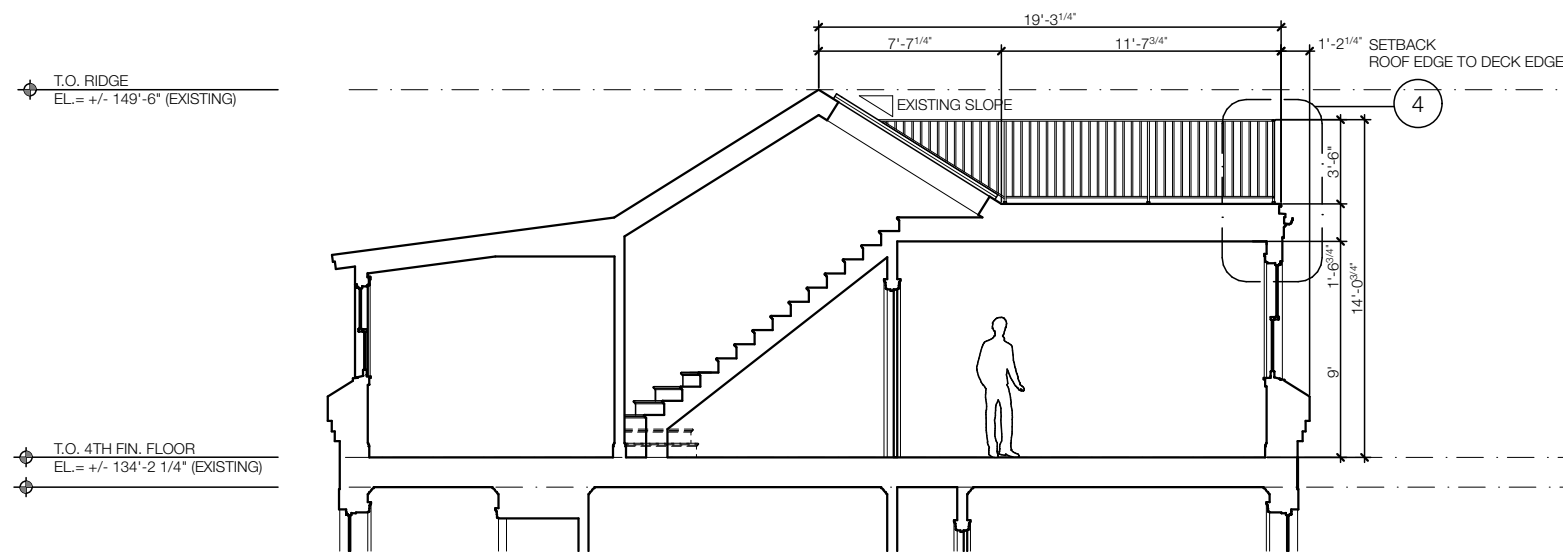
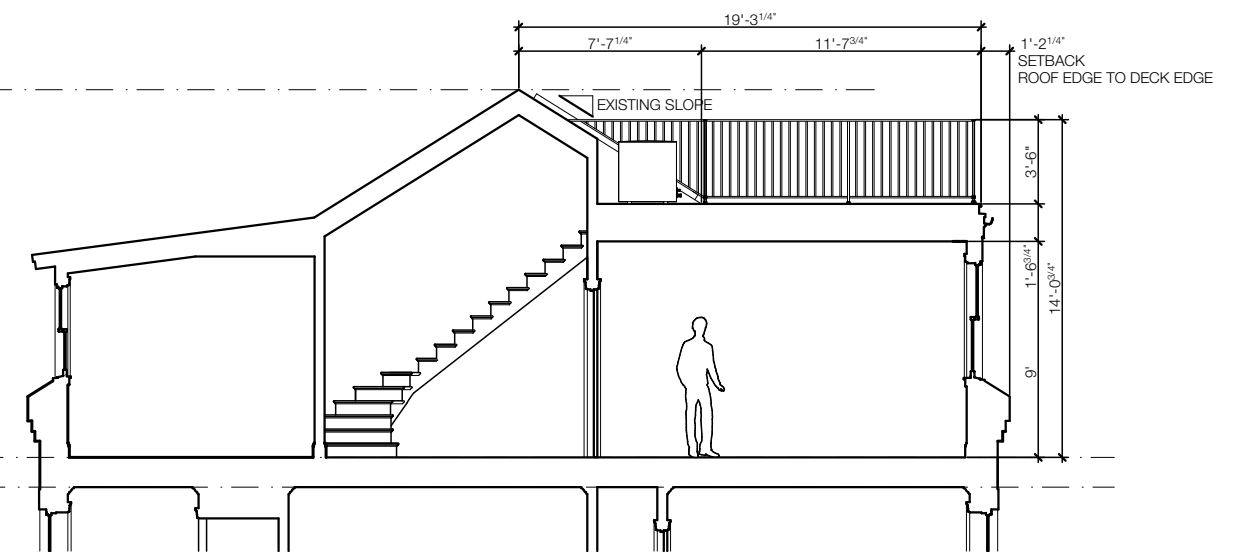
2 PARTIAL SECTION AT ROOF DECK HATCH
1/8" = 1'-0"

3 PARTIAL SECTION AT CONDENSER ALCOVE
1/8" = 1'-0"

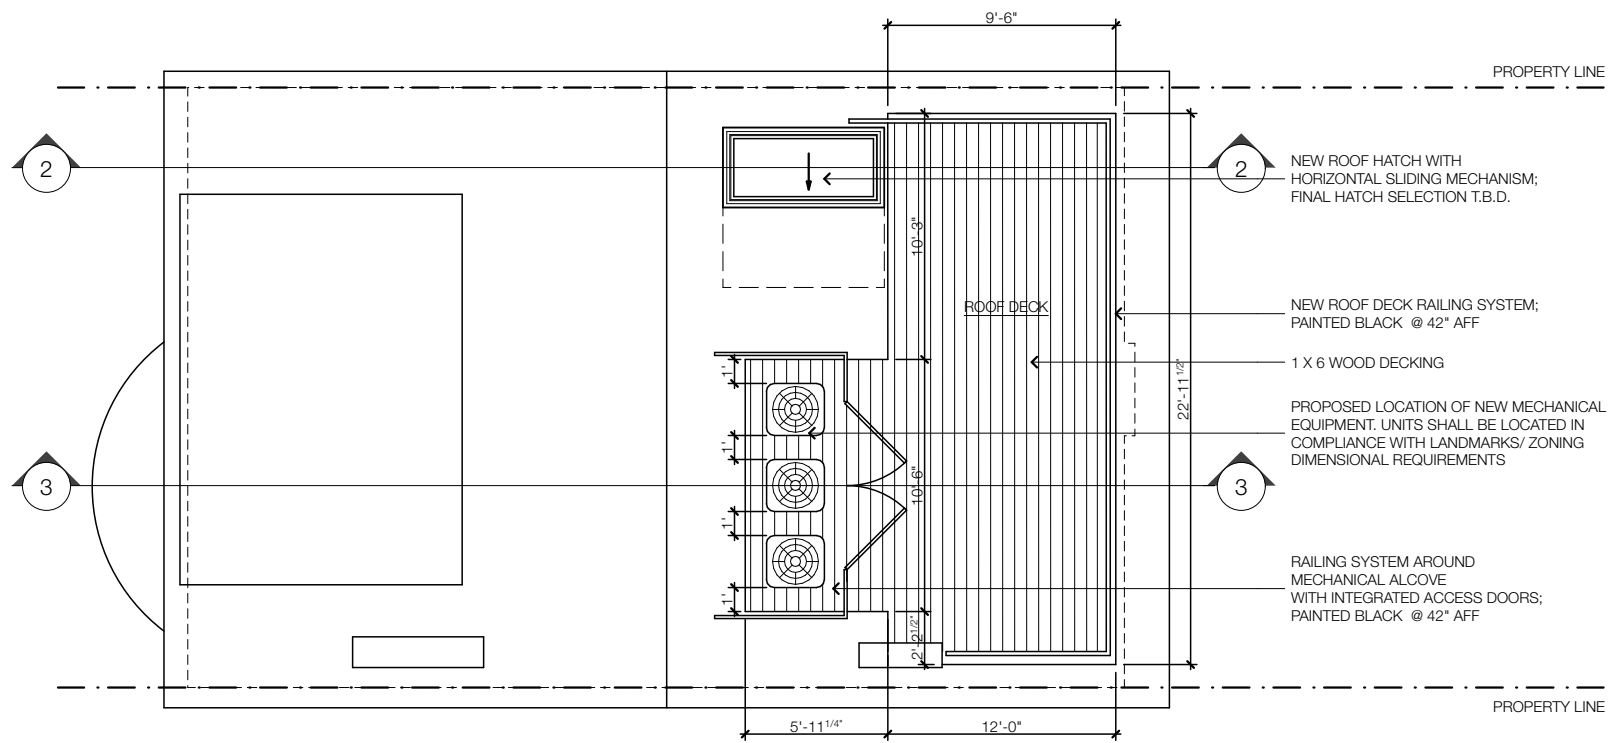
1 PROPOSED ROOF PLAN
1/8" = 1'-0"

4 PARTIAL REAR ELEVATION
1/8" = 1'-0"
