This letter is to certify the existing condition of the two-garden level front elevation windows at 38 Dwight Street, South End, Boston.

#38 DWIGHT STREET, UNIT #2
BOSTON, M.A. 02118

2 TOTAL: 3/2, DOUBLE HUNG BOWED SASHSETS / FLAT GLASS"

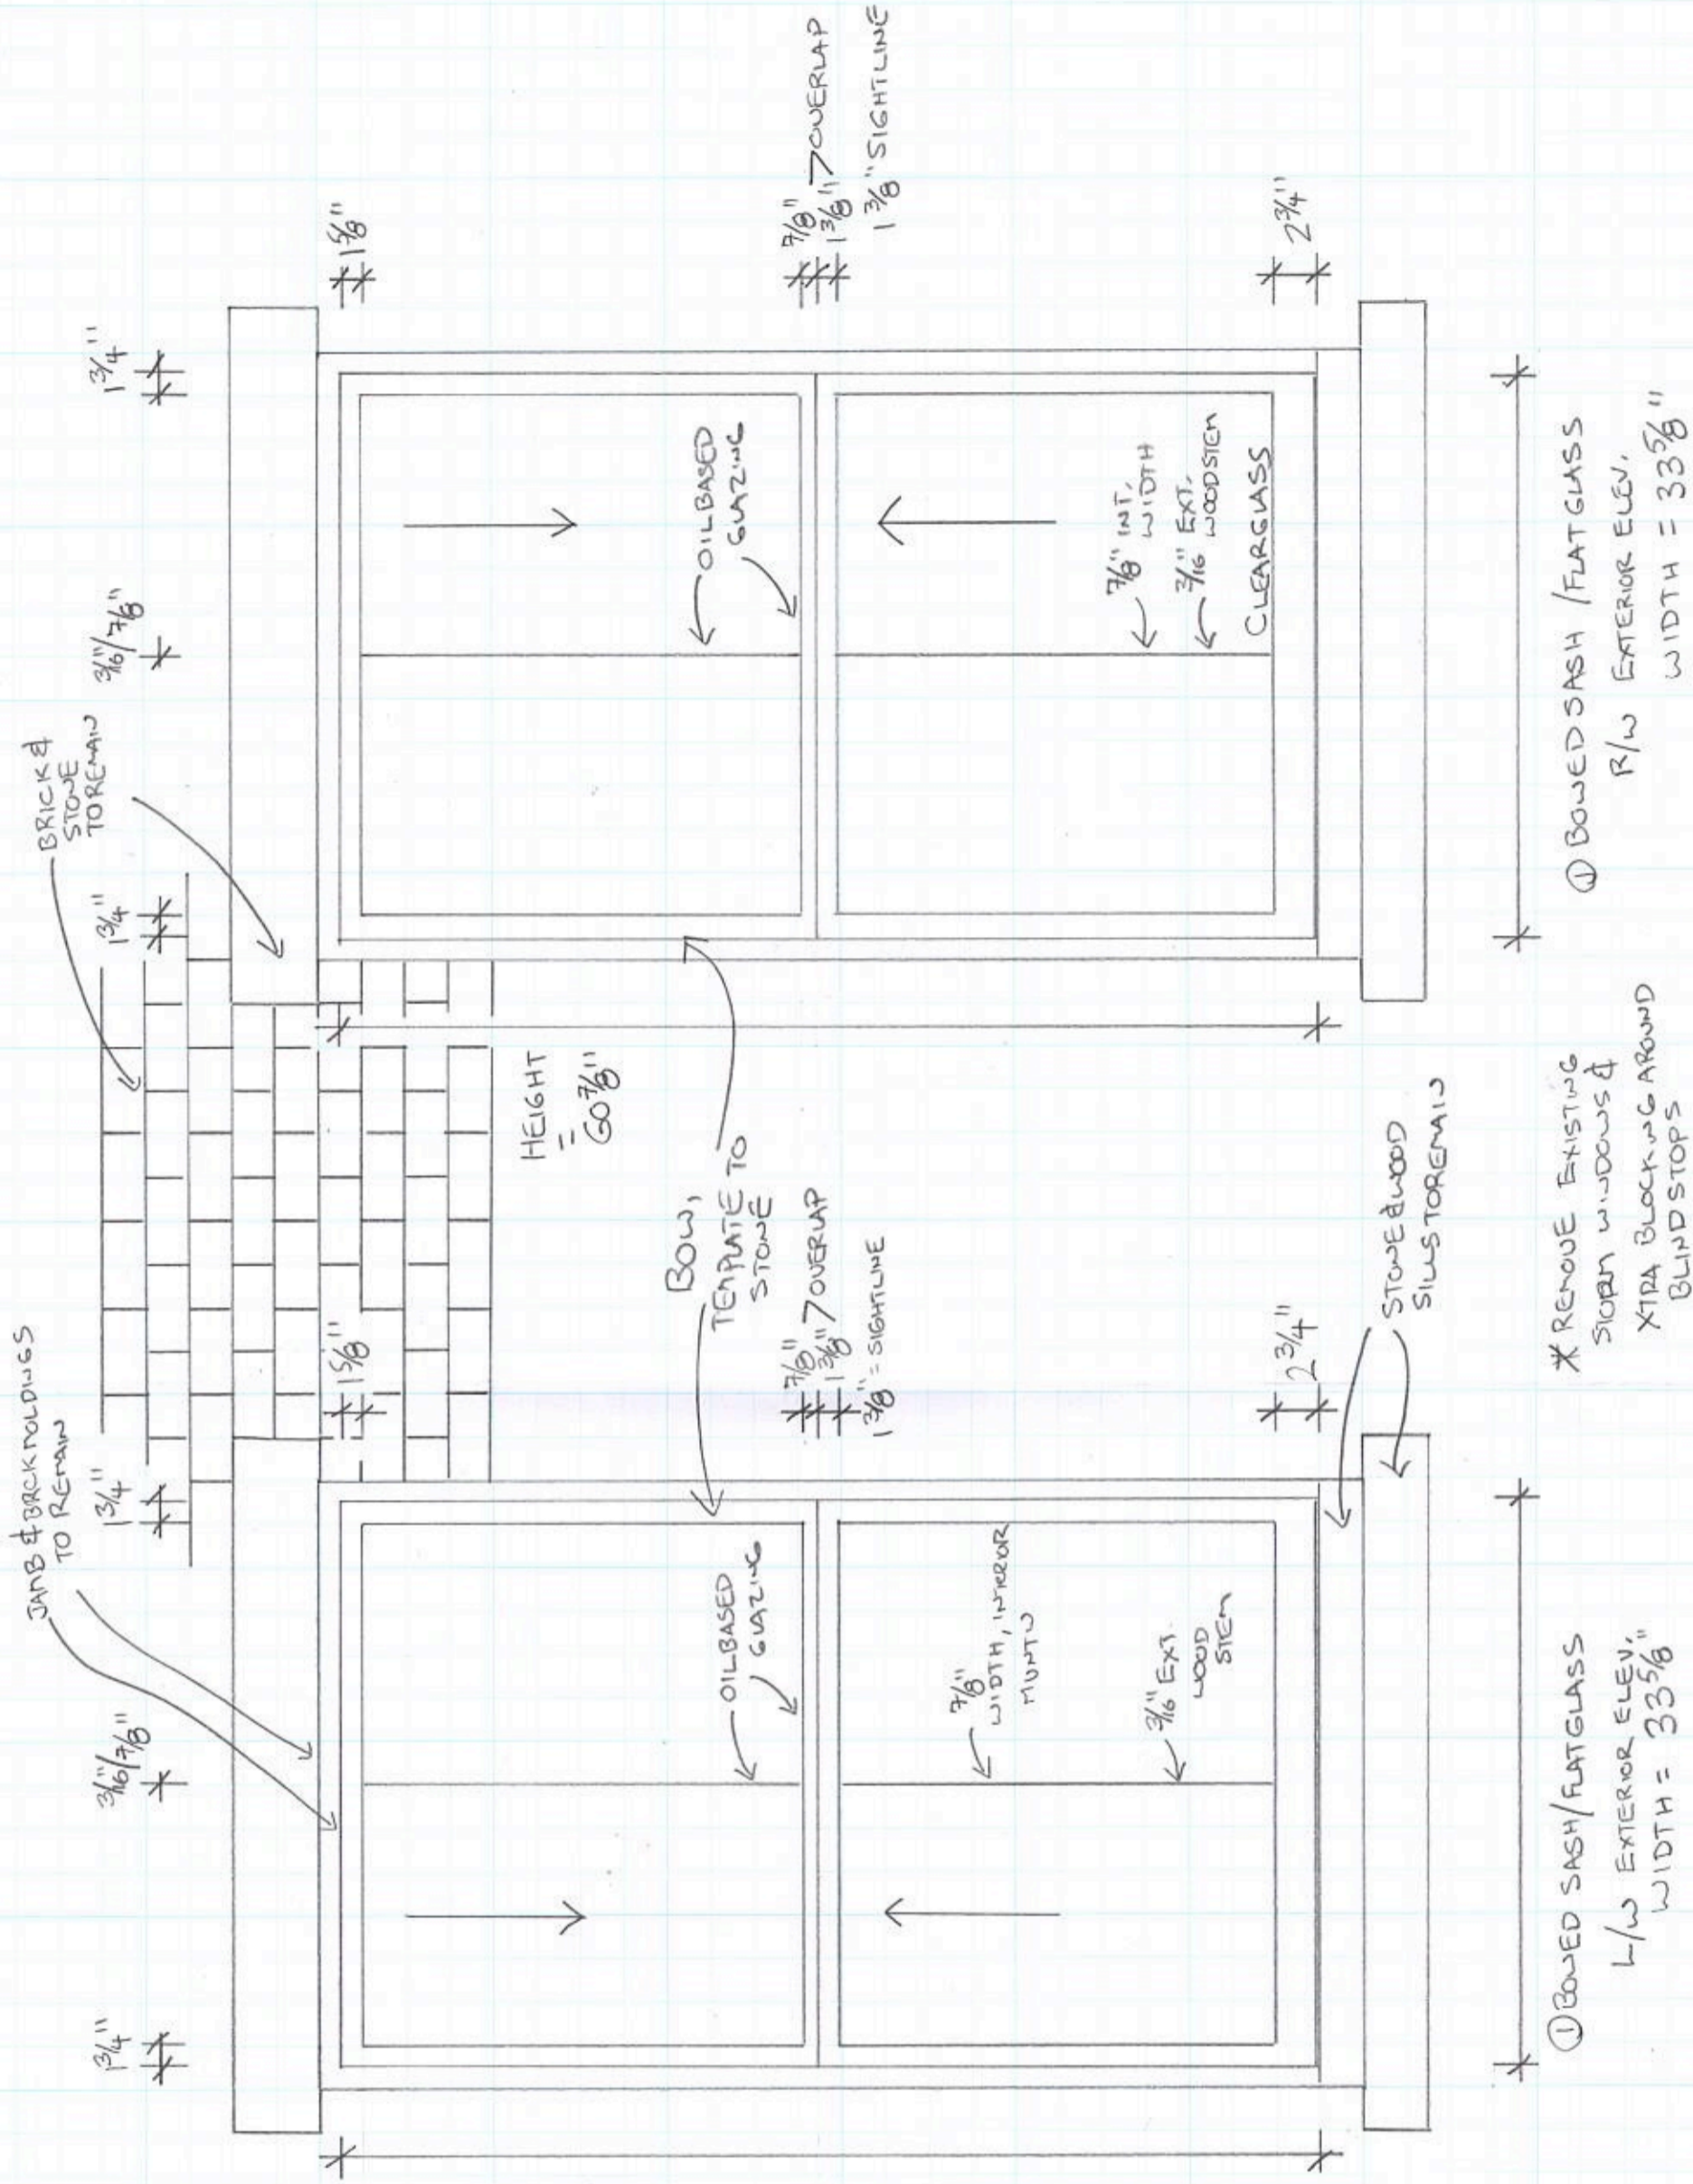
SHEET NO. 1 OF 3.

2 NEW MAHOGANY, MORTISED & TENON, SOLID BLOCK WOOD, DOUBLE HUNG SASHSETS, TRUE DIVIDED LIGHT & PAINTED CUSTOM BEIGE

COLOR AT EXTERIOR TO MATCH EXISTING
HEIGHT = 60 3/4"

① BOWED SASH / FLAT GLASS
R/W EXTERIOR ELEV.
WIDTH = 33 5/8"

* REMOVE EXISTING STONE WINDOWS & EXTRA BLOCKING AROUND BLINDSTOPS

① BOWED SASH / FLAT GLASS
L/W EXTERIOR ELEV.
WIDTH = 33 5/8"
