20 Temple ST

28 Temple ST BOSTON MA

20 Temple St Bld Front

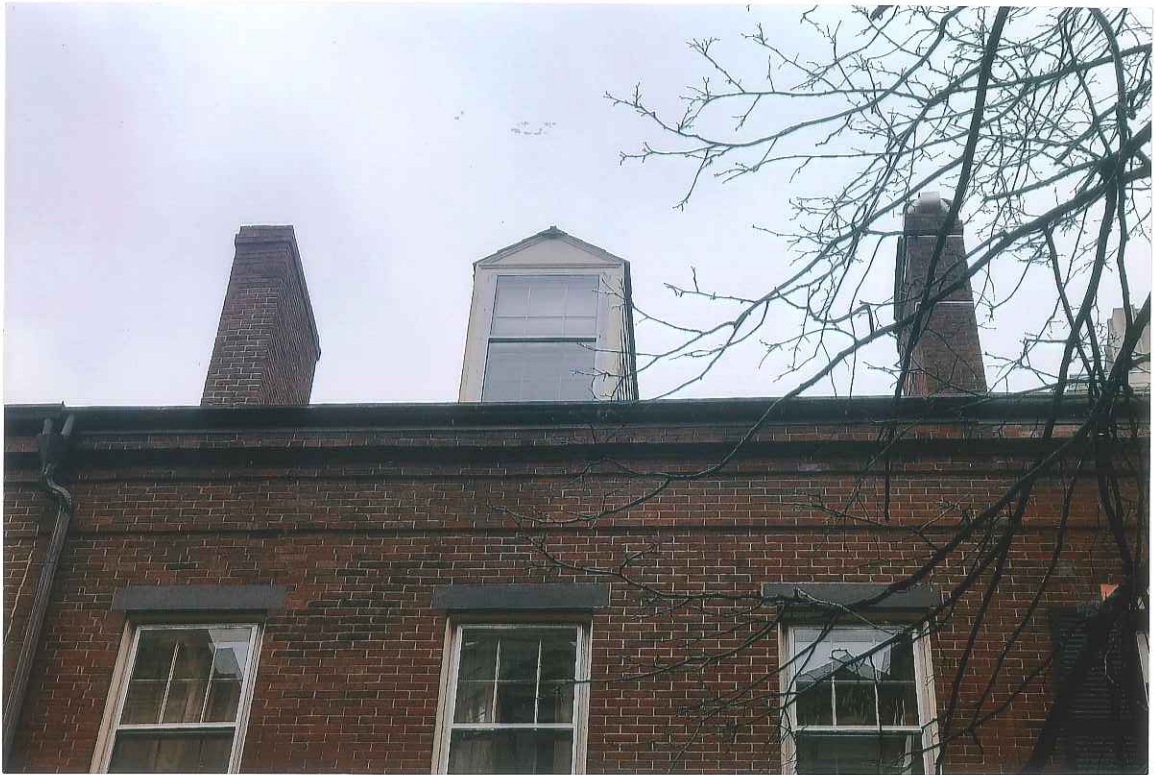
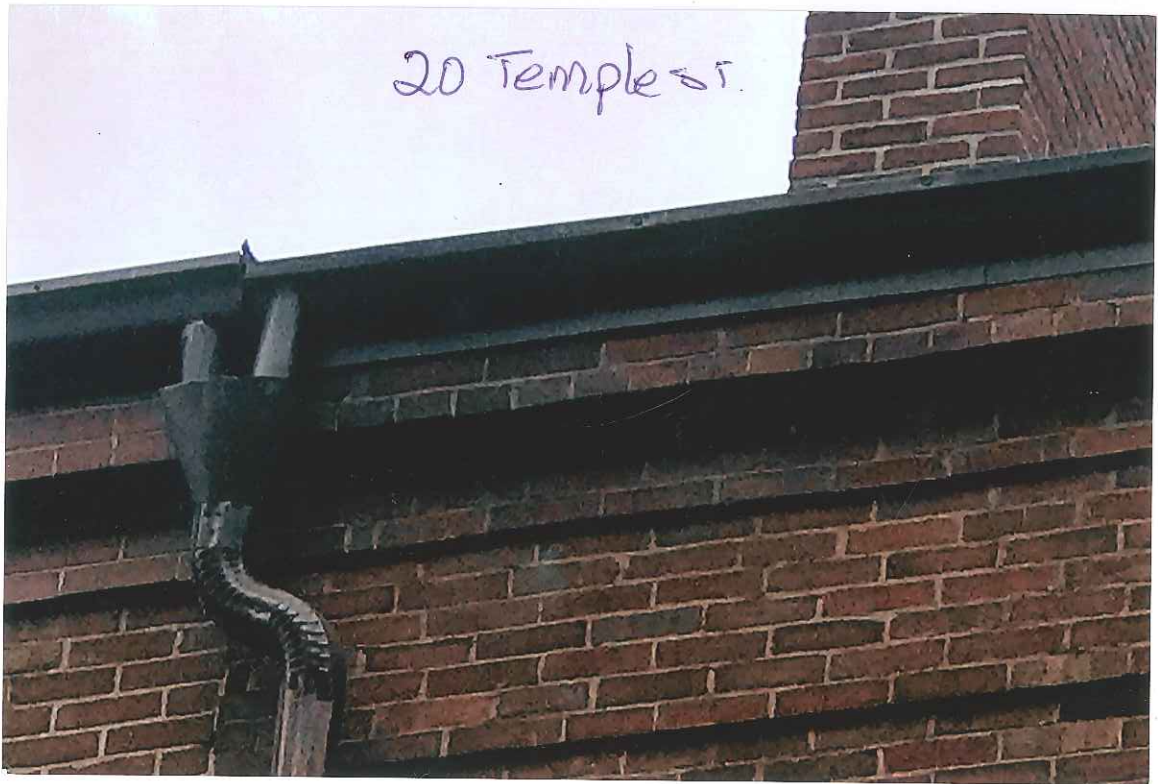
FRONT ROOF GUTTER

Blue line shows FRONT GUTTER.
Solid vertical lines denote
EXISTING RAIN CONDUCTOR PIPE

Broken red lines show where
we propose to ~~to~~ install new
Copper pipe to elevate low spot
in existing gutter where collecting
water does overflow.

pipe will be set (above all windows)
