**Jamaica Pond Park Pathways & Entrances:
Phase 2 Additional Work**
Jamaica Pond Park, Jamaica Plain
October 22, 2019

SCOPE OF WORK

- **Cobblestone spillway for stormwater improvement**

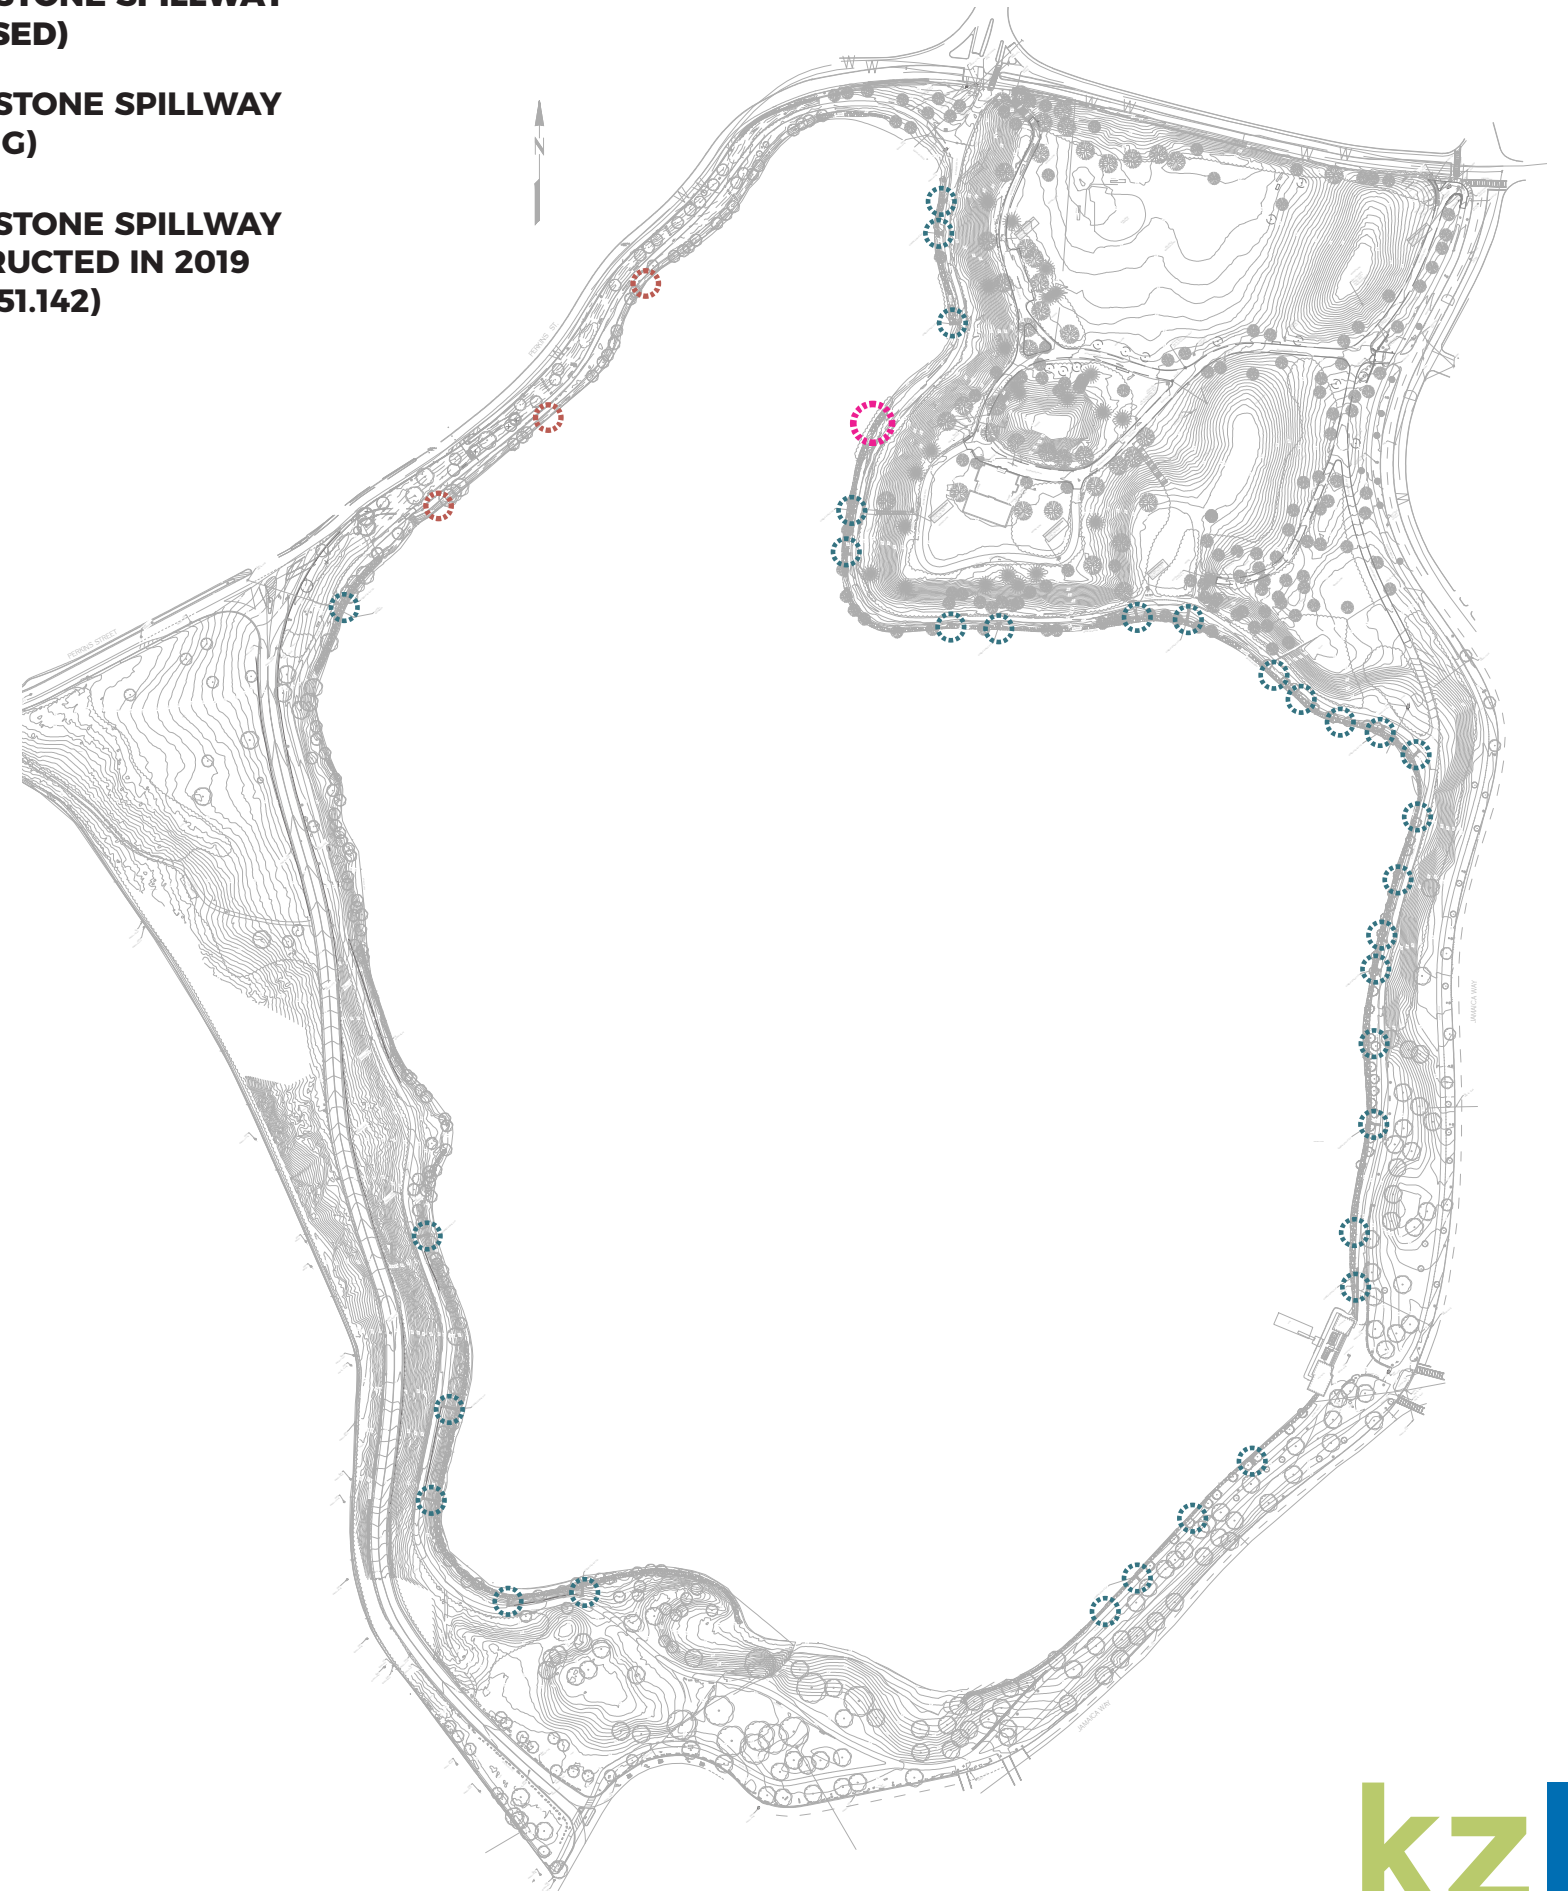
STORMWATER MANAGEMENT SPILLWAYS - EXISTING AND PROPOSED

- **COBBLESTONE SPILLWAY (PROPOSED)**
- **COBBLESTONE SPILLWAY (EXISTING)**
- **COBBLESTONE SPILLWAY (CONSTRUCTED IN 2019 PER 19.551.142)**

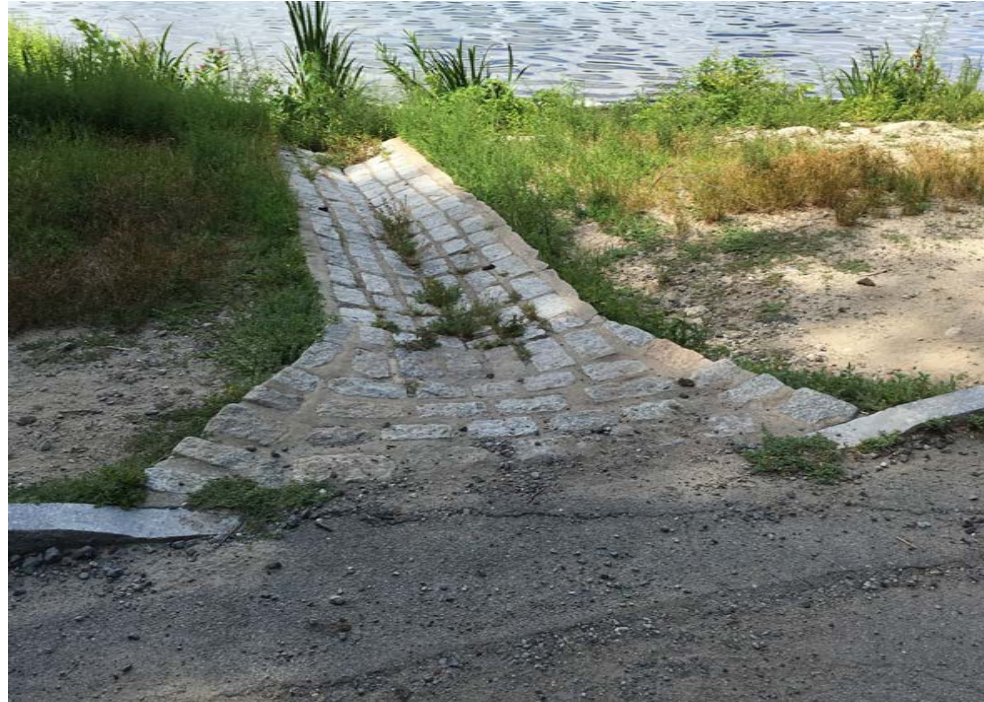
Example of an existing cobblestone spillway, prior to retrofit.

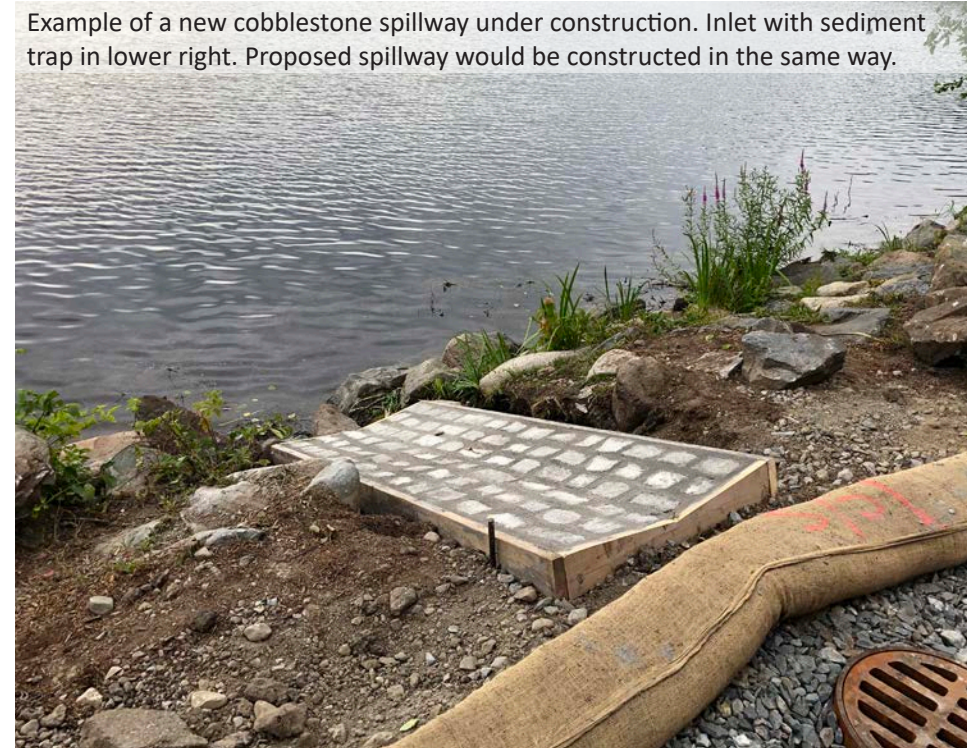
Example of a new cobblestone spillway under construction. Inlet with sediment trap in lower right. Proposed spillway would be constructed in the same way.

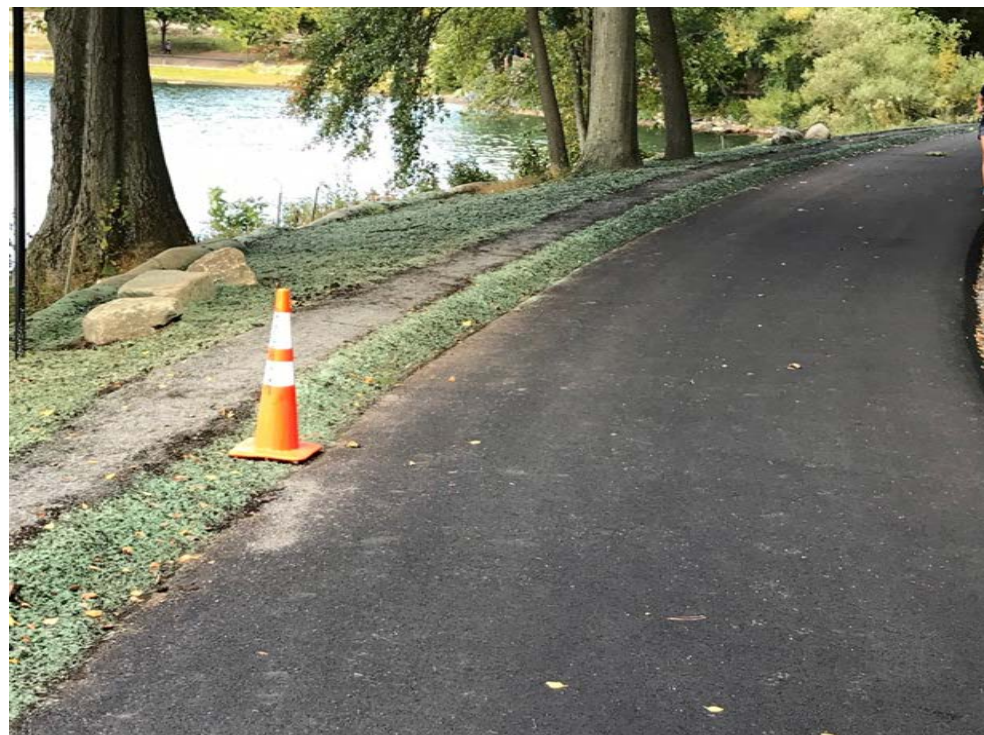
Location of proposed cobblestone spillway; Sediment shows evidence of puddling.

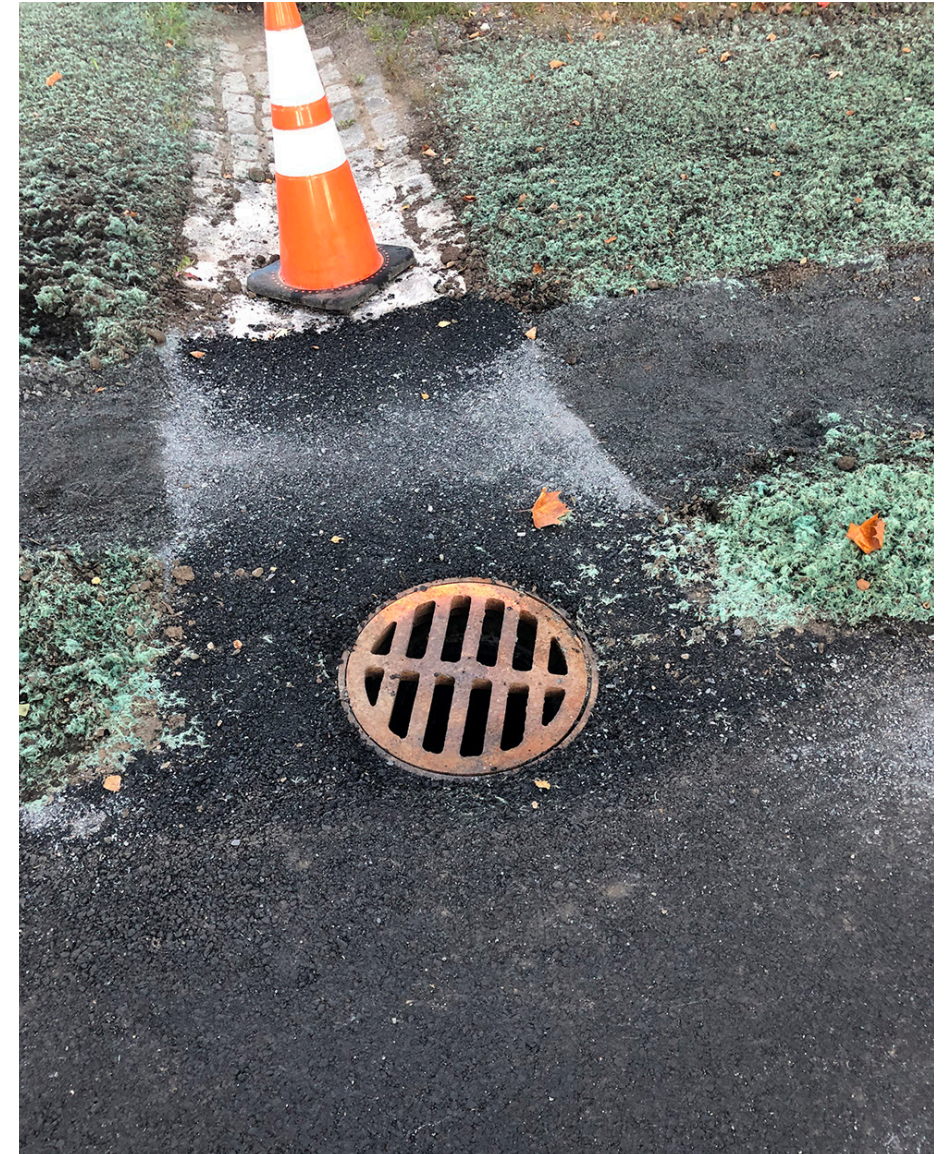
Example of a new cobblestone spillway nearing completion. Proposed spillway would be constructed in the same way.

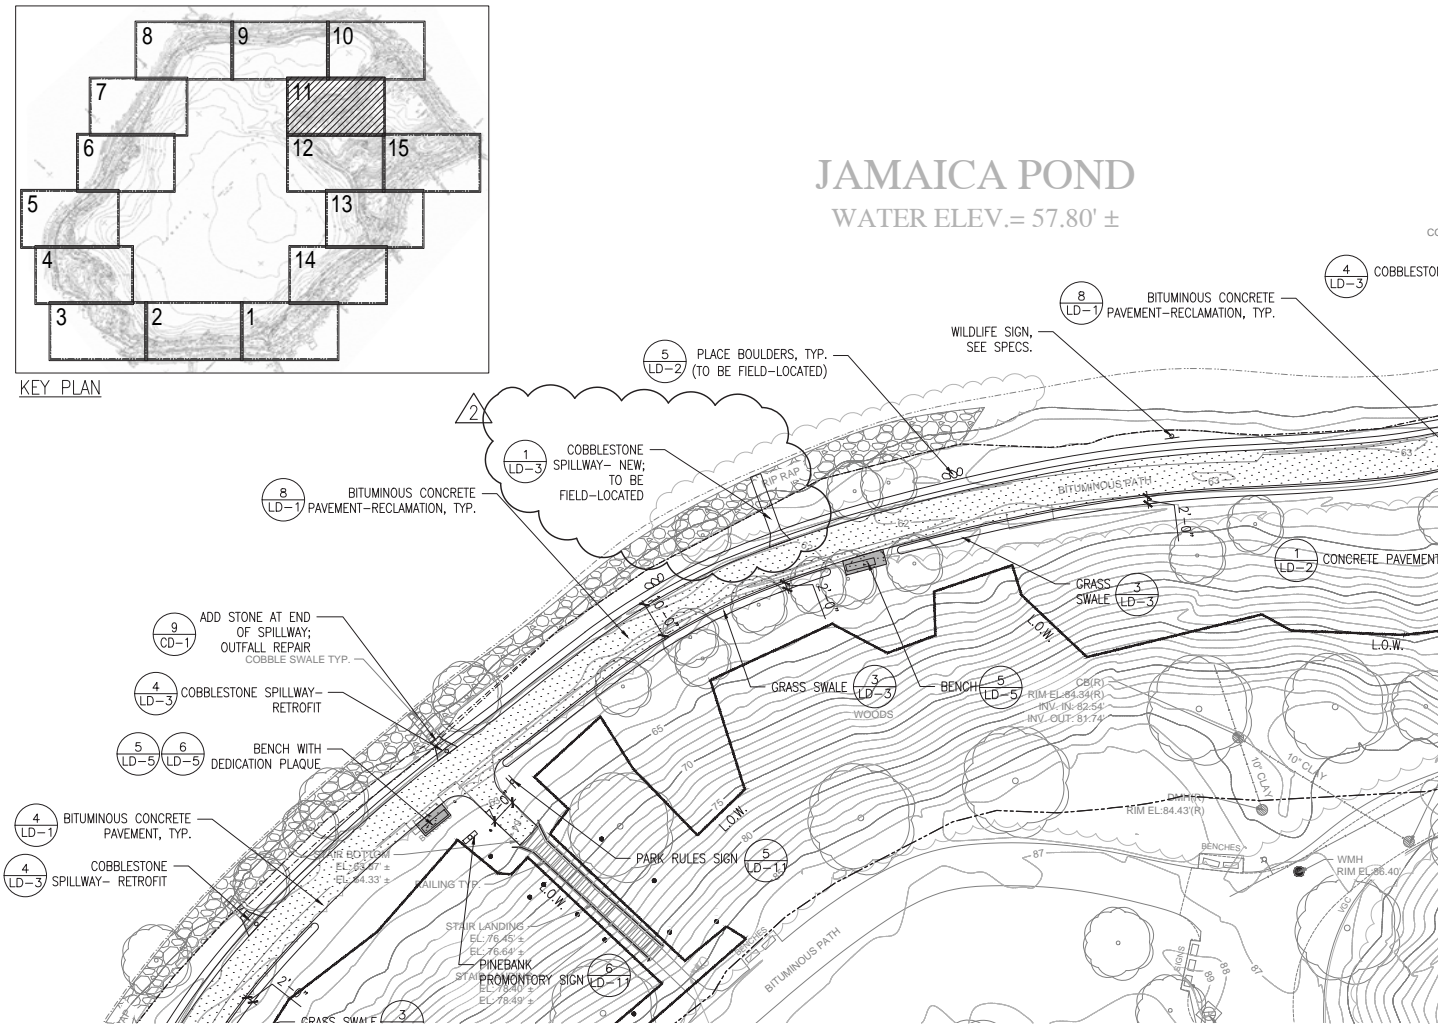
Location of proposed cobblestone spillway in NE corner of Jamaica Pond Park

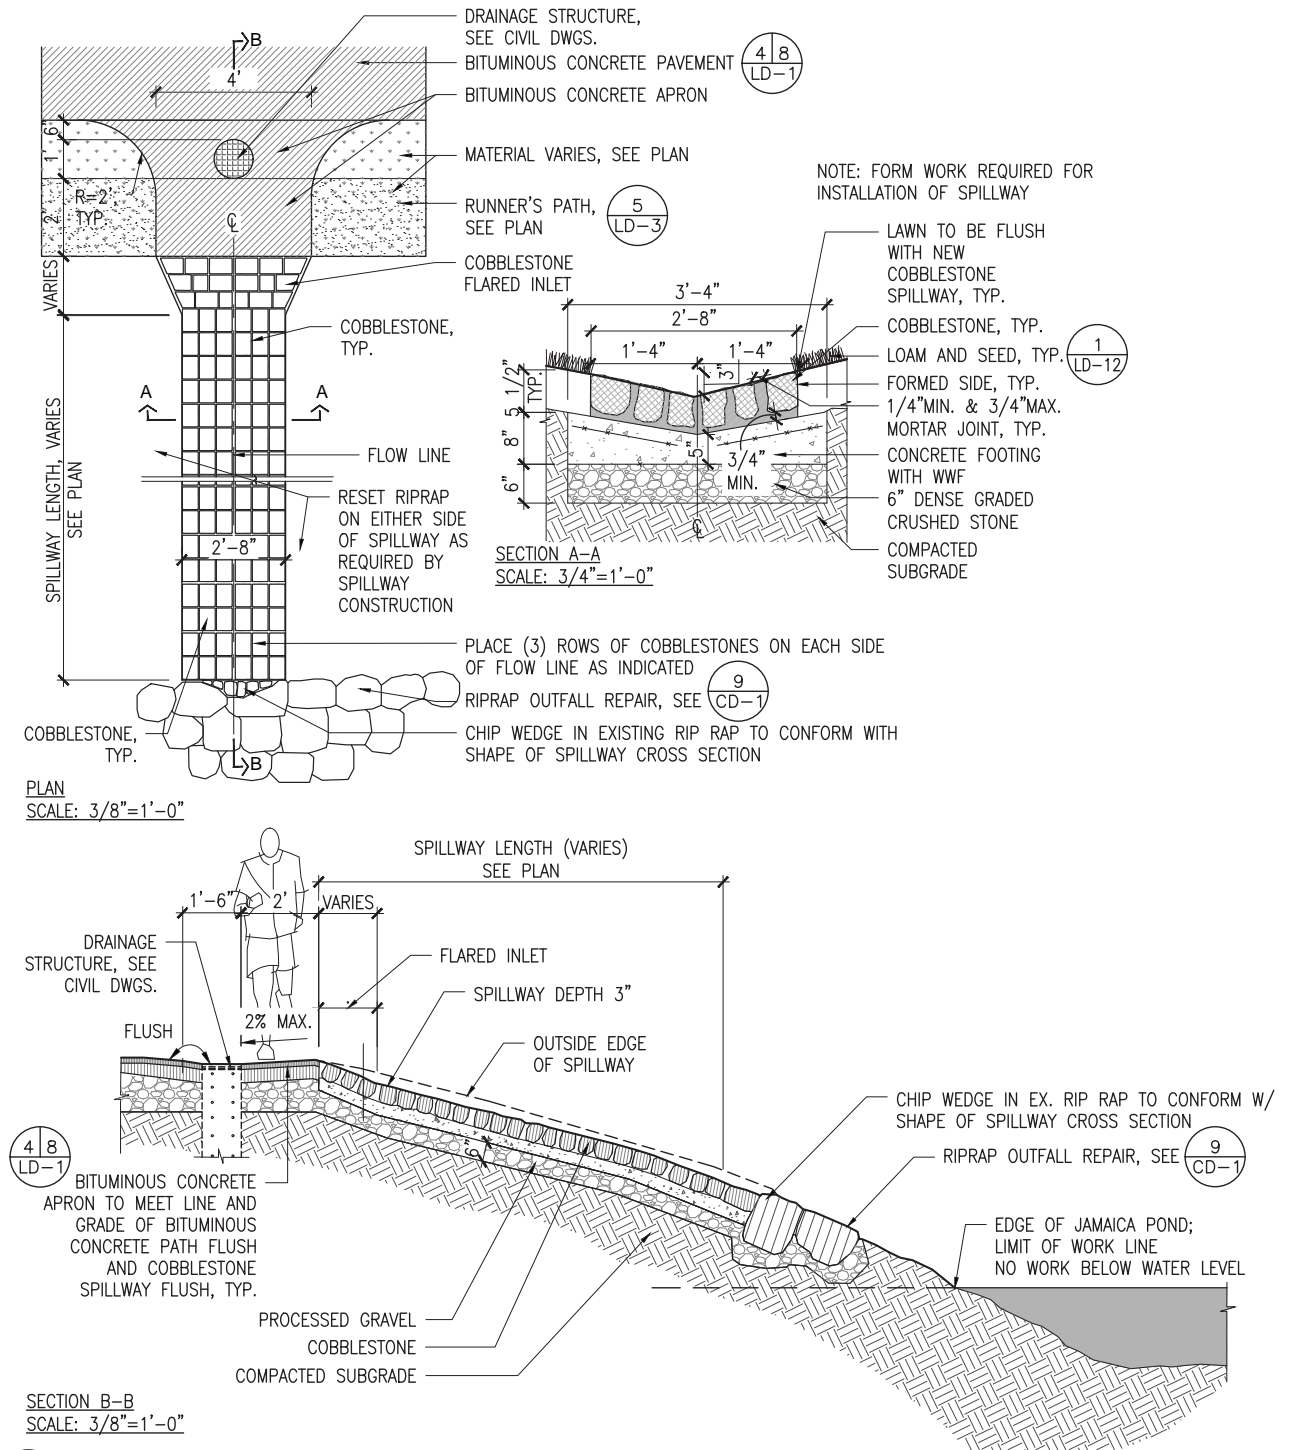
1 COBBLESTONE SPILLWAY
SCALE: 3/8" = 1'-0"

Construction detail for the proposed cobblestone spillway in NE corner of Jamaica Pond Park
