BLESSED SACRAMENT COMPLEX

BOSTON LANDMARKS COMMISSION STUDY REPORT

Report on the Potential Designation of

**The Blessed Sacrament Complex
361 Centre Street, 21 Creighton Street, 35 Creighton Street, 20-24 Sunnyside Street,
and 30 Sunnyside Street, Boston, Massachusetts**

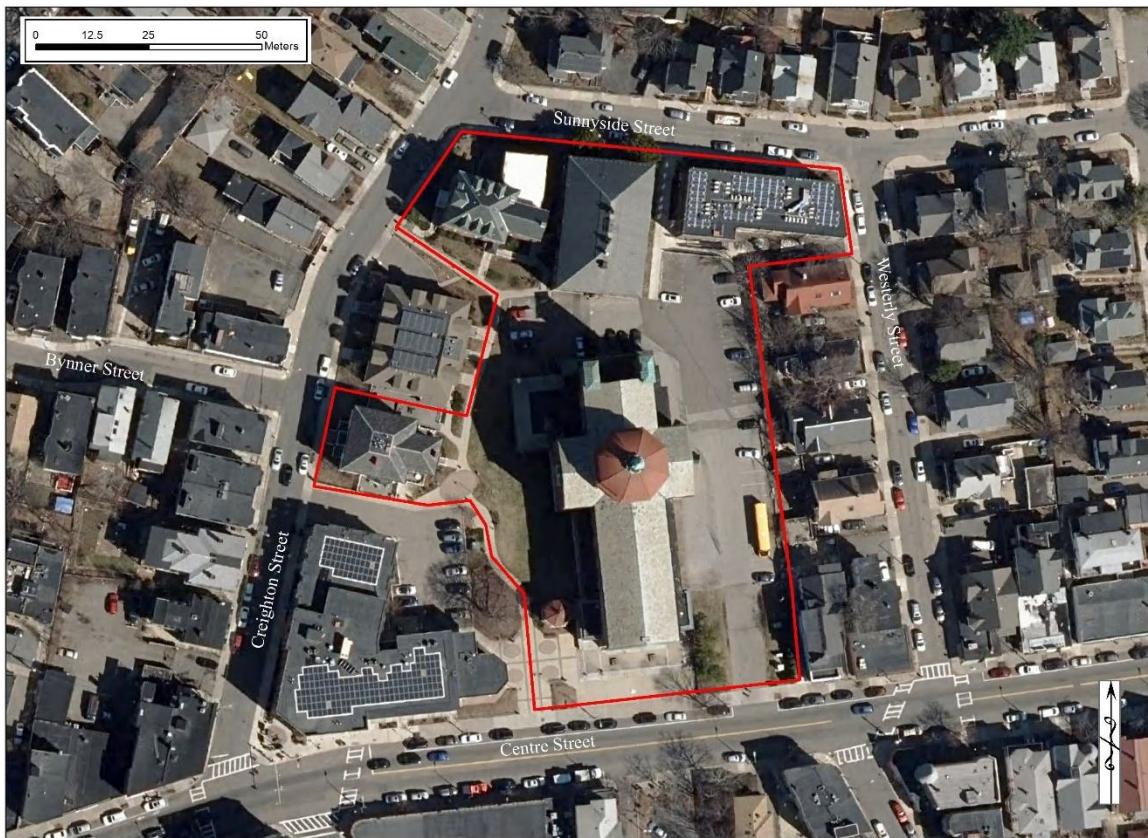
Figure 1. Map showing the boundary of the proposed Landmark, which includes portions of parcels # 1002038018, 1002038030, 1002038012, 1002038014, and 1002038016.

The entire complex site is bounded by Centre Street on the south, on the east by the rear of the residential lots lining Westerly Street; on the north by Sunnyside Street; and on the west by Creighton Street. The surrounding streets are lined with multi-family residences dating from around the turn of the last century. Many of these buildings include commercial establishments on the lower stories, particularly along Centre Street. The former St. Norbert School is located at the far northeastern corner of the parcel at 20-24 Sunnyside Street, the former Cheverus School building is found to the west of that building at 30 Sunnyside Street and the former Sisters Convent of the Blessed Sacrament is found just west of the Cheverus School at 35 Creighton Street. The entire church campus measures 3.2 acres in size and incorporates greenspaces and parking throughout.

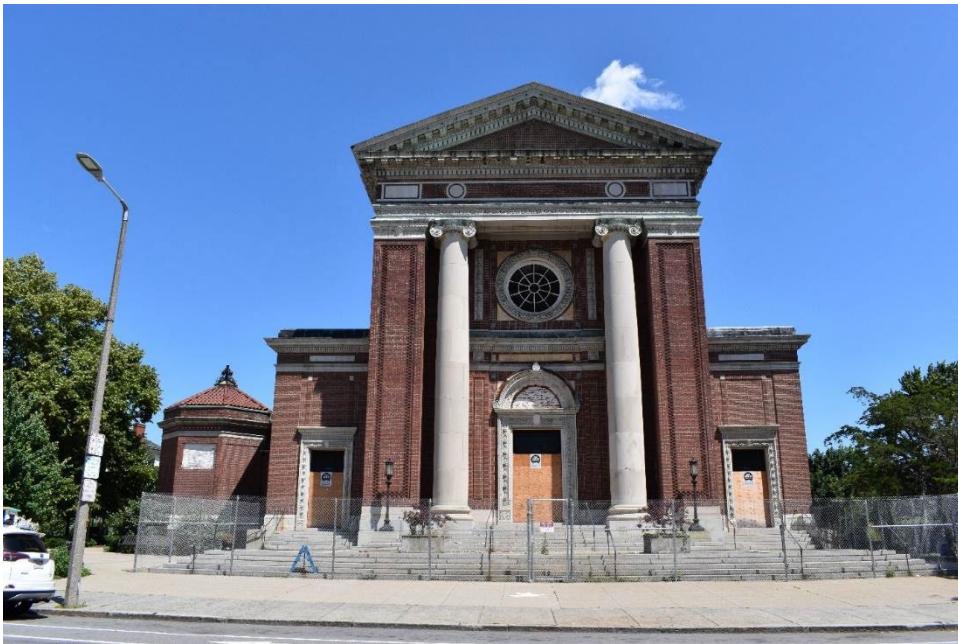
Figure 2. South (front) elevation of the Church, facing north. Taken June 20, 2022.

The building rests on a granite foundation that is slightly elevated on the side and rear elevations to accommodate the sloping lot. A wide limestone belt course encircles the building on all elevations and defines the base of the façade above the steps. The walls are brick set in a Flemish bond with

The central bay is arranged to be aligned with the altar and is accessed by the main entrance, which is topped by a deeply set, arched hood featuring rows of richly carved elements such as foliate swags, acanthus leaves, and a cherub at the apex of the arch. The carving that once filled the tympanum arch above the door has been removed leaving an empty brick wall in its place. A trefoil rosette tops the arch and is also found at each corner. Green and pink marble blocks are used to further enhance the brickwork around the door. The door surround is separated from the arch above by a narrow projecting cornice. The door itself is a multi-paneled double-leaf wooden unit with four square panels arranged vertically on each side. It is topped by a metal grate which covers the original transom window. The surround also features several richly layered carvings ranging from a traditional coved molding to swags, to wide foliate bands. The entire surround is surmounted by an oval plaque found above the door.

The attic story is defined along the base by several bands of elaborately carved trim depicting oak leaves and thistles. This is topped by a wide egg and dart band that is in turn topped by a line of raked copper flashing. Beneath the cornice, a brick soffit is divided by circular marble plaques found above each column and rectangular plaques above each pier. The raking pediment is outlined by a deep cornice trimmed by a wide double band of carved trim set atop a modillioned cornice. Alternating between each modillion is a rosette facing toward the ground. A denticulated band of limestone lines the interior of the tympanum on all sides. The same carved molding and dentils separated by a narrow line of egg and dart lines the base of the pediment. A line of soldier course bricks also lines the interior of the triangular tympanum.

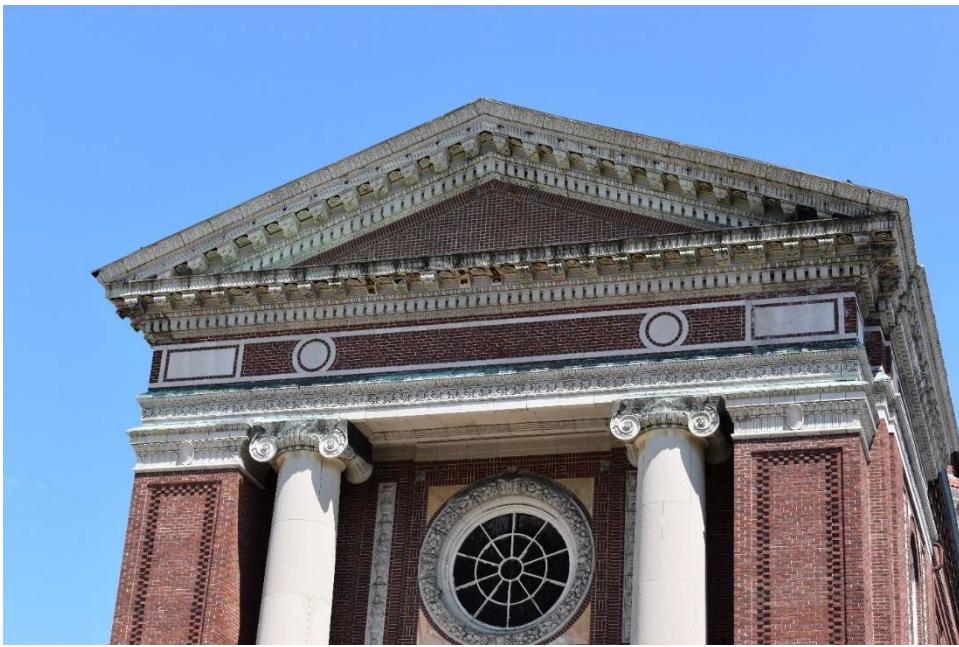
Figure 4. Detail of the portico, facing northwest. Taken June 20, 2022.

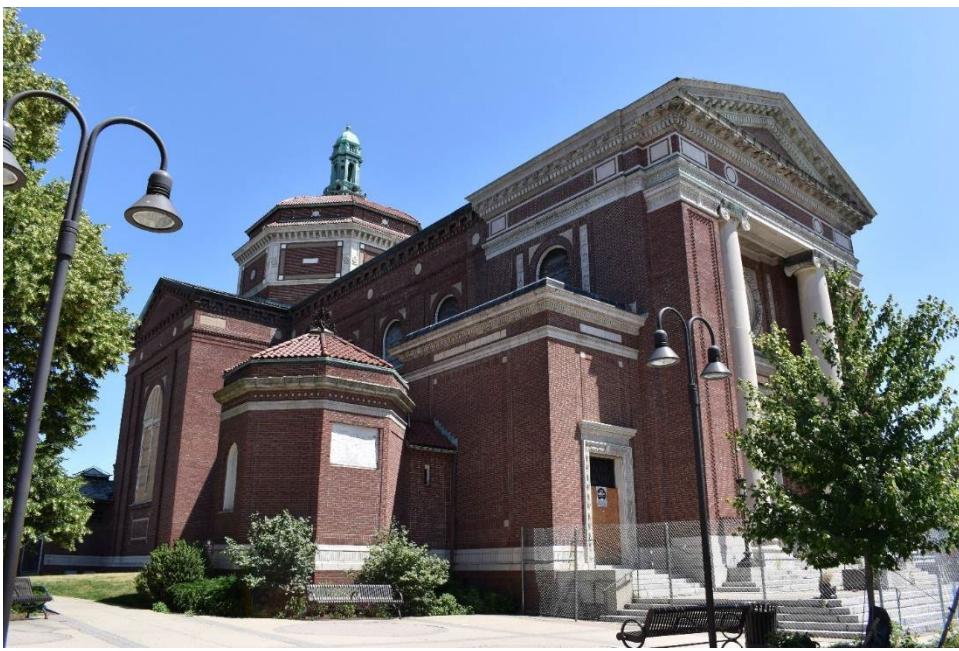
Figure 5. West elevation of the Church, facing northeast. Taken June 20, 2022.

An octagonal baptistery extends from the western elevation. It is topped by an elaborate wrought iron finial at the apex of the clay tiled roof. A line of copper molding lines the roof and tops a band of brick set above a projecting stone cornice. Beneath the cornice is a freeze band featuring a geometric pattern formed by marble blocks and brickwork set above a limestone belt course. Each wall of the baptistery is inset with a brick panel in lieu of a window. It appears that a square window was found on the southern elevation but has since been removed and boarded shut. An arched window is found on the western wall of the baptistery.

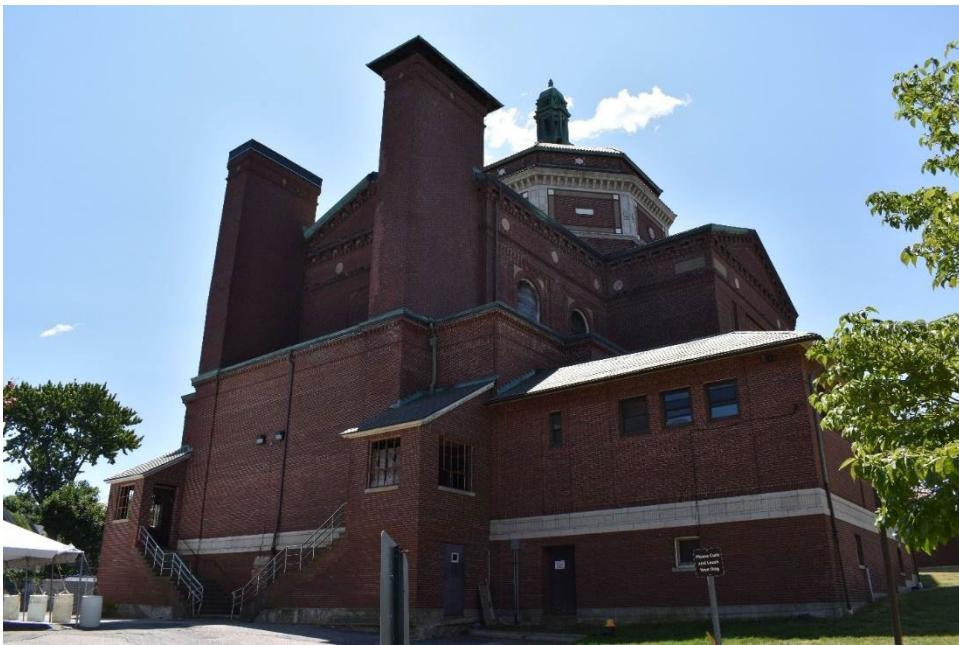
Figure 8. North (rear) elevation of the Church, facing southeast. Taken June 20, 2022.

identify them as a particular member. Two stairways (added in 1937) provide access to the from the rear of the building. They each lead from the side aisles found on either side of the sanctuary and are shielded beneath shed roofed ells that extend to the north. Each enclosed portion of the stairwell is fitted with a single twelve-light window and has two flights of stairs. The stairs are lined by metal railings and face each other to meet on a concrete pad at the ground level. The decorative limestone belt course found on the side elevations continues here as does the brickwork depicting the same modillioned cornice found on the side elevations. The rear wall and side elevations of the sanctuary are blind on all elevations.

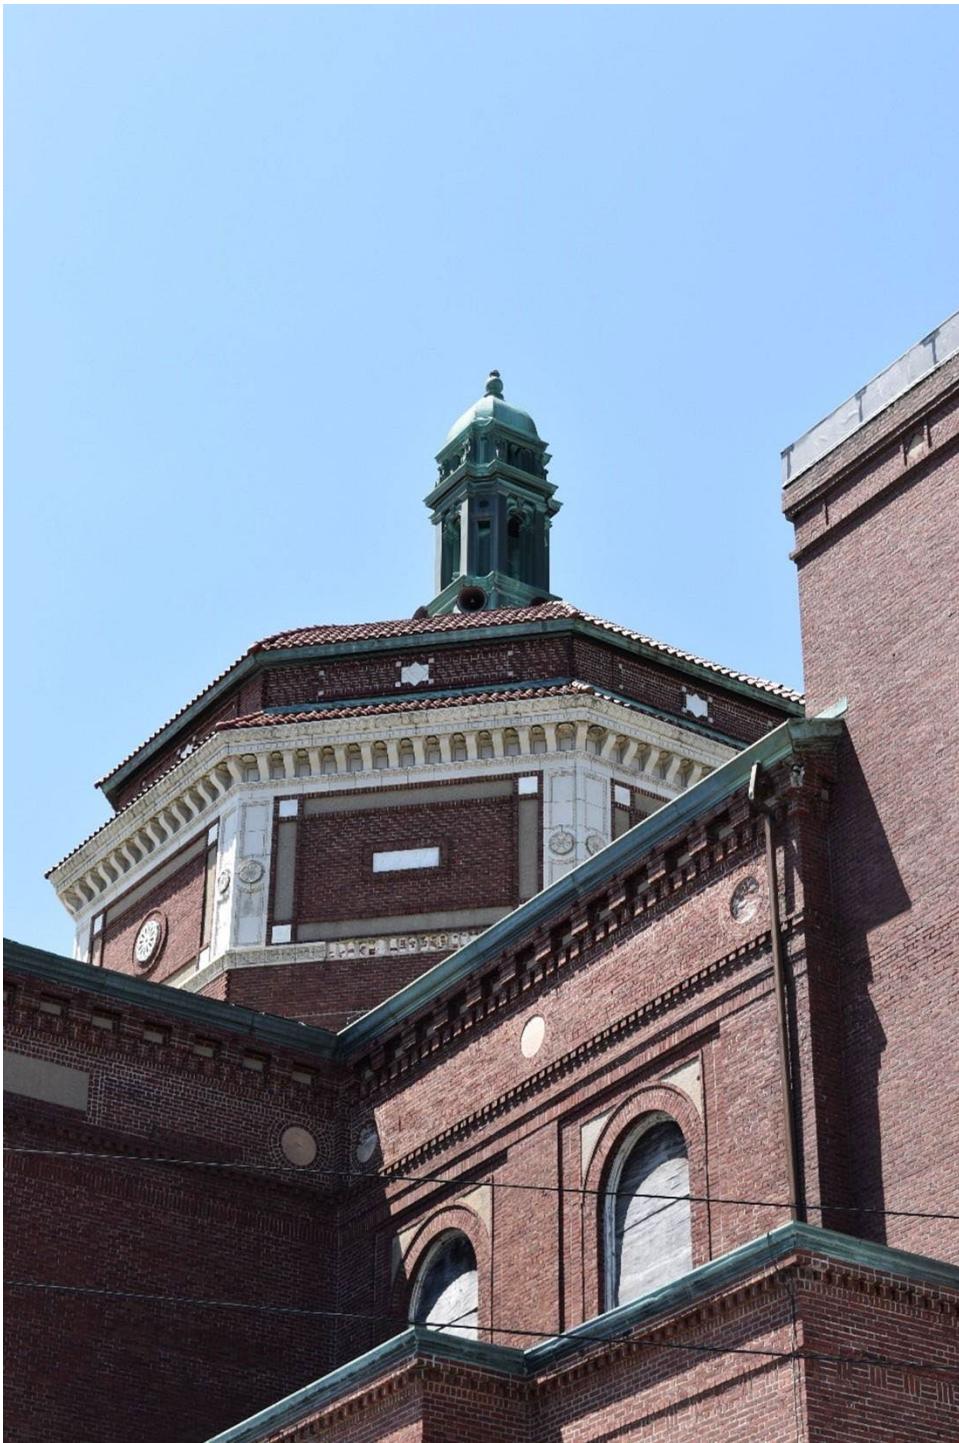
Figure 12. Detail of the dome of the Church on the east elevation, facing southwest. Taken June 20, 2022.

An octagonal dome rises above the crossing with brick panels set between paneled limestone frames further decorated by rosettes. Each panel is accentuated by secondary marble frames featuring an alternating design of rectangles and circles at their centers. The projecting cornice of limestone is found beneath a narrow roof clad in red tiles and a line of copper flashing. Above this is a second narrow soffit featuring a paneled design decorated by marble rounds at the center. Another copper cornice lines the eave of the domed roof, which is also clad in red tiles. At the apex of the dome is a distinctive multi-tiered, copper belvedere with arched openings on the north and south elevations and a domed lantern culminating in a pinnacle.

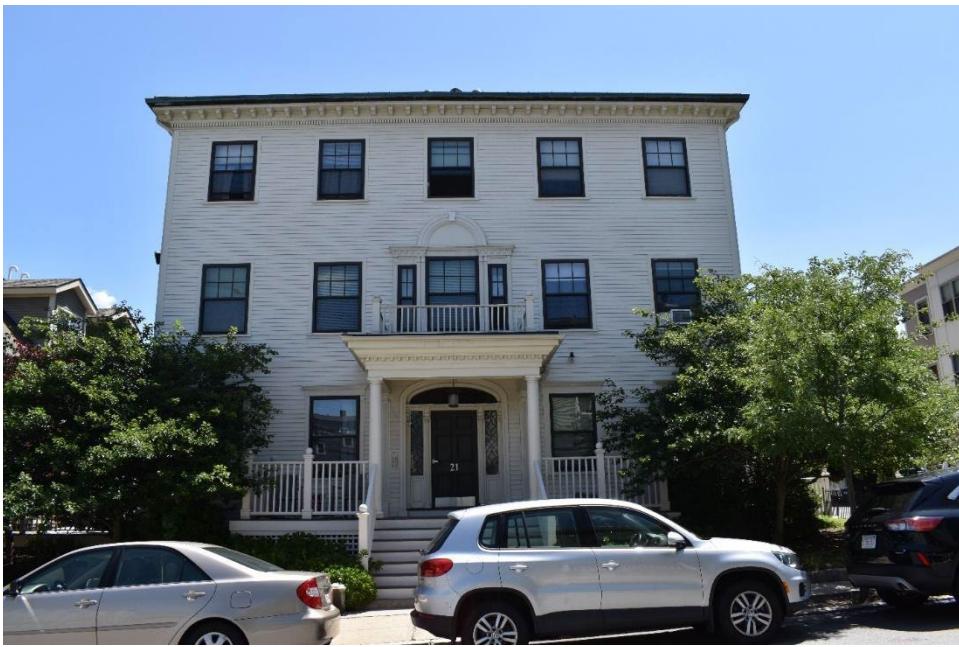
Figure 13. West (front) elevation of the rectory, facing east. Taken June 20, 2022.

Centered above the door on the second story is a tripartite window topped by a molded arched enclosing a blind transom with a keystone motif at the apex. A projecting, modillioned cornice is supported by smaller versions of the same fluted columns found on the first story entrance. Each of the smaller side windows are topped by an incised panel.

The remainder of the windows are one-over-one double-hung sash replacements trimmed with narrow sills and tall cornices on the first story. On the second and third stories the windows are six-over-one sash set within flat trim. The eaves are lined by a row of dentils set below a modillioned cornice beneath a row of copper coping. A tall brick chimney is found on the rear elevation of the roof.

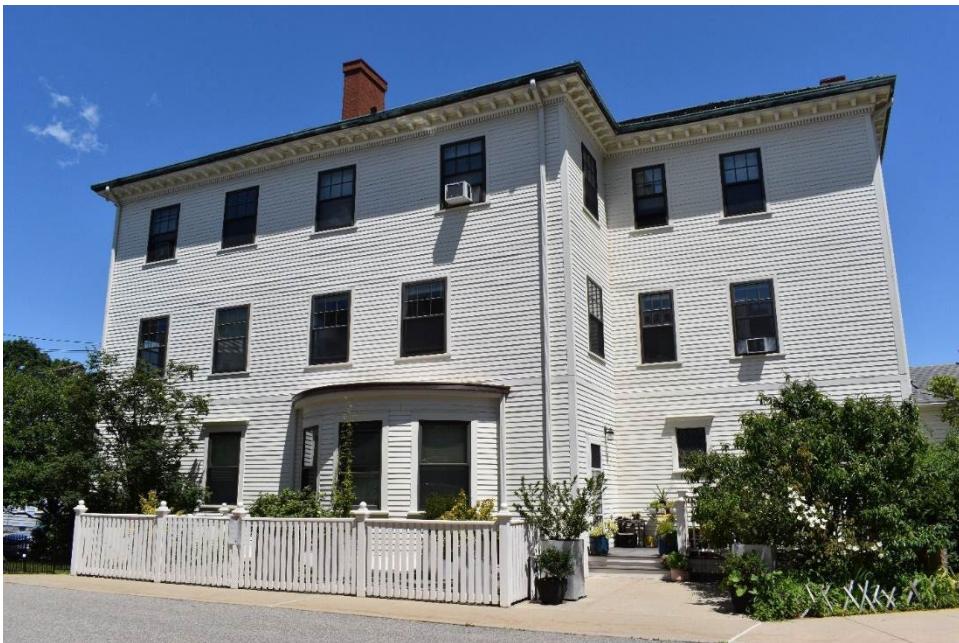
Figure 17. South elevation of the rectory, facing north. Taken June 20, 2022.

The side elevations are also four bays deep with cornices on the windows of the first story. On the east end of the southern elevation is a single-story projecting bay. Two decorative leaded windows are found on the lower story of the south elevation.

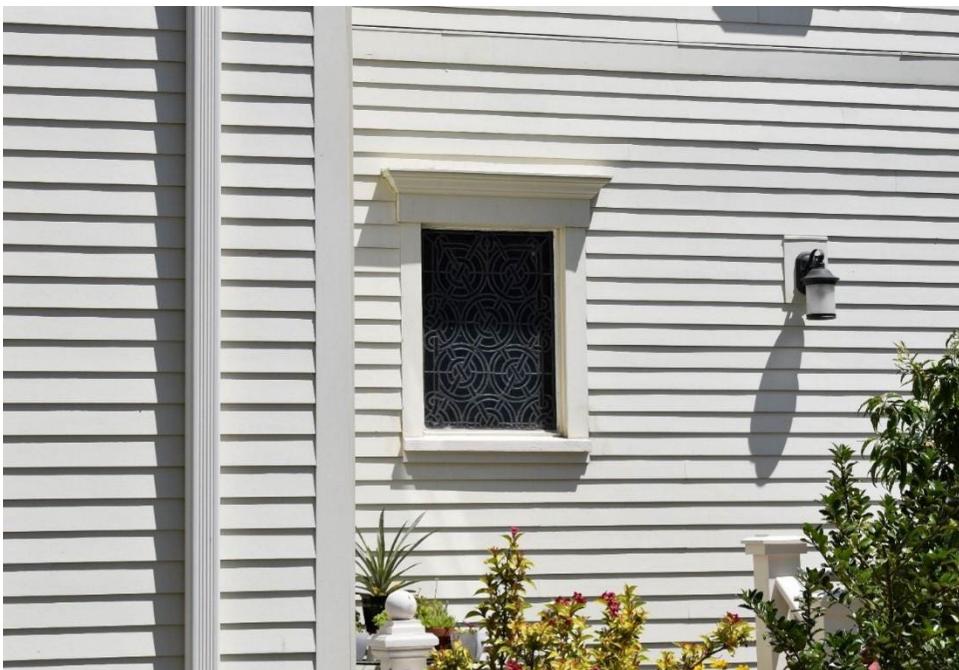
Figure 18. Detail of leaded glass window on the south elevation of the rectory, facing north. Taken June 20, 2022.

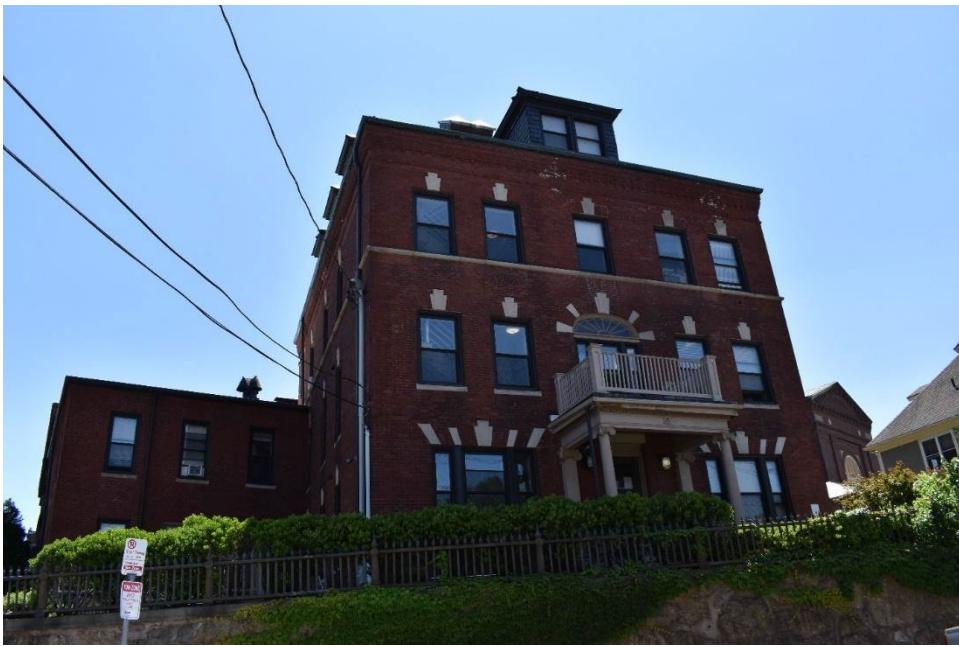
Figure 19. West (front) elevation of the convent, facing southeast. Taken June 20, 2022.

The openings on the first story of the façade consist of two tripartite windows flanking the central entrance. They have limestone sills and are topped by splayed lintels featuring a central keystone and alternating limestone voussoirs. Above the entrance is an elliptical fanlight filled with intricate tracery and topped by a segmental arch decorated with a limestone keystone and decorative limestone voussoirs similar to the design found on the first story windows. The fanlight tops a tripartite window composed of narrow double hung sash flanking a central double-hung sash window. Windows throughout contain 1/1 sash with narrow limestone sills. The remainder of the

A narrow, limestone string course connects the sills of the five third story windows and continues around to the side and rear elevations. The windows on the third story feature the same splayed lintel and keystone design found on the second story. The roof is lined by an elaborate corbelled brick cornice which is lined at the top by copper coping.

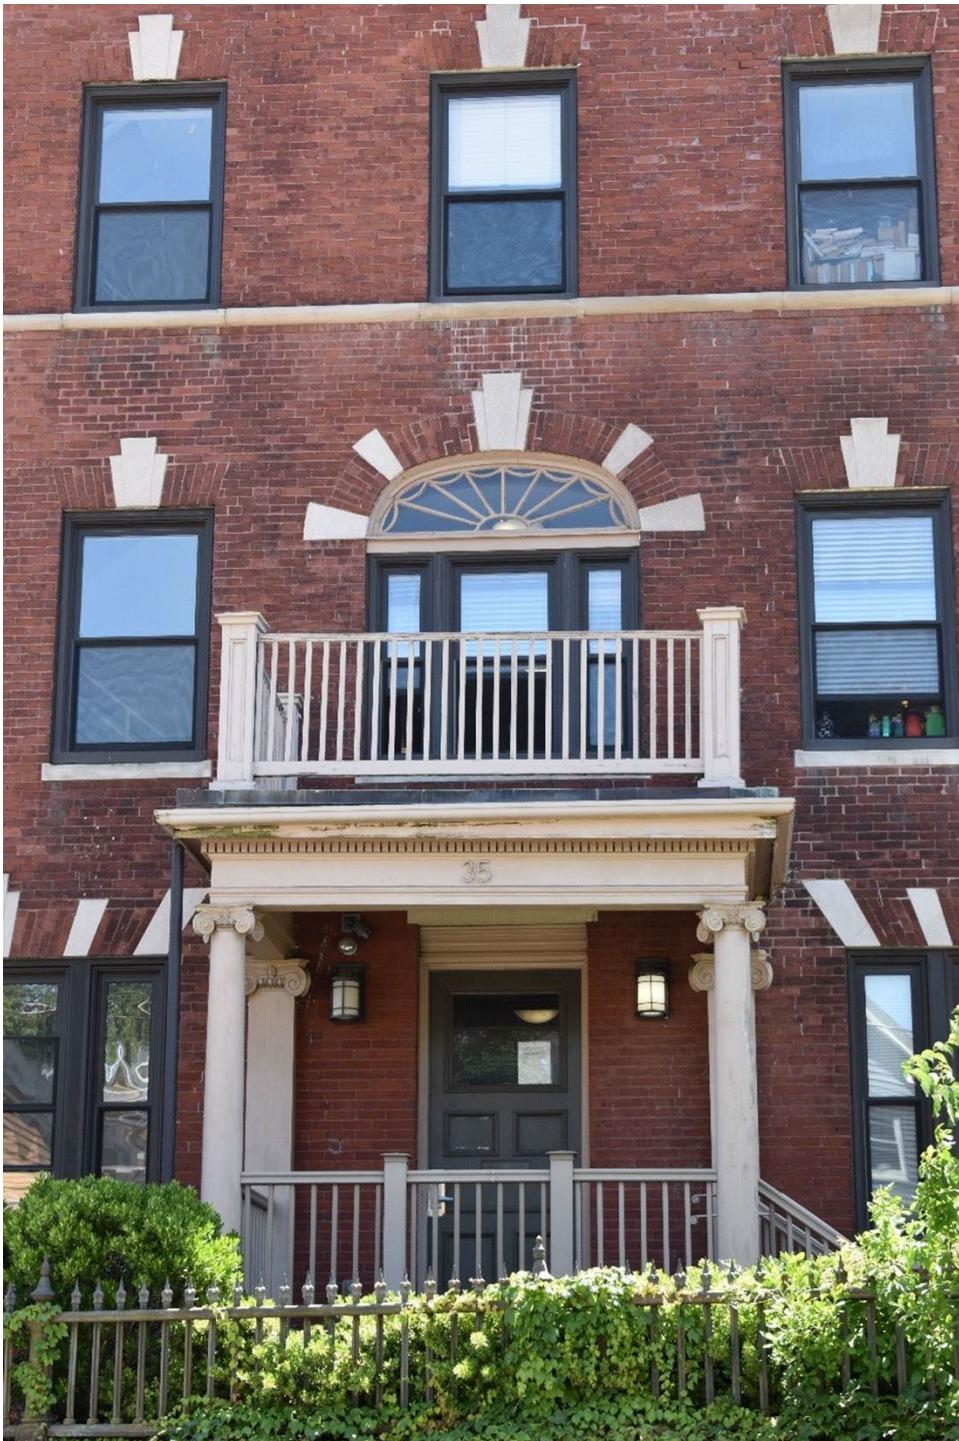
Figure 21. Detail of the main entrance of the convent, facing east. Taken June 20, 2022.

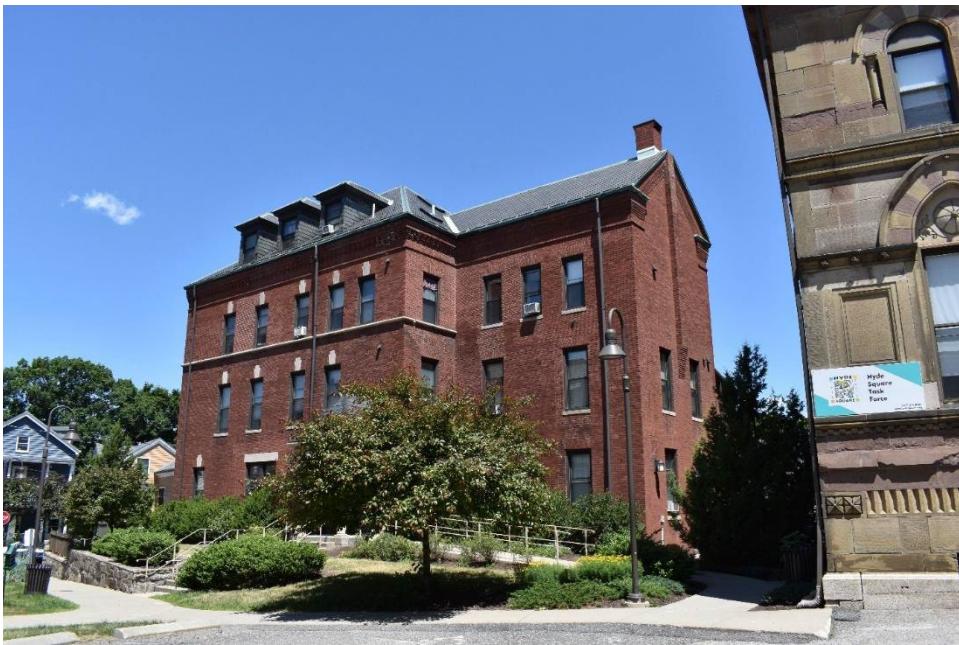
Figure 24. East (rear) elevation of the convent, facing northwest. Taken June 20, 2022.

The eastern elevation includes the original rear wing of the building which continues the same decorative features such as the corbeled cornice and limestone sills found on the main block.

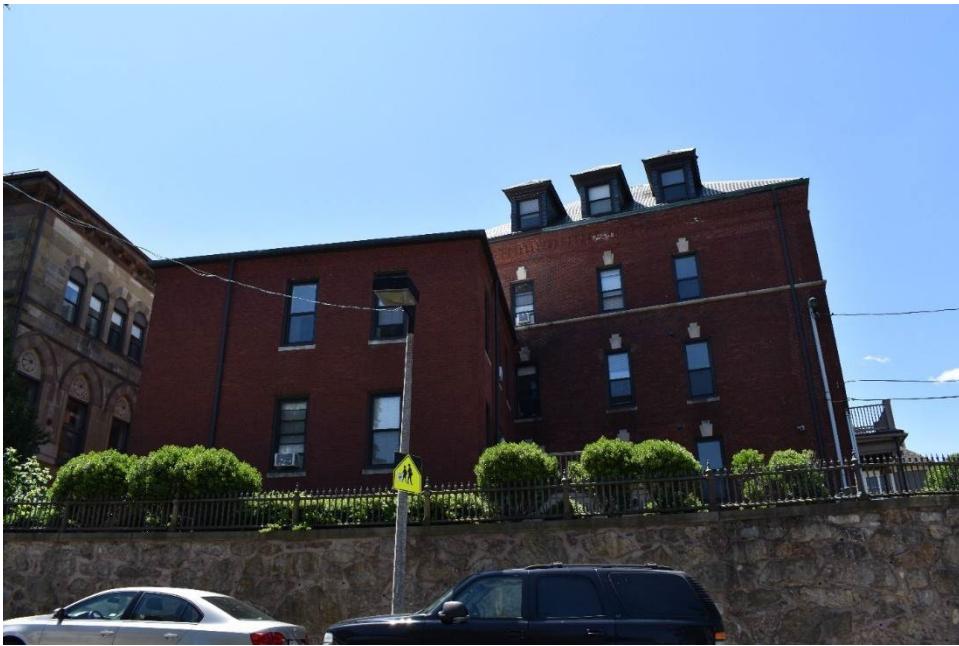
Figure 25. North elevation of the convent, facing south. Taken June 20, 2022.

The northern elevation of the building features three symmetrically placed windows which are arranged beneath the dormers above. They are all decorated in the same manner as the windows found on the third story of the façade. The 1926 addition extends from the eastern end of this elevation and is utilitarian in design. It does not employ any specific style and has a flat roof. It is three symmetrically placed bays on the side elevations (west and east) and two bays on the northern elevation. These two bays are offset toward the western side of the elevation. The only decorative features on this addition are narrow limestone sills, soldier coursed slightly splayed brick lintels and a simple corbeled cornice lining the roof which has a very shallow pitch (described in the building permit as "French") and lined by metal coping.

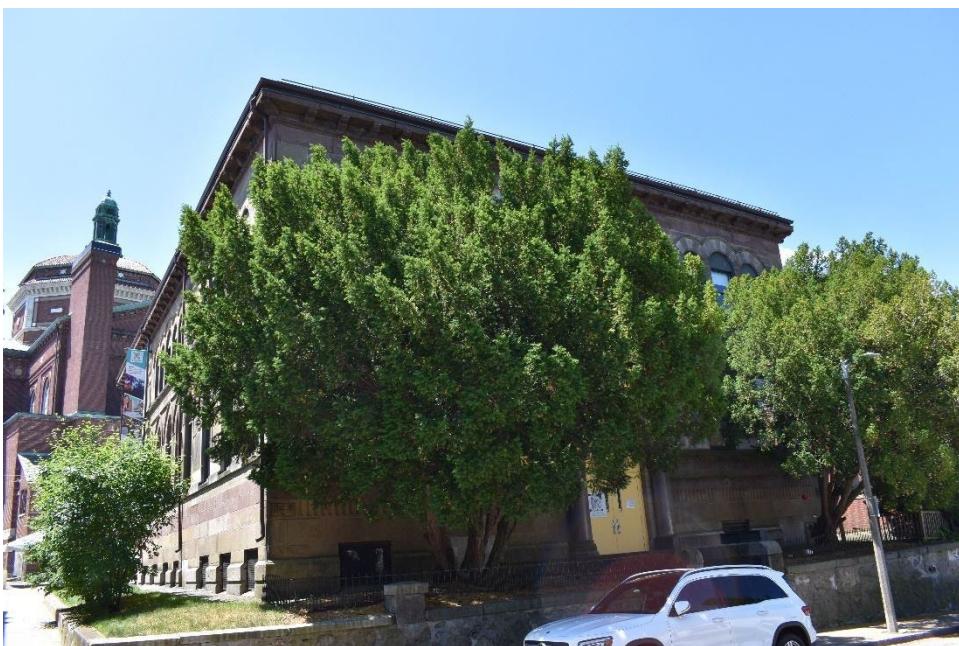
Figure 27. North (front) elevation of the Cheverus School, facing southwest. Taken June 20, 2022.

The façade is arranged symmetrically around a central entrance which is accessed by a flight of eight granite steps set into the puddingstone retaining wall lining the street. The wall is capped by rounded granite shoulders on either side of the stairwell and is lined along the top edge by a delicate wrought iron fence. The stone wall lining the street intersects with low granite block stair walls on either side of the steps. A second opening in the retaining wall is located immediately west of the building and provides access to the alley between this and 35 Creighton Street. A granite foundation and water table lines the base of the building and includes a number of regularly-spaced openings centered above the bays on the upper stories. On the façade these openings have been enclosed with cement block or metal grates.

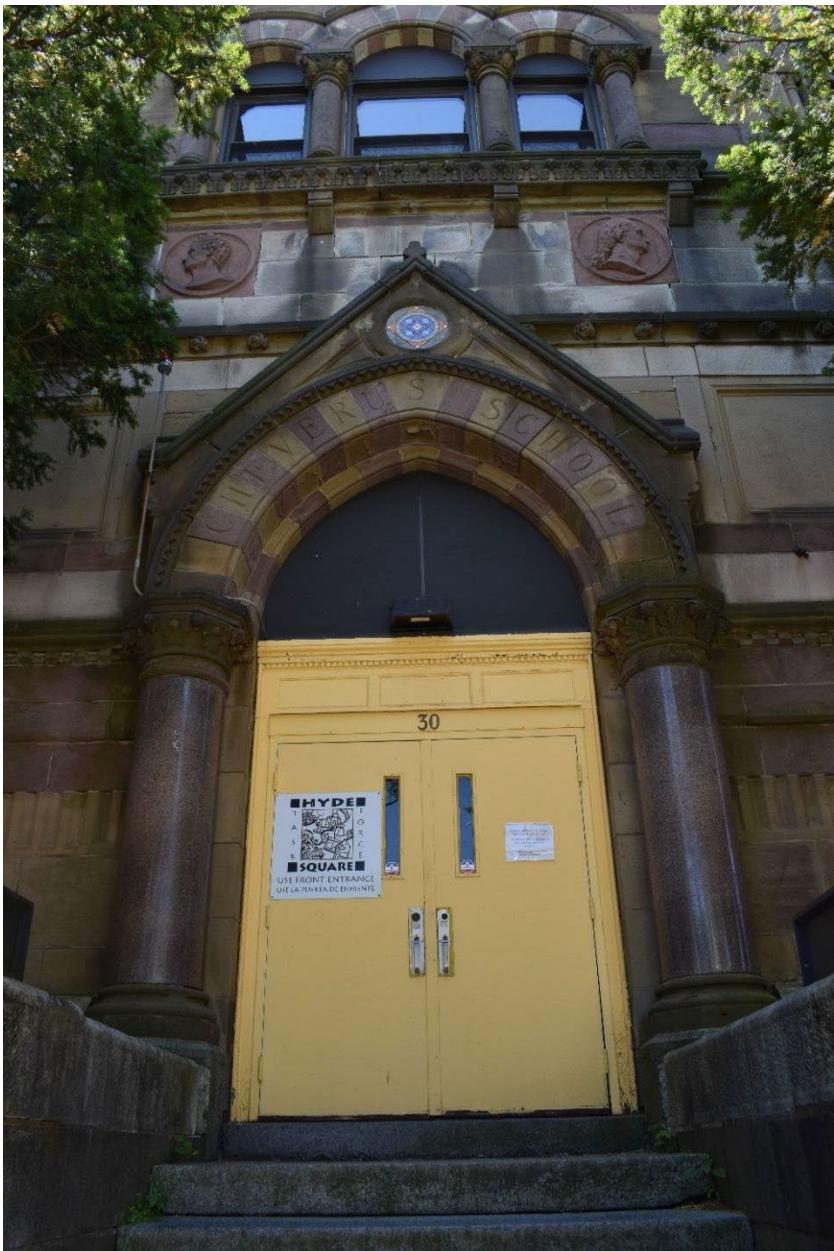
Figure 28. Detail of front entrance of the Cheverus School, facing south. Taken June 20, 2022.

The entrance is the focal point of the building and is defined by a shallow gabled portico with a slate “roof” lined by a narrow band of cornice trim. The gabled end is infilled with a round medallion. A narrow line of denticulated molding lines the pointed arch above the door which contains alternating red and white voussoirs, each inscribed with letters spelling “CHEVERUS SCHOOL”. This arch springs from polished marble columns flanking the entrance topped with capitals featuring an acanthus leaf design. These are, in turn, topped by an octagonal abacus. The same octagonal shape is found on the marble base and granite pier on which each capital rests. The door itself is fitted with a modern steel double door, each one narrow window in the upper half. An arched transom (now covered) is set above a molded wooden cornice which tops the door above three horizontal panels and a denticulated line of trim. Above this line is another rough dressed stone course, above which are cast stone plaques set in a recessed, molded surround that infill the spaces between the windows of the first story. Just beneath the second story windows, are two terracotta medallions with high relief profiles of Abraham Lincoln (east) and George Washington (west). The south elevation mirrors the north exactly, except that instead of the medallions of Lincoln and Washington’s profiles, there are rosettes beneath the second story windows and a cast stone plaque between them.

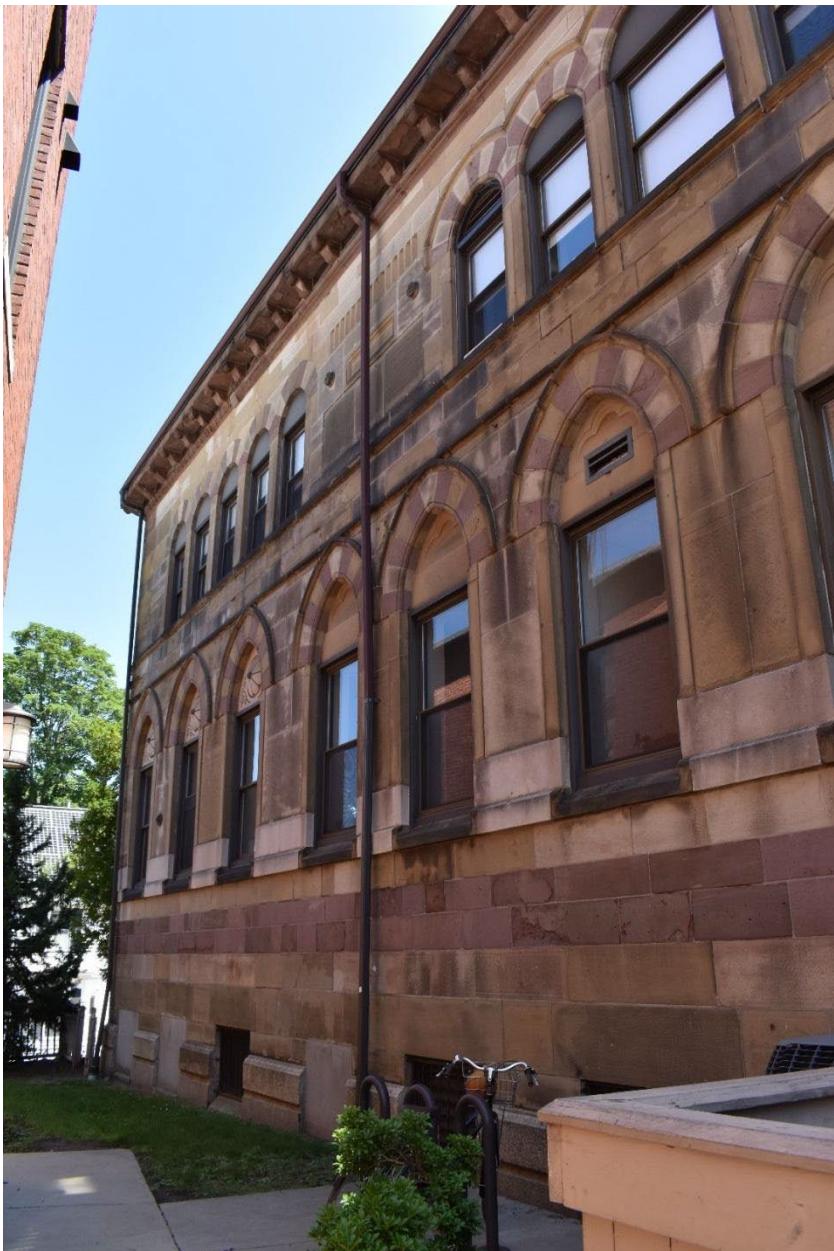
Figure 30. West elevation of the Cheverus School facing northeast. Taken June 20, 2022.

The east and west elevations are arranged symmetrically in three parts, each with five windows on the upper story and four below. The windows on the side elevations mimic those found on the façade with slightly less detail and flat belt and string courses. Windows with pointed arches continue to run along the first story of the side and rear elevations, and on the second story round arched windows are arranged in runs of five.

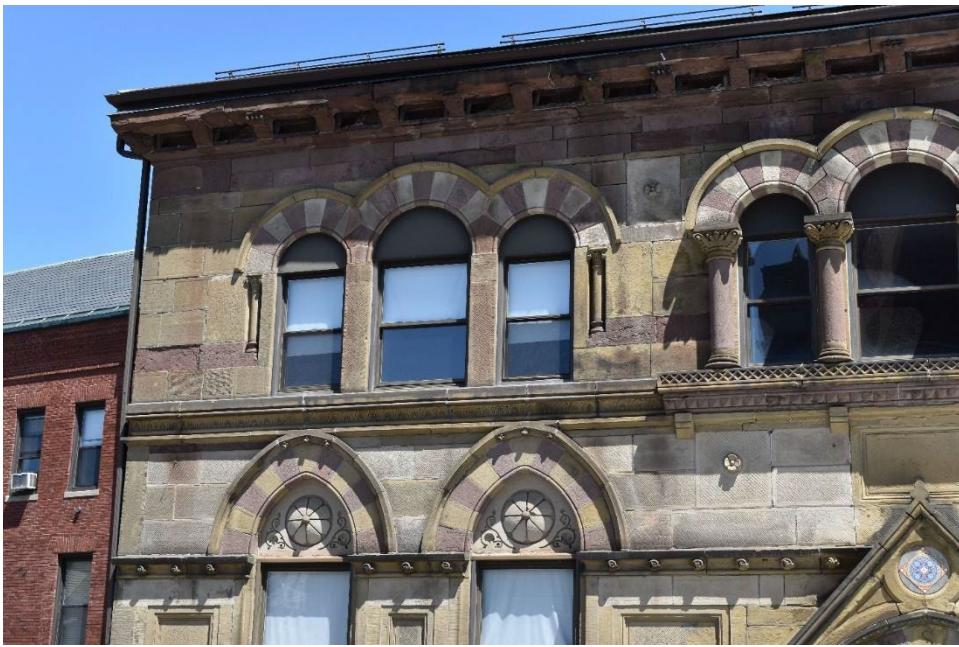
Figure 33. Detail of decorative trim on the south (rear) elevation of the Cheverus School, facing north. Taken June 20, 2022.

elevations as plain stone. Glazing has been modernized to one-over-one double hung replacement windows throughout with single light, arched transoms. Rosette bosses also appear on small panels between each of the second story windows. A wide projecting stone cornice lines the roof and features scrolled modillion blocks set above a line of egg and dart trim. The cornice and its associated decorative elements wrap around the entire building

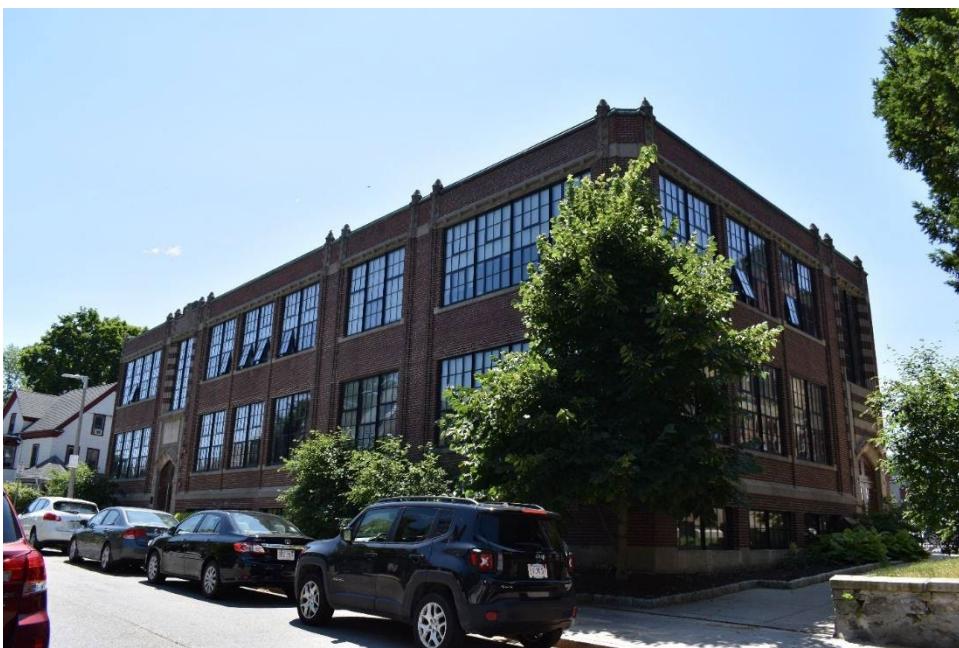
Figure 36. North (front) elevation of St. Norbert School, facing southeast. Taken June 20, 2022.

The St. Norbert Roman Catholic Parochial School, designed by noted architect Charles Reggio Greco (1873-1963), was built in 1926 at 20-24 Sunnyside Street. The two-story Jacobethan Revival-style former school faces north towards Sunnyside Street. The rectangular plan of the building measures seven bays across the façade by three bays deep. The building widens slightly on the eastern end to match the line of the street and there is a shallow projection extending from the western end of the southern elevation. The walls are constructed of brick with cast stone details and the flat roof is sunken behind a low parapet on all sides. The brick is set in a Common bond with Flemish bond every 6th course.

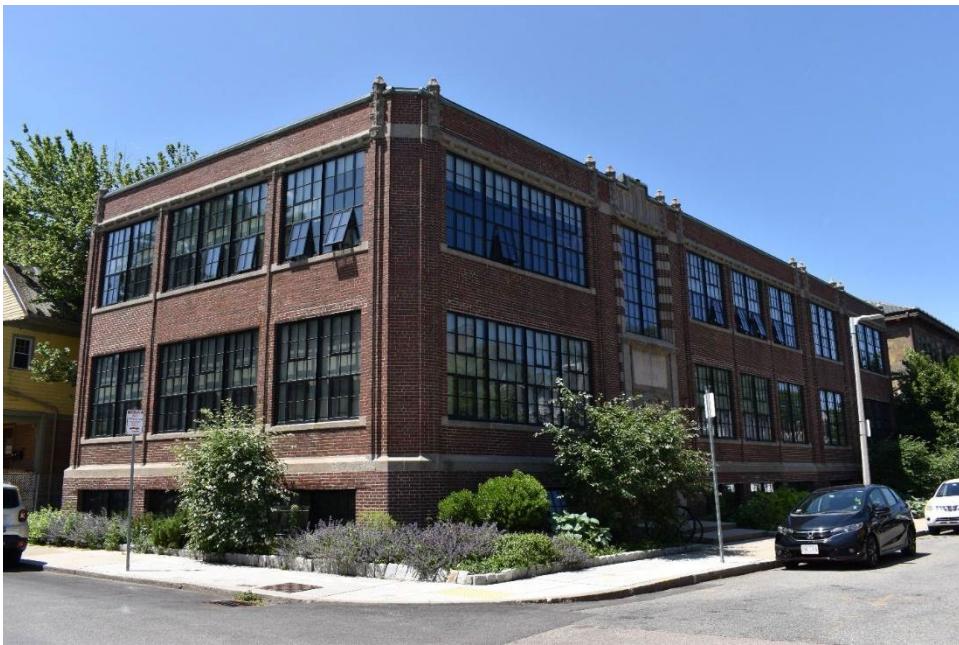
Figure 38. North (front) and east elevation of St. Norbert School facing southwest. Taken June 20, 2022.

These same decorative elements continue onto the east and west elevations. On the eastern elevation the building is set close to Westerly Street. Pairs of windows are found on first and second stories and flank triple windows of the central bay. The same configuration of openings is found on the western elevation with the addition of a second entrance found in the rear stair tower. This entrance and window above mimic the ones found on the façade, but with alternating lines of bricks and cast stone over the door instead of the school name plaque found on the façade.

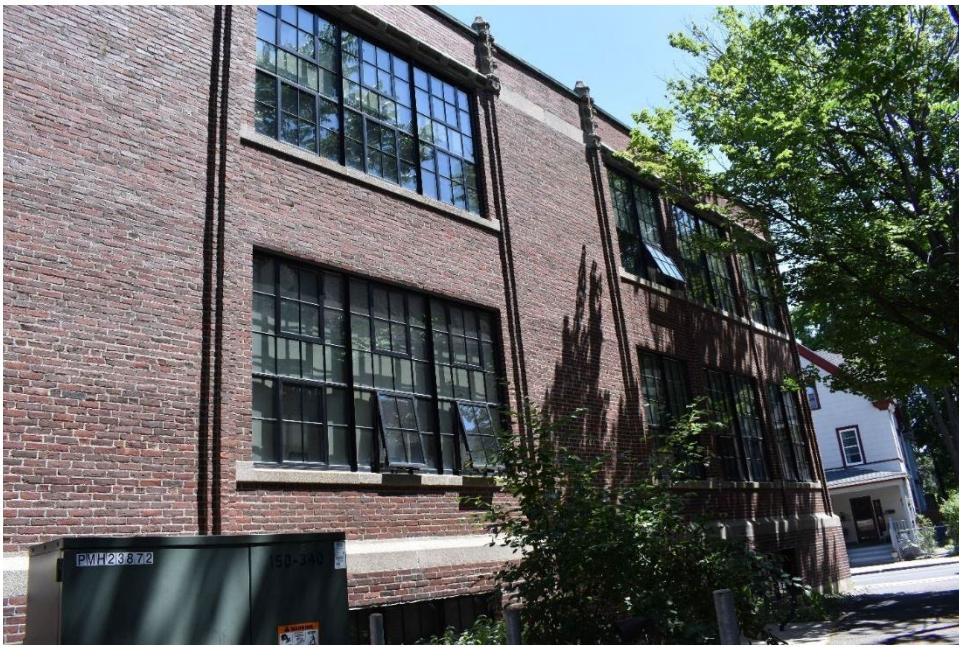
Figure 40. South (rear) elevation of St. Norbert School, facing northeast. Taken June 20, 2022.

The rear of the building (southern elevation) is visible from Centre Street. The copper coping lining the roof parapet remains along with a flat belt course at the height of the roof. Windows are arranged irregularly with blind walls on the western half of the building. A single window on the first and second stories is found west of a triple window like those found on the other elevations. This is set within a stepped brick surround similar to the ones found on the façade and west entrances, but without the polychromatic details.

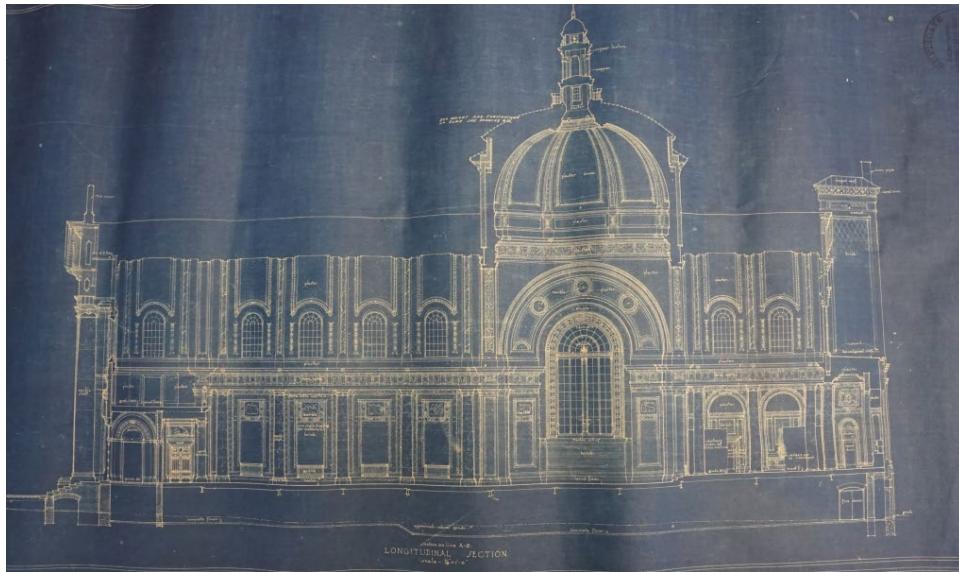
Figure 45. Longitudinal section of the Church as drawn by Charles Greco.

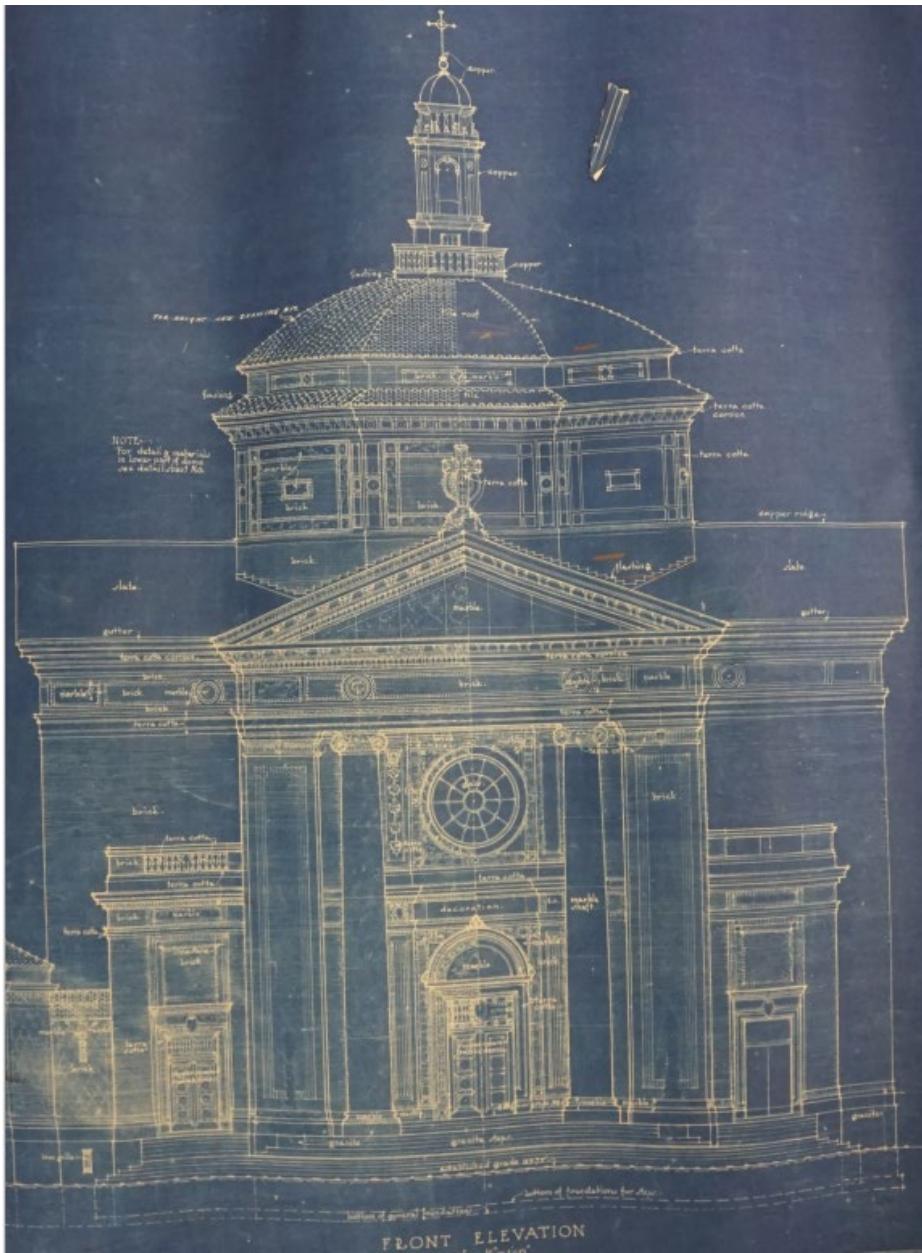
Figure 46. Elevation of the façade of the Church as drawn by Charles Greco.

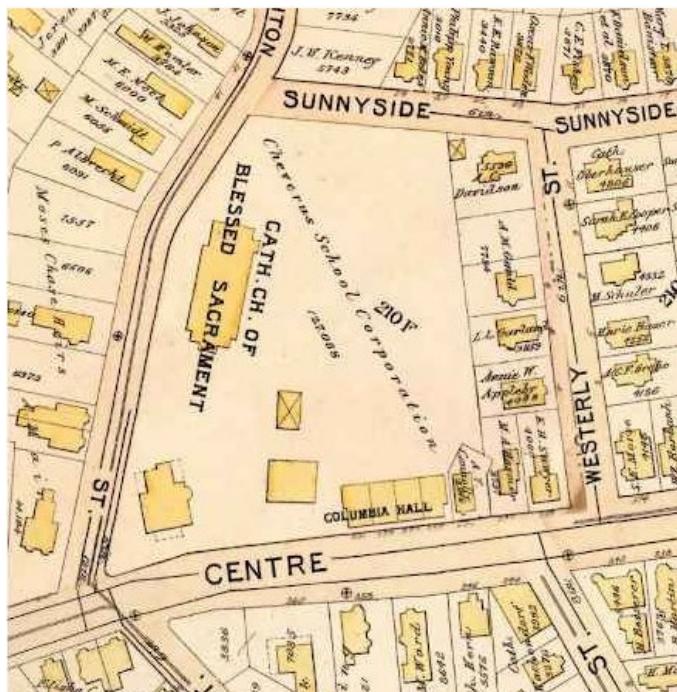
Figure 56. Excerpt from an 1895 map of the Blessed Sacrament Complex area.

On the 1895 Bromley map, the Catholic Church of the Blessed Sacrament is shown occupying the western side of the parcel. This was the original wooden church and school constructed on the property in 1891. The rectory was located at the southwest corner of a lot near Centre Street and Columbia Hall was found along the south edge of the lot, facing Centre Street. The “Cheverus School Corporation” is shown as owner of a portion of the parcel.
