TREMONT TEMPLE

BOSTON LANDMARKS COMMISSION

STUDY REPORT

The Tremont Temple
78-88 Tremont Street, Boston, Massachusetts

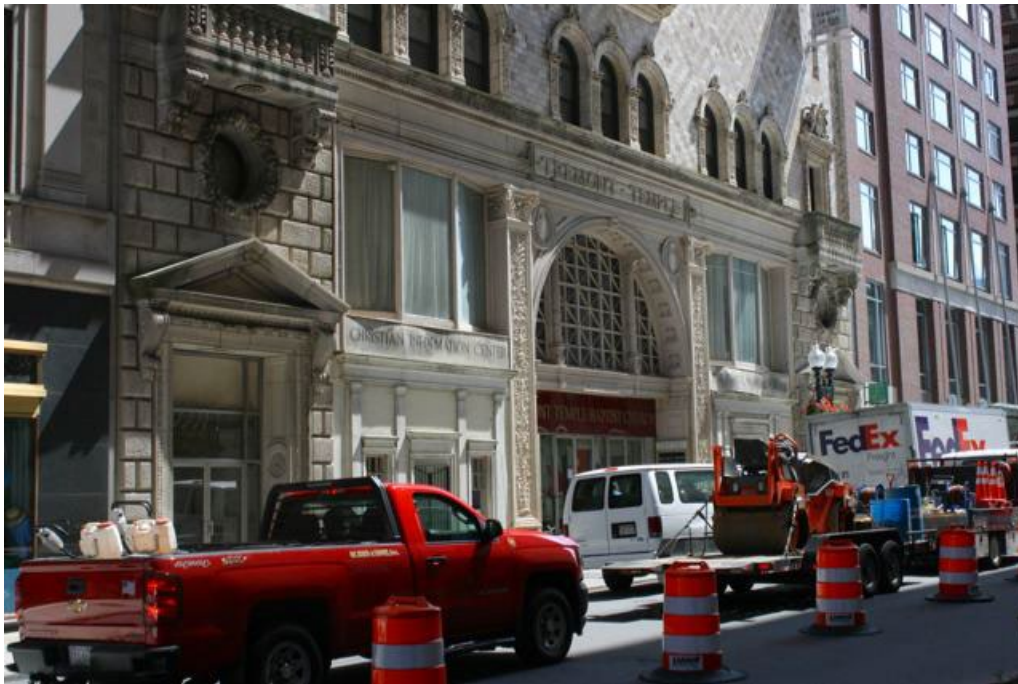
Figure 3. Façade (west) elevation: Base of building with storefronts and entrances.

The two-story base of the façade contains three building entrances (one main entrance in the center and two in the outer bays) alternating with two storefront bays (Figure 3). The end bays are clad with rusticated and vermiculated limestone; their terra cotta-trimmed doorways, now containing modern glass and metal infill, are framed with multiple bands of ornate molding and a pediment supported by a pair of console brackets. Surmounting each of the outer entrances is a large oculus window encircled by a high relief molding with botanical motifs (Figures 5 and 6). The entire two-story base is capped by a high, terra cotta entablature with classical moldings and dentils; centered over the main entrance is a plaque with the building name, “TREMONT TEMPLE”.

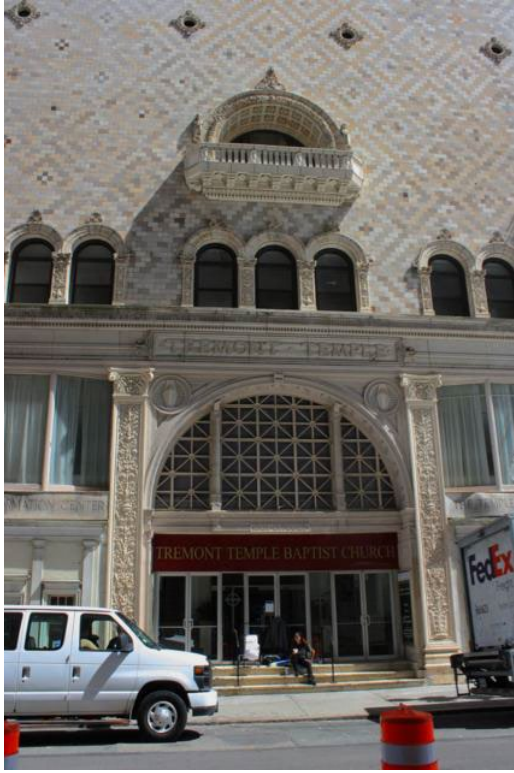
Figure 4. Façade (west elevation): Main entrance.

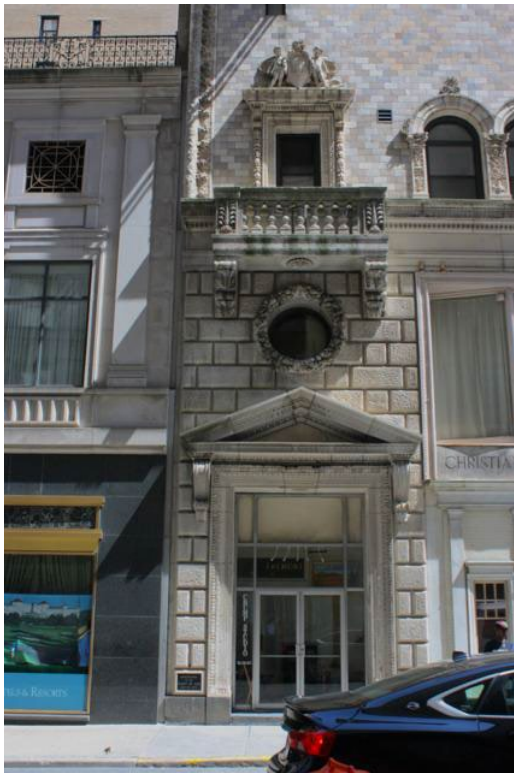
Figure 5. Façade (west elevation): Left (north) entrance.

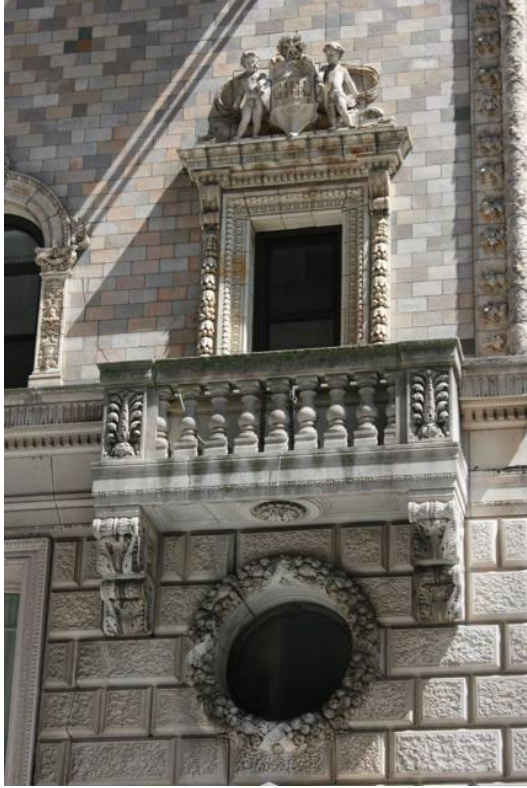
Figure 6. Façade (west elevation): Detail of ornament over left (north) entrance, 2nd and 3rd floors.

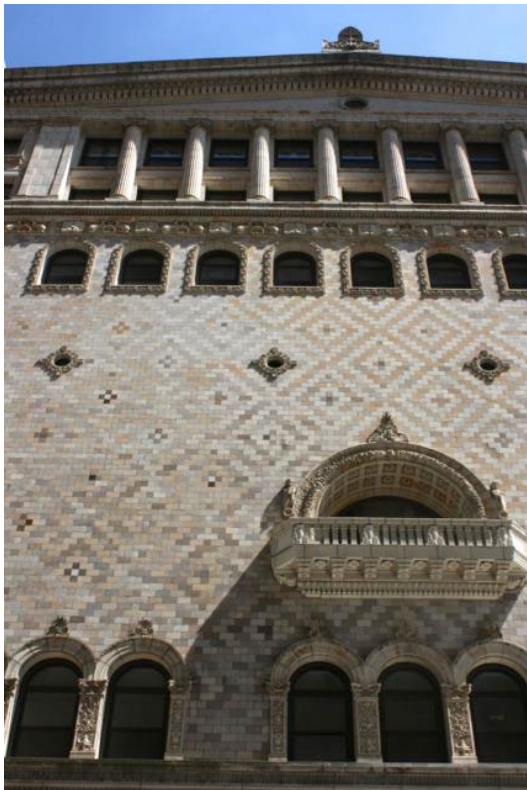
Figure 7. Façade (west elevation): 3rd through 8th floors.

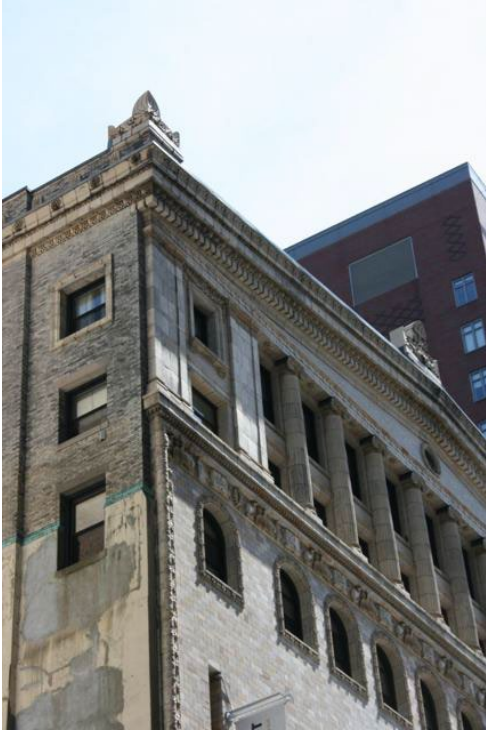
Figure 8. Northwest corner of building (north and façade elevations), 5th through 8th floors and detail of roof edge.

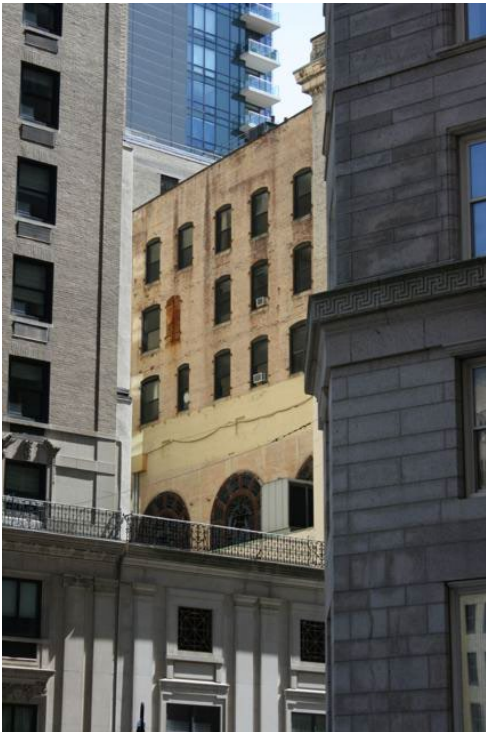
Figure 9. North elevation (light-ochre color wall in center of image), upper floors.

At the rear block of Tremont Temple, the north elevation is recessed about ten feet behind the frontispiece (Figures 2 and 9). Constructed of brick (painted a light-ochre color), this comparatively utilitarian wall displays six large, round-arched windows with original or early stained glass at the fourth-story level and a multitude of evenly spaced, segmentally arched windows at the sixth through eighth floors, all without visible trim beyond a stone or cast stone sill and a curved lintel of three courses of header brick. Most windows appear to retain metal pintels, and one pair of solid metal shutters is visible. The photo in the 1980 survey form (BOS.2070) shows the south elevation having similar massing and fenestration; the neighboring building at 90 Tremont Street now obscures all but the top three floors of the westernmost bay of the south elevation.
