9 Claremont Park Fencing/ Railings

Landmarks

Oversight for Review

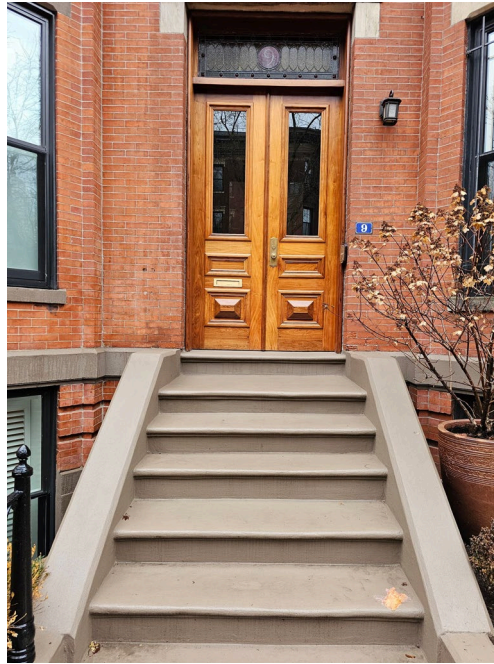
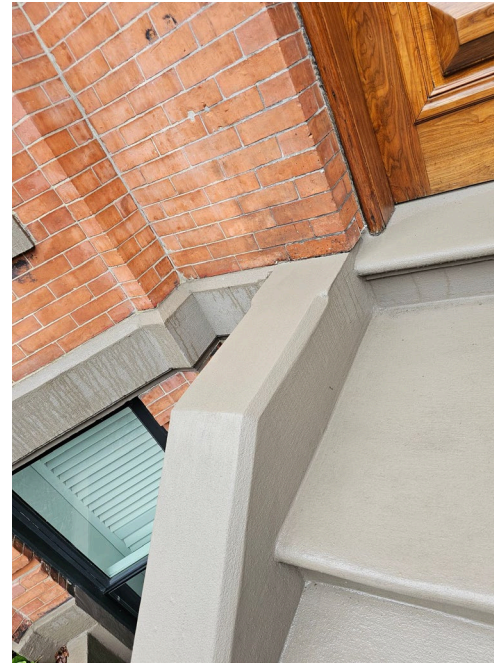
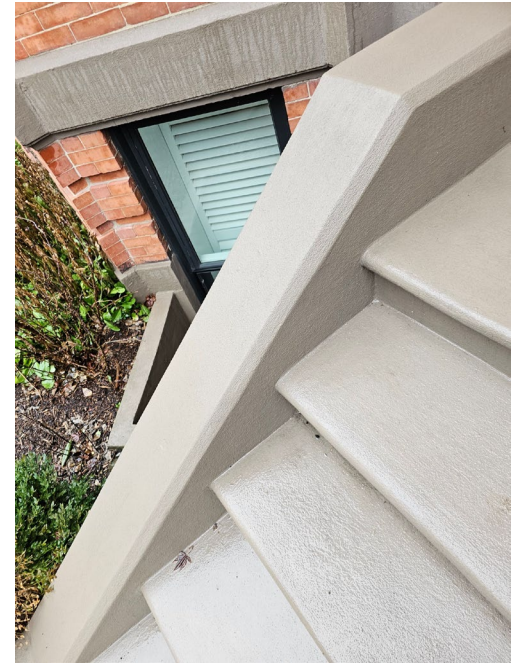
Current Status at 9 Claremont

- No handrail on stairs
- No fencing
- No holes for fence or rail indicating never been installed.

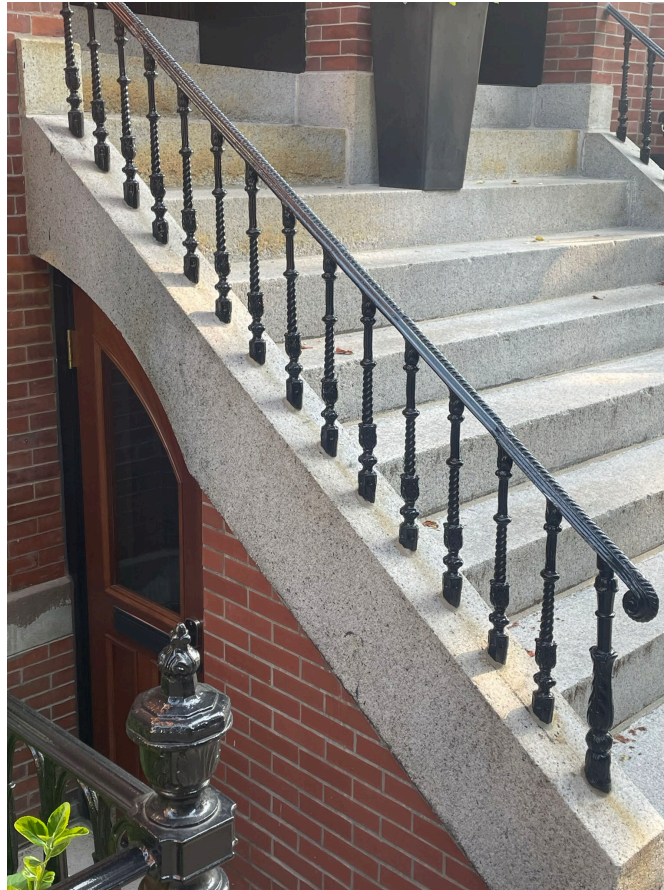
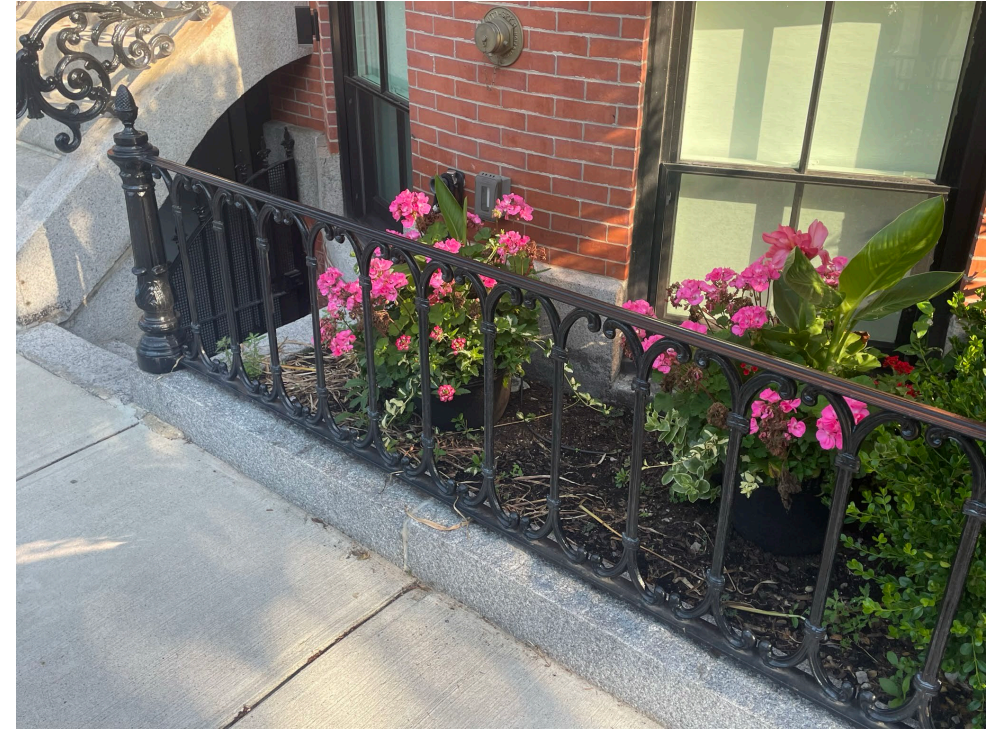
Owner request

- Owner is asking to approve this detail for railing and post

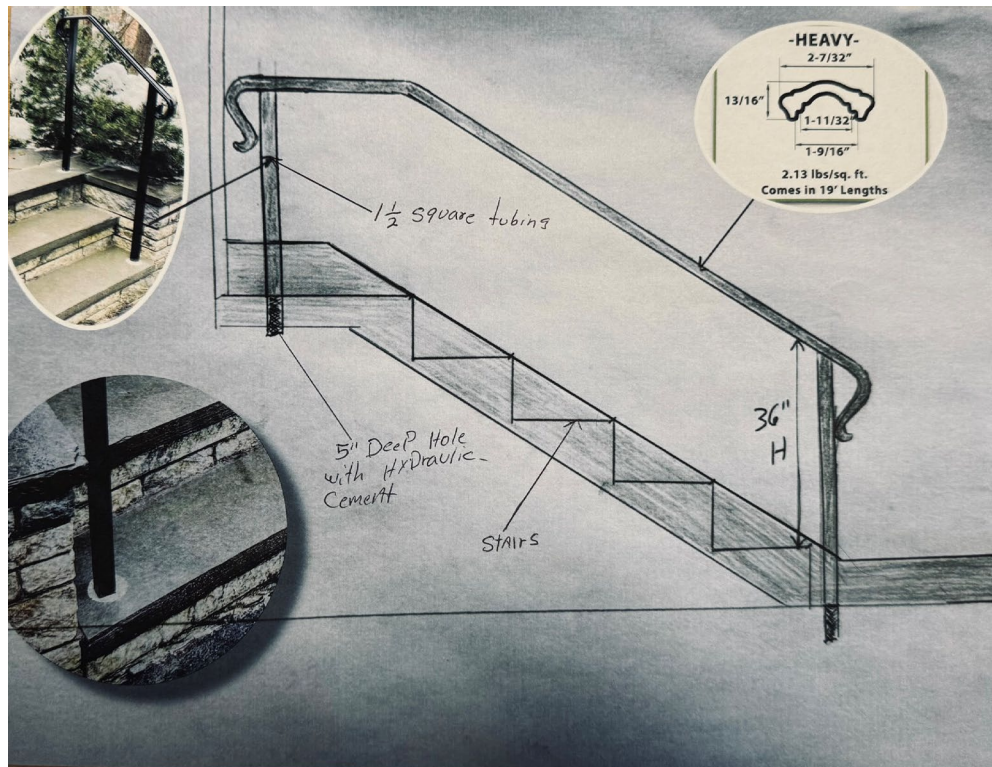
Material Details

Top Handrail Made of heavy Commercial steel molding 2 7/32"

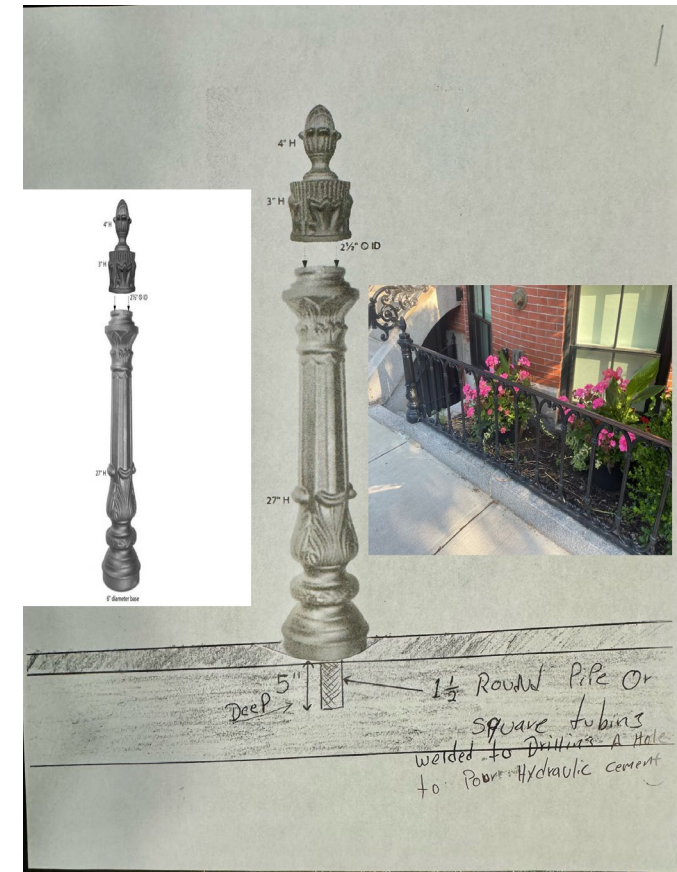
Post Cast iron Fence Post, 1 piece, 1- or 2-piece base with 1 1/2 tubing weld it to bottom and core drill 2" hole 5" deep and pour hydraulic Cement

Top Heavy Commercial Molding, 26" Tall Cast Iron Baluster w/scroll ends, double faced Panel

On Bottom 1 1/2 x 1/2 Flat batt
