## RONAN PARK – CONSTRUCTION UPDATE #1

September 4, 2026

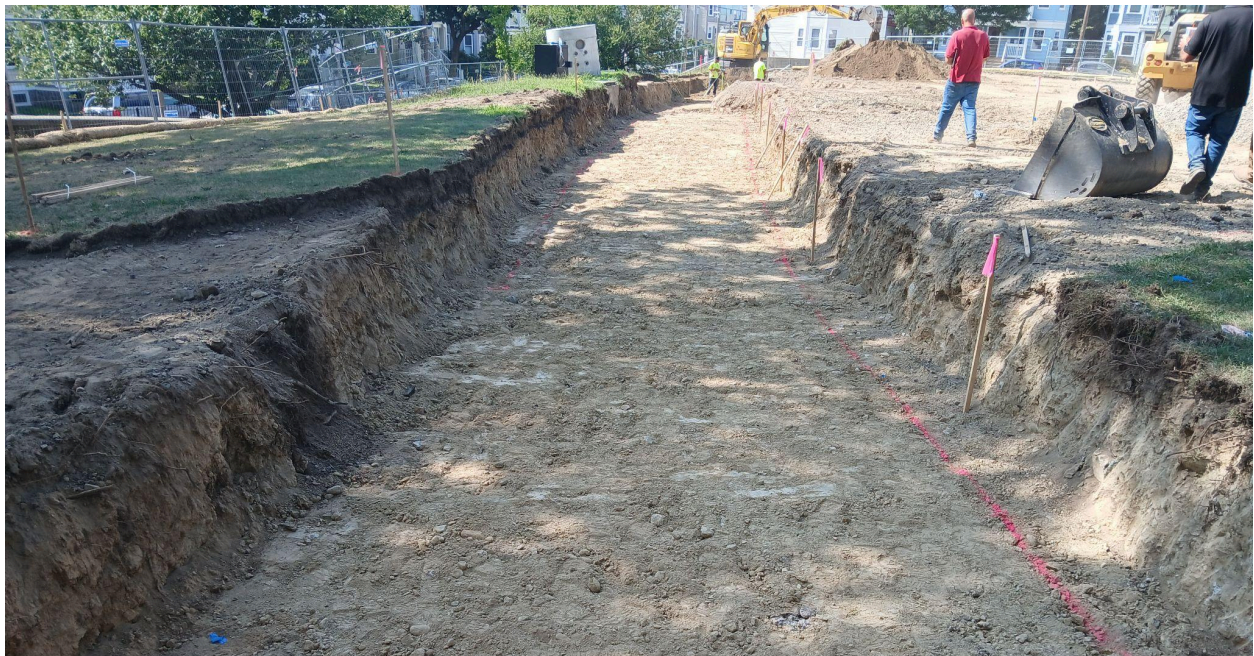
*Excavation for new porous asphalt pathway loop.*

- Paving: existing paving has been demolished, including the large staircase between the upper and lower park areas next to the basketball courts. Excavation for the porous asphalt pathways to a depth of 36" is nearly complete.

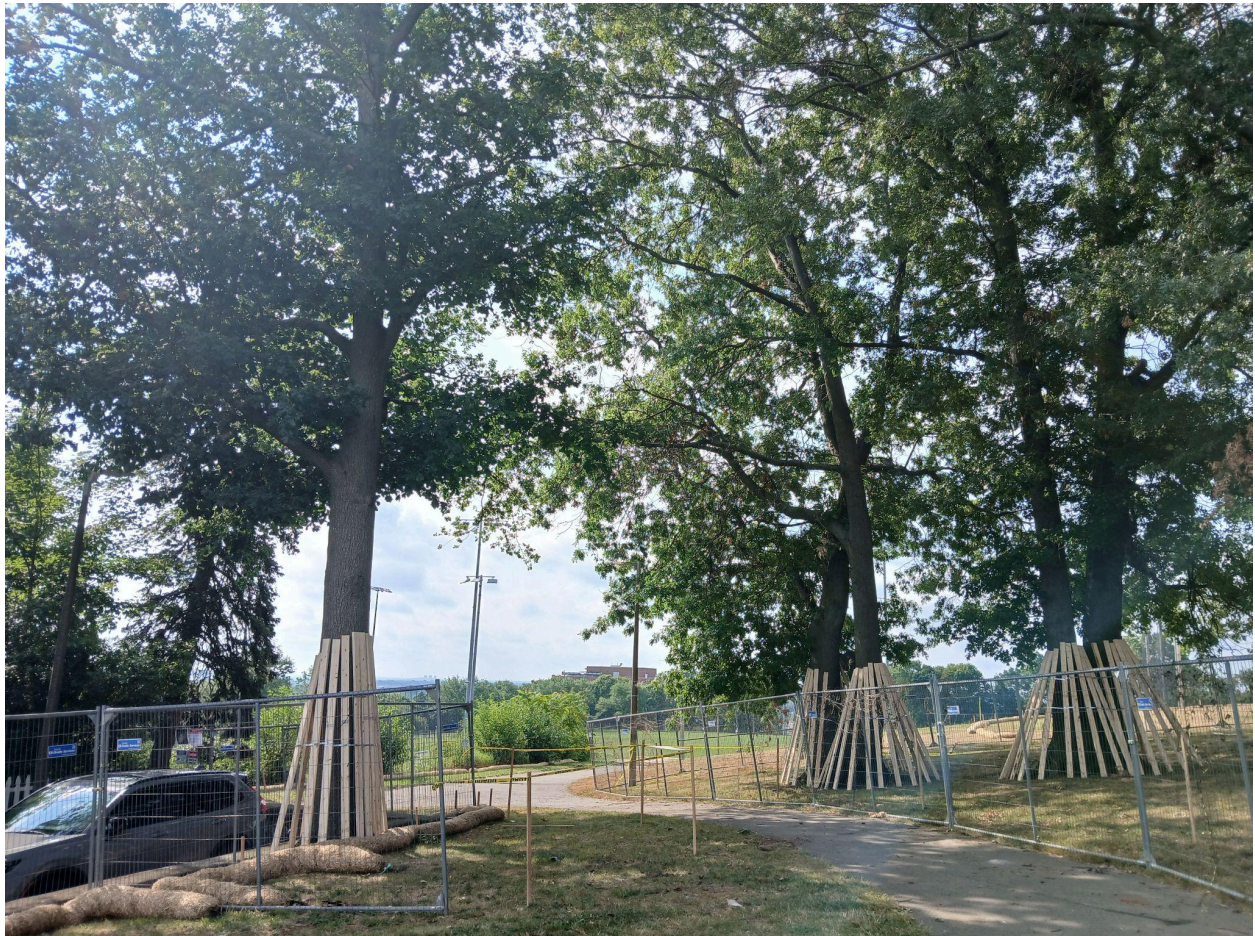
*Tree protection measures.*

- Tree Protection: existing trees have been wrapped with 2x4s to protect their trunks from equipment, and chain link fencing has been installed at the edge of tree canopies to create a protected zone that will remain clear of construction.

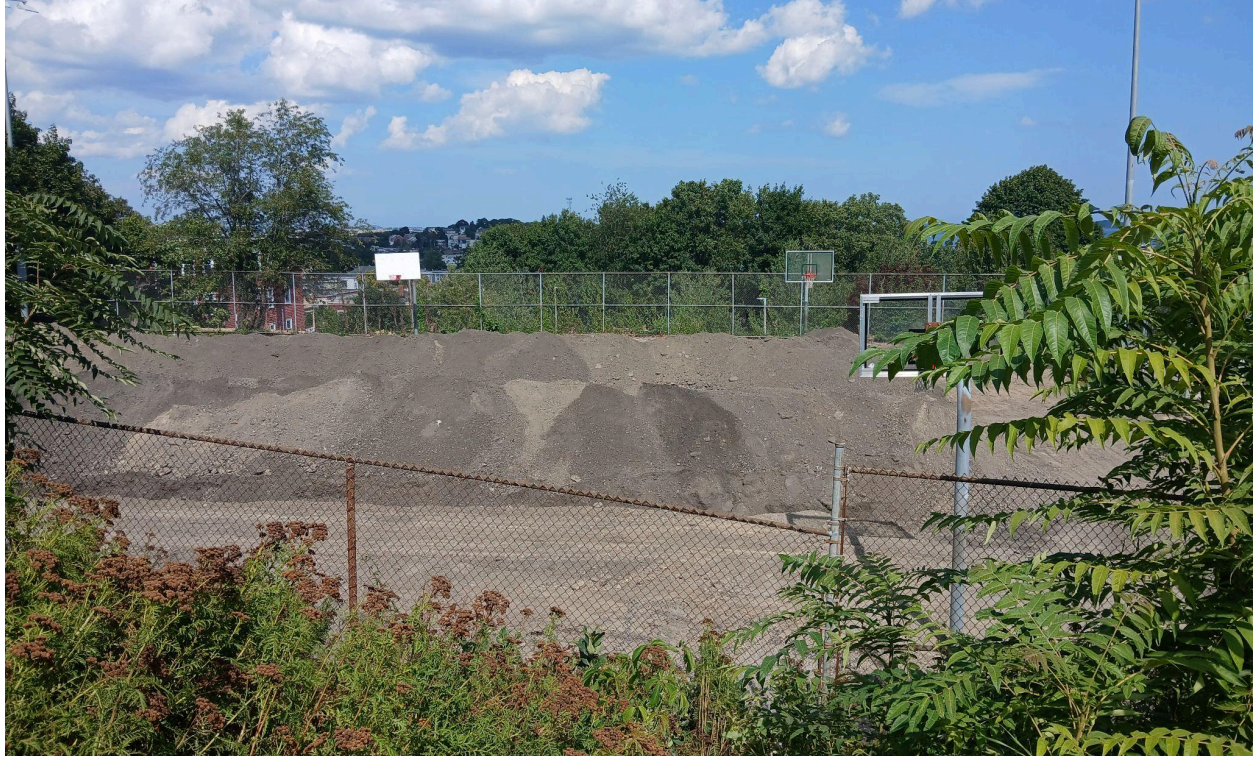
*Basketball court pavement demolition as seen from the former stair.*

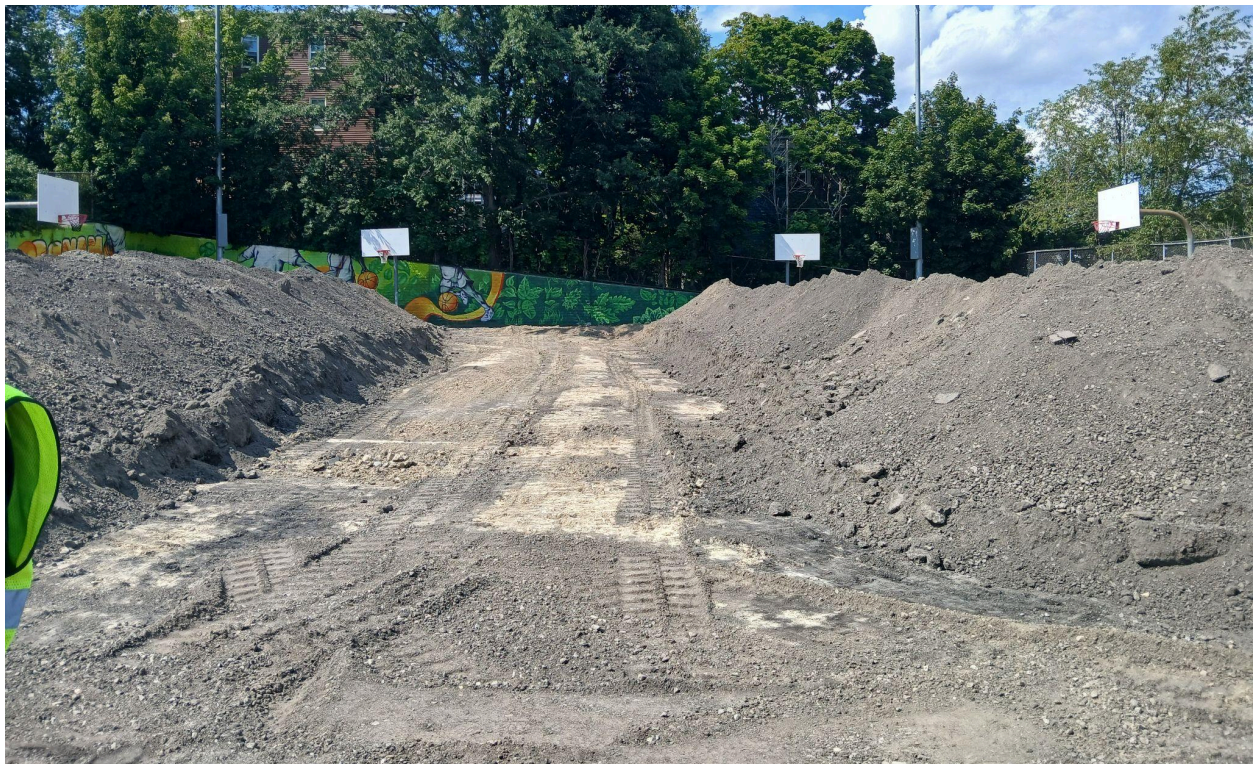
*Basketball court pavement demolition with view of protected mural beyond.*

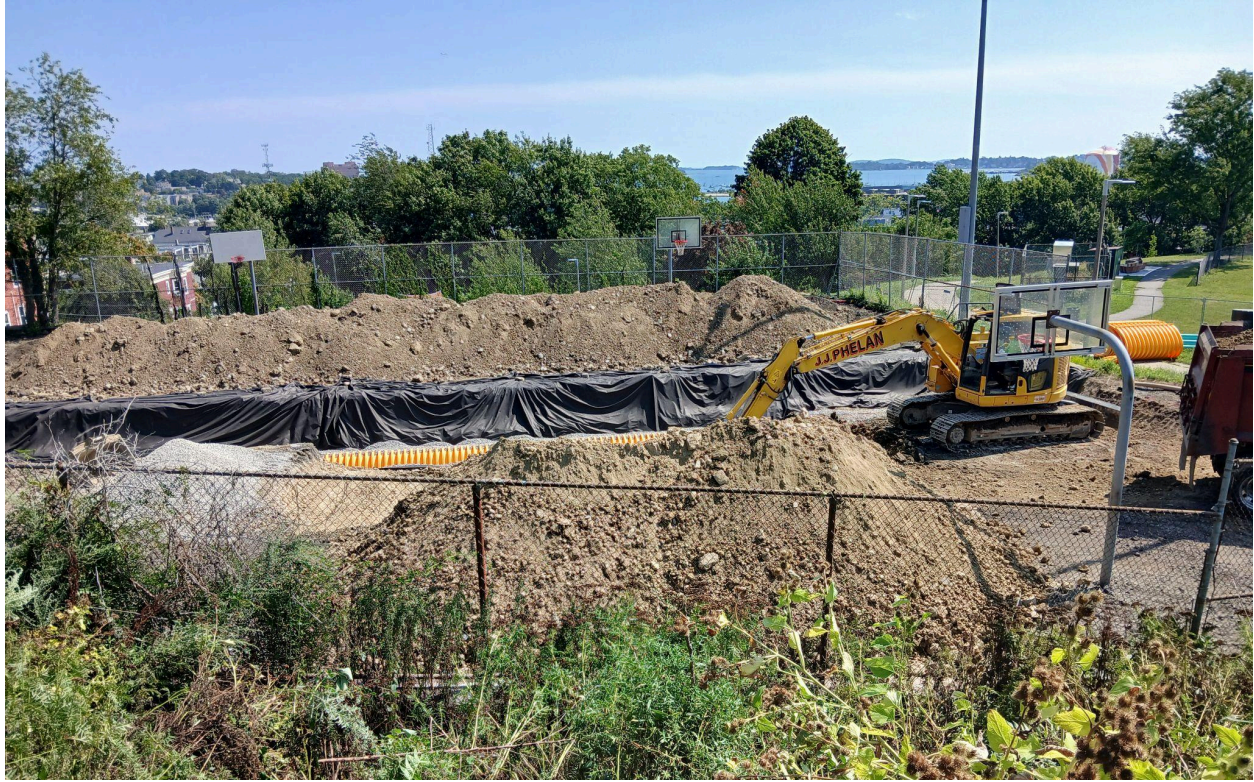
*Basketball court drainage infrastructure being installed.*

- Drainage: subsurface infiltration chambers for the non-porous pathways and court pavement have been installed beneath the basketball courts. Drywells and catch basin infrastructure are nearing completion. BWSC has been out to inspect and approve installations.

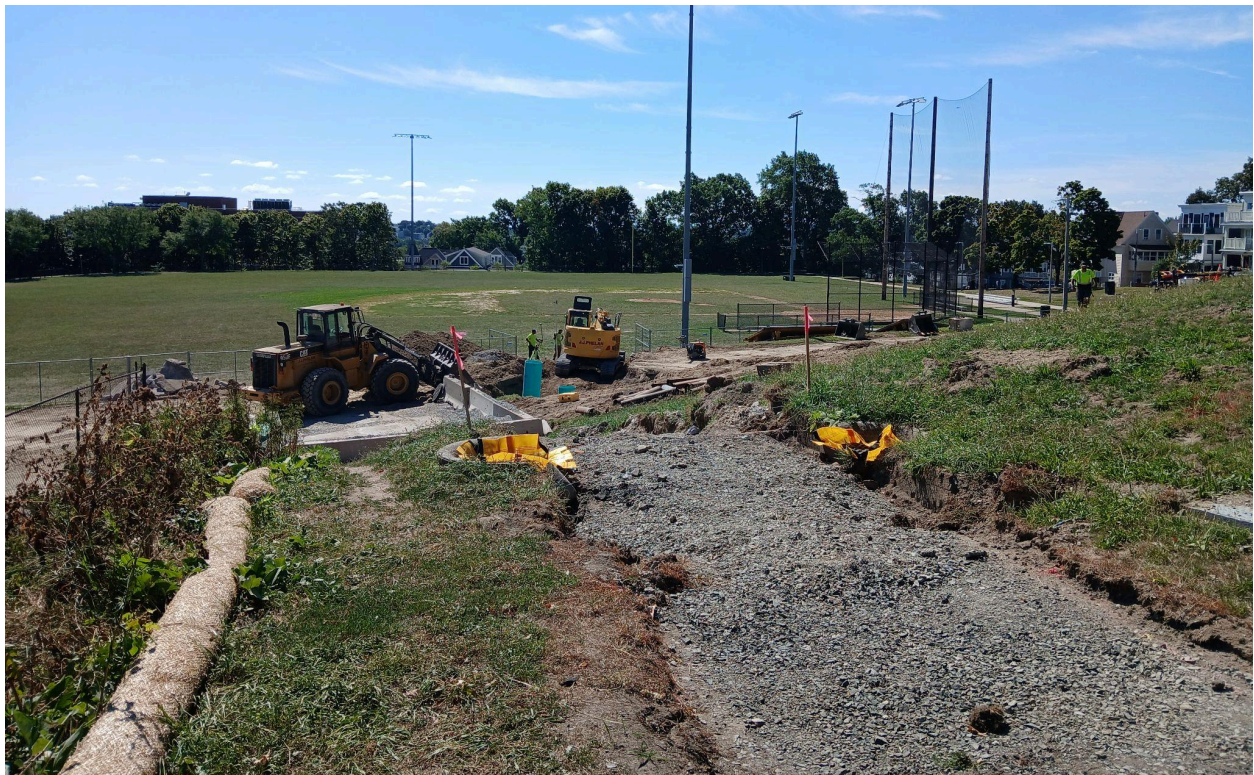
*View down from the top of the former staircase to where more drainage infrastructure is being installed.*

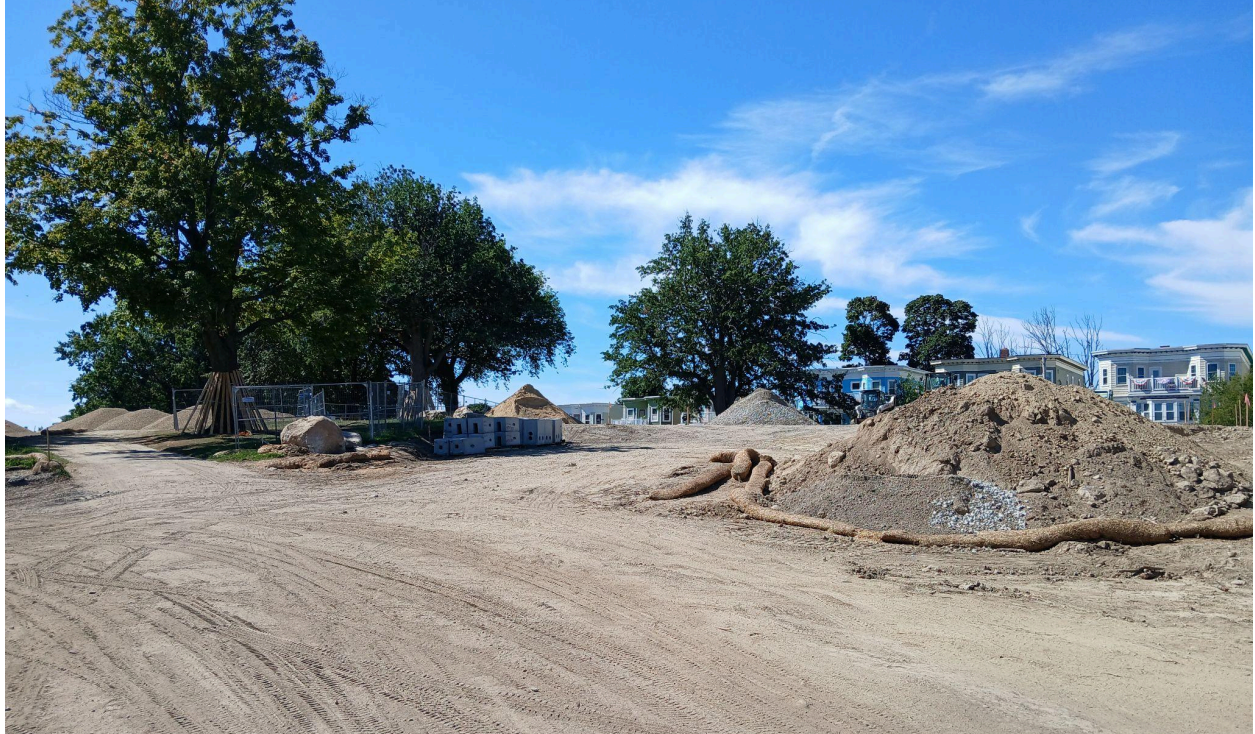
*A view into the site from the vehicular entrance at Marie Street. The contractor uses a watering truck to spray down the ground and piles each day to prevent dust in the air.*

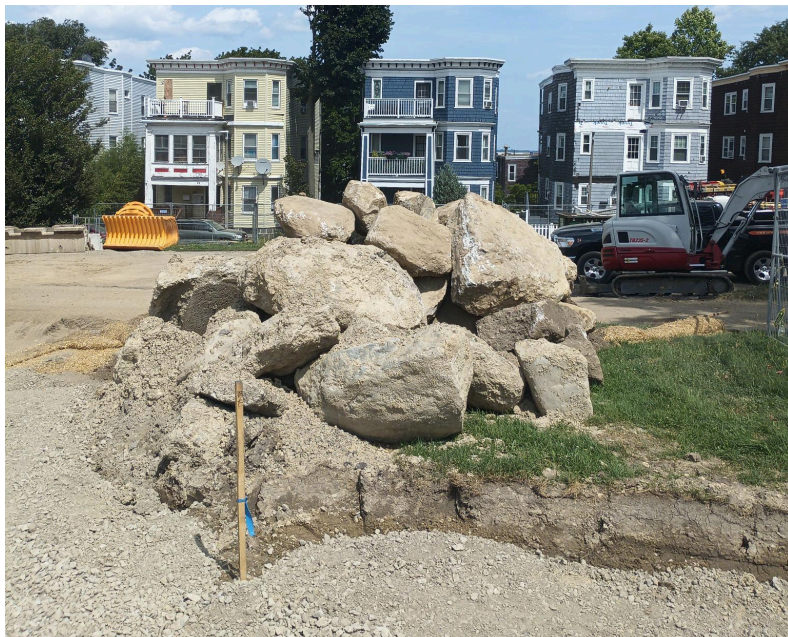
*Some of the boulders that have been uncovered and collected during excavation, which will be incorporated into the renovation in various ways.*

- Other: several large boulders have been uncovered from below ground, and will be incorporated into the renovation in different ways. Invasive species have been treated and removed from the hillside between the stair and the basketball courts. Existing seatwalls and other elements to remain have been protected with wood 2x4s.
